## **RCRA Inspection Report**

Safety-Kleen Systems, Inc.  
120 Richardson Drive  
Jackson, MS 39209

EPA ID# MSD000776765

Appendix 1  
Safety-Kleen  
RCRA CEI Photographs  
Mark Anthony Relon, US EPA

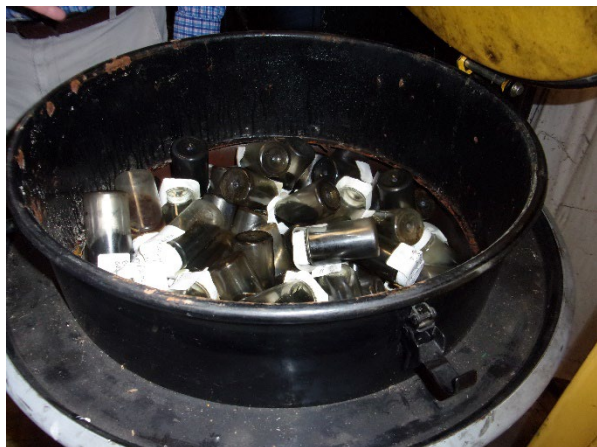
Figure 1: 9:21 AM Retain Storage Area

Safety-Kleen manages a satellite accumulation area (SAA) in the Retain Storage Area for managing hazardous waste combustible liquids that are generated by sampling their customers' waste (Figure 1). The inspectors observed one 55-gallon container in this SAA. The drum was located adjacent to flammable cabinets storing the temporary retained samples (Figure 4), and it was equipped with a latching lid (for draining into an open head drum), which was closed (Figure 2). The drum was marked as "SAMPLES-JAB", labeled D001, D006, D007, D008, D018, D039, D040 hazardous waste Retain/Oil Samples, and identified with a US Department of Transportation (DOT) flammable placard (Figure 3).

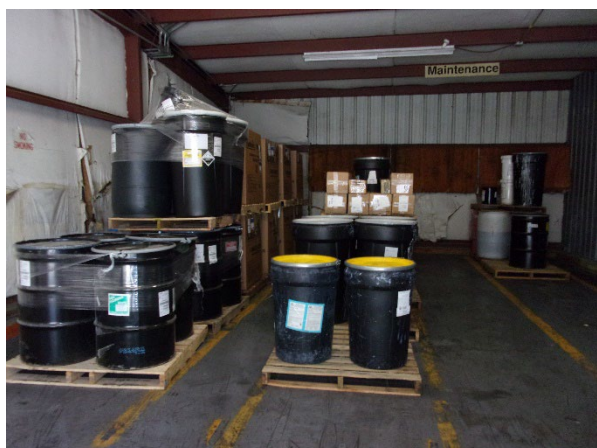
Figure 5: 9:27 AM Permitted Storage Area

Safety-Kleen manages a permitted storage area containing a central accumulation area (CAA), a 10-day transfer area, and waste pending analysis for managing hazardous waste toxic liquids, bleach products, etc. that is generated by customers' waste. The inspectors observed two 55-gallon containers and one 5-gallon container of hazardous waste in this CAA. The drums were located on the left section of the storage area, and they were equipped with drum cover lids, which were closed (Figure 5). The first 55-gallon container was marked as "HAZL-TOXIC,"

The CAA was identified with a sign which read “danger, hazardous waste storage.” Safety-Kleen manages ignitable waste ignitable waste in this CAA, and the inspectors observed “No Smoking” signs posted on the wall where the permitted storage area stores the containers (Figure 5).

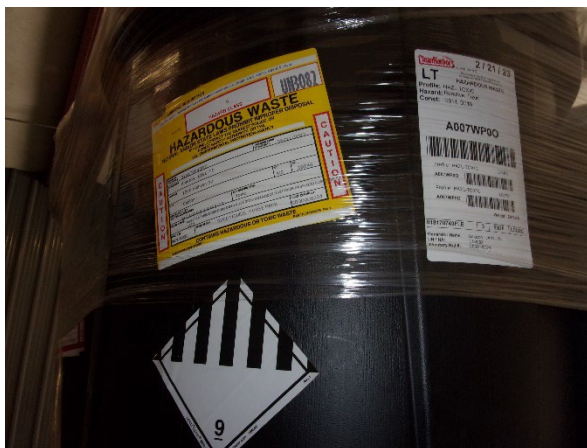
Figure 6: 9:29 AM Permitted Storage Area

labeled D005, D006, D008, D010, D011, D016, D018, D022, D027, D035, D039, U129 hazardous waste toxic liquids – loose pack, and identified with a DOT Class 9 Miscellaneous placard (Figure 6). The second 55-gallon container was marked as “HAZL-HYPOCHLOR,” labeled corrosive hazardous waste liquid hypochlorite bleach products, and identified with a DOT corrosive placard (Figure 7). The 5-gallon container was marked as “HAZS-FLAMREACT,” labeled D001, D008, D011 hazardous waste flameless ration heater or snaps, and identified with a DOT Class 9 Miscellaneous placard (Figure 10).

Inspectors notified facility personnel that the indication of hazards respective to Class 9 Miscellaneous placarding is not within EPA guidance and are needed to be changed respective to the responsible party. Since the container(s) were from Amazon and stored within the 10-day transfer area, the generator is therefore responsible for properly labeling containers with an indication of hazards compliant to RCRA standards.

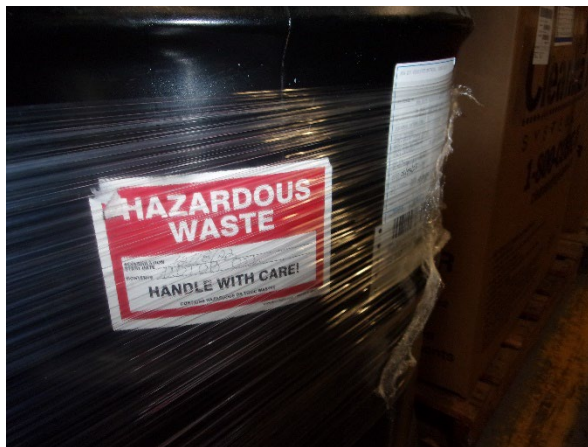
Figure 8: 9:32 AM Permitted Storage Area

Inspectors observed two 55-gallon containers with hazardous waste labels (Figure 8). Facility personnel stated the two 55-gallon containers were not hazardous waste (Figure 9). Inspectors notified facility personnel to relabel containers that were not hazardous waste and was corrected at the time of the inspection.

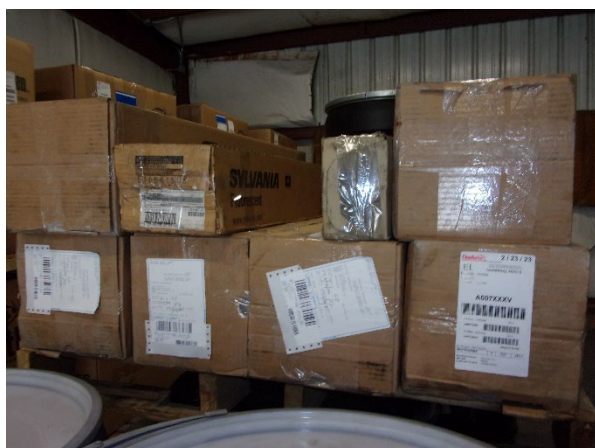
Figure 11: 9:41 AM Permitted Storage Area

Within the permitted storage area was waste pending analysis, universal waste, and non-hazardous waste located in the middle section (Figure 11 through 16).

Safety-Kleen manages universal waste lamps within the permitted storage area located in the middle section in front of the waste pending analysis area. The inspectors observed 8 containers of universal waste lamps in this area during the inspection. Eight 4-foot boxes of lamps, which were closed and marked with an accumulation start date, were labeled universal waste lamps (Figure 11). The oldest date observed on any container of lamps was February 23, 2023.

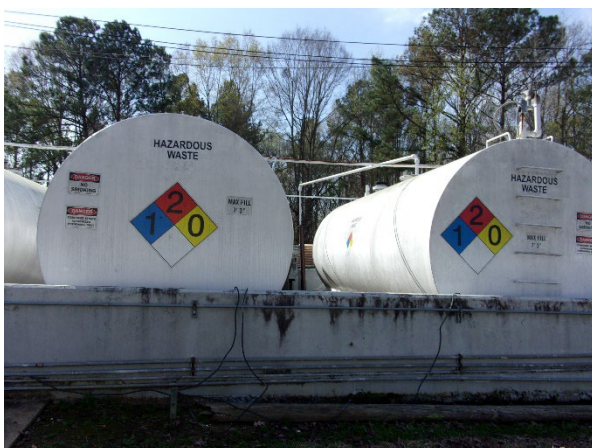
Figure 17: 10:01 AM Tank Farm

The tank farm consists of two hazardous waste tanks and one product tank containing clean solvent. One hazardous waste tank was offline/not in service (Figure 17). Inspectors observed

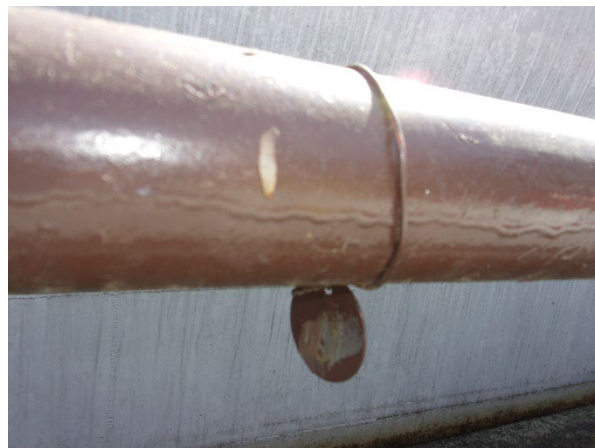
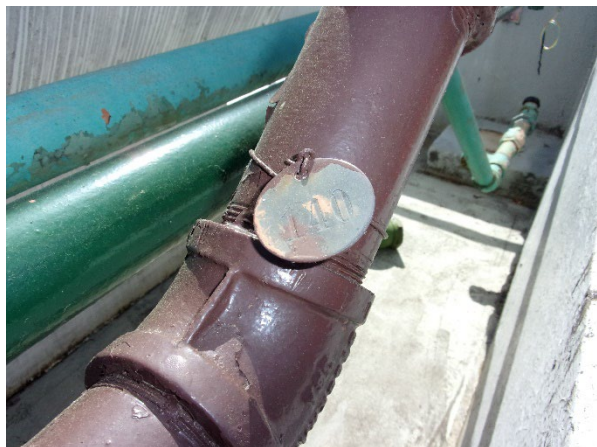
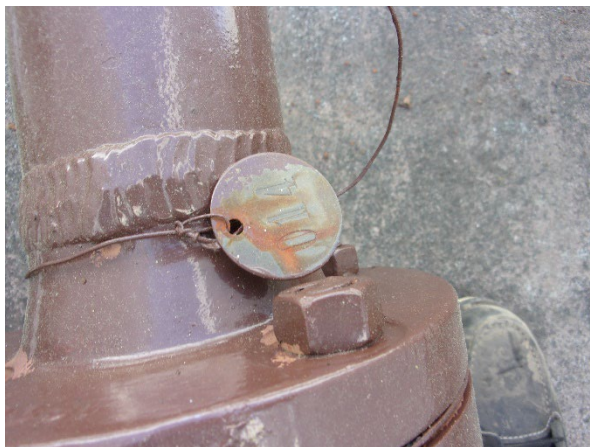
multiple instances within the tank farm displaying hazardous waste tank tags rusted and illegible due to weathering (Figure 18 through 20). From the permit application, it states “The inspection items have been properly tagged in accordance with 40 CFR 264.1050(d) and are inventoried on the environmental piping schematic diagrams included in Appendix E.9.”

**Pursuant to 11 Miss. Admin. Code Pt. 3, R. 1.3 [40 C.F.R. § 262.17(a)(2)], which incorporates 11 Miss. Admin. Code Pt. 3, R. 1.11 [40 C.F.R. Part 265, Subpart BB], and is a condition of the LQG Permit Exemption, a generator accumulating hazardous waste in tanks must comply with the RCRA Subpart BB organic air emission standards for equipment leaks, including, but not limited to, each piece of equipment to which this subpart applies shall be marked in such a manner that it can be distinguished readily from other pieces of equipment. 11 Miss. Admin. Code Pt. 3, R. 1.7 [40 C.F.R. § 264.1050(d)].**

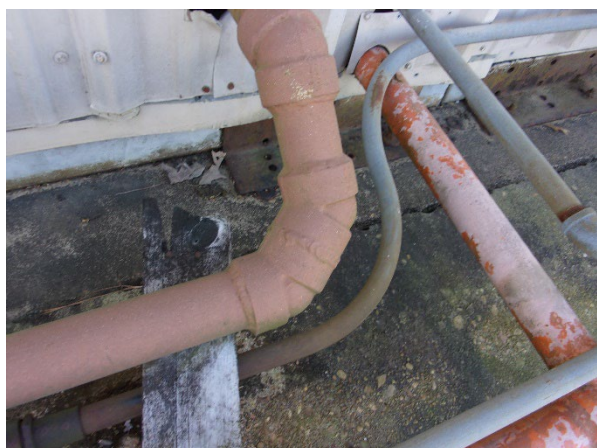
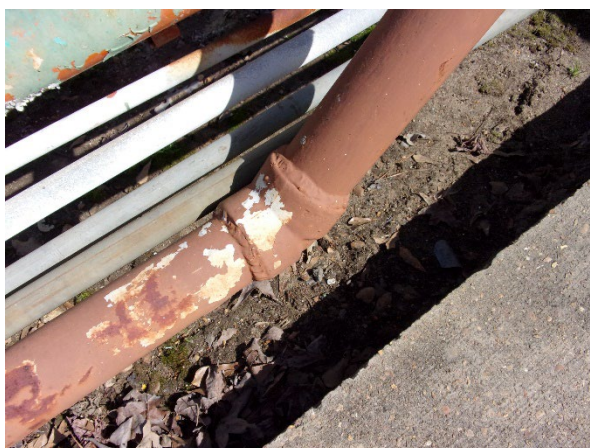
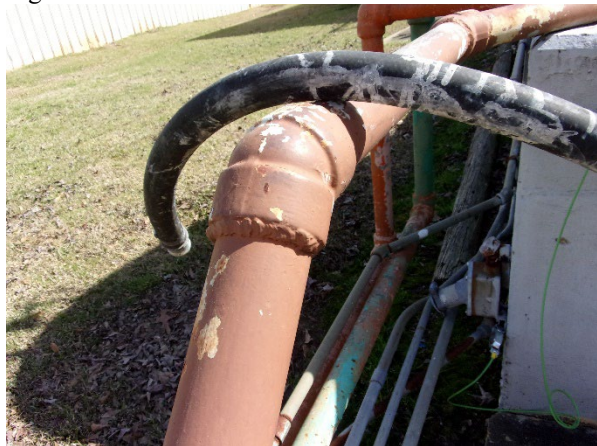
Inspectors observed welded piping outside the secondary containment area respective to the tank farm (Figures 21 through 23). Therefore, they were not subject to Subpart BB requirements such as tagging/markings of equipment.

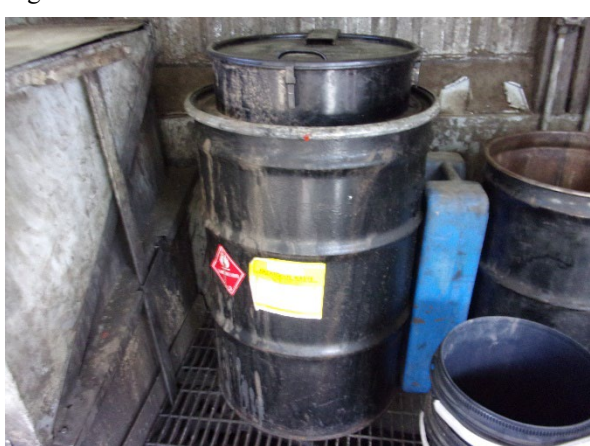
Figure 24: 10:08 AM Return and Fill Station

Safety-Kleen manages a SAA in the Return and Fill Station for managing hazardous waste branch debris that is generated by the filling and cleaning process of containers from customer waste. The inspectors observed one 55-gallon container in this SAA. The drum was located adjacent to the metal box for filling and cleaning containers, and it was equipped with a latching lid (for draining into an open head drum), which was closed (Figure 24). The drum was labeled hazardous waste branch debris and identified with a DOT flammable placard (Figure 25).

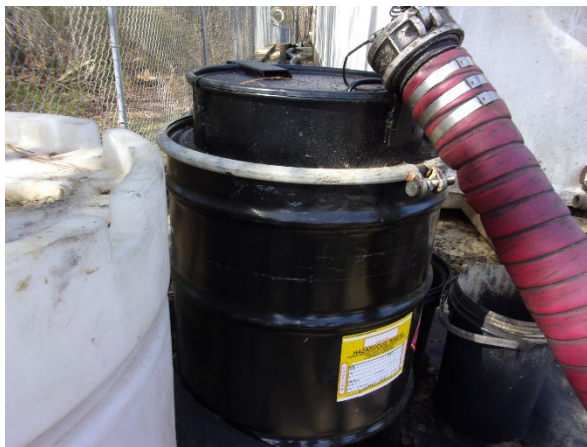
Figure 26: 10:14 AM Non-Hazardous Waste Frac Tank Area

Safety-Kleen manages a SAA in the non-hazardous waste frac tank area for managing hazardous waste branch debris that is generated by extracting, filling, and cleaning (e.g., spills) the non-hazardous waste frac tank. The inspectors observed one 55-gallon container in this SAA. The drum was located adjacent to the frac tank, and it was equipped with a latching lid (for draining into an open head drum), which was closed (Figure 26). The drum was labeled hazardous waste branch debris and identified with a DOT flammable placard (Figure 27).

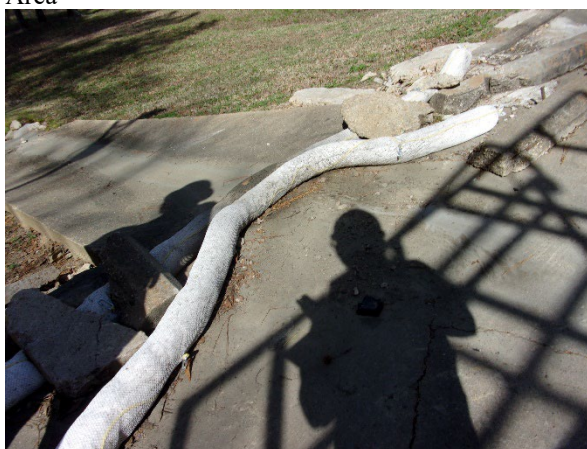
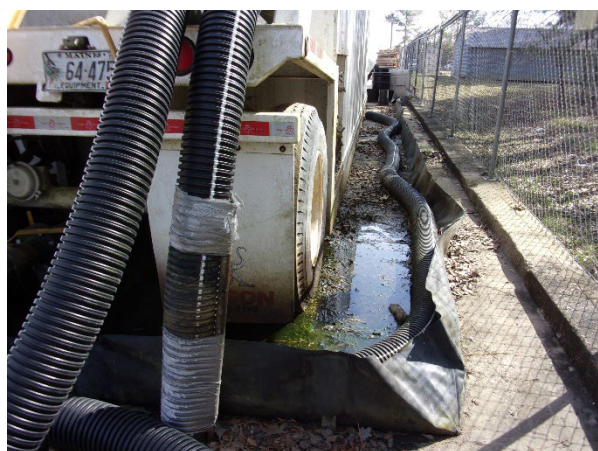
Inspectors observed the area surrounding the frac tank (Figures 28 and 29). MDEQ inspector William Rider asked facility personnel if there were sufficient documentation in determining that the facility is a “zero discharge” system with respect to their frac tank. Facility personnel stated they believed they have sufficient containment to provide zero discharge. William Rider recommended that the facility follow up with permit writers to potentially apply for an industrial stormwater permit so they can review their current secondary containment and their stormwater conveyance for minimizing release of potential pollutants.

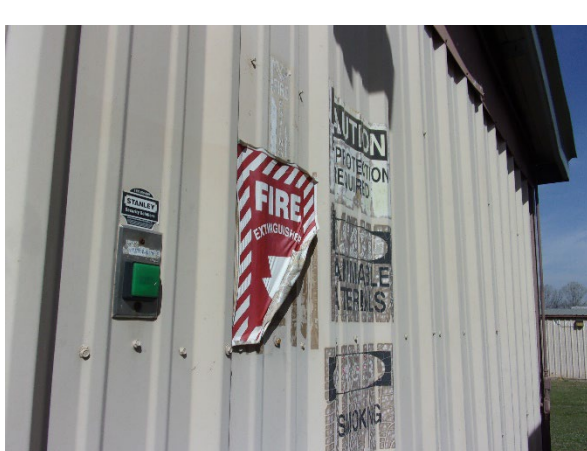
Figure 30: 10:20 AM Flammable Storage Shelter

This area contained flammable product set for storage (Figure 31). Inspectors noticed the storage shelter signs were deteriorating due to weathering and sun damage (Figure 30). Inspectors notified facility personnel to replace the label.

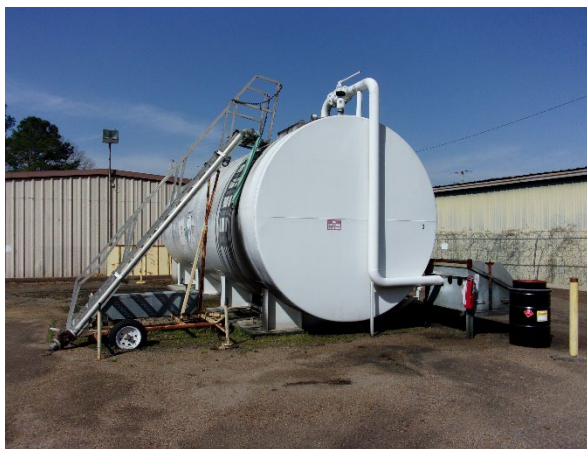
Figure 32: 10:25 AM Used Oil Tank Area

Safety-Kleen manages a SAA in the Used Oil Tank area for managing hazardous waste branch debris that is generated by used oil rags and cleanup (Figure 32). The inspectors observed one 55-gallon container in this SAA. The drum was located near the used oil tank, and it was equipped with a latching lid (for draining into an open head drum), which was closed (Figure 33). The drum was labeled hazardous waste branch debris and identified with a DOT flammable placard (Figure 34).
