RCRA COMPLIANCE EVALUATION INSPECTION

Kerry Bio-Science
158 State Highway 320
Norwich, New York

September 17, 2024

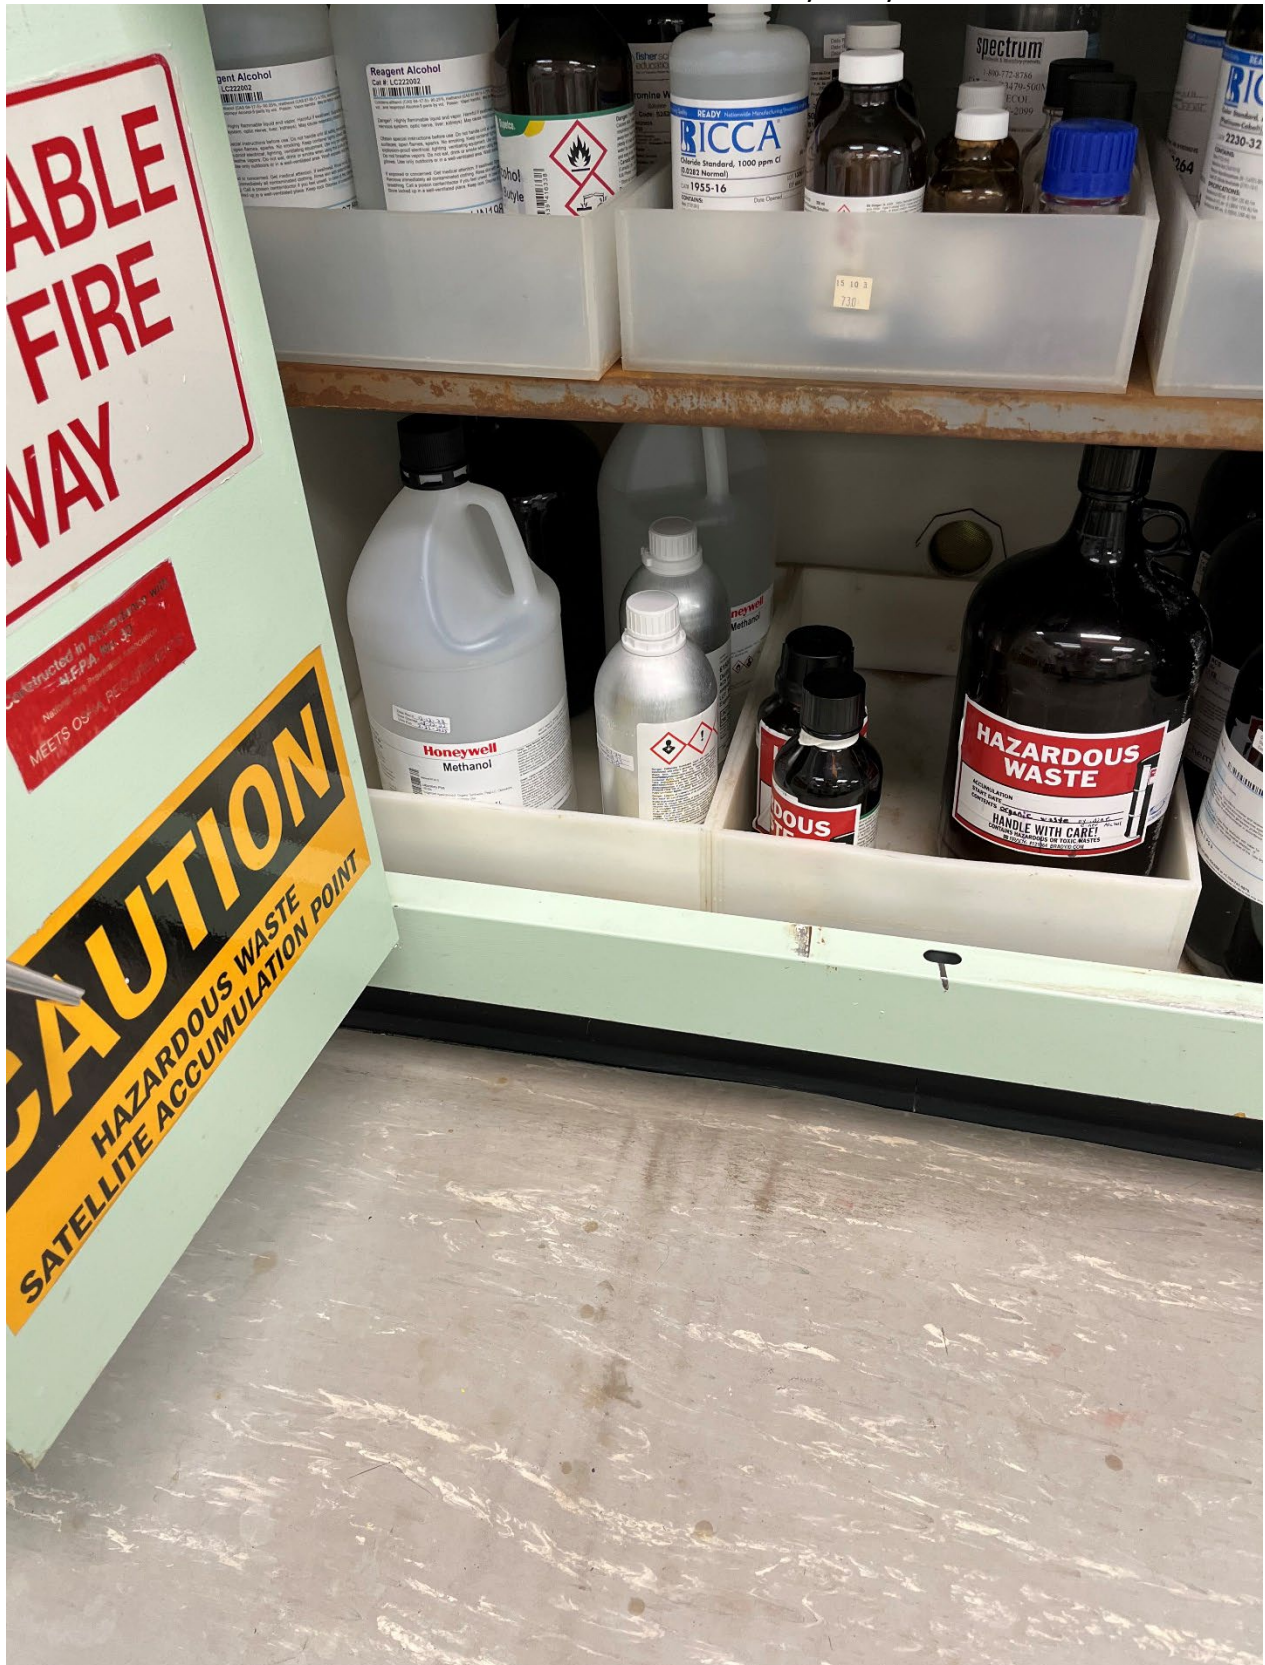
Photo #1: View of a satellite accumulation area in the Quality Analytical Lab.

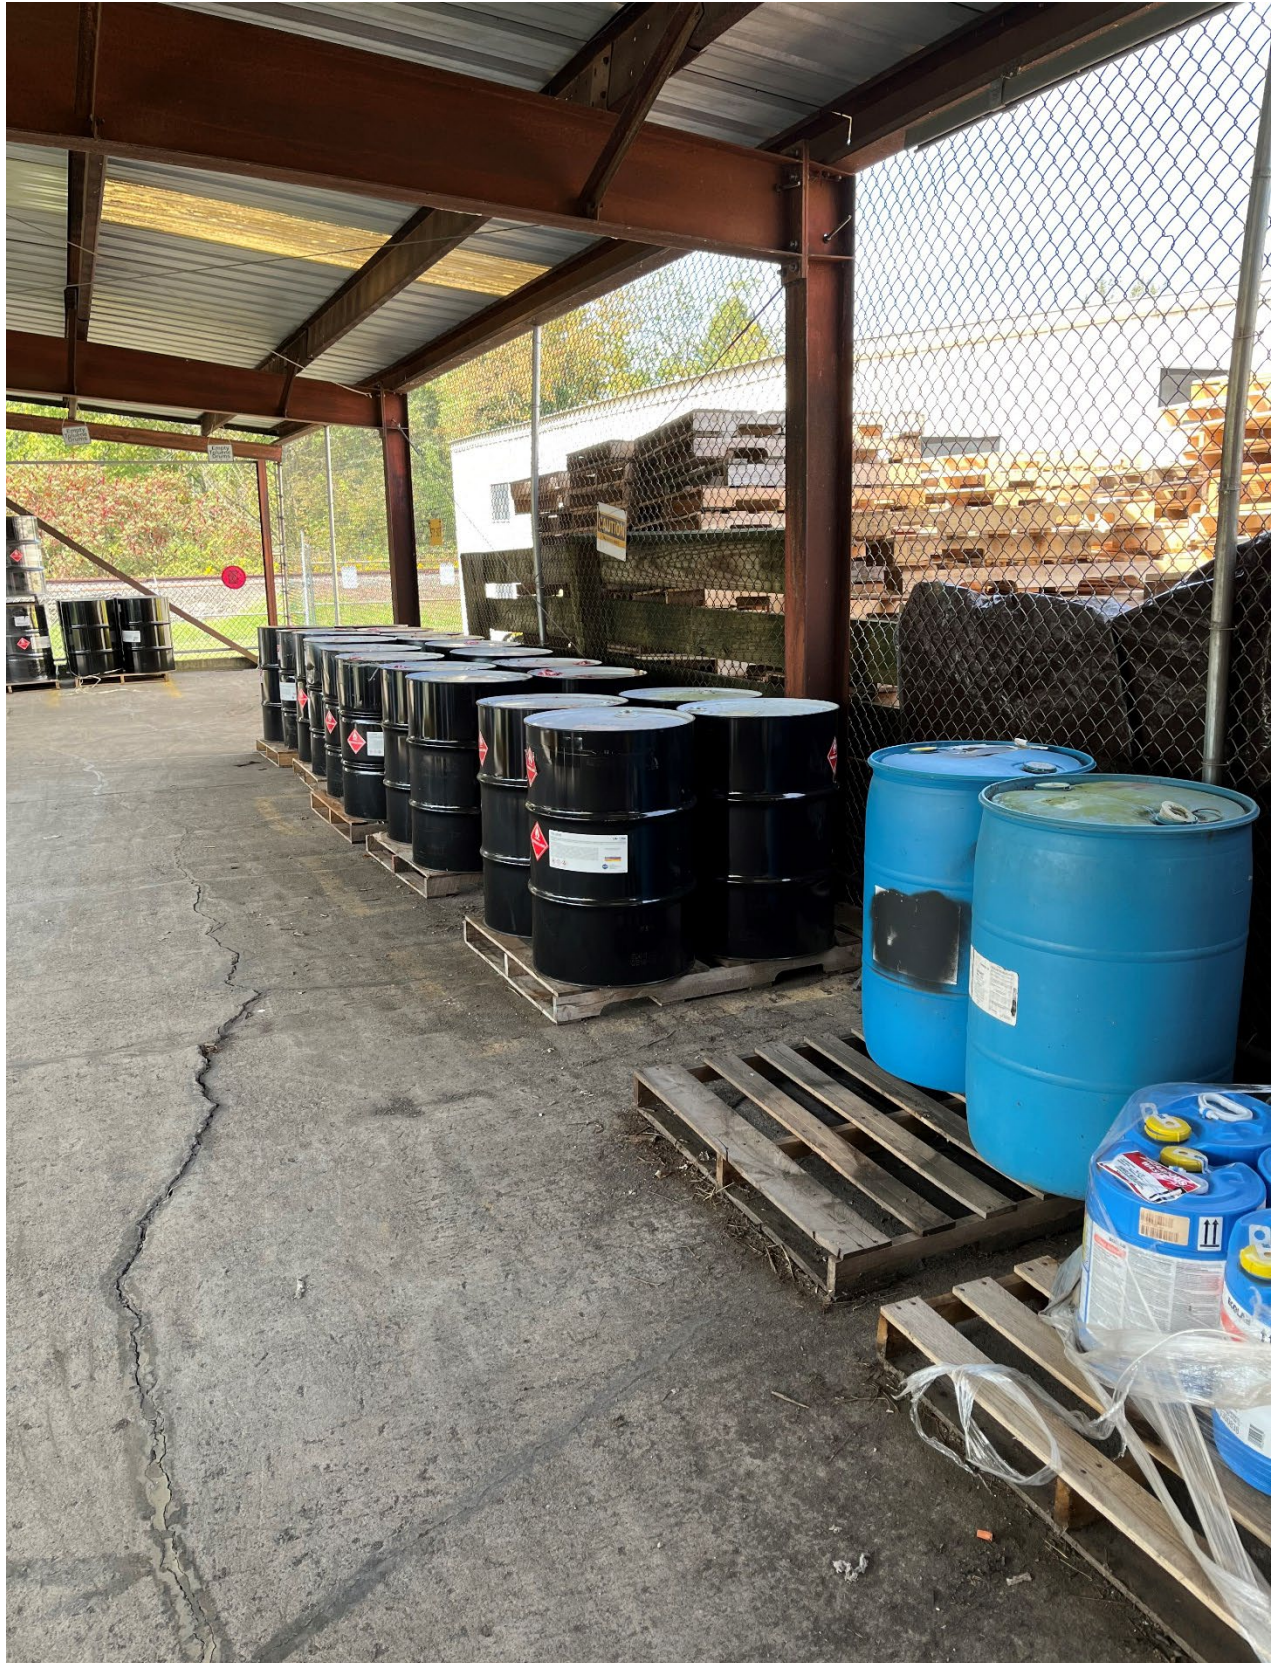
On the day of the inspection, there were twenty 55-gallon metal drums of waste toluene, two 55-gallon drums of waste acids, and seven 5-gallon containers of waste organic peroxides being stored in the Chemical Storage Area. All containers were labelled as hazardous waste with EPA waste codes and accumulation start dates.

Photo #2: View of the Chemical Storage Area.

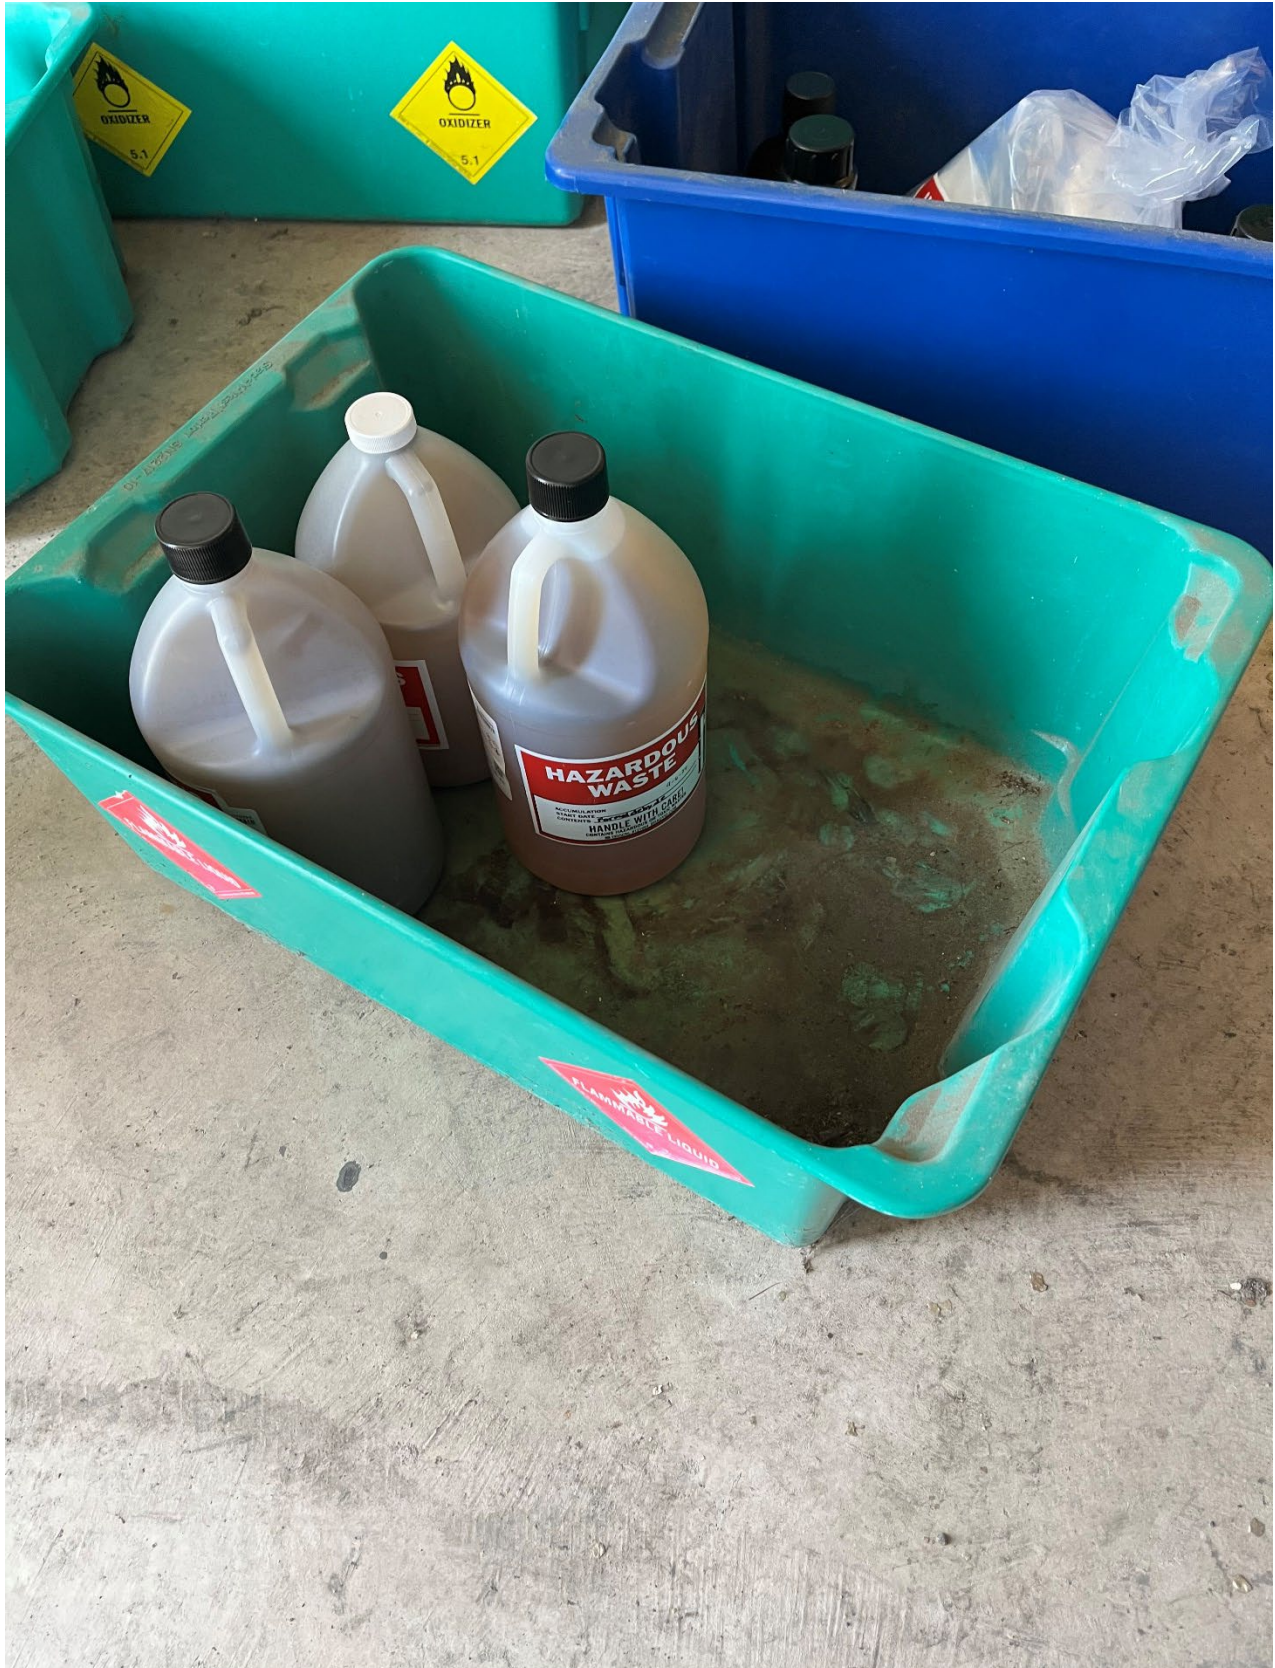
In the Satellite Accumulation Room, there were four 1-gallon containers of formaldehyde waste being stored in secondary containment bins. Three of the four containers had hazardous waste labels with accumulation start dates. One of the containers had a hazardous waste label with no accumulation start date. Flammable hazard labels were attached to the bins.

Photo #3: View of three containers of formaldehyde waste in the Satellite Accumulation Room.

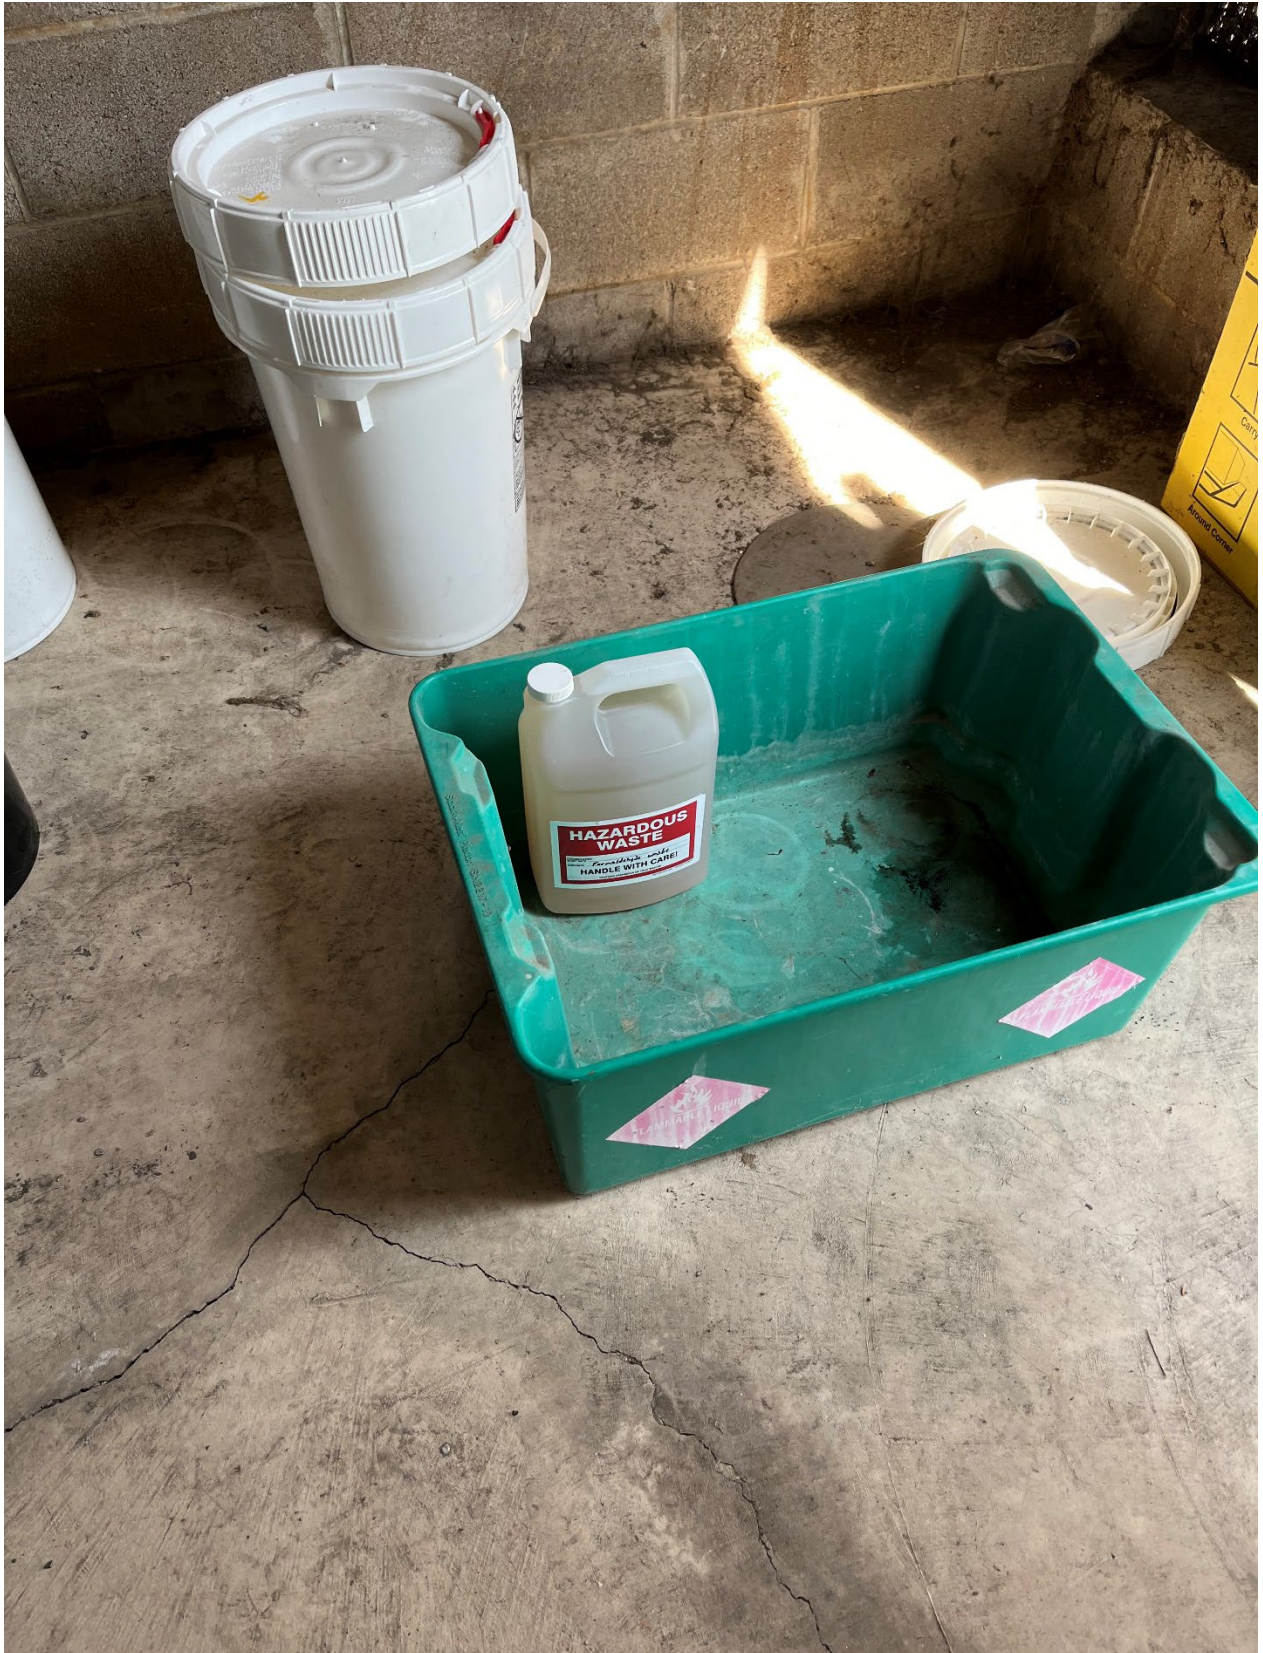
One of the 1-gallon containers of formaldehyde waste in the Satellite Accumulation Room did not have an accumulation start date on the hazardous waste label, as required in 40 CFR Section 262.34(a)(2). The facility representative was informed of this requirement and the accumulation start date (9/17/24) was immediately placed on the label. The facility representative explained that the container had recently been transferred to the Satellite Accumulation Room on the morning of the inspection. There were no other violations or compliance issues found on the day of the inspection.

Photo #4: View of the container of formaldehyde waste with no accumulation start date.

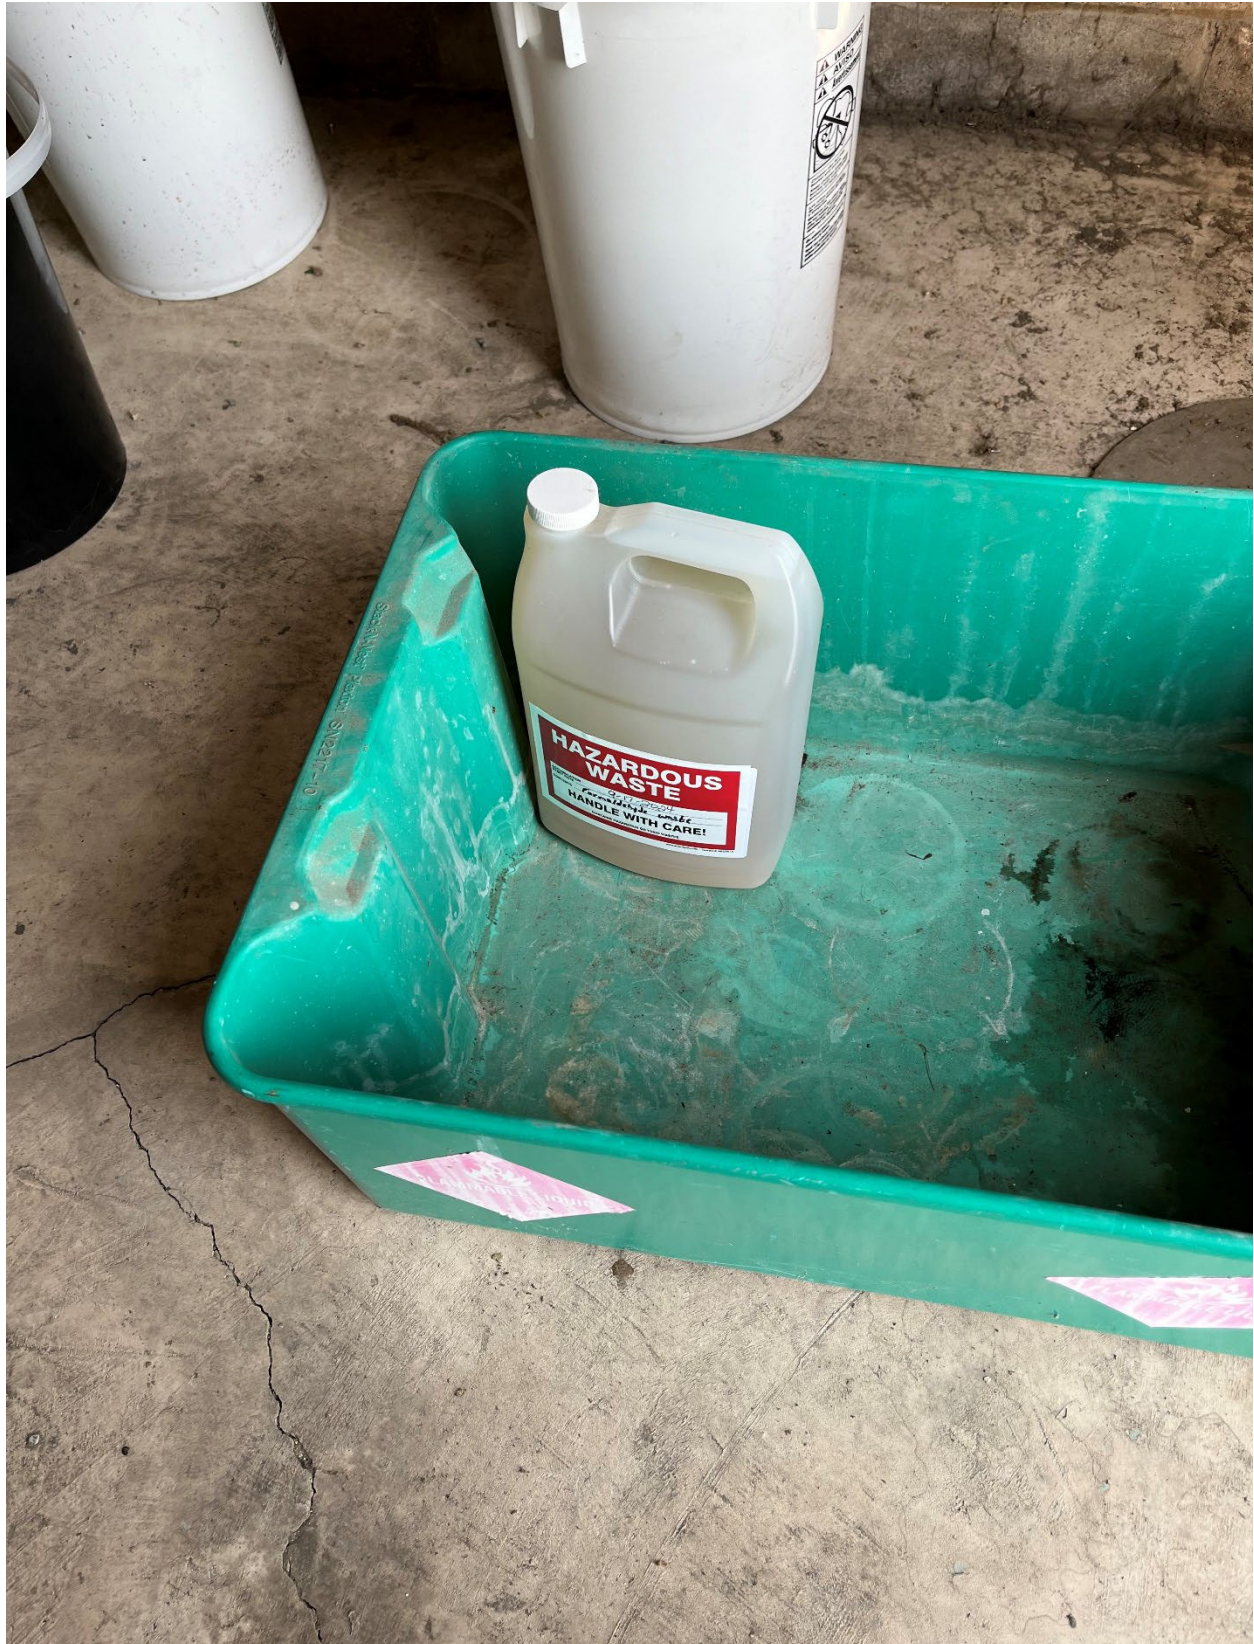
Photo #5: View of the container of formaldehyde waste marked with the accumulation start date.
