INSPECTION REPORT

| Type of Inspection | Compliance Evaluation Inspection | |
| Facility Name | City of Orofino WWTP | |
| Permit Number | ID0020150 | |

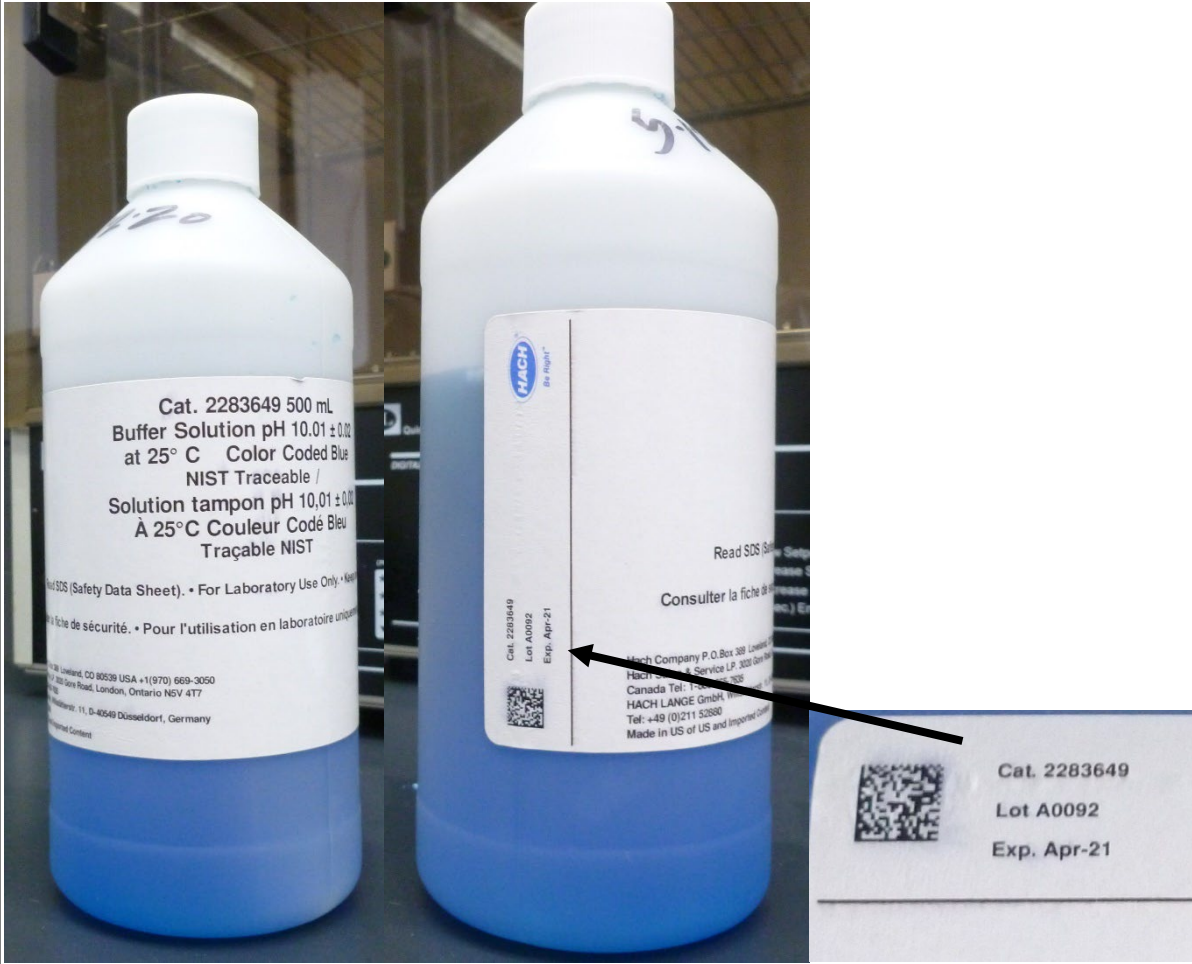
| In the facility's lab, I observed the pH 10.0 calibration buffer solution was expired. | |

| <p><b>AOC:</b></p> <p>The pH 10.0 calibration buffer solution was expired.</p> | |
