**Region 6 - Enforcement & Compliance Assurance Division**  
**INSPECTION REPORT**

| Inspection Date(s): | 07/28/2021 | |
| Regulatory Program(s) | CAFO | |
| Company Name: | Jacobs Dairy II | |

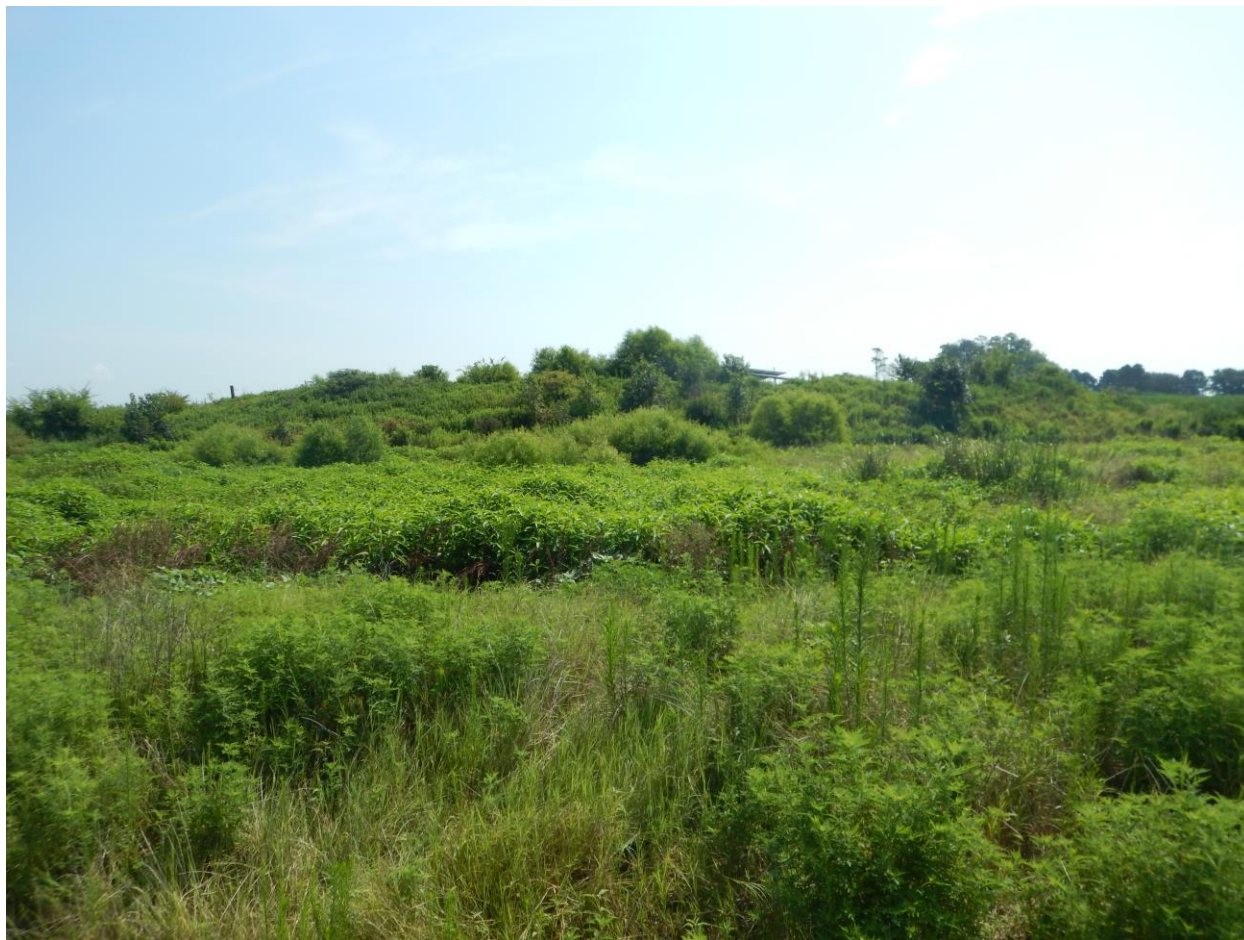
Photo No. 1

Description: Looking at the area where the middle RCS was supposed to be located. We were unable to definitively locate the lagoon due to the lack of maintenance and mowing. The view is toward the northeast.

- 1) The dairy is required to maintain its lagoons per the requirements of its TCEQ CAFO General Permit (Section III.A.10.(a)(c)(e) and (f)). This includes managing the embankments of the units, removing trees, and mowing the perimeter to allow access and observe embankment integrity.
- 2) Lagoon levels must be managed thru land application to maintain the storage capacity for the 25-yr/24-hr rain event (Section III.A.10.(a)(1) and (2)). This is to be accomplished thru weekly documented lagoon level measurements using the lagoon pole markers.
- 3) The facility must maintain all the CAFO permit required lagoon maintenance records including the weekly lagoon levels (Part III.A.15.(a)(2)), lagoon embankment maintenance records, and land application records (Part IV.4.), and the annual wastewater and manure solids sampling records (Part IV.5.).

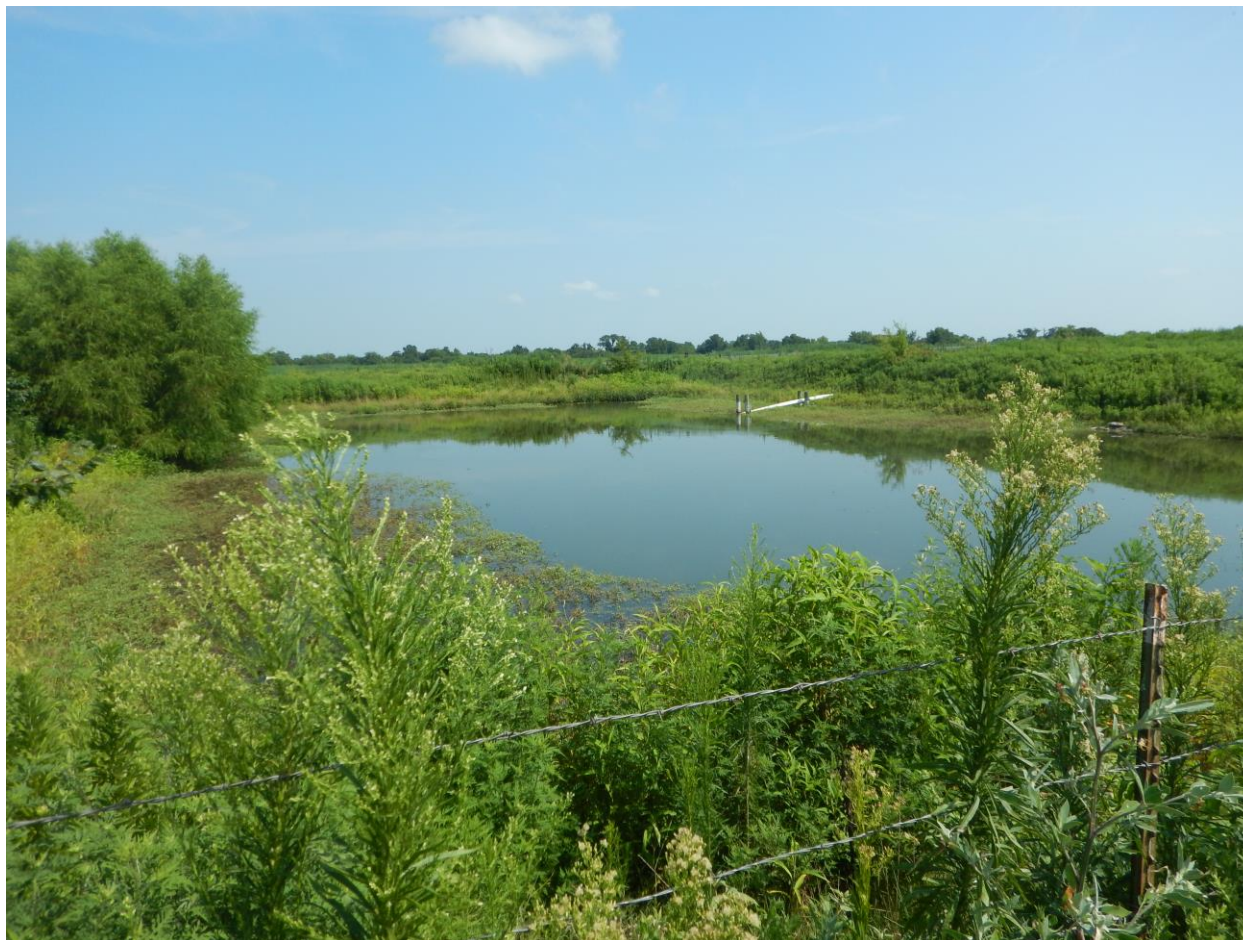
Photo No. 2

Description: Looking at the most eastern RCS. The unit is overgrown with tall vegetation and trees. The view is toward the northeast.

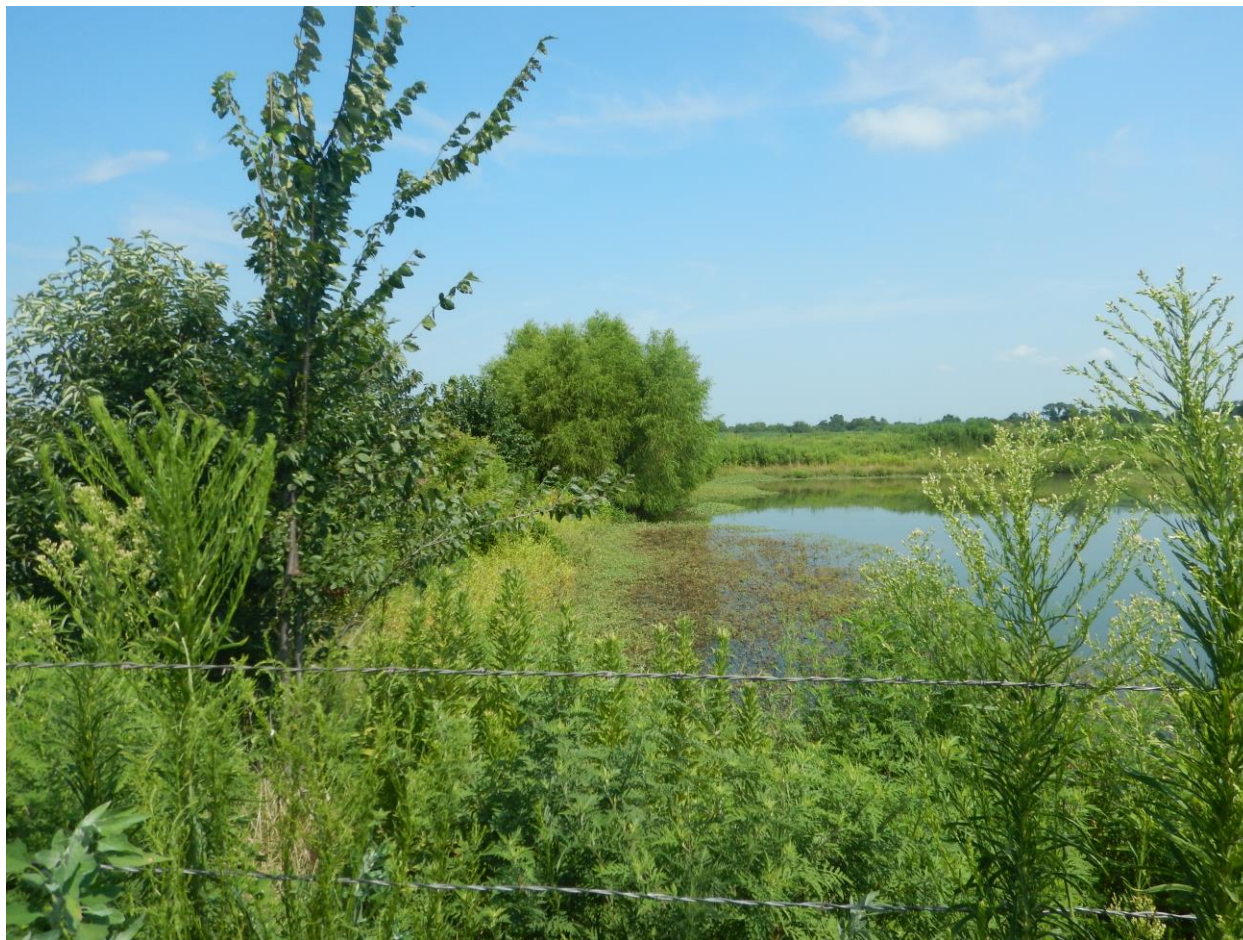
Photo No. 3

Description: Another view of the most eastern RCS. The unit is overgrown with tall vegetation and trees. The view is toward the east.

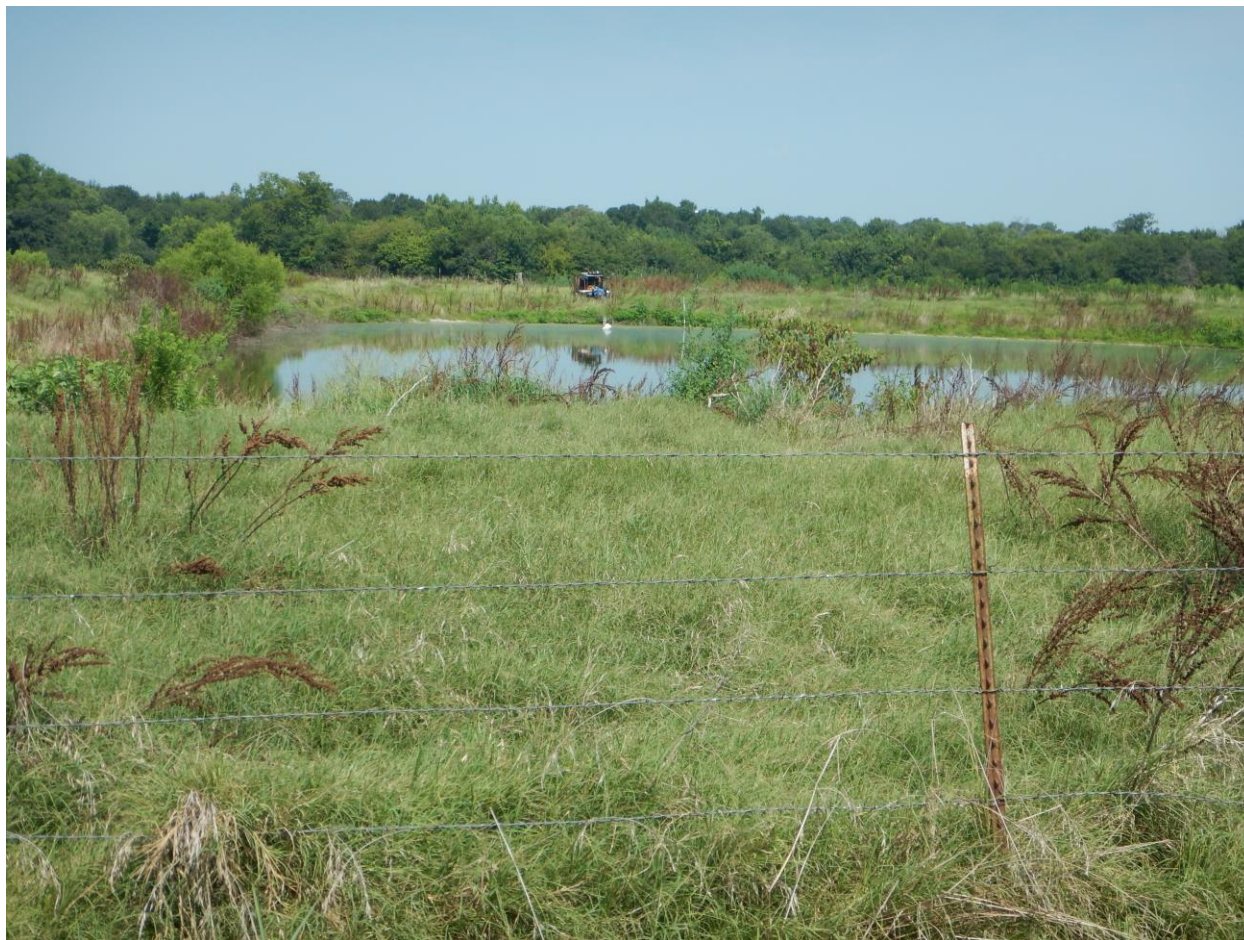
Photo No. 4

Description: Looking at the most western RCS. The unit is overgrown with tall vegetation and trees. A pole marker is seen at the far east side of the lagoon, near the dewatering equipment. The view is toward the east.

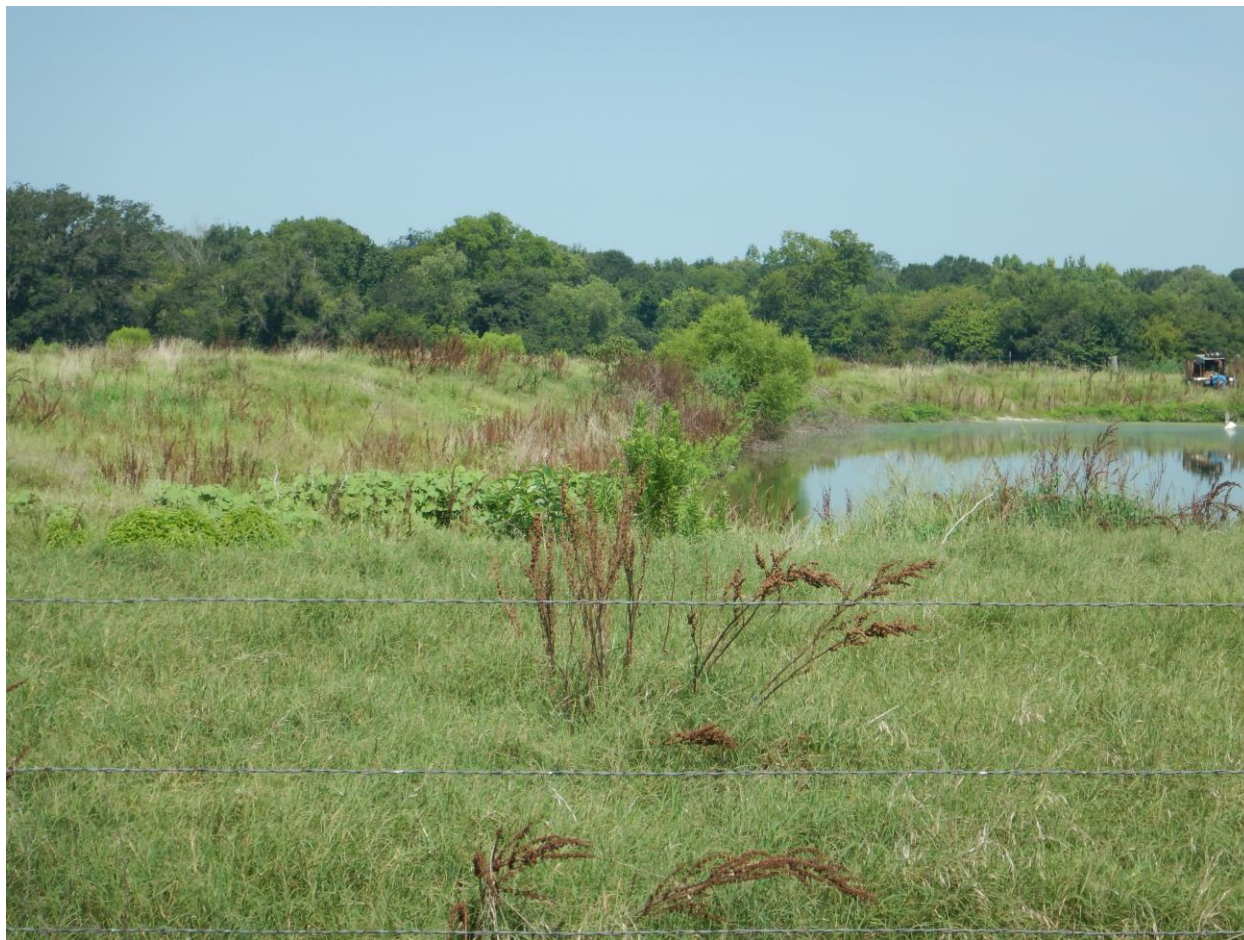
Photo No. 5

Description: Looking at the most western RCS. The unit is overgrown with tall vegetation and trees. The view is toward the east.

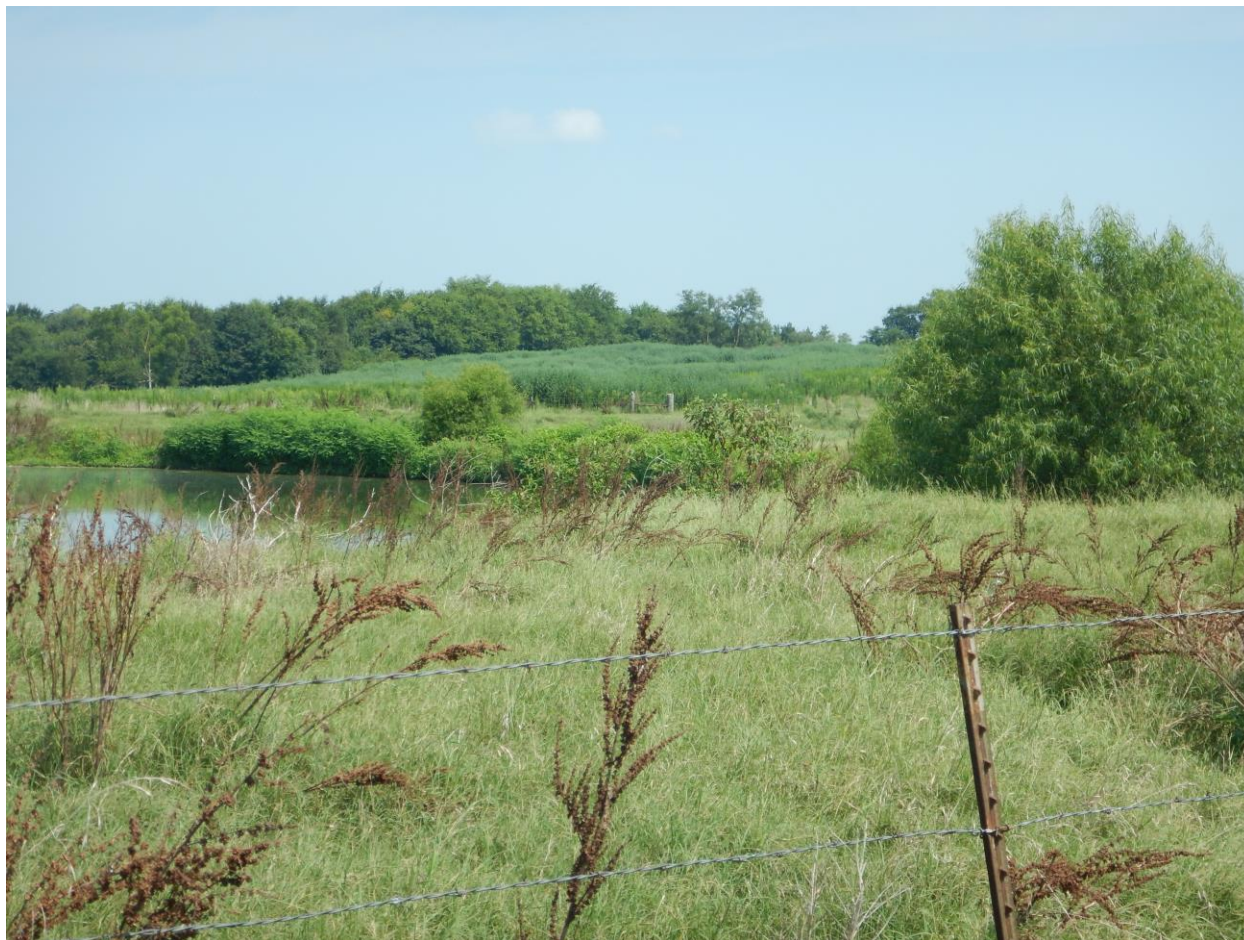
Photo No. 6

Description: Another view of the most western RCS. The unit is overgrown with tall vegetation and trees. The view is toward the northeast.

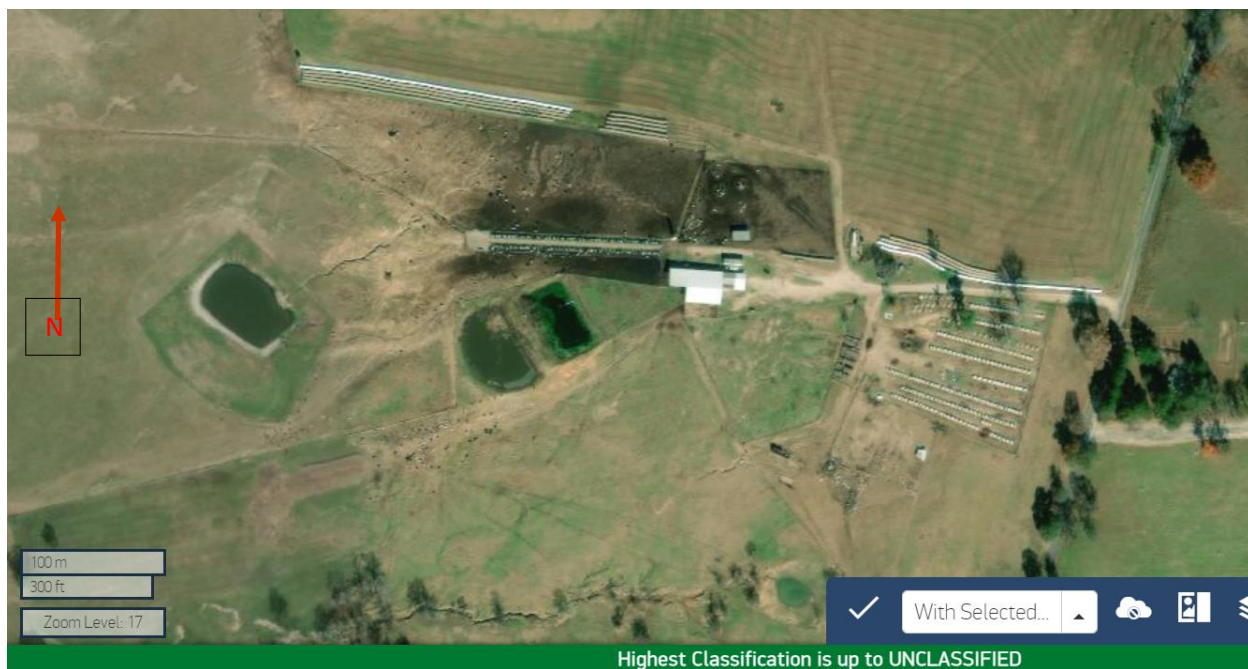
Photo No. 7

**Jacobs Dairy II DigitalGlobe Aerial photograph dated 12/19/2020 showing the three lagoon locations**
