Re: U.S. EPA-Region 1 Inspection Report of Amazon.com Services, LLC
(BDL2), July 26, 2022

RCRA HAZARDOUS WASTE INSPECTION REPORT

- a. **Facility Name:** Amazon.com Services, LLC (BDL2)
- b. **Inspection Date:** July 26, 2022
- c. **Inspection Type:** RCRA Compliance Evaluation Inspection (CEI)

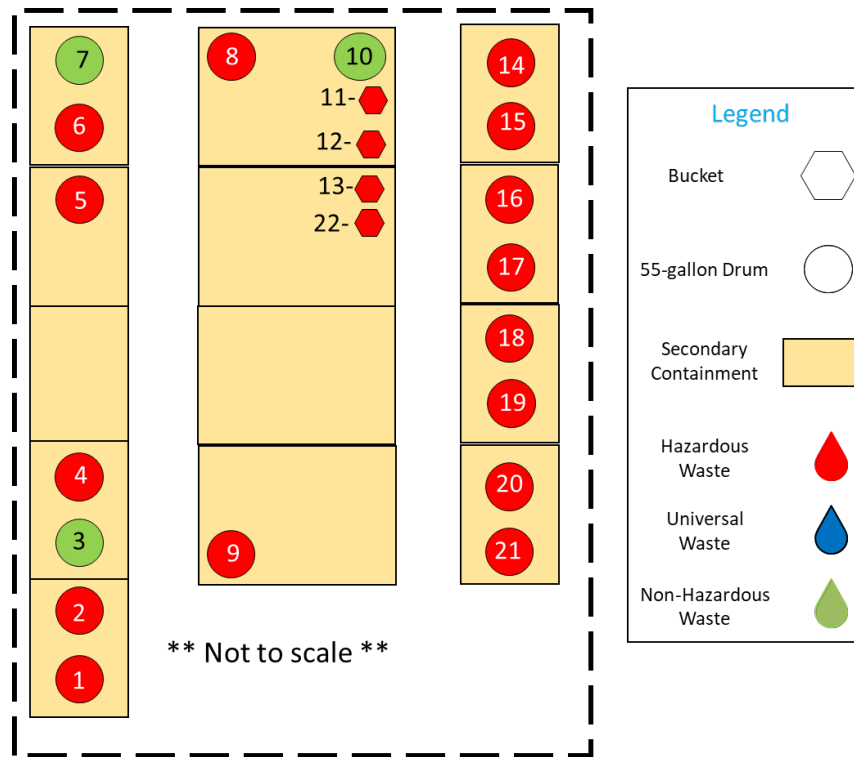
Figure 1 Diagram depicting approximate layout of HWAA "Waste Cage"

All drums and buckets were on plastic secondary containment pallets with hazardous waste markings, DOT shipping labels as appropriate, accumulation dates and contents clearly marked. Drum # 10 as depicted in *Figure 1*, was a blue, poly, removable head drum with biohazard stickers on the sides, and a paper on the top reading "Do Not Open!". A second piece of paper was on top of the drum with partially obstructed writing. "Waiting on instructions" was visible while the rest of the writing was not visible. Inspector Carew asked about the contents, Ms. Flynn consulted with Brian Hidalgo, a Waste Coordinator, and relayed the drum was empty and was staged in case it is needed to store bodily fluids (See Attachment 1, Photos 19-20). Inspector Meyer recommended empty containers be marked as empty to assist first responders in the event of an emergency.

Two drums were identified by Inspector Meyer as potentially incompatible. The two drums were located on the same secondary containment pallet, drums #16 & #17 in *Figure 1* (See photos 29 – 32 & 41 of Attachment 1). Drum #16 was a blue, poly, removable head drum (See photo 29 of Attachment 1) with DOT shipping labels Class 3 Flammable Liquid, and Class 8 Corrosive. The hazardous waste label contained the following information (See photo 30 of Attachment 1):

A copy of the SDSs and a screenshot of the facility's "Gensuite Waste Tracker" system for the two drums were provided by Amazon. Mrs. Flynn stated in a letter that the contents of the drums included various products and the two drums were compatible. No further information requested.

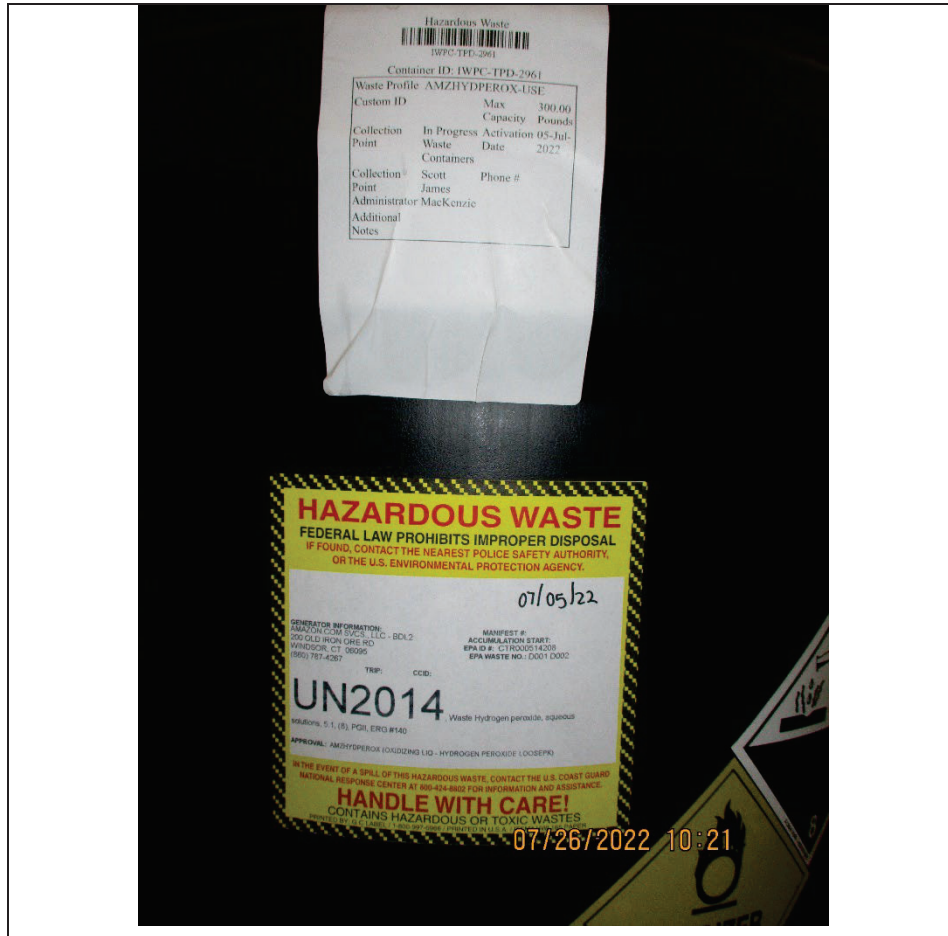
Photo No. 2

Photo #	Description
1	Container #1, drum in Hazardous Waste Storage Area "The Cage"
2	Hazardous Waste marking on waste container #1 in Hazardous Waste Storage Area "The Cage"
3	Container #2, drum in Hazardous Waste Storage Area "The Cage"
4	Hazardous Waste marking on waste container #2 in Hazardous Waste Storage Area "The Cage"
5	Container #3, drum marked as "Non-Regulated Material" in Hazardous Waste Storage Area "The Cage"
6	Marking on waste container #3 with "Non-Regulated Material" sticker in Hazardous Waste Storage Area "The Cage"
7	Container #4, drum in Hazardous Waste Storage Area "The Cage"
8	Hazardous Waste marking container #4 drum in Hazardous Waste Storage Area "The Cage"
9	Container #5, drum in Hazardous Waste Storage Area "The Cage"
10	Hazardous Waste marking on container #5 in Hazardous Waste Storage Area "The Cage"
11	Container #6, drum in Hazardous Waste Storage Area "The Cage"
12	Hazardous Waste marking on container #6 in Hazardous Waste Storage Area "The Cage"

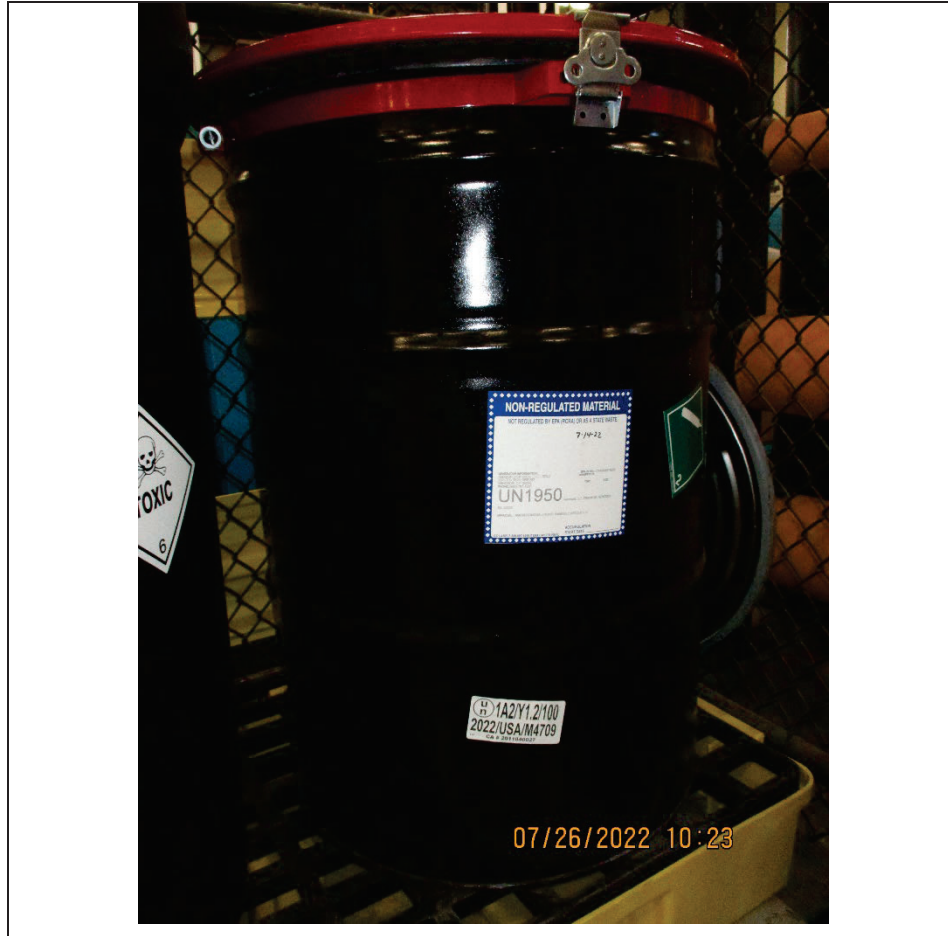
Photo No. 13

13	Container #7, drum marked as "Non-Regulated Material" in Hazardous Waste Storage Area "The Cage"
14	Marking on container #7 with "Non-Regulated Material" sticker in Hazardous Waste Storage Area "The Cage"
15	Container #8, drum in Hazardous Waste Storage Area "The Cage"
16	Hazardous Waste marking on container #8 in Hazardous Waste Storage Area "The Cage"
17	Container #9, drum in Hazardous Waste Storage Area "The Cage"
18	Hazardous Waste marking on container #9 in Hazardous Waste Storage Area "The Cage"

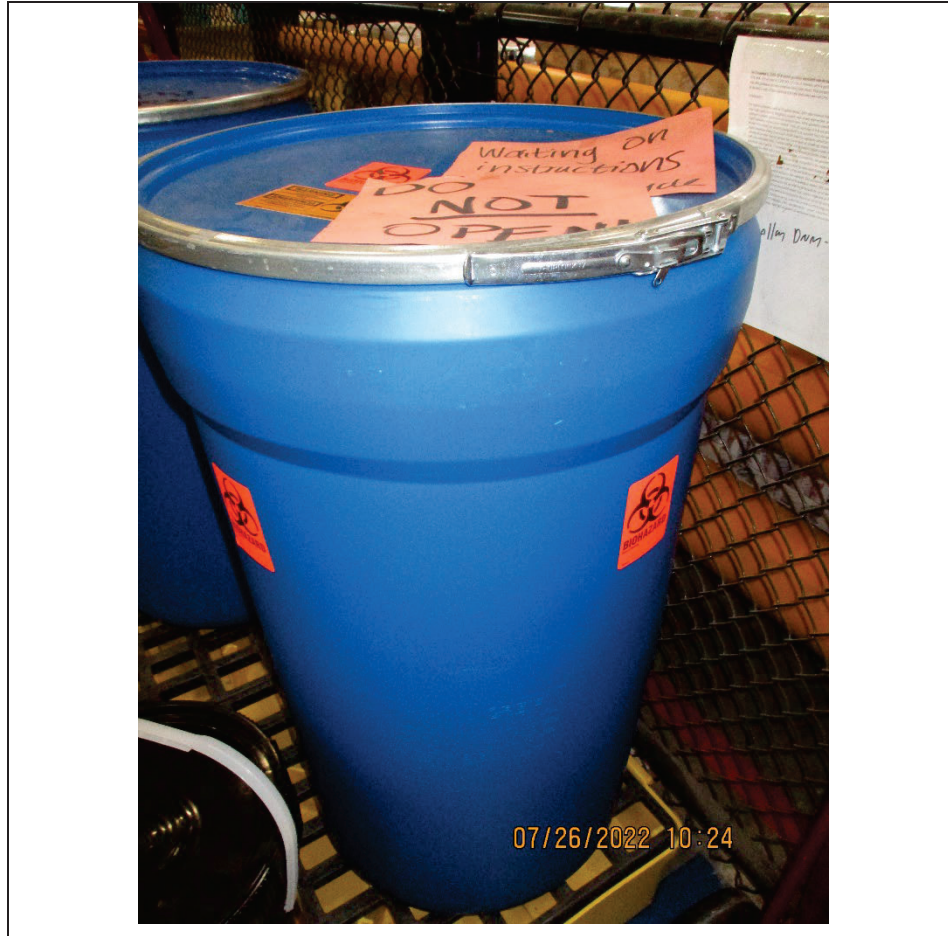
Photo No. 19

Photo #	Description
19	Container #10, drum in marked as "Bio Hazard" in Hazardous Waste Storage Area "The Cage"
20	Marking on container #10 with "Do Not Open" & "Waiting on Instructions" warnings in Hazardous Waste Storage Area "The Cage"
21	Container #11 in Hazardous Waste Storage Area "The Cage"
22	Container #12 in Hazardous Waste Storage Area "The Cage"
23	Container #13 in Hazardous Waste Storage Area "The Cage"
24	Container #14 in Hazardous Waste Storage Area "The Cage"
25	Container #15 in Hazardous Waste Storage Area "The Cage"
26	Hazardous Waste marking on container #15 in Hazardous Waste Storage Area "The Cage"
27	Container #16, drum in Hazardous Waste Storage Area "The Cage"
28	Hazardous Waste marking on container #16 in Hazardous Waste Storage Area "The Cage"
29	Container #17, drum in Hazardous Waste Storage Area "The Cage"
30	Hazardous Waste marking on container #17 in Hazardous Waste Storage Area "The Cage"

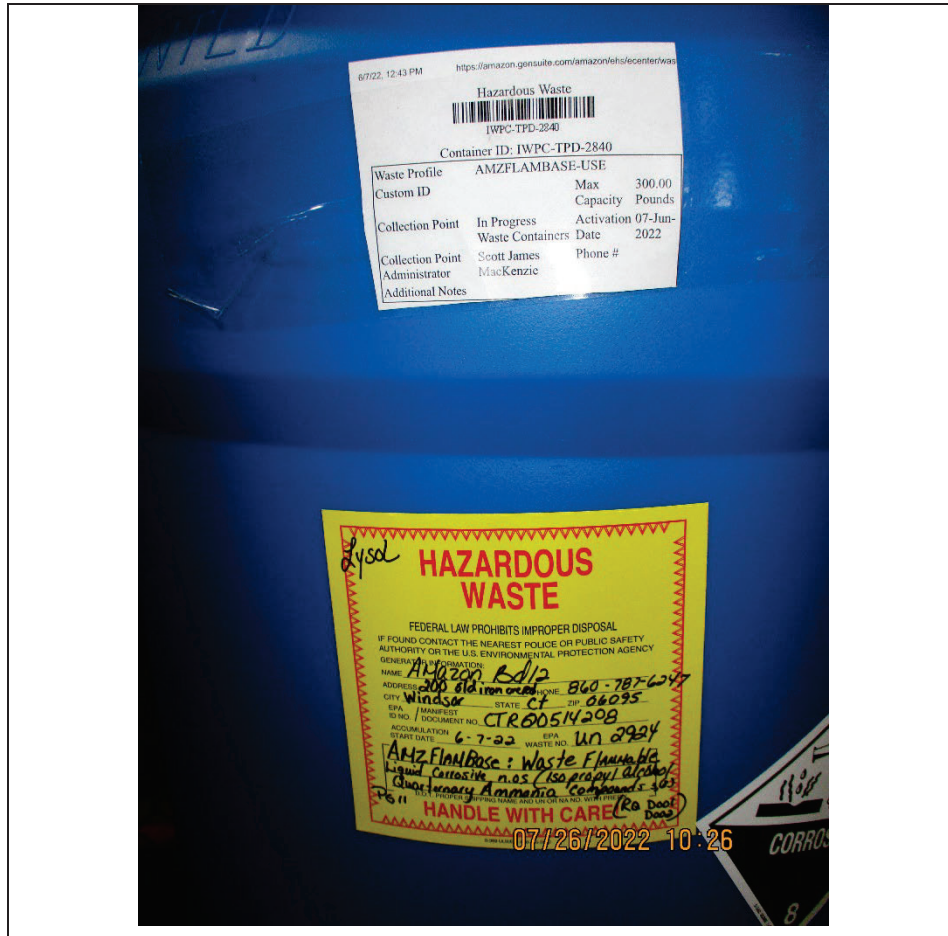
Photo No. 30

- UN 2924 Waste Flammable Liquid Corrosive NOS (Isopropyl Alcohol, Quarternary Ammonia Compounds PGII (RQ D001, D002)
- Accumulation start date: 7 June 2022

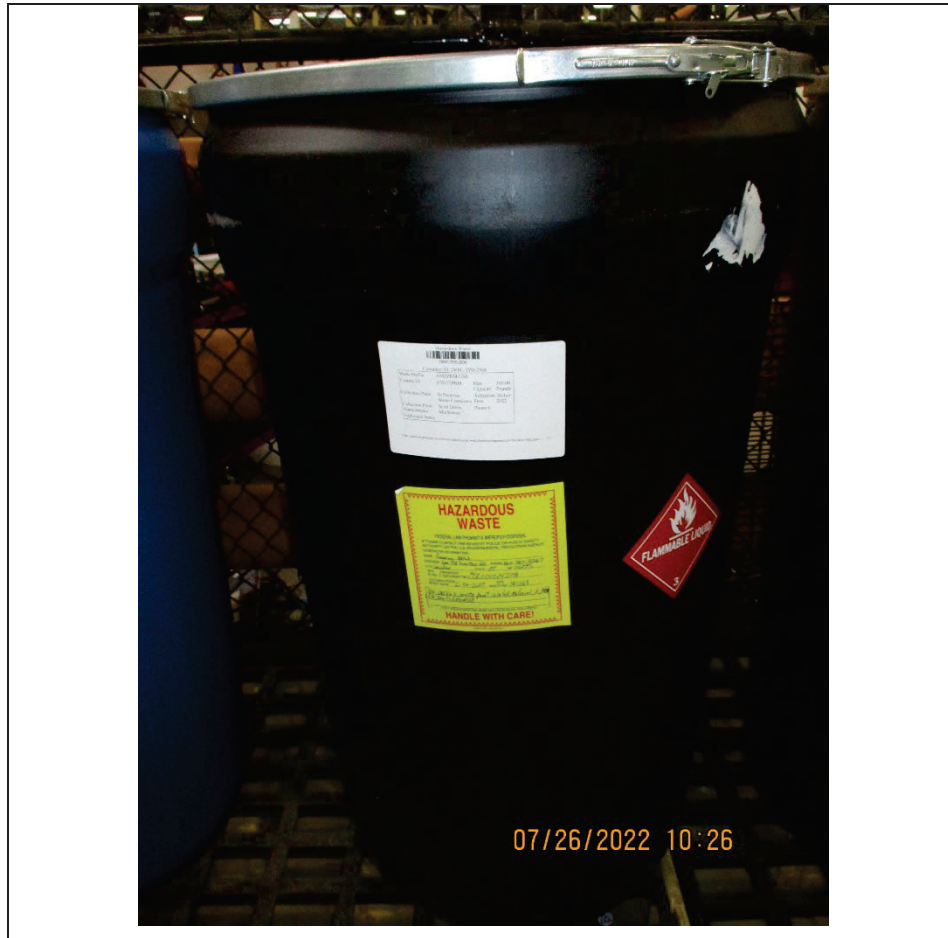
Photo No. 31

Drum #17 was a black, poly, removable head drum (See photo 31 of Attachment 1) with DOT shipping label Class 3 Flammable Liquid. The hazardous waste label contained the following information (See photo 32 of Attachment 1):
