# Death Valley

## Historic Resource Study A History of Mining

##### 6. Panamint Mine

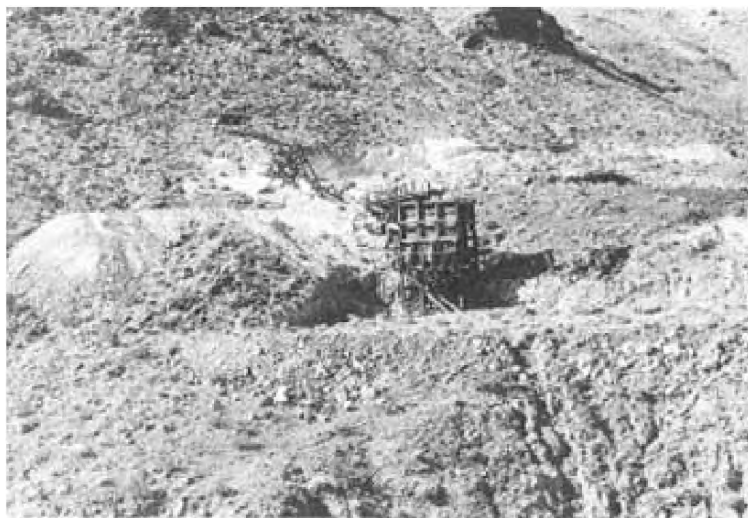
The road turns west from here for about one-half mile, becoming a four-wheel-drive route, and leads to an abandoned ore bin and adit. Evidence of exploratory activity is evident for a half mile along the south wall of the canyon. At its upper end is a large three-chute ore bin positioned on a truck-loading level with the remains of a single ore chute hanging from the hillside above. Ore cars evidently trammed the ore to the surface of the mine and outside, proceeding up an inclined set of tracks and dumping their load into the single chute, which emptied into cars on the second level; these cars then dumped the ore into the lower three-chute bin, from which it was guided into trucks for transport. The workings in this area consist of an inclined shaft about sixty feet long with a twenty-foot drift extending west from the bottom of the shaft. Above the mine portal on the hillside is a frame equipment shelter. These are the oldest workings on the Panamint property, dating from the early 1950s; they produced only a small amount of talc. Most of the talc shipped from this group has come from a deposit about 1,000 feet south-southwest of this shaft--an area mined by an open cut in the mid-1950s. [248]

Illustration 56. Ore bin and workings at Panamint Talc Mine.  
Photo by Linda W. Greene, 1978.

The ore bin, ore chute, and tramway ruins of the Panamint Talc Group are of recent (1950s) vintage. Neither they nor the two ruined buildings near the Warm Spring Road junction are historically significant.

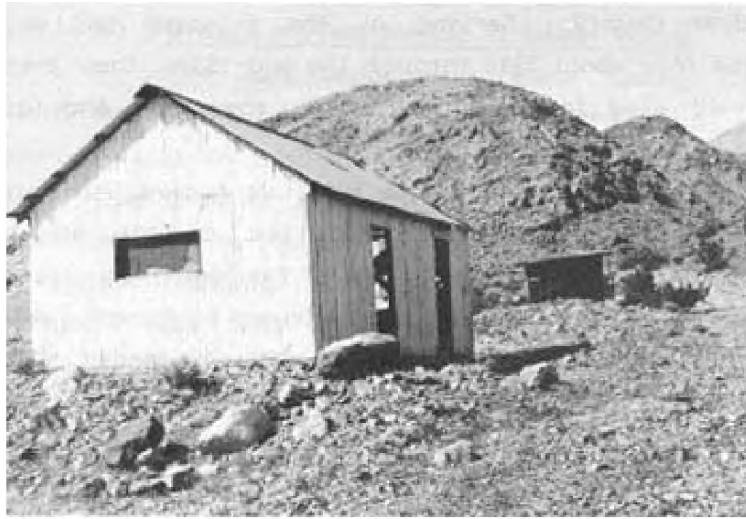
Today the Panamint Talc Group consists of ten unpatented claims: Panamint #3-5 claim, Panamint Millsite, Panamint Millsite No. 1, Panamint Talc Nos. 1-2 lode mining claims, and Panamint Talc Nos. 6-8. The mining area is reached via a dirt road jutting off to the south at the mouth of Warm Spring Canyon. (This route continues on south through Wingate Wash.) About one-quarter mile south on this road are two structures of recent origin. One is a large, two-room, corrugated-metal residence building with a poured concrete floor and plywood walls covered with graffiti, containing two metal bunks. The other empty structure is a small wood and composition-paper shack.

Illustration 57. Modern buildings east of Panamint Talc Mine.  
Photo by Linda W. Greene, 1978.
