INSPECTION REPORT

| Type of Inspection | Follow-up Inspection (FUI) | | |
| Permittee Name | Scioto County Commissioners | | |
| Facility or Site Name | Wheelersburg WWTP | | |

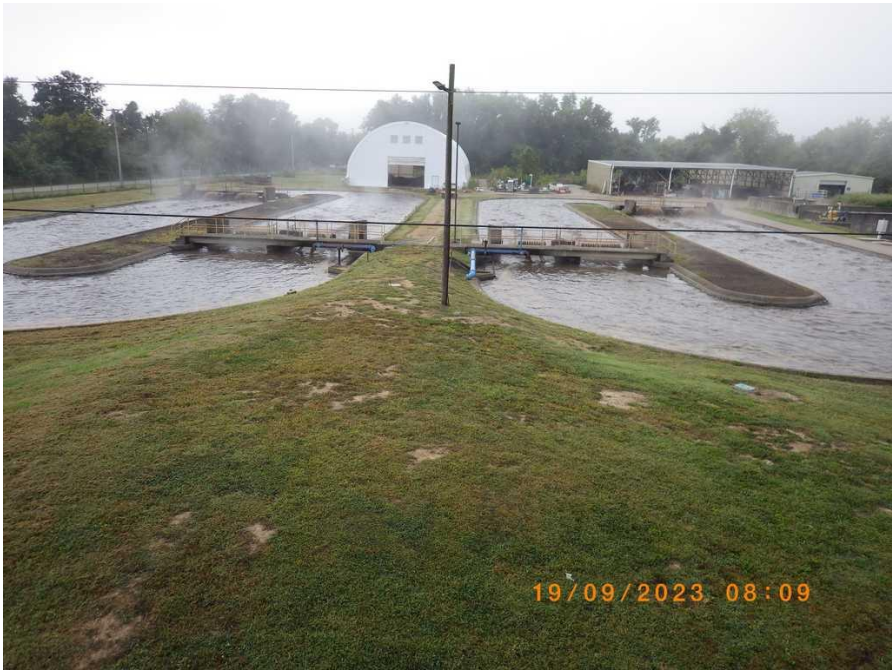
| Oxidation Ditches | | | RIMG3211.JPG |

| Overview of the two oxidation ditches at the Wheelersburg WWTP. Camera looking south. | | | |

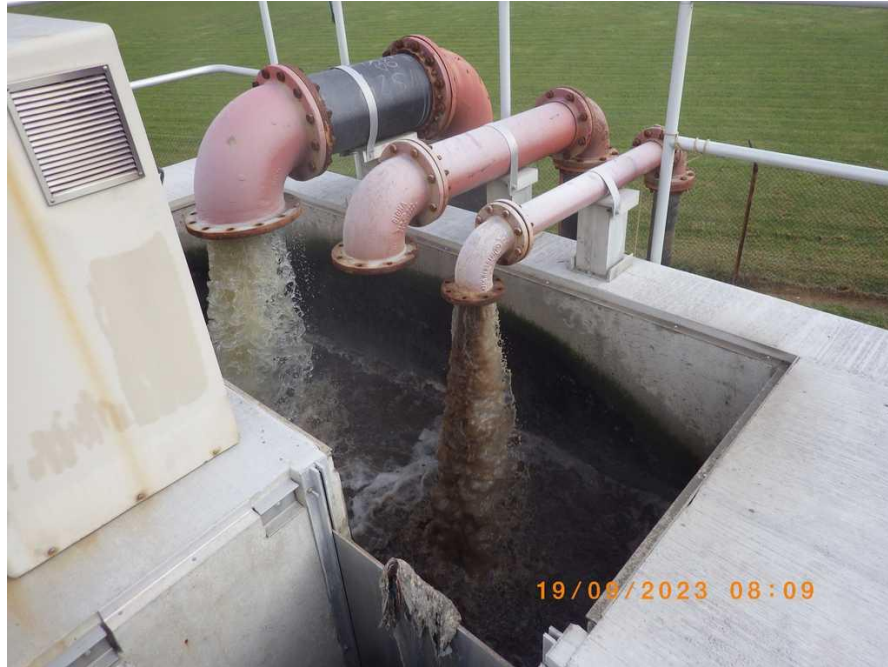
| Inflow and return pipes at the headworks of the Wheelersburg WWTP. The bigger pipe that is seen discharging in the photo, is the one from the city of Wheelersburg and the smallest one discharging is the return flow from the aerobic digesters. Camera looking north. | | | |

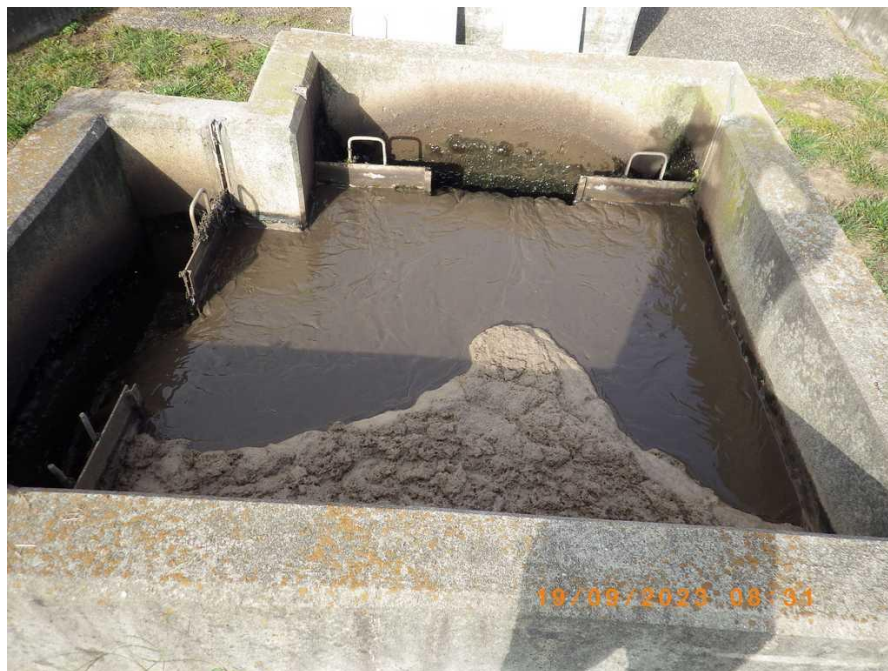
| Split box | | | RIMG3213.JPG |

EPA observed dark brown water and a layer of foam in one of the splitter boxes. Photo RIMG3213. EPA observed scum and bubbles floating on top of the west clarifier. Photo RIMG3216. EPA observed floating scum in the old contact tank before the Ultraviolet (UV) channel. Photos RIMG3217 and RIMG3219.

| One of the two splitting boxes that routes water from the oxidation ditches to two of the clarifiers. Camera looking west. | | | |

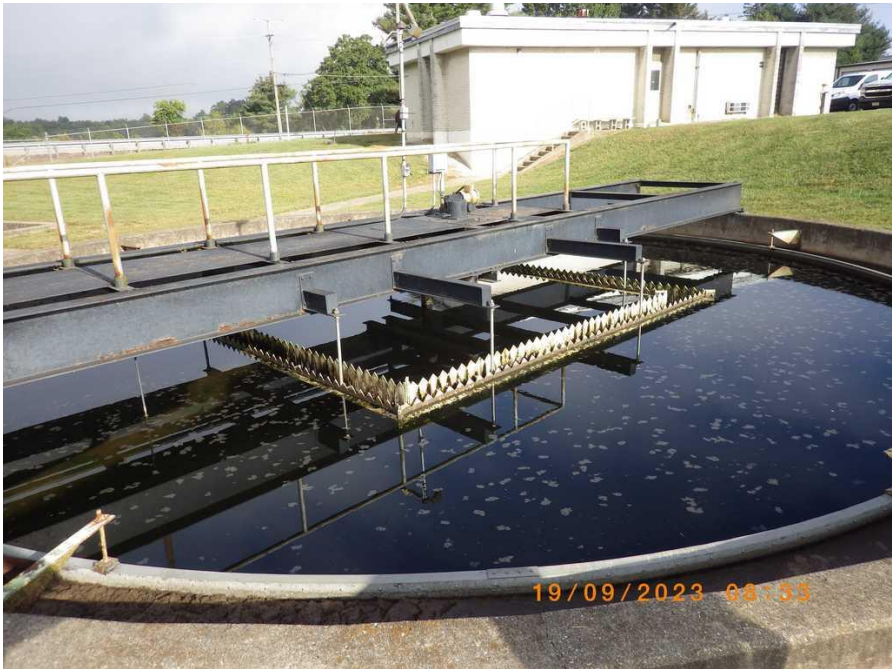
| North Clarifier | | | RIMG3214.JPG |

| North clarifier. Camera looking north. | | | |

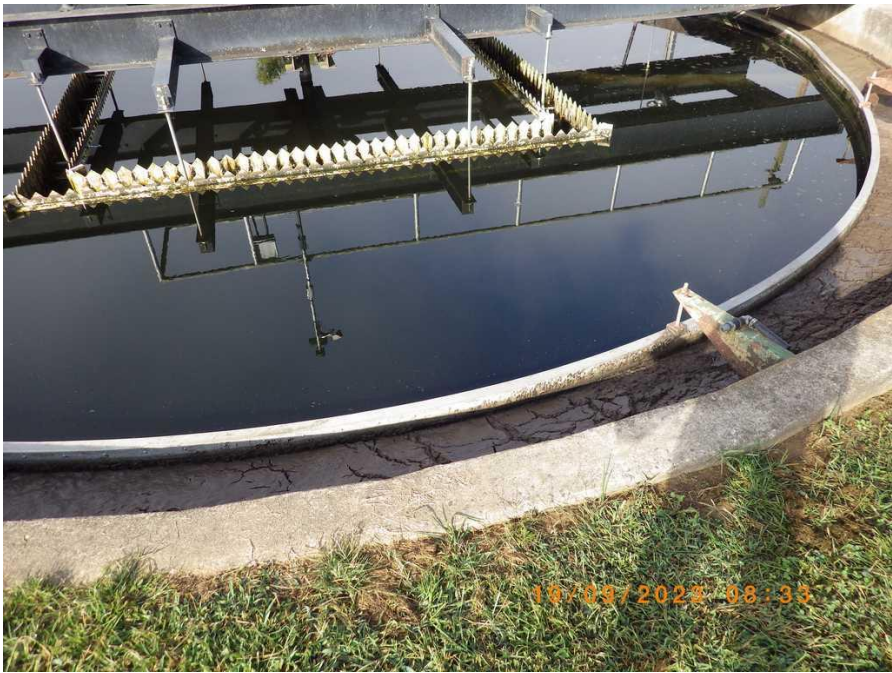
| South Clarifier | | | RIMG3215.JPG |

| The south of three clarifiers at the Wheelersburg WWTP. Camera looking west. | | | |

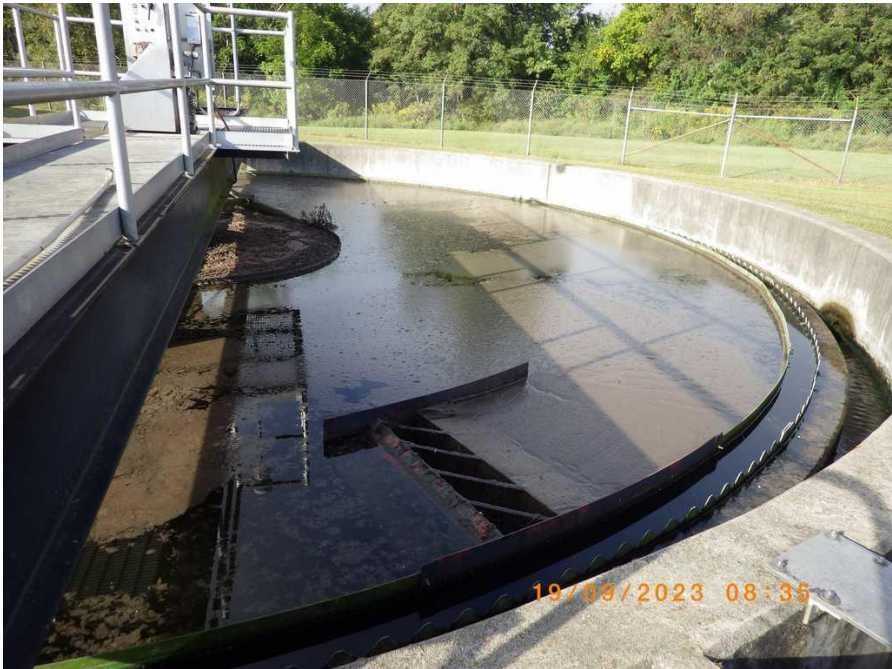
| West Clarifier | | | RIMG3216.JPG |

| The west clarifier at the Wheelersburg WWTP. Camera looking west. | | | |

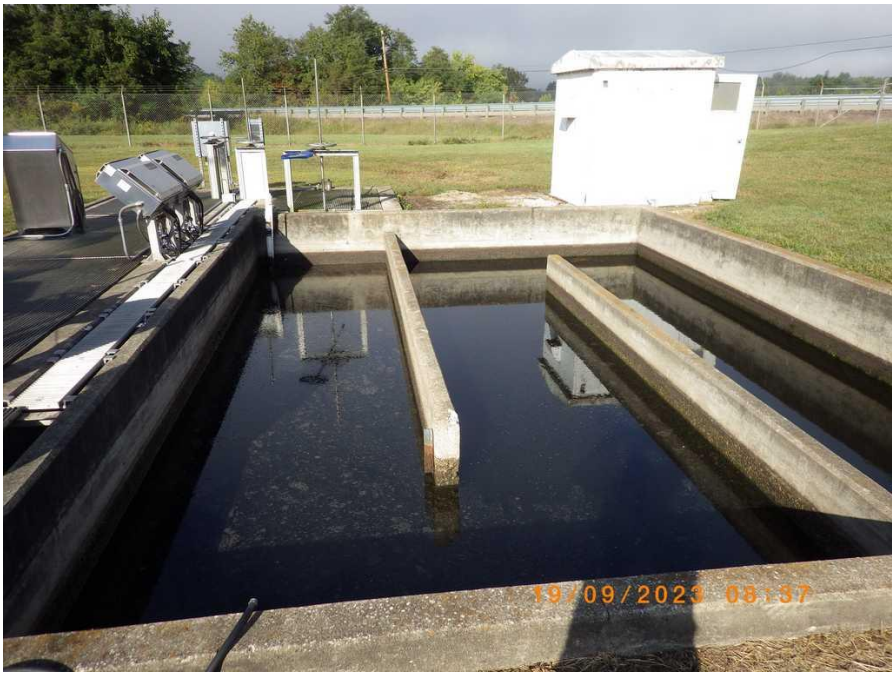
| Old chlorine contact tank | | | RIMG3217.JPG |

| Old chlorine contact tank used as an equalization tank before water is routed to the UV channel. Camera looking west. | | | |

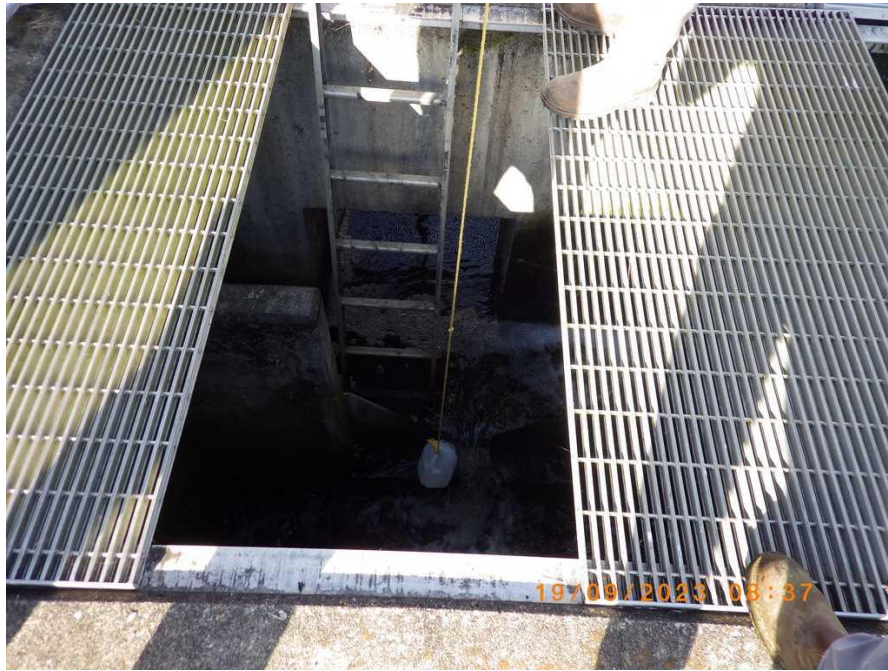
| Monitoring location 001 | | | RIMG3218.JPG |

| Monitoring location for outfall 001 during grab sampling. Camera looking west. | | | |

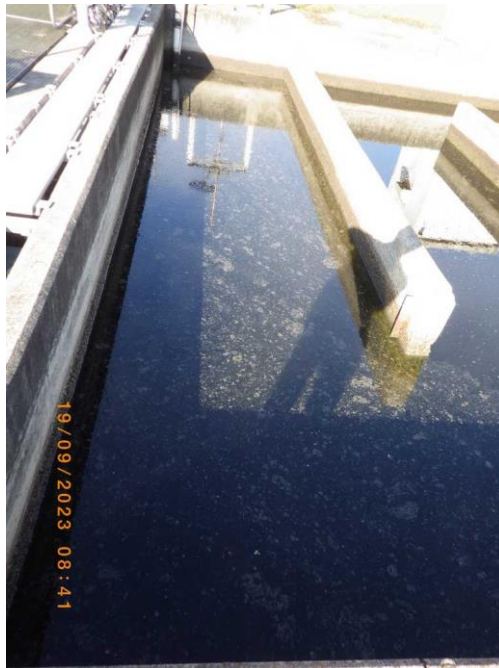
| Old chlorine contact tank | | | RIMG3219.JPG |

| Old chlorine contact tank. Camera looking west. | | | |

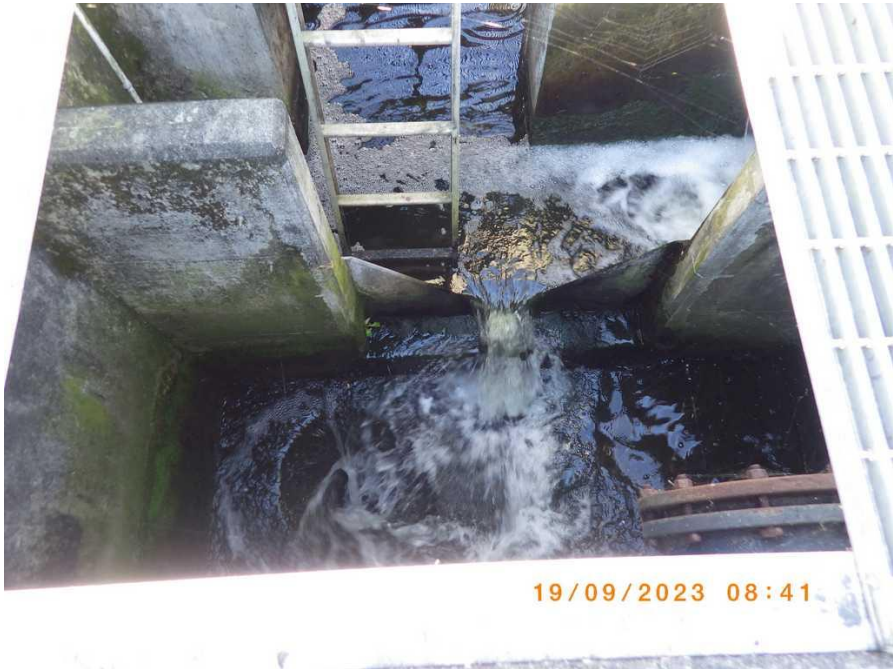
| Effluent at monitoring location 001 | | | RIMG3220.JPG |

tank was used to treat water with chlorine before discharge, but since the installation of the UV disinfection system, it serves as an equalization tank before water is routed to the UV channel. EPA observed that the UV control panel was not properly working at the time of the inspection. Photo RIMG3223. EPA observed the discharge through the v-notch weir at the sampling location for outfall 001. EPA did not observe any turbidity or discoloration in the water being discharged, at the time of the inspection. Photo RIMG3220.

| Effluent at the monitoring location for outfall 001. Camera looking down. | | | |

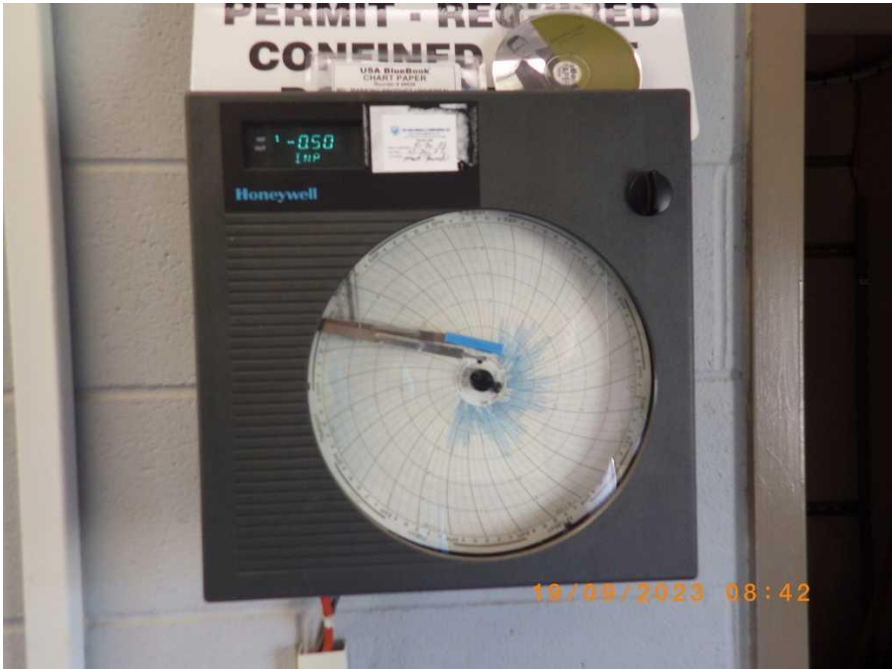
| Effluent flow recorder | | | RIMG3222.JPG |

| Effluent flow recorder inside the lab at the Wheelersburg WWTP. | | | |

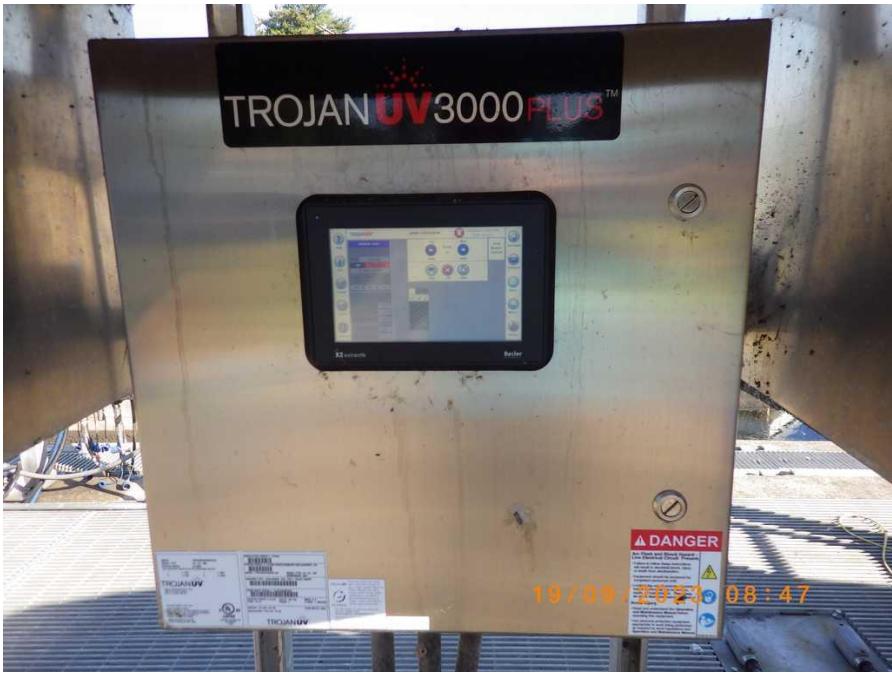
| UV Panel | | | RIMG3223.JPG |

EPA observed that the UV control panel was not properly working at the time of the inspection. Photo RIMG3223.

| The UV panel at the UV channel. Camera looking north. | | | |

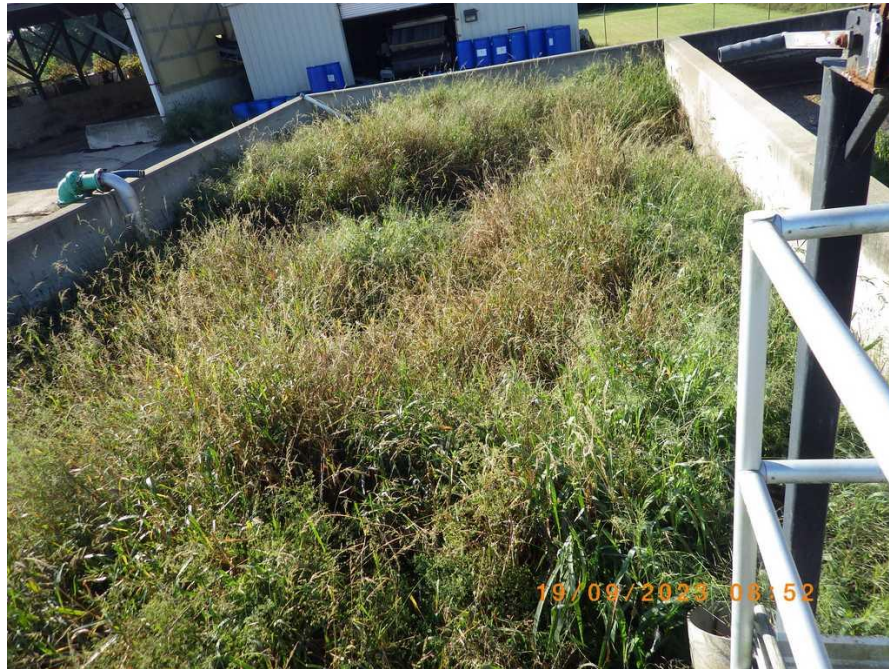
| Aerobic Digester | | | RIMG3224.JPG |

| <b>AOC:</b><br><br>EPA observed two sludge holding tanks (digesters) at the site. Each tank is split into two via a concrete wall. Only one tank was actively receiving sludge at the time of the inspection. The other sludge tanks were full and covered with growing vegetation. Photos RIMG3224 - RIMG3227. | |

| Aerobic digester tank 1 at the Wheelersburg WWTP. Camera looking south. | | | |

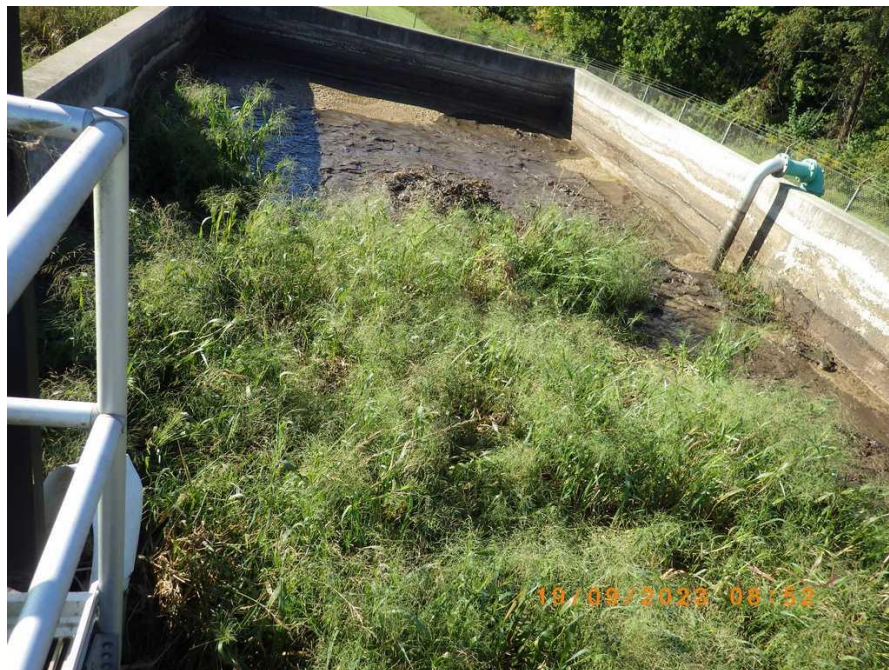
| Aerobic digester tank #2 | | | RIMG3225.JPG |

| Aerobic digester tank #2. Camera looking south. | | | |

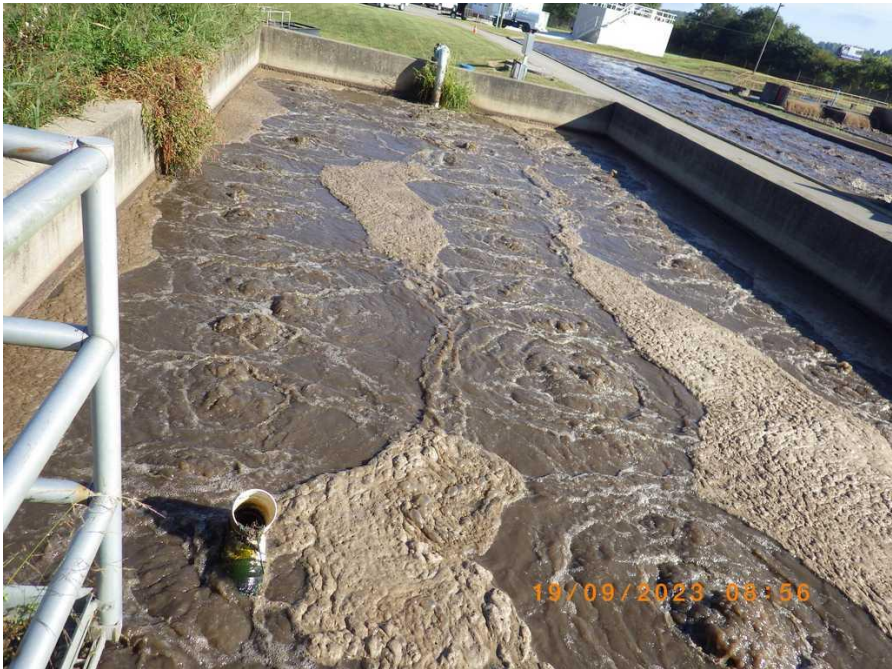
| Aerobic digester tank #3 | | | RIMG3226.JPG |

| Aerobic digester tank #3. Camera looking north. | | | |

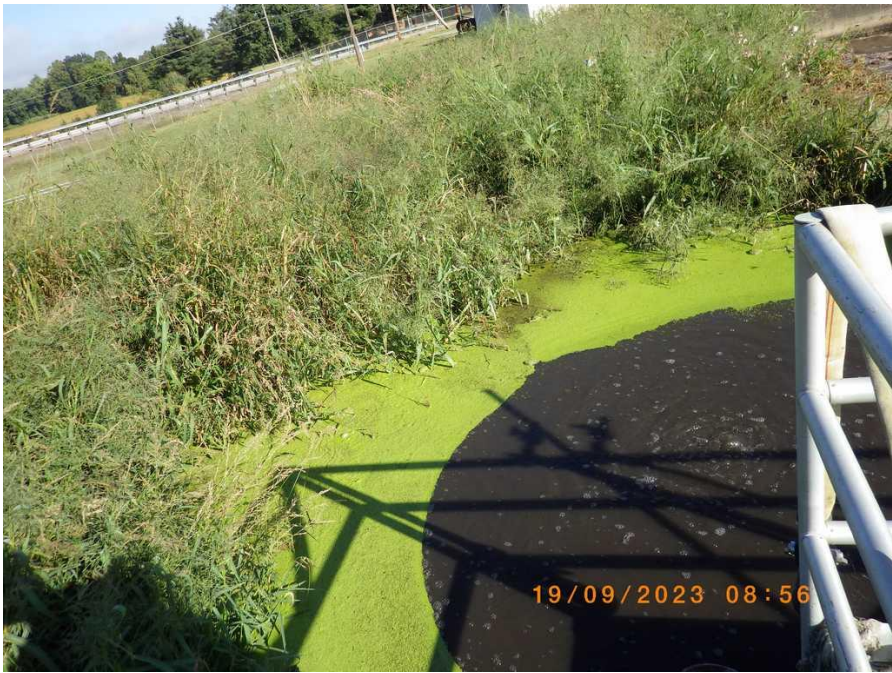
| Aerobic digester tank #4 | | | RIMG3227.JPG |

| Aerobic digester tank #4. Camera looking north. | | | |

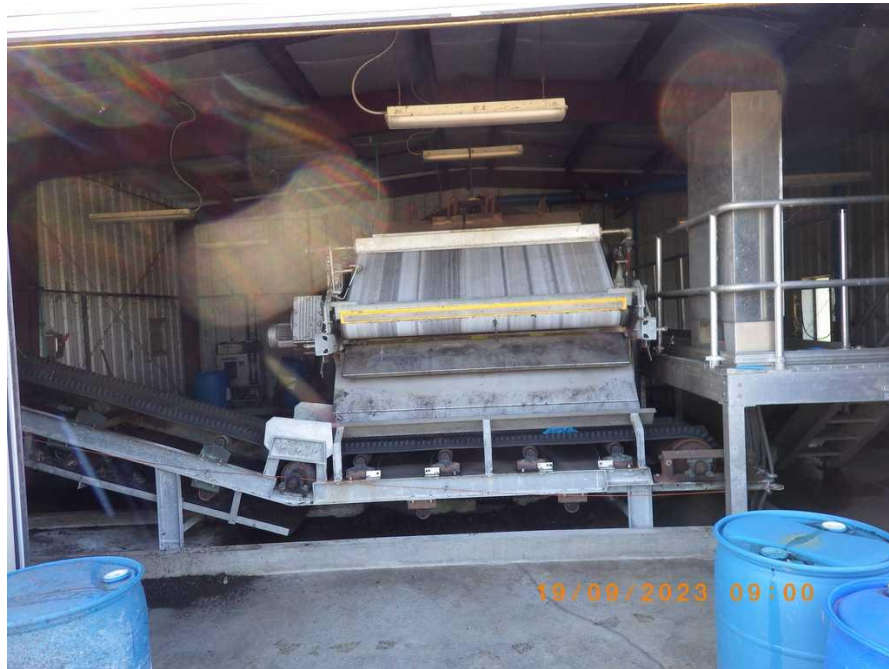
| Sludge belt press | | | RIMG3228.JPG |

| Sludge belt press at the Wheelersburg WWTP. Camera looking south | | | |

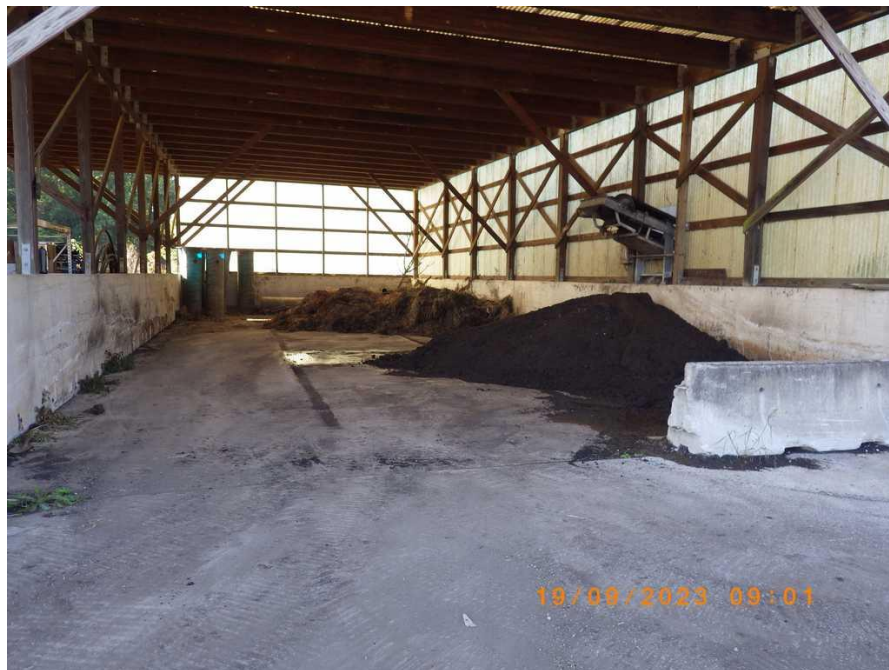
| Sludge storage shed | | | RIMG3229.JPG |

| Sludge storage shed east of the belt press. Camera looking south. | | | |

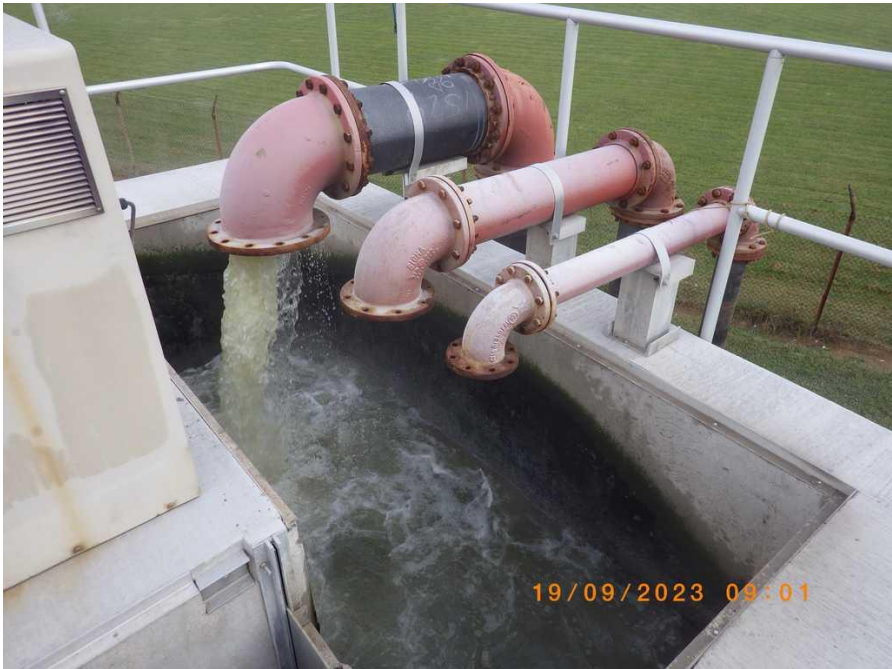
| Inflow pipes | | | RIMG3207.JPG |

| Inflow and return pipes at the headworks of the Wheelersburg WWTP. The bigger pipe that is seen discharging in the photo, is the one from the city of Wheelersburg. Camera looking north. | | | |

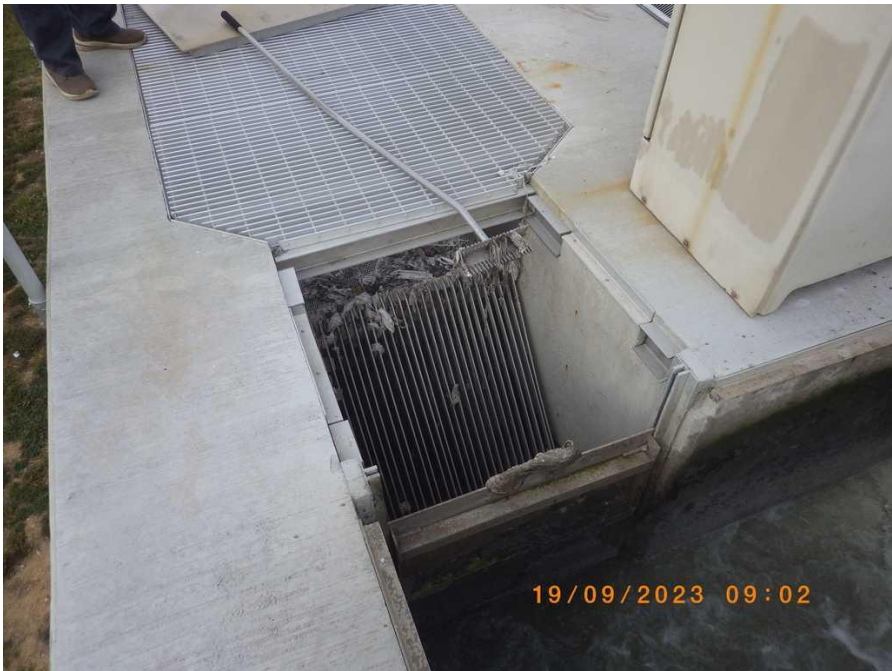
| Trash bar screen | | | RIMG3208.JPG |

| Trash bar screen at the headworks of the Wheelersburg WWTP. Camera looking south. | | | |

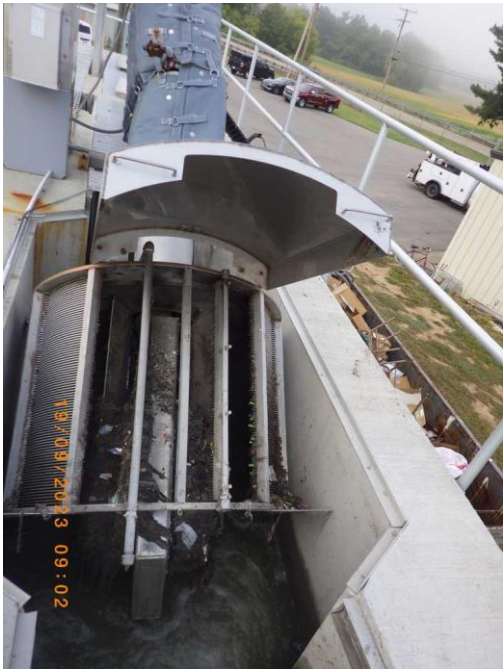
| Spiral Screw Screen | | | RIMG3209.JPG |

The automatic rotary drum screen was not working at the time of the inspection. Mr. Ryan Smith explained later during the inspection that the screen operates automatically based on the water level in the inflow channel; however, EPA did not observe it operate within the 3-hour window during which there was continuous flow from the inflow pipes. EPA observed a full bottle inside the autosampler and no thermometer inside the refrigerator of the autosampler. Mr. Andrew Schackart stated that he takes grab samples of the influent and has not used the autosampler.

| A spiral screw mechanical screen at the headworks that removes coarse trash coming into the wastewater treatment plant. Camera looking north. | | | |

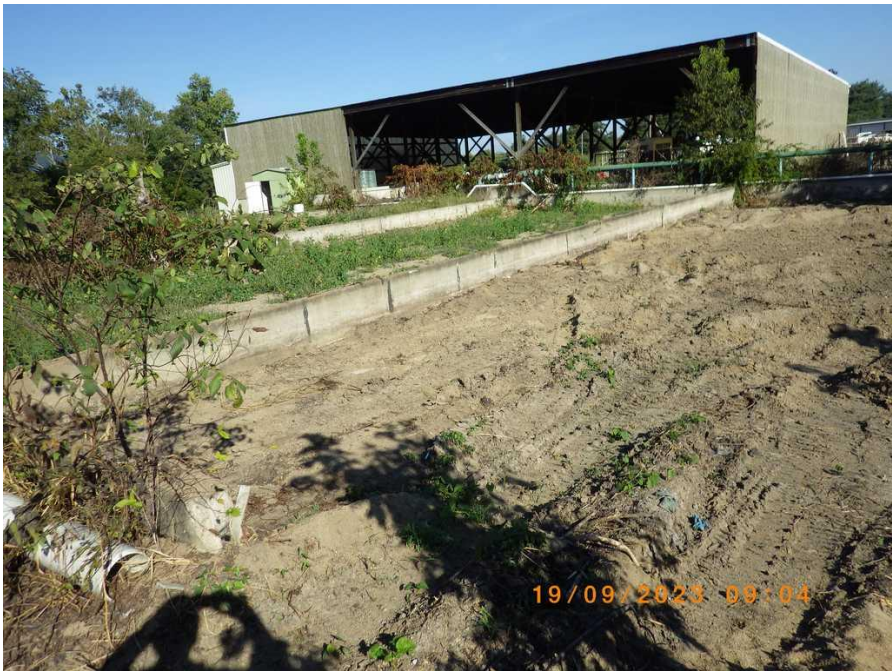
| Unused sludge drying beds | | | RIMG3230.JPG |

| Unused sludge drying beds south of the sludge storage shed. Camera looking north | | | |

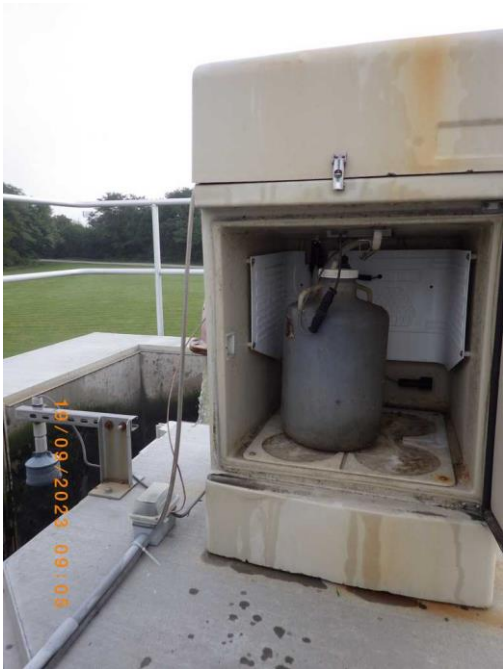
| Autosampler at the Headworks | | | RIMG3210.JPG |

| <b>AOC:</b><br><br>The autosampler was not used for sample collection (technician indicated that autosampler was not operational) for composite sampling. Chain of custody sheets are not used for sample collection and analysis at the Wheelersburg WWTP.<br><br>EPA observed that sample collection bench sheets do not adequately document sample collection and analysis times. | |

| Autosampler at the headworks of the Wheelersburg WWTP. Inside the autosampler there is a bottle full of water. | | | |

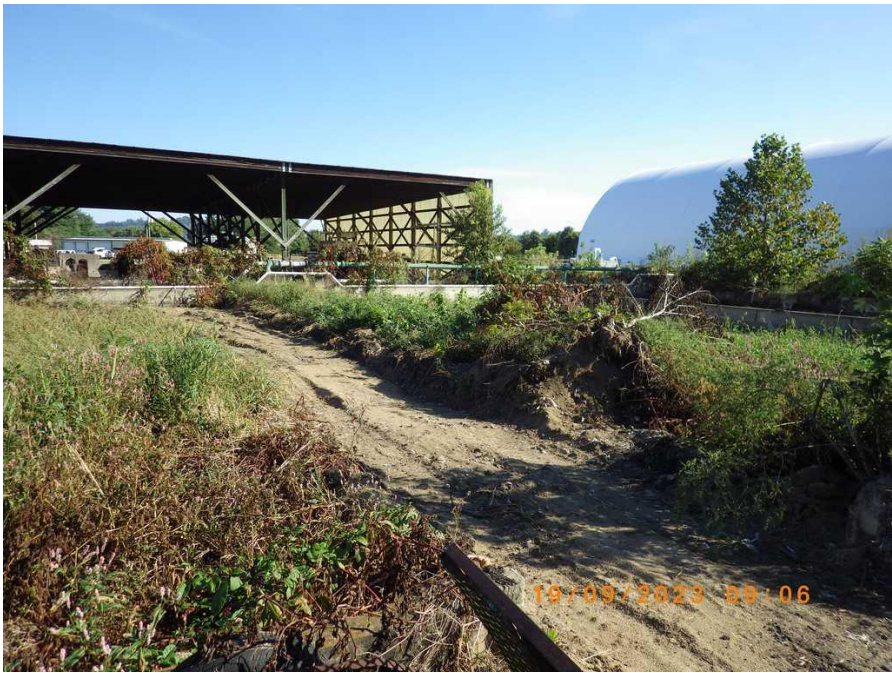
| Unused sludge drying beds | | | RIMG3231.JPG |

| Unused sludge drying beds south of the sludge storage shed. Camera looking north. | | | |

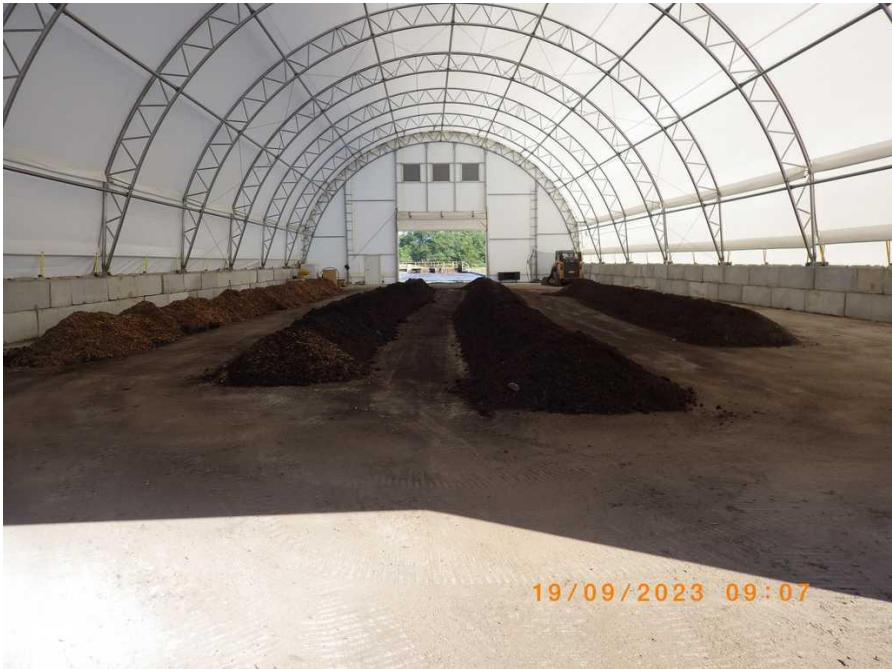
| New sludge storage shed | | | RIMG3232.JPG |

| New sludge storage shed where sludge is mixed with woodchips and left to dry. Camera looking north. | | | |

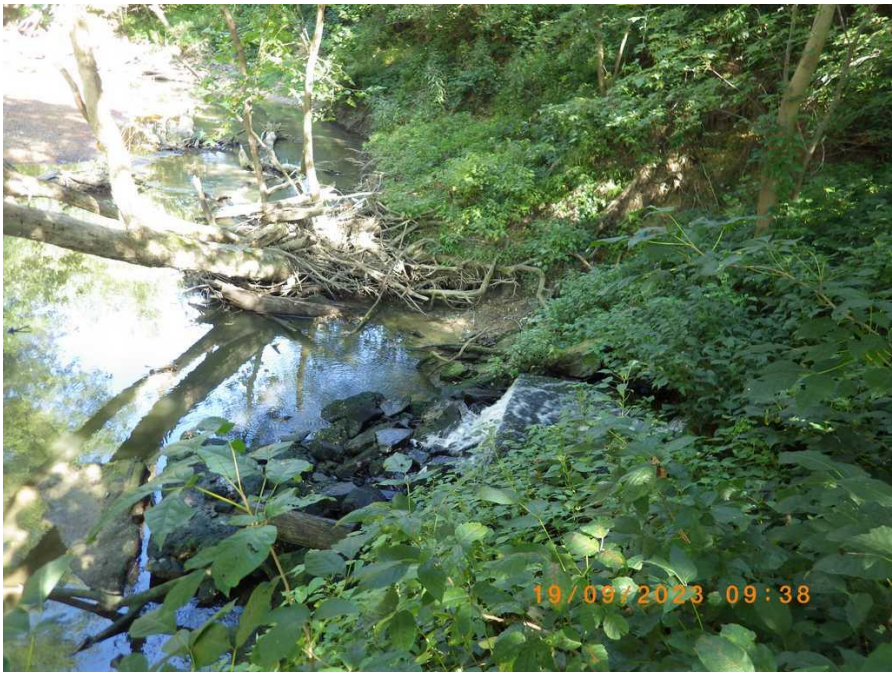
| Outfall 001 | | | RIMG3233.JPG |

| Outfall 001 discharging into Pine Creek. Camera looking northwest. | | | |

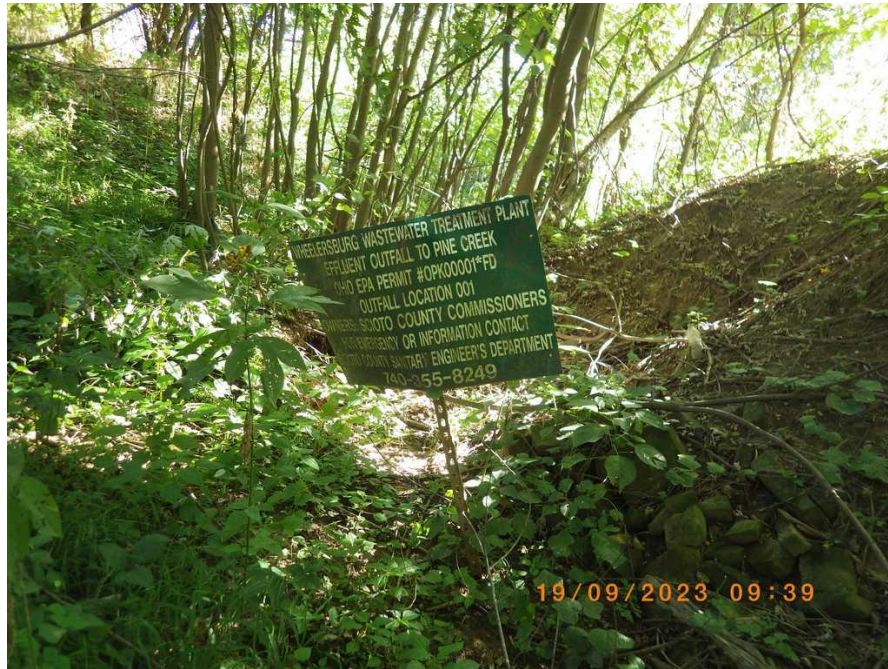
| Outfall 001 signage | | | RIMG3234.JPG |

| Outfall 001 signage on the banks of Pine Creek. Camera looking north. | | | |
