## **RCRA Inspection Report**

Niteo Products LLC (Niteo)  
720 Vaiden Drive  
Hernando, Mississippi 38632

**COMPLIANCE EVALUATION INSPECTION**

**October 28, 2021**

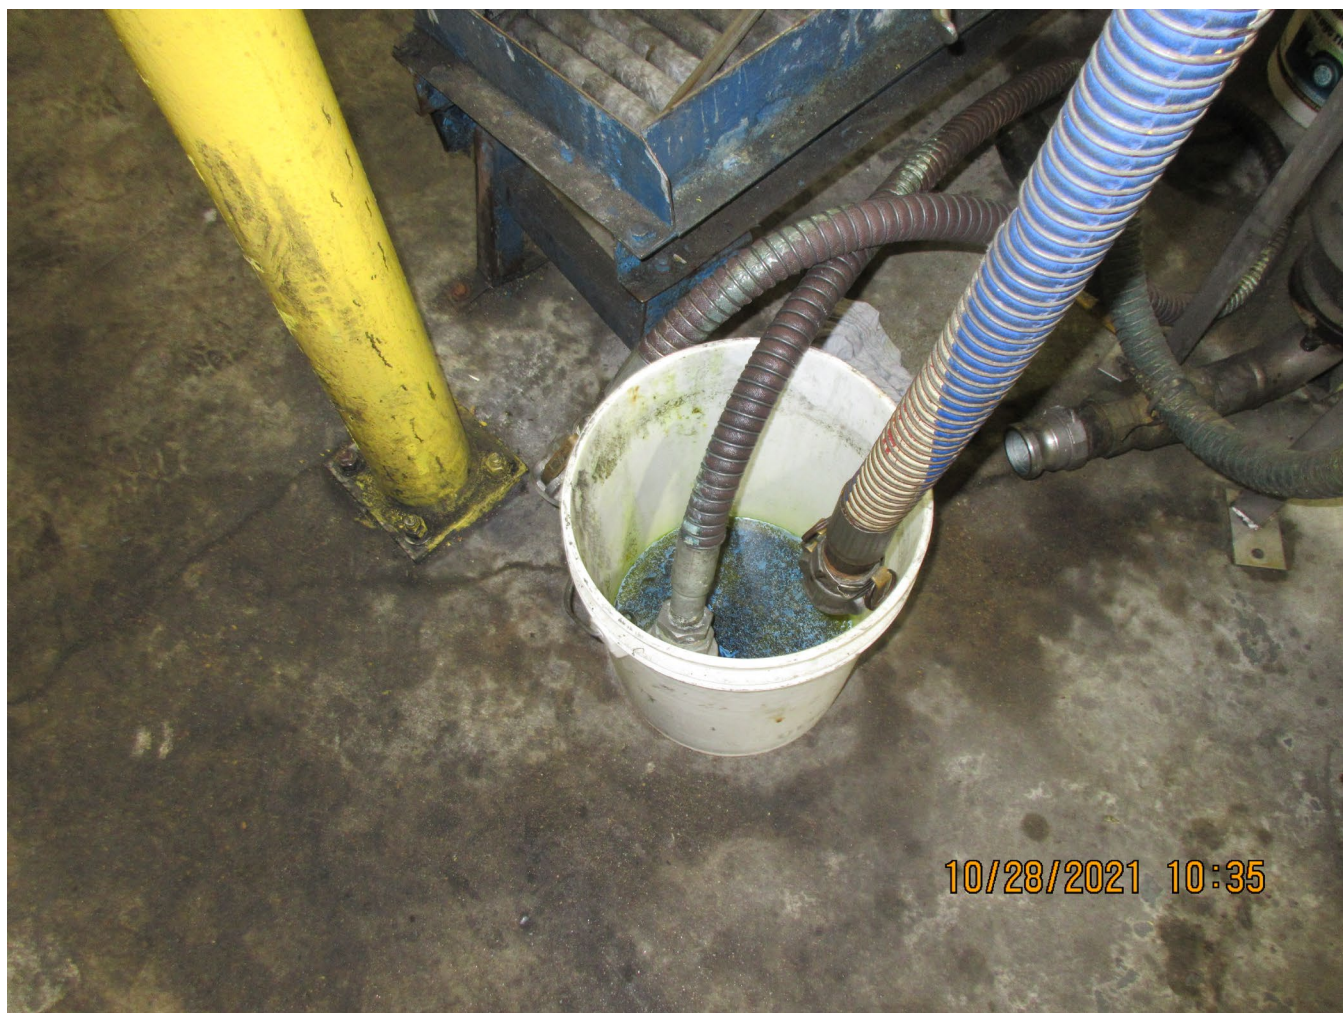
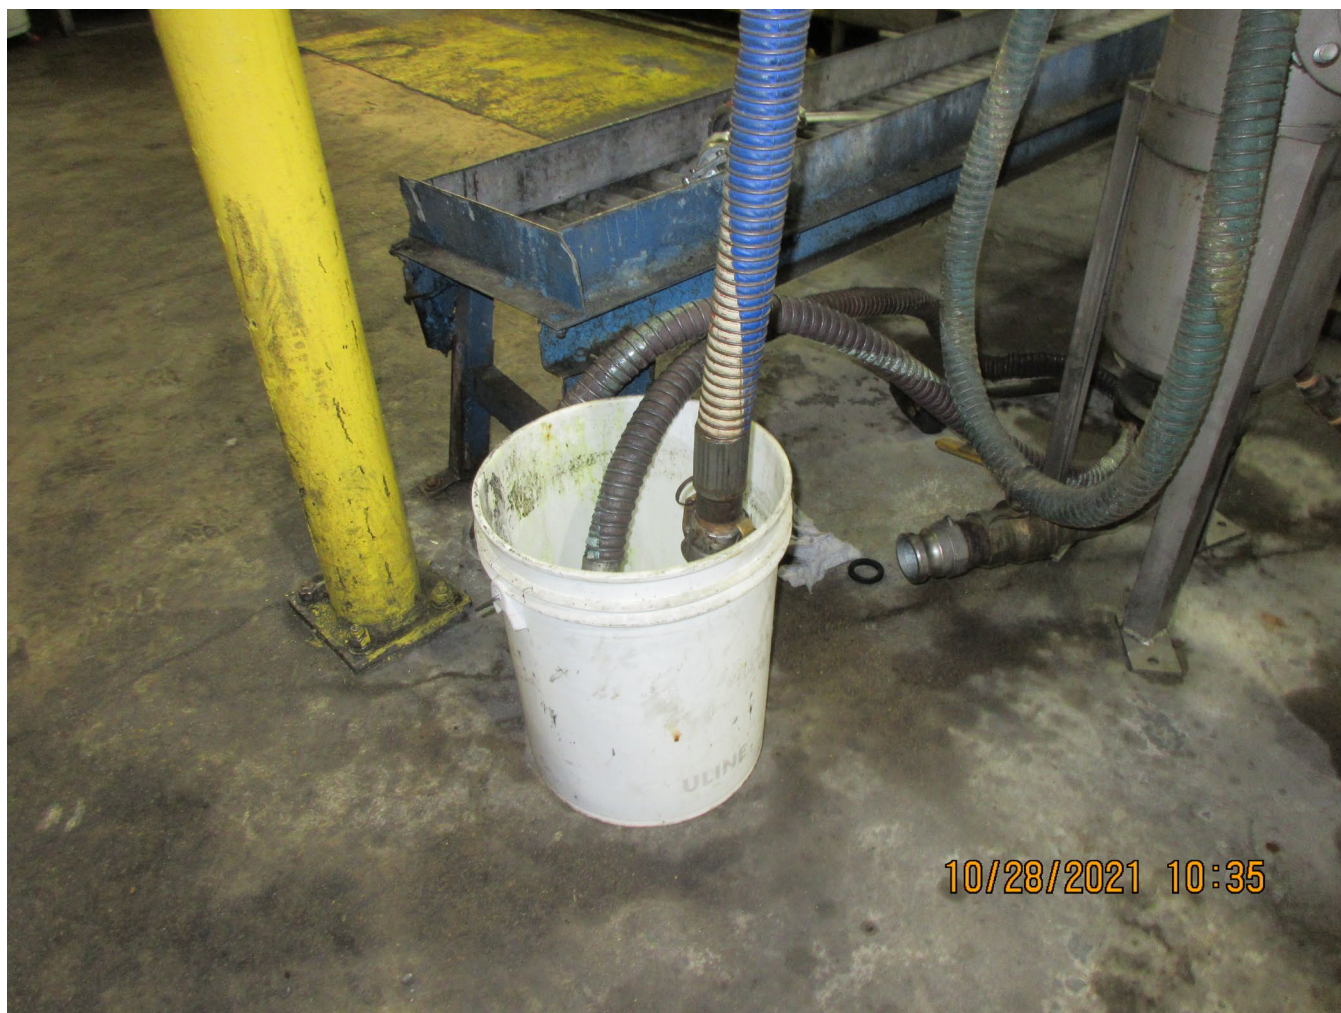
This area was located on the far east side of the facility in one of its blending areas. One five-gallon plastic container (Photos 1 and 2) was observed within a satellite accumulation area (SAA) in this location with approximately three inches of waste solvent in the container. This container was being used to collect drippage from fill hoses for brake cleaning solvent including xylene, toluene, and heptane. Dripping from the fill hoses into the container had ceased at the time of the inspection. At the time of the inspection, the container was open and unlabeled.

**Photo 1 – Hazardous Waste in 5-gallon bucket in the Old Blend Room**

**Photo 2 – Hazardous Waste in 5-gallon bucket in the Old Blend Room**

**Pursuant to 11 Miss. Admin. Code Pt. 3, R. 1.3 [40 C.F.R. § 262.15(a)], a generator may accumulate as much as 55 gallons of non-acute hazardous waste in containers at or near the point of generation where wastes initially accumulate, which is under the control of the operator of the process generating the waste, without a permit or without having interim status, as required by Section 17-17-27(4) of the Mississippi Code of 1972, Miss. Code Ann. § 17-17-27(4) [Section 3005 of RCRA, 42 U.S.C. § 6925], and without complying with 11 Miss. Admin. Code Pt. 3, R. 1.3 [40 C.F.R. § 262.16(b) or §262.17(a)], except as required in 11 Miss. Admin. Code Pt. 3, R. 1.3 [40 C.F.R. § 262.15(a)(7) and (8)], provided that the generator complies with the satellite accumulation area conditions listed in 11 Miss. Admin. Code Pt. 3, R. 1.3 [40 C.F.R. § 262.15(a)] (hereinafter referred to as the "SAA Permit Exemption").**

**Pursuant to 11 Miss. Admin. Code Pt. 3, R. 1.3 [40 C.F.R. § 262.15(a)(5)(ii)], which is a condition of the SAA Permit Exemption, a generator is required to mark or label its containers(i) with the words "Hazardous Waste" and (ii) with an indication of the hazards of the contents.**

**Pursuant to 11 Miss. Admin. Code Pt. 3, R. 1.3 [40 C.F.R. § 262.15(a)(4)], which is a condition of the SAA Permit Exemption, a generator is required to keep containers of hazardous waste closed at all times during accumulation, except when adding, removing, or consolidating waste; or when temporary venting of a container is necessary for the proper operation of equipment, or to prevent dangerous situations, such as build-up of extreme pressure.**

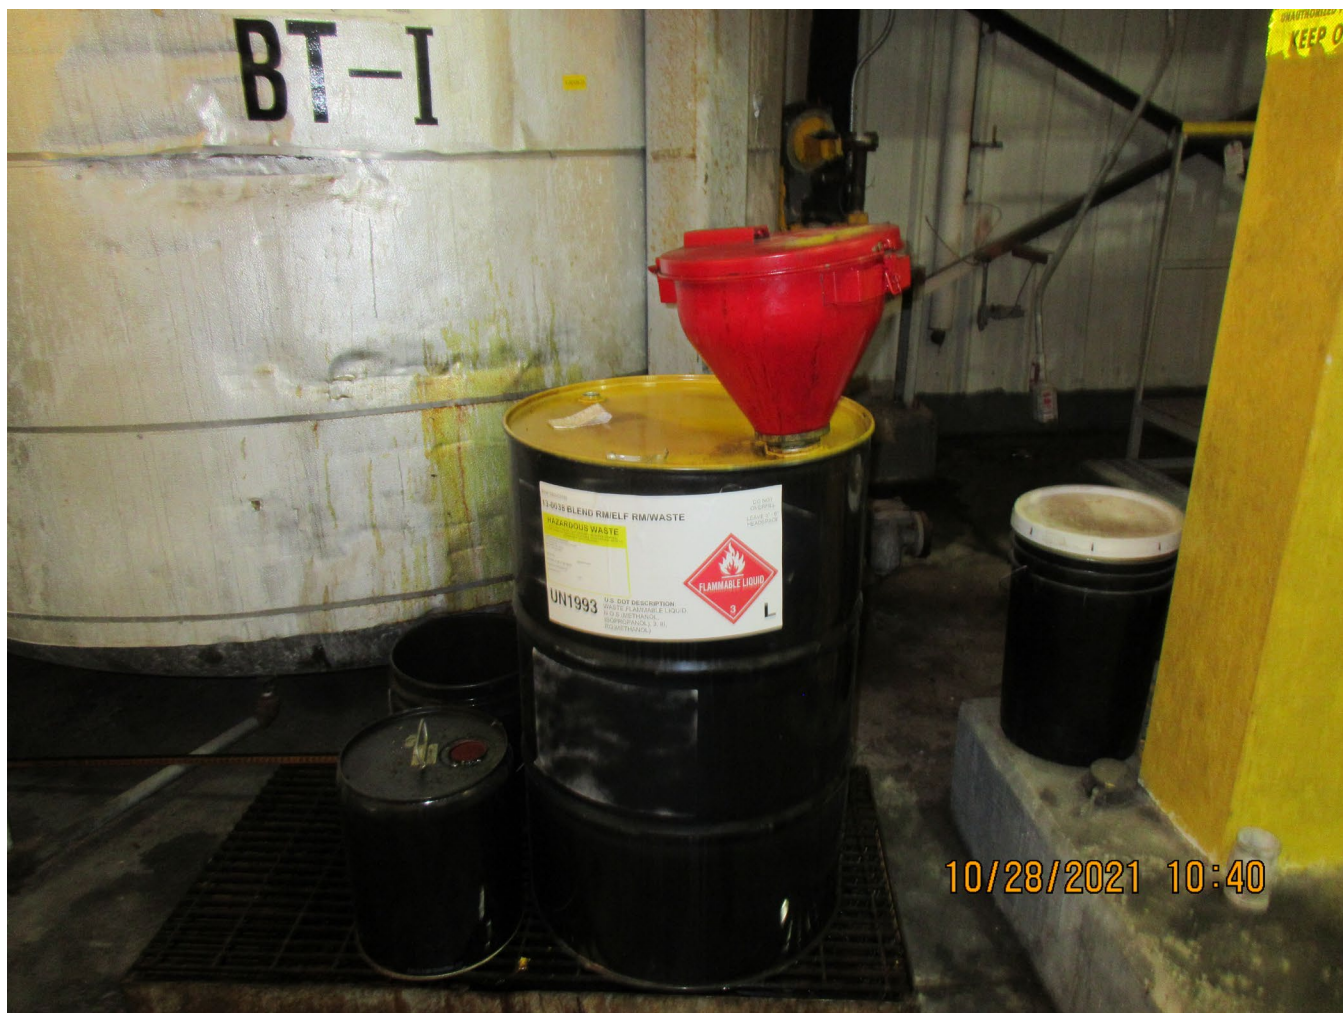
A 55-gallon drum (Photo 3) was also observed within a separate SAA in the Blend Room used for collecting hazardous waste from the production of brake cleaning fluids. At the time of the inspection, the container was open as the fastening device for the facility's funnel was not latched.

**Photo 3 – 55-gallon container of hazardous waste in SAA in the Blend Room and 5-gallon container (front left) of contaminated rags.**

**Pursuant to 11 Miss. Admin. Code Pt. 3, R. 1.3 [40 C.F.R. § 262.15(a)(4)], which is a condition of the SAA Permit Exemption, a generator is required to keep containers of hazardous waste closed at all times during accumulation, except when adding, removing, or consolidating waste; or when temporary venting of a container is necessary for the proper operation of equipment, or to prevent dangerous situations, such as build-up of extreme pressure.**

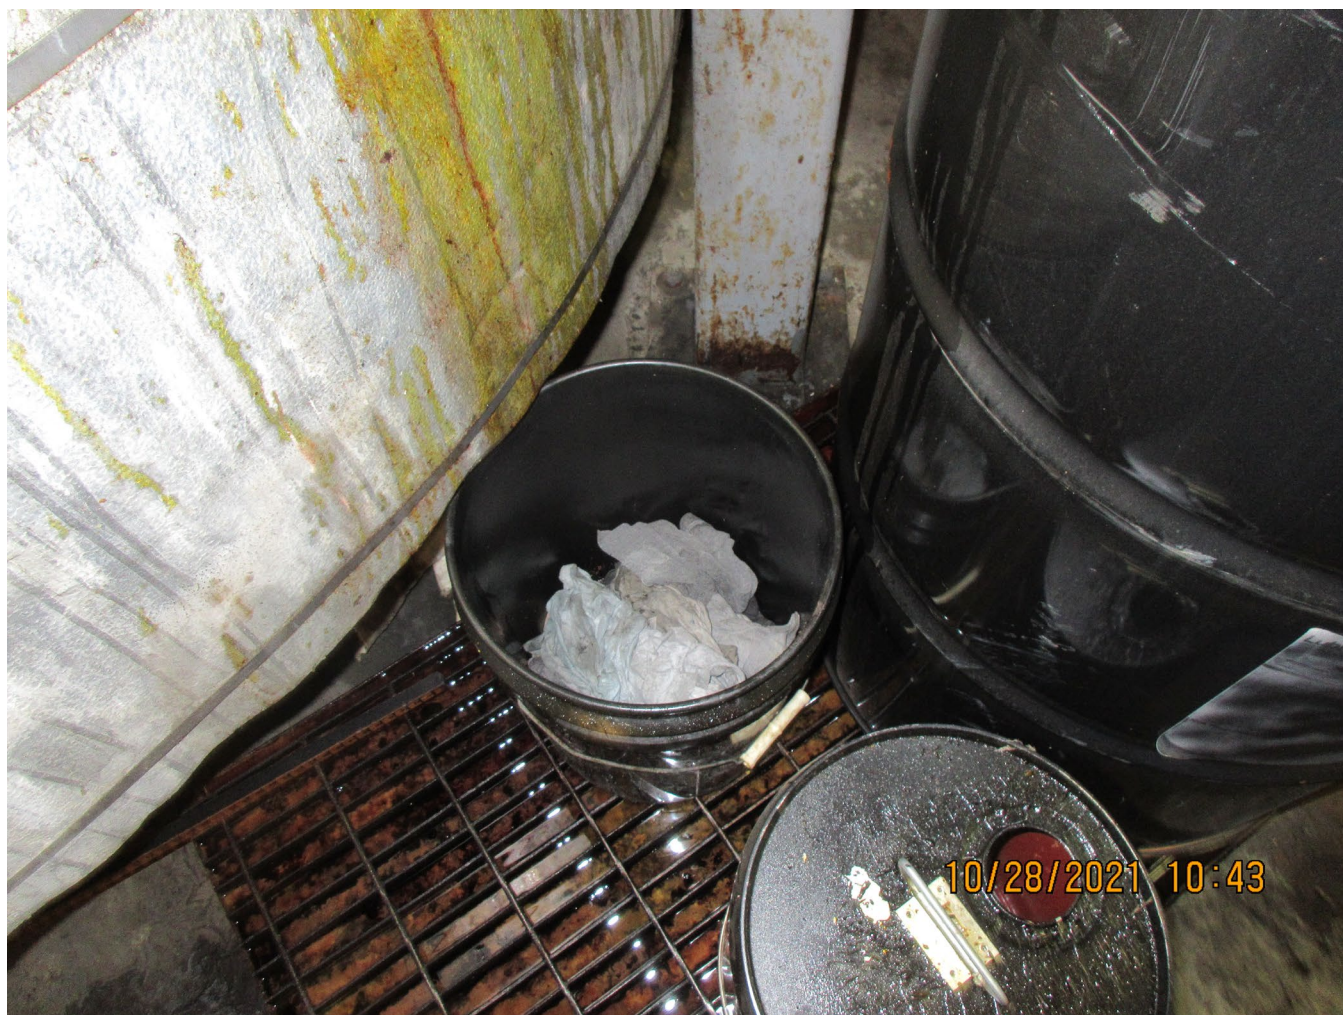
One 5-gallon container (Photo 4) with contaminated rags was observed next to the designated 55-gallon container (Photo 3) in the SAA identified immediately above. Facility personnel did not know if the rags were contaminated with brake cleaning fluids and should be managed as hazardous waste at the time of the inspection.

**Photo 4 – Contaminated Rags in 5-gallon container in the Blend Room**

**Pursuant to 11 Miss. Admin. Code Pt. 3, R. 1.3 [40 C.F.R. § 262.11], a person who generates a solid waste, as defined in 11 Miss. Admin. Code Pt. 3, R. 1.3 [40 C.F.R. § 261.2], must make an accurate determination as to whether that waste is a hazardous waste in order to ensure wastes are properly managed according to applicable RCRA regulations articulated in 11 Miss. Admin. Code Pt. 3, R. 1.3 [40 C.F.R. § 262.11].**

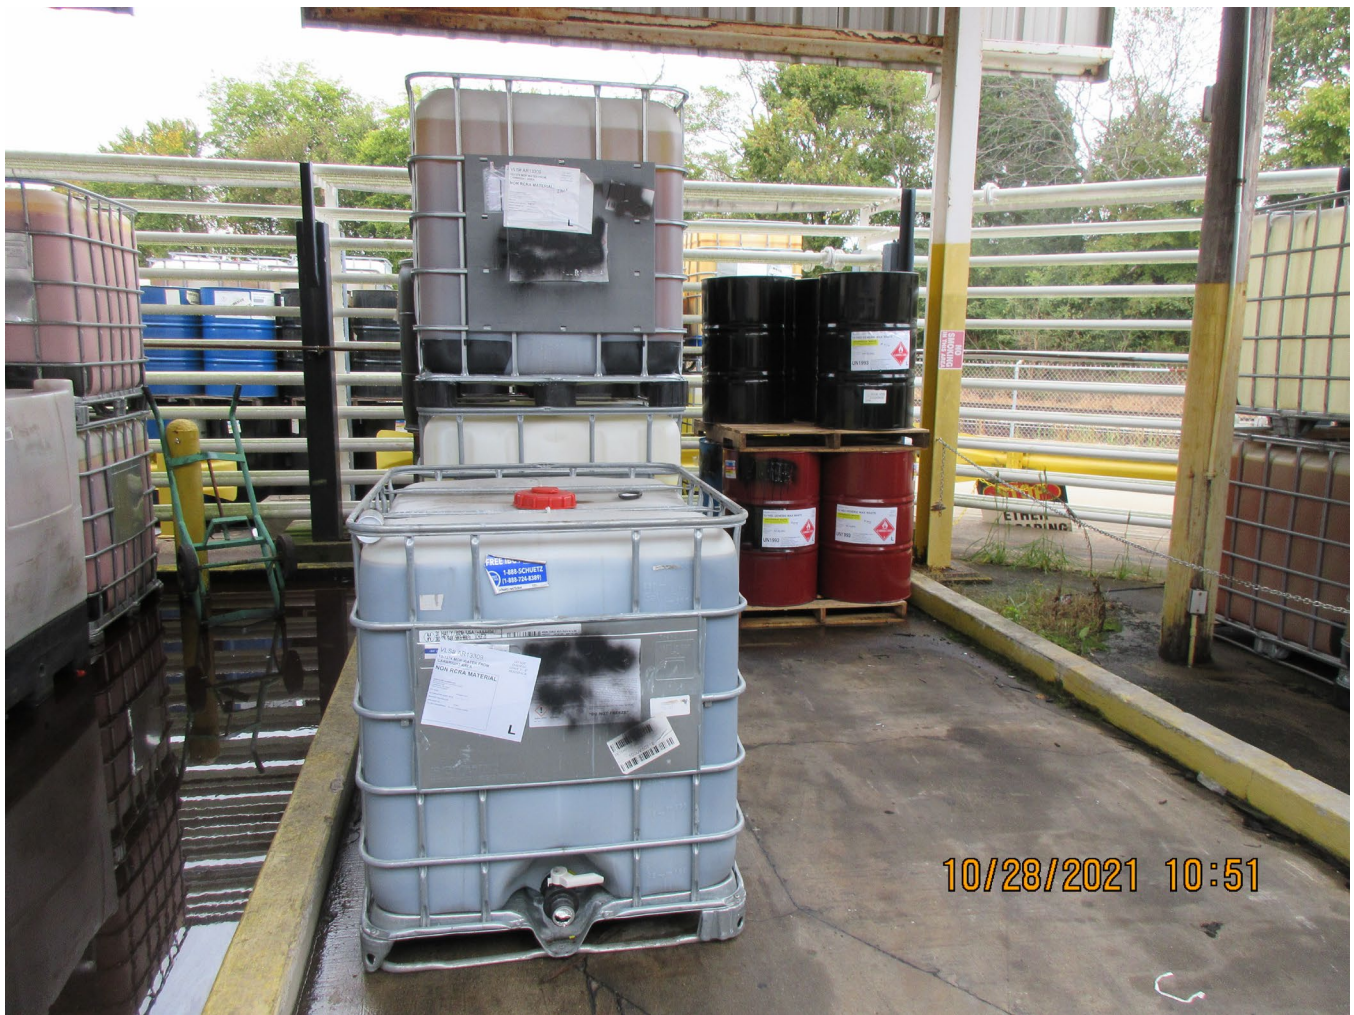
This area was comprised of a concrete pad bermed on 4 sides with the entrance side being curved. The pad was covered with a metal roof (Photo 5).

Ten 55-gallon drums of hazardous waste were observed on pallets stacked two high in this area at the time of the inspection shown in back right on Photo 5. Each of the drums were observed to be closed and labeled with the words "Hazardous Waste" and an indication of the hazard contents of the container. Each container was also dated within the past 90 days. A fire extinguisher, spill kit and "No Smoking" signs were observed in the area.

**Photo 5 – 90-day hazardous waste accumulation area**

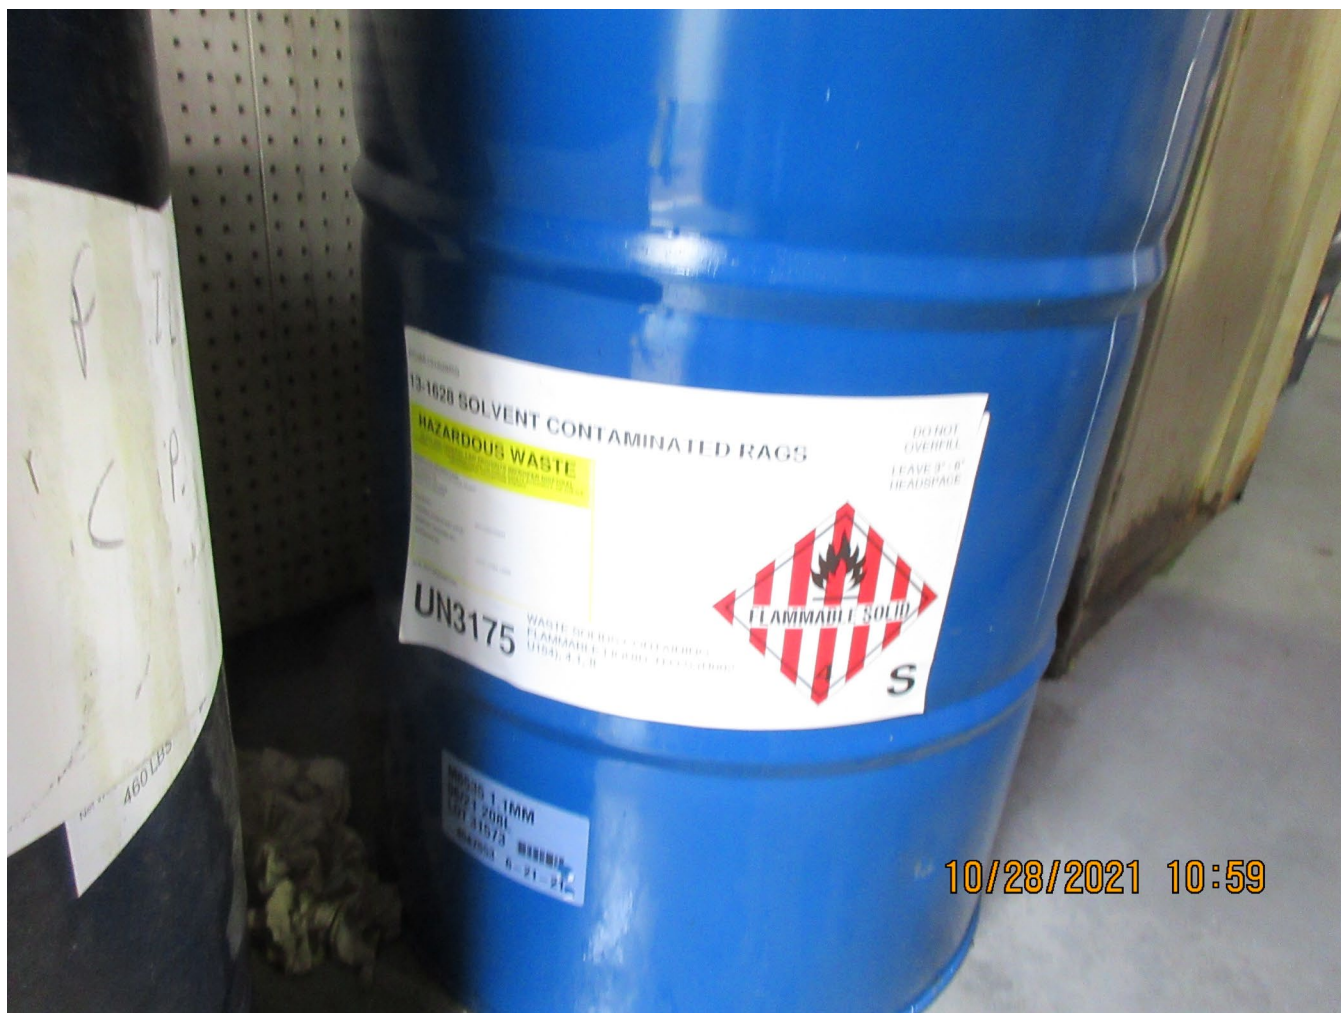
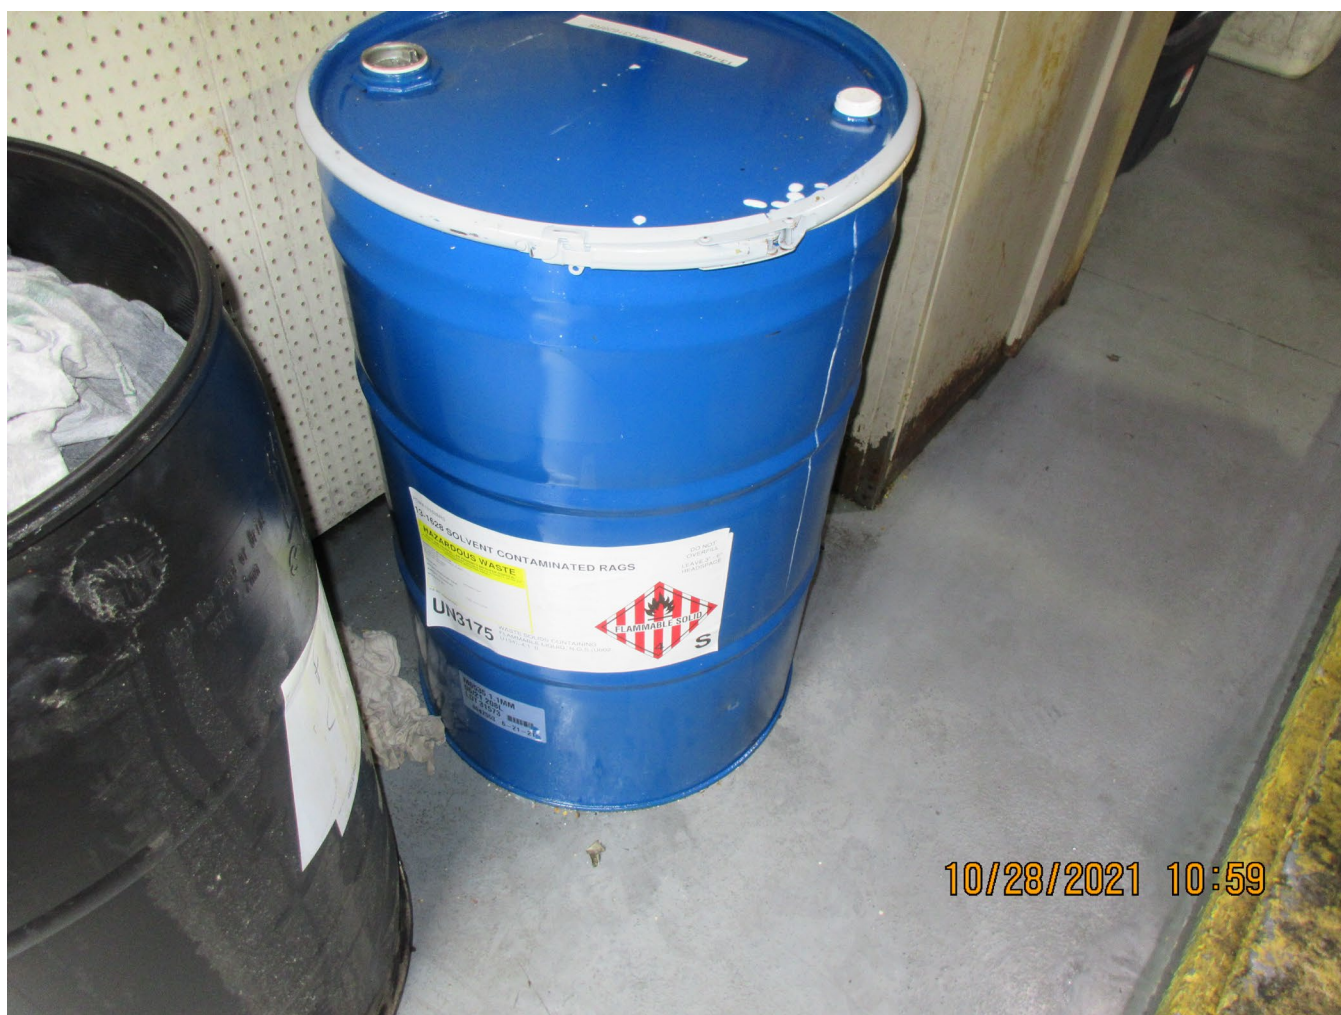
This SAA was located in the Line 2 Fill Room. One 55-gallon drum of hazardous waste rags (Photos 6 and 7) destined for disposal were observed in this area at the time of the inspection.

**Photo 6 – Label on container in SAA # 4**

**Photo 7 – Container of Hazardous Waste Rags in SAA # 4**

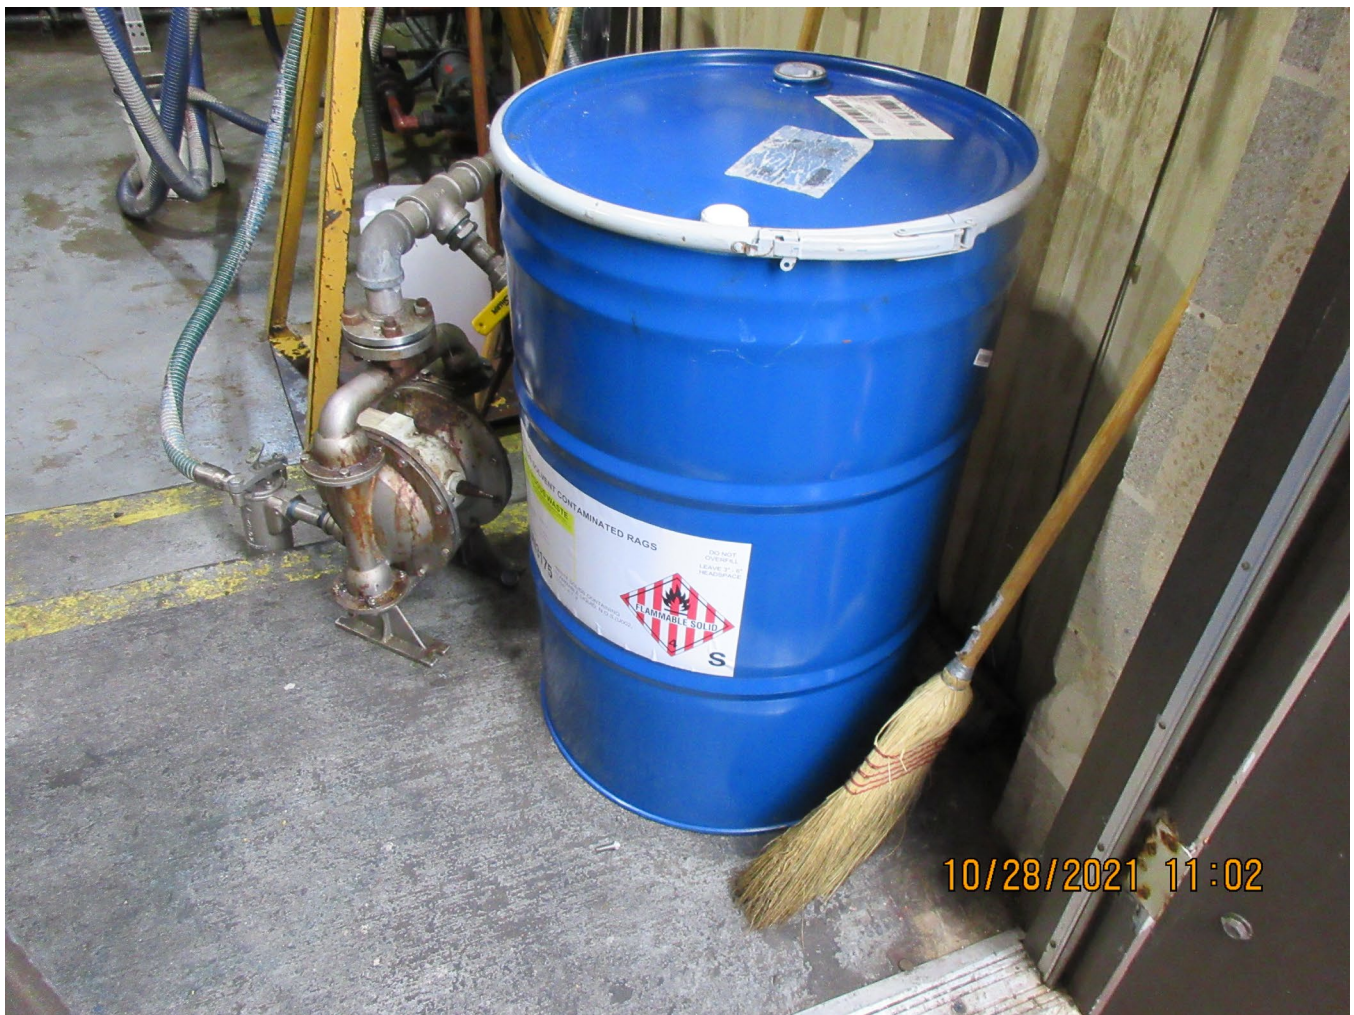
This SAA was located in the Line 1 Fill Room. One 55-gallon drum of hazardous waste rags (Photo 8) destined for disposal were observed in this area at the time of the inspection.

**Photo 8 – Container of Hazardous Waste Rags in SAA # 5**

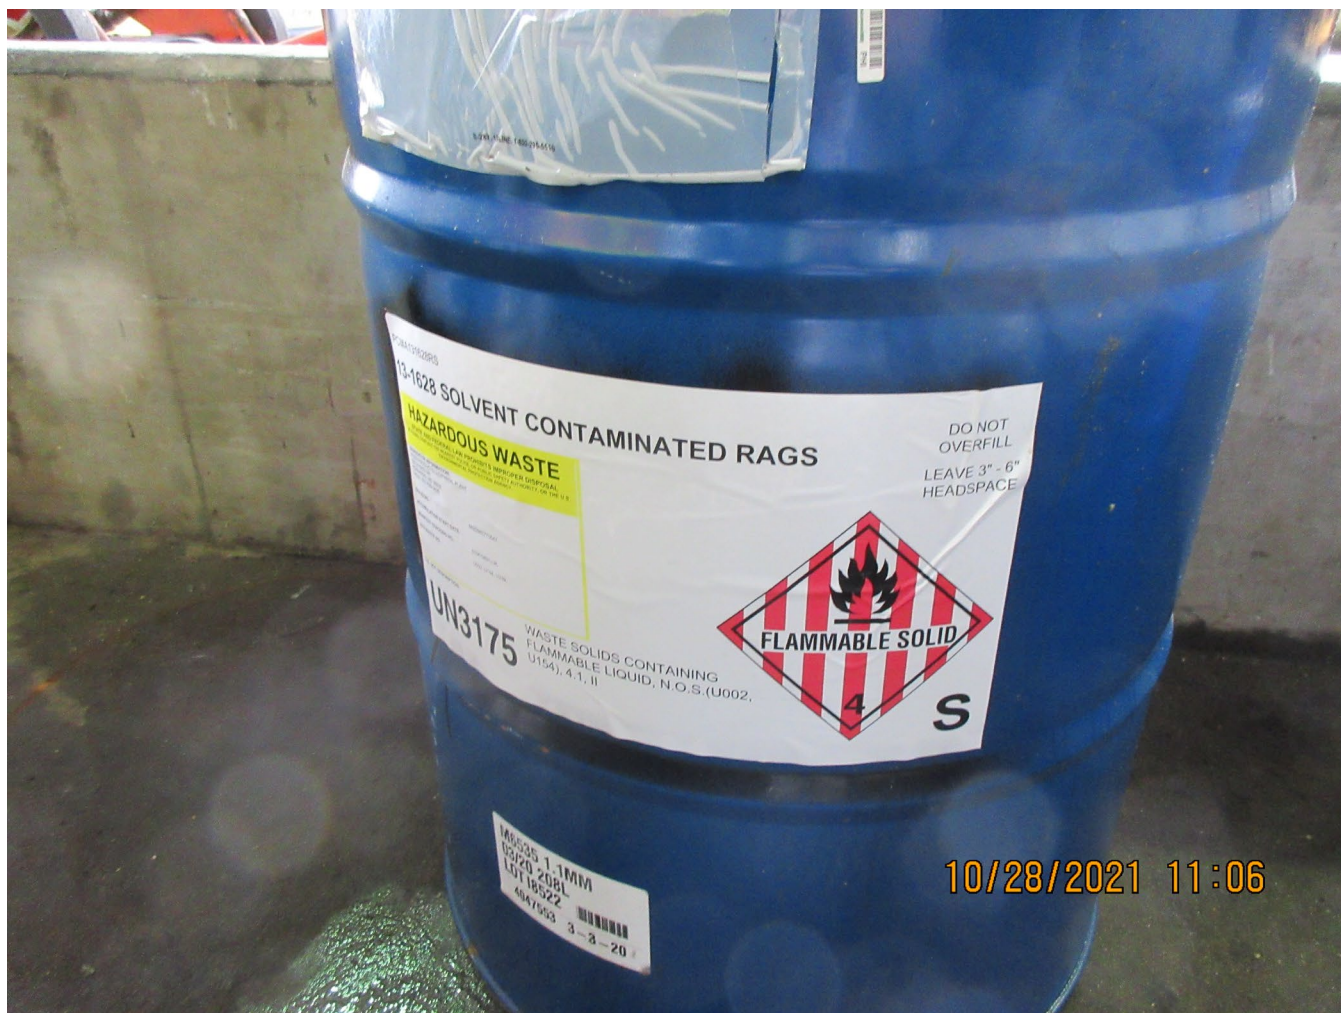
Two SAA were located in the area of the facility's truck rack. One 55-gallon drum of hazardous waste rags (Photo 9) destined for disposal was observed in this area at the time of the inspection. In addition, one 55-gallon drum of hazardous waste solvent (Photo 10) was also observed in this area at the time of the inspection.

**Photo 9 - Container of Hazardous Waste Rags in SAA # 6**

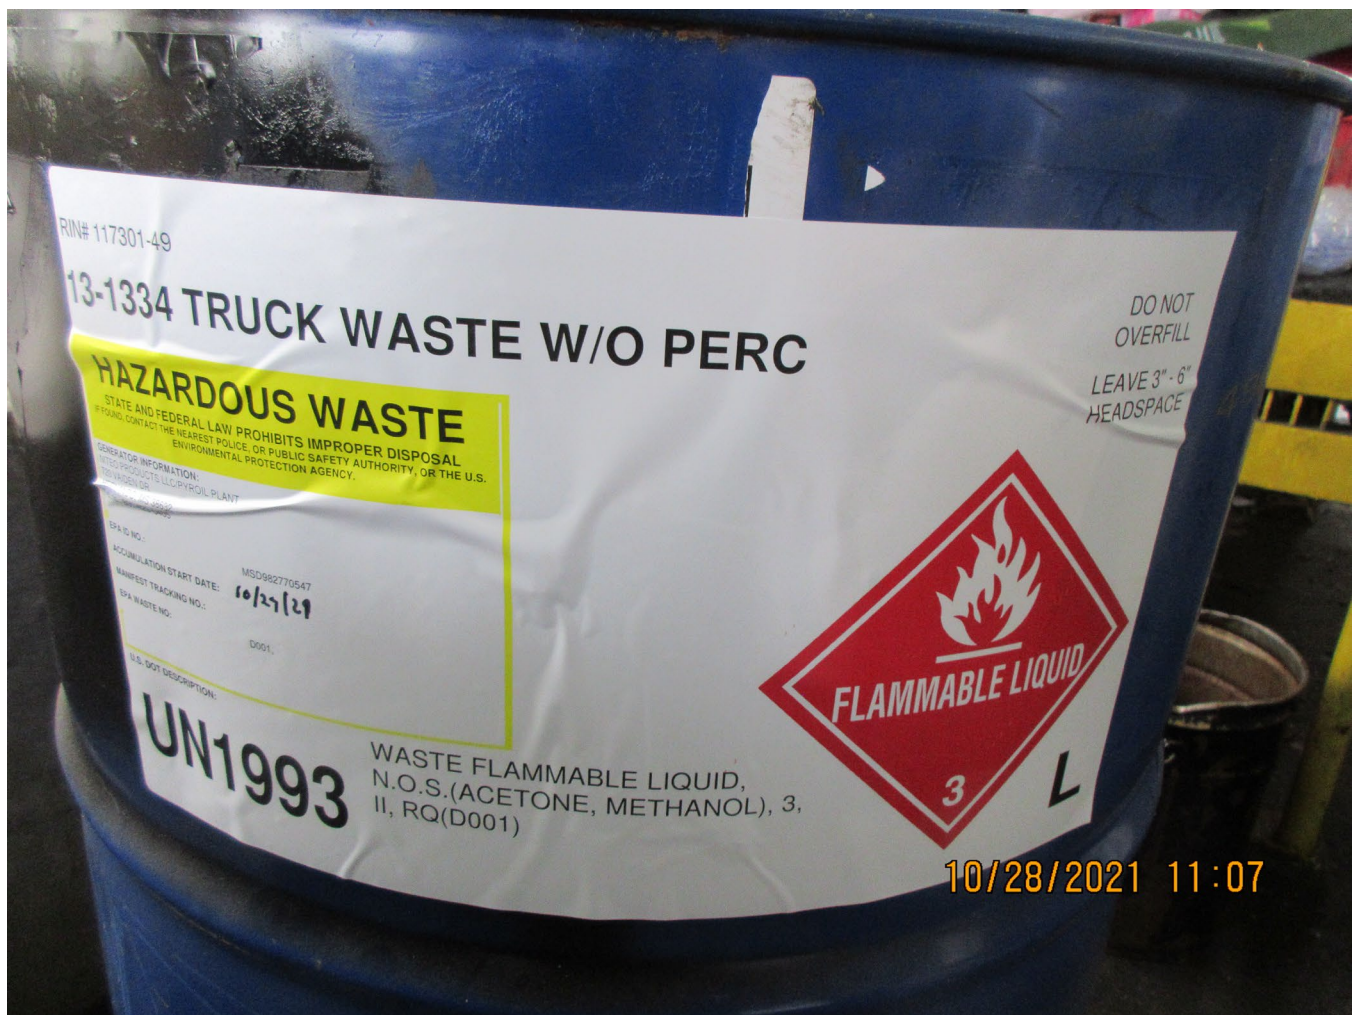
**Photo 10 - Container of Hazardous Waste Liquid in SAA # 6**

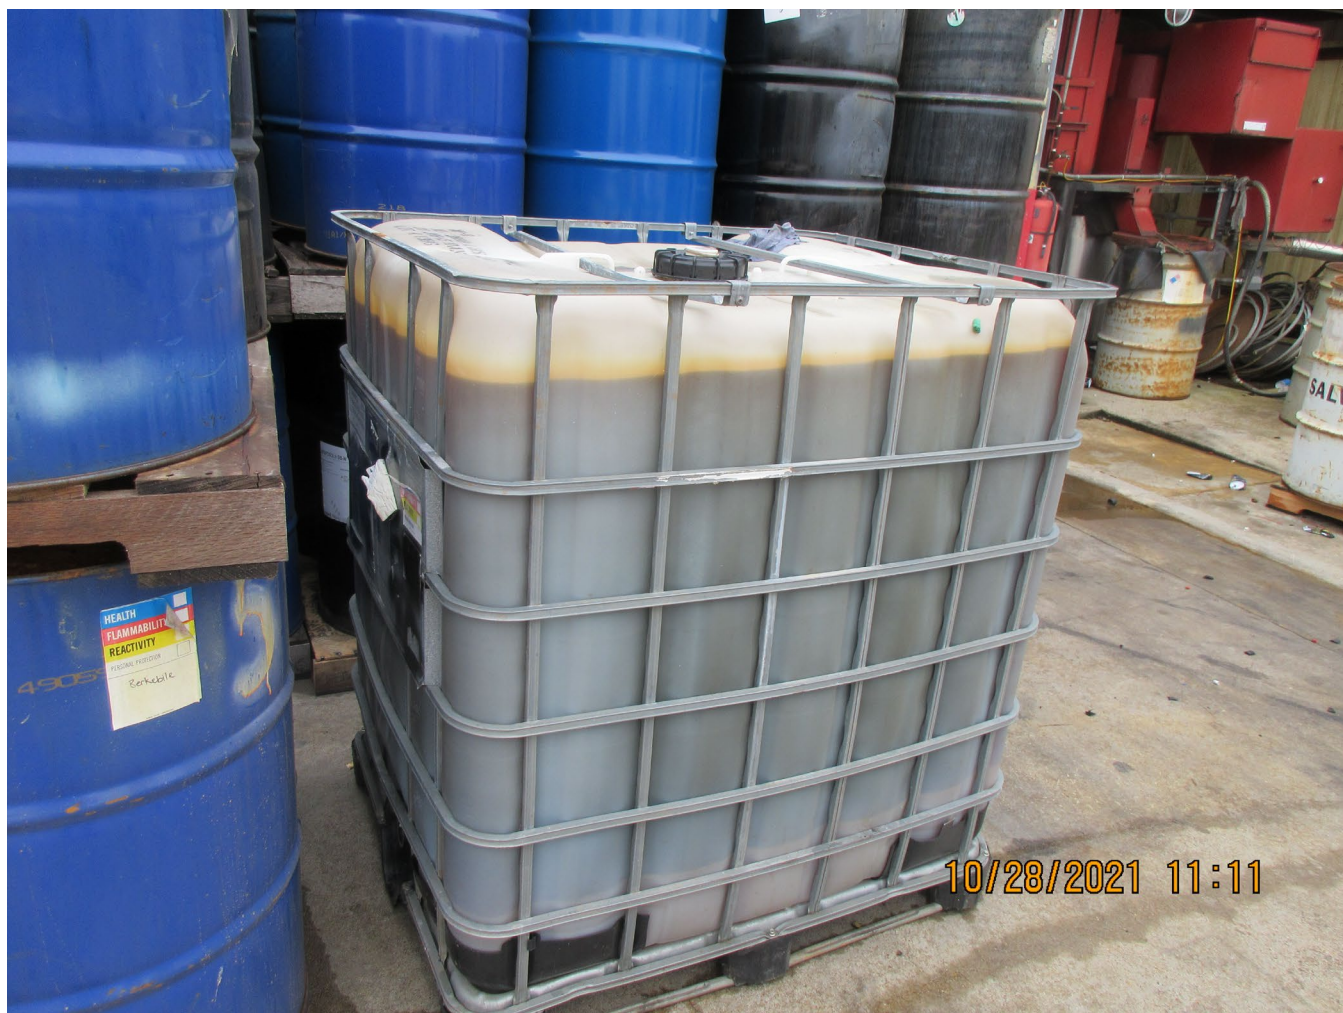
In addition, one 265-gallon plastic tote of used oil without a label was also observed in this area (Photo 11).

**Photo 11 – 265-gallon tote of used oil located outside of main building in Reclaim Area**

**Pursuant to 11 Miss. Admin. Code Pt. 3, R. 1.22 [40 C.F.R. § 279.22(c)(1)], containers and aboveground tanks used to store used oil at generator facilities must be labeled or marked clearly with the words "Used Oil."**

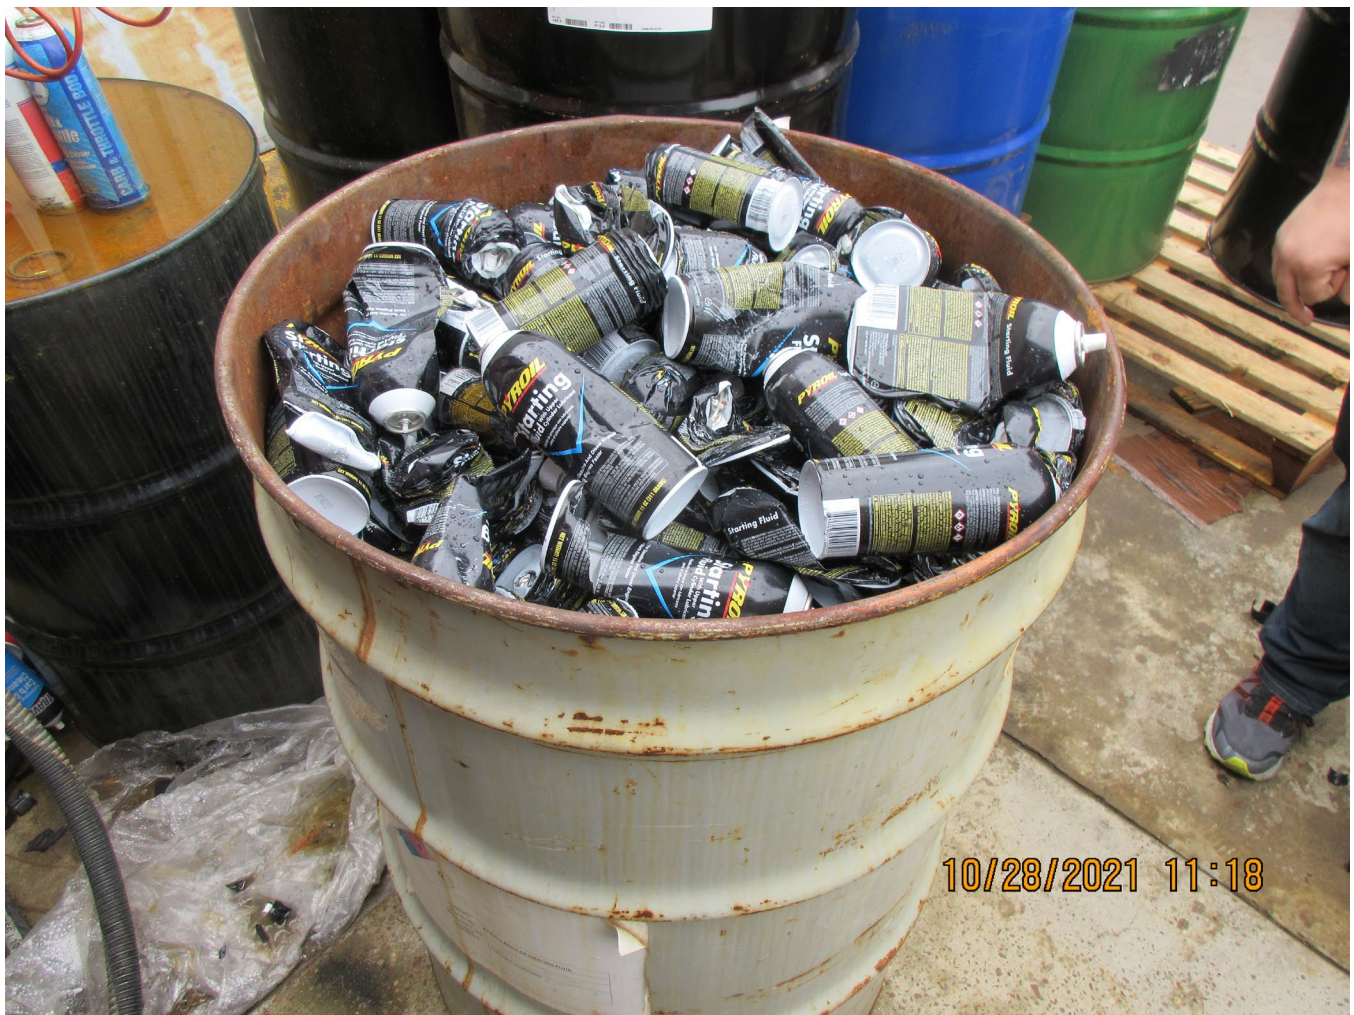
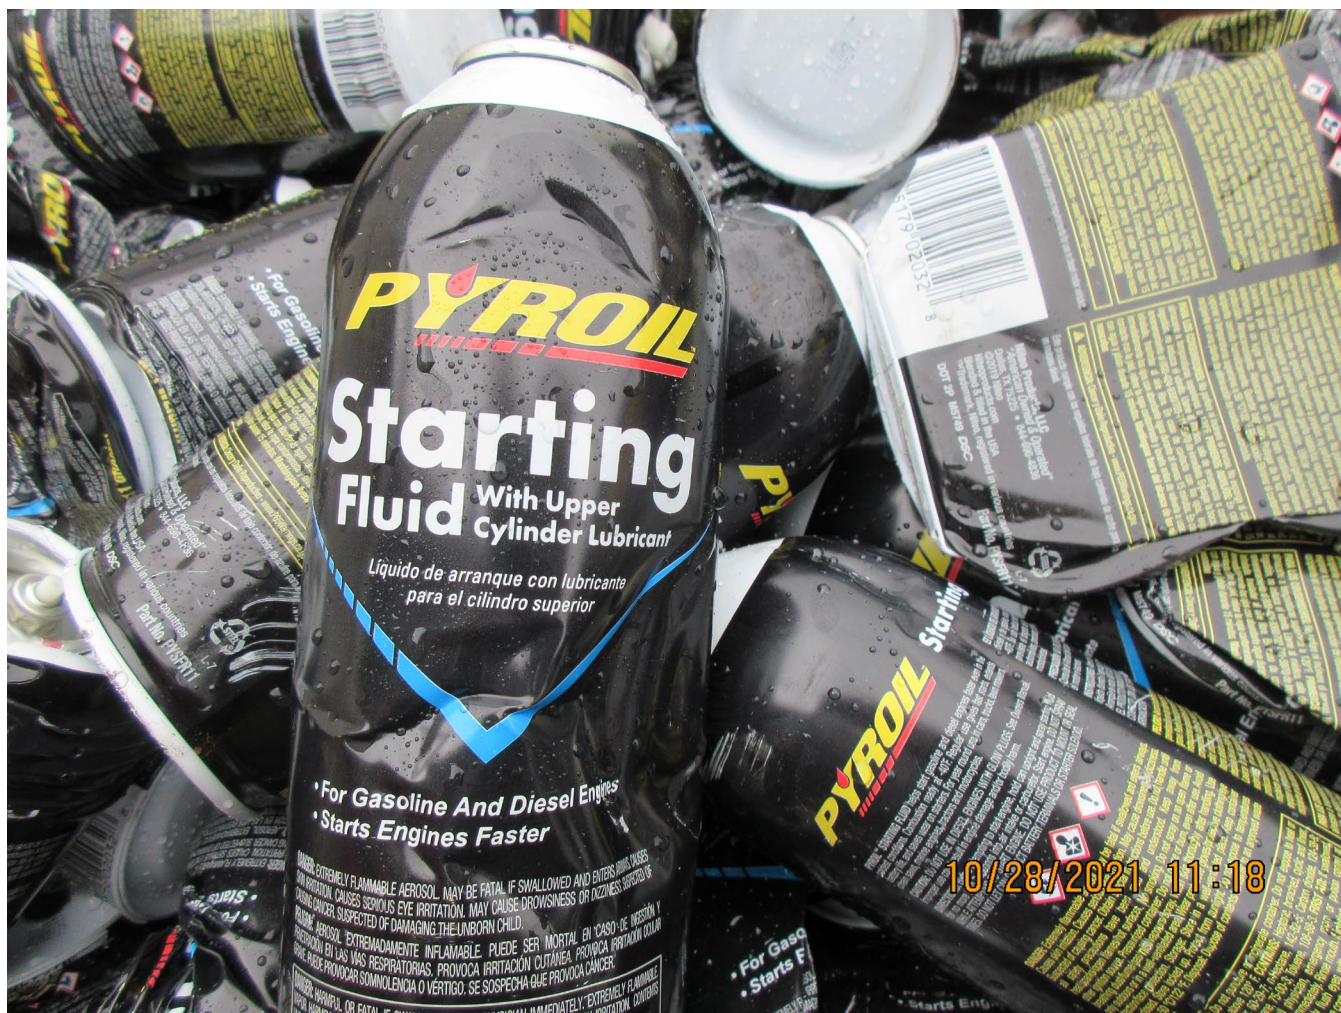
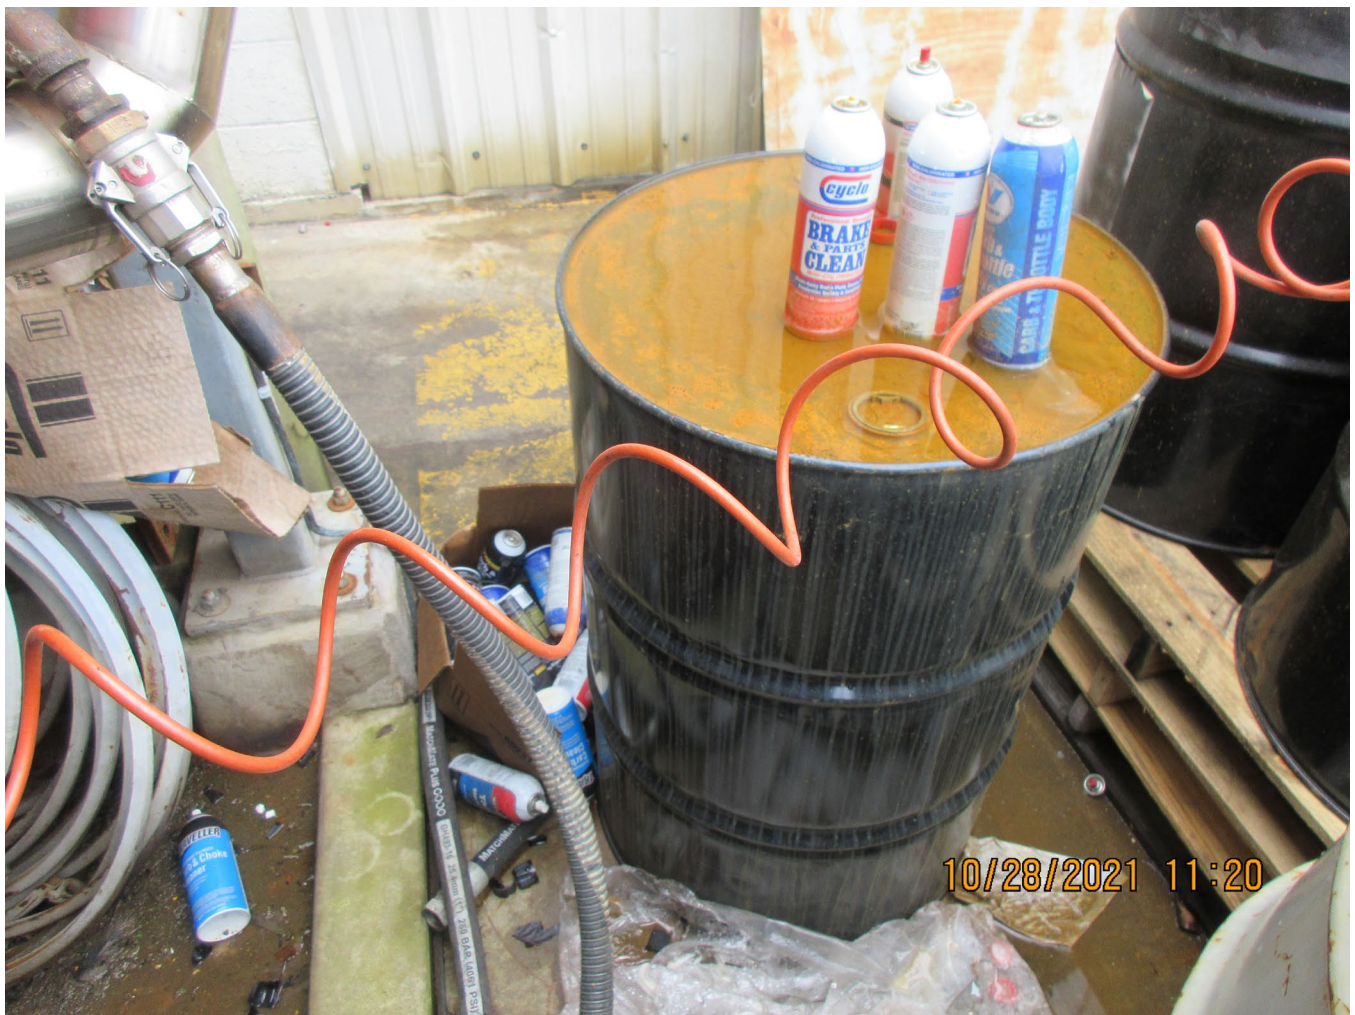
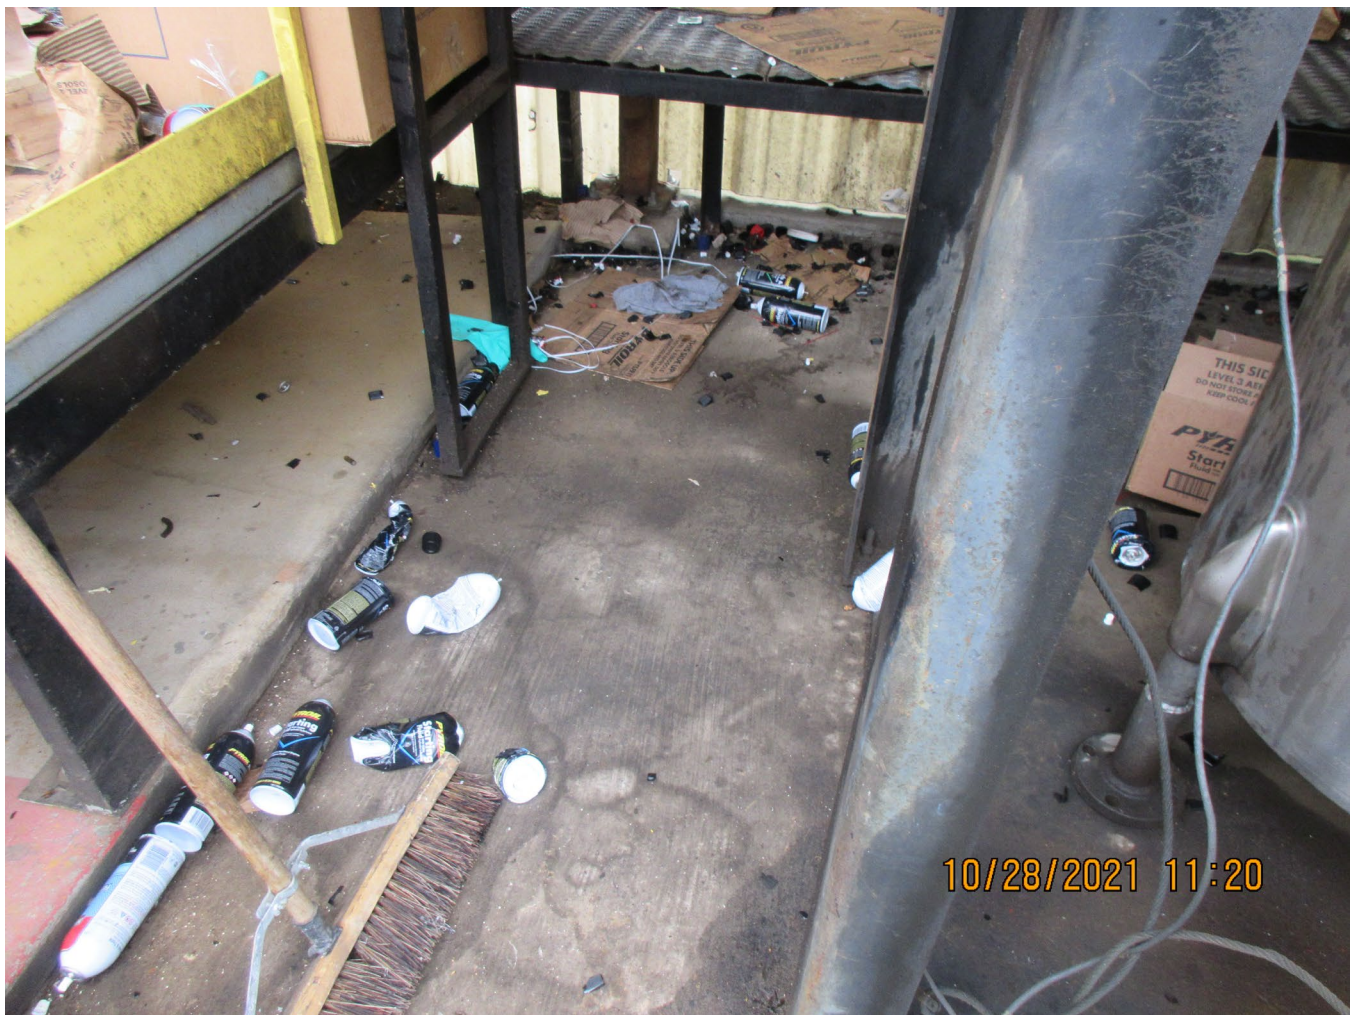
This area was located on the north side of the building. Equipment observed in this area is used to puncture and crush containers with defective dispersing mechanisms (Photos 12 - 15) which contain product solvents which can be recovered and used as is. *Facility personnel were advised that better care of such containers should occur to ensure the contents of the containers are not released to the environment.*

**Photo 12 – Containers with solvents to be recovered and blended back into products**

Photo 13 - Containers with solvents to be recovered and blended back into products

**Photo 14 - Containers with solvents to be recovered and blended back into products**

**Photo 15 - Containers with solvents to be recovered and blended back into products**
