## **RCRA Inspection Report**

Niteo Products LLC (Niteo)  
720 Vaiden Drive  
Hernando, Mississippi 38632

**COMPLIANCE EVALUATION INSPECTION**

**October 28, 2021**

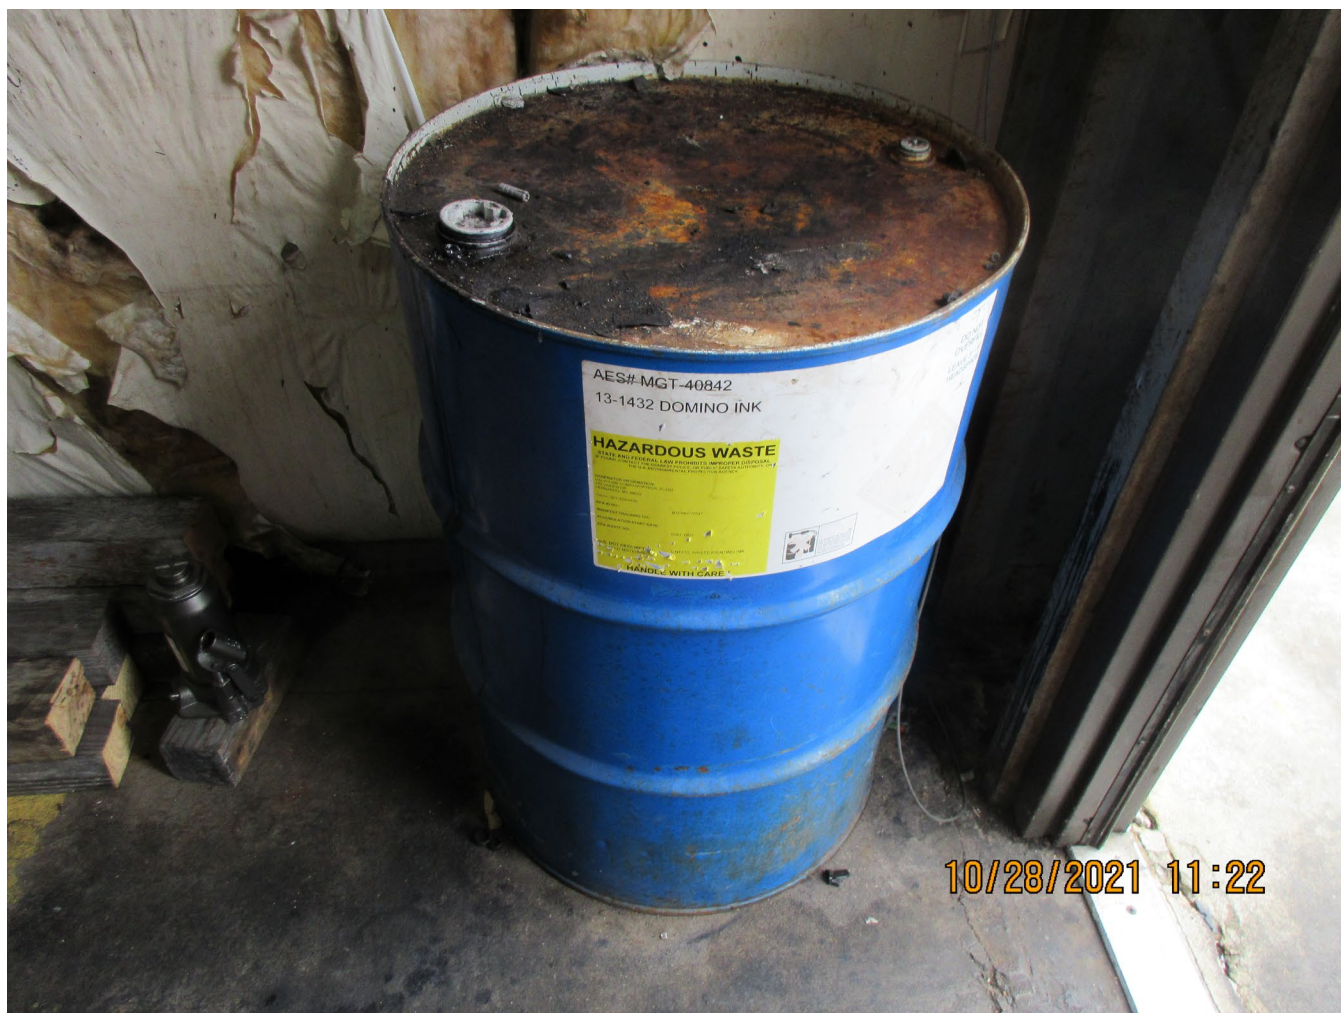
This SAA was located in the Line 3 Filler Room. One 55-gallon drum of hazardous waste ink (Photo 16) destined for disposal was observed in this area at the time of the inspection.

**Photo 16 - Container of Hazardous Waste Ink in SAA 7**

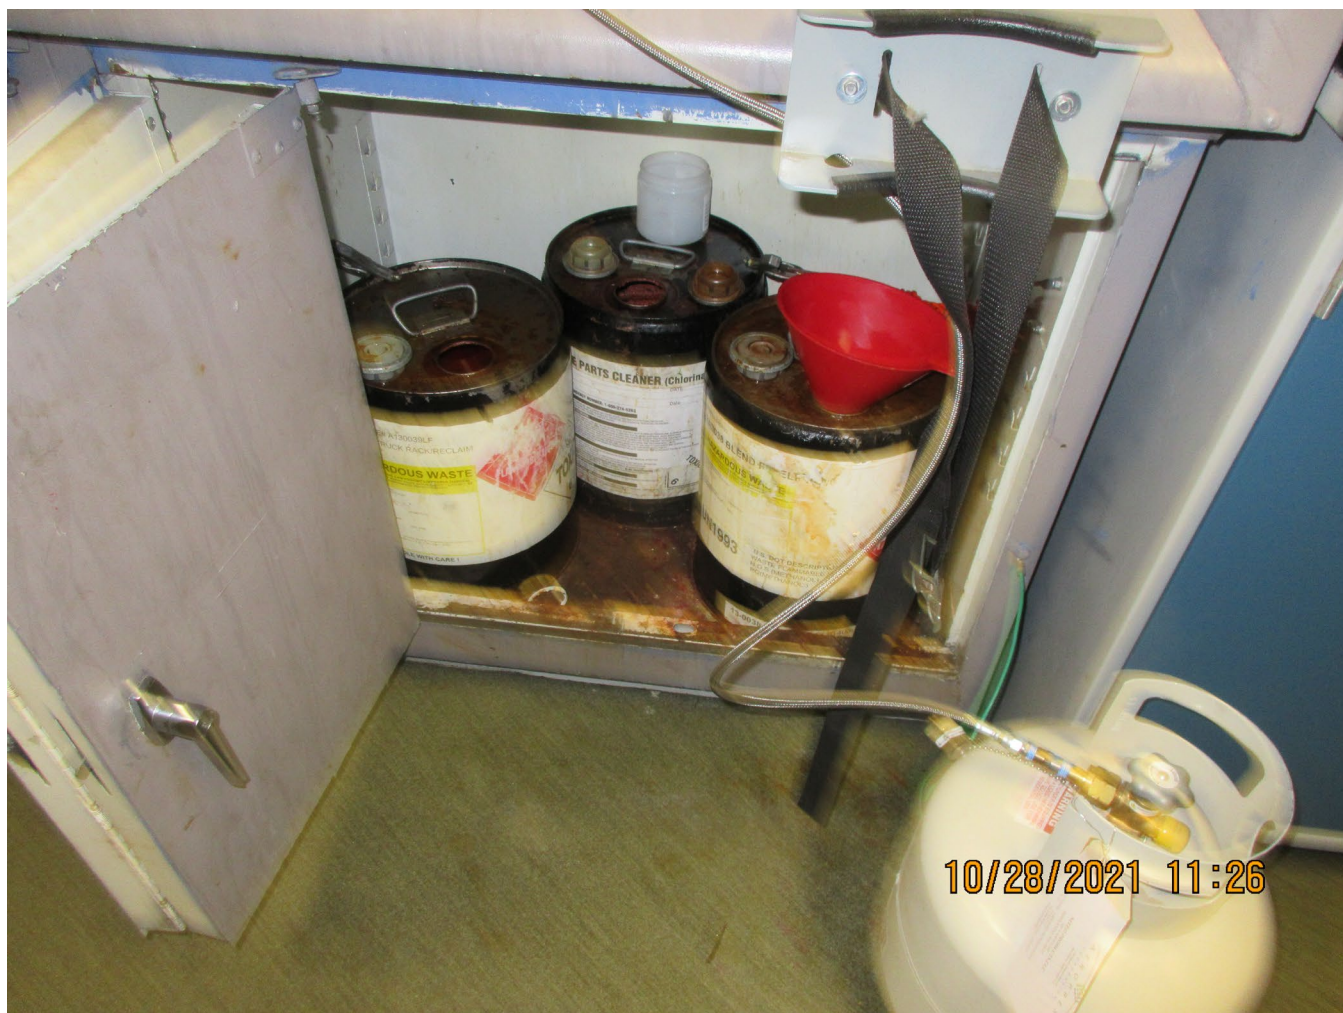
This SAA was located in the Facility's Testing Lab. Three 5-gallon containers of hazardous waste solvents (Photo 17) were observed in a cabinet beneath a lab hood. All three containers

were observed to be open at the time of the inspection. One of the containers was not marked with an indication of the hazard contents of the container.

**Photo 17 – Three 5-gallon container of hazardous waste in facility's Testing Lab**

**Pursuant to 11 Miss. Admin. Code Pt. 3, R. 1.3 [40 C.F.R. § 262.15(a)(5)(ii)], which is a condition of the SAA Permit Exemption, a generator is required to mark or label its containers (ii) with an indication of the hazards of the contents.**

**Pursuant to 11 Miss. Admin. Code Pt. 3, R. 1.3 [40 C.F.R. § 262.15(a)(4)], which is a condition of the SAA Permit Exemption, a generator is required to keep containers of hazardous waste closed at all times during accumulation, except when adding, removing, or consolidating waste; or when temporary venting of a container is necessary for the proper operation of equipment, or to prevent dangerous situations, such as build-up of extreme pressure.**

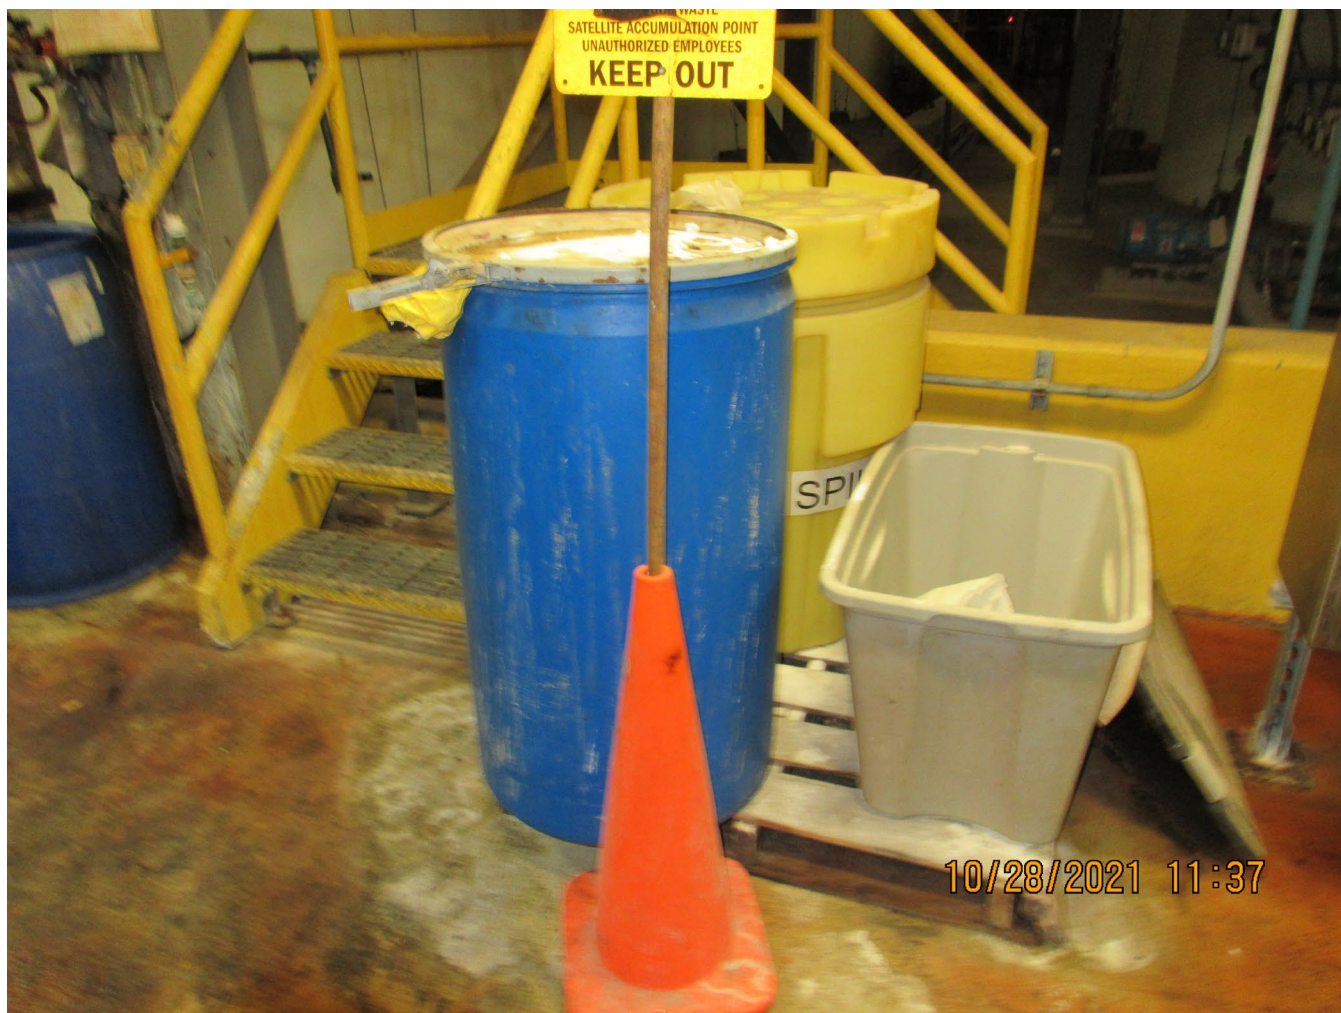
One 55-gallon container of a nonhazardous liquid waste stream (Photo 18) was observed in this area. The liquid waste generated in this area is non-RCRA-corrosive.

**Photo 18 - Container of nonhazardous liquid waste containing soda ash in SAA # 9**

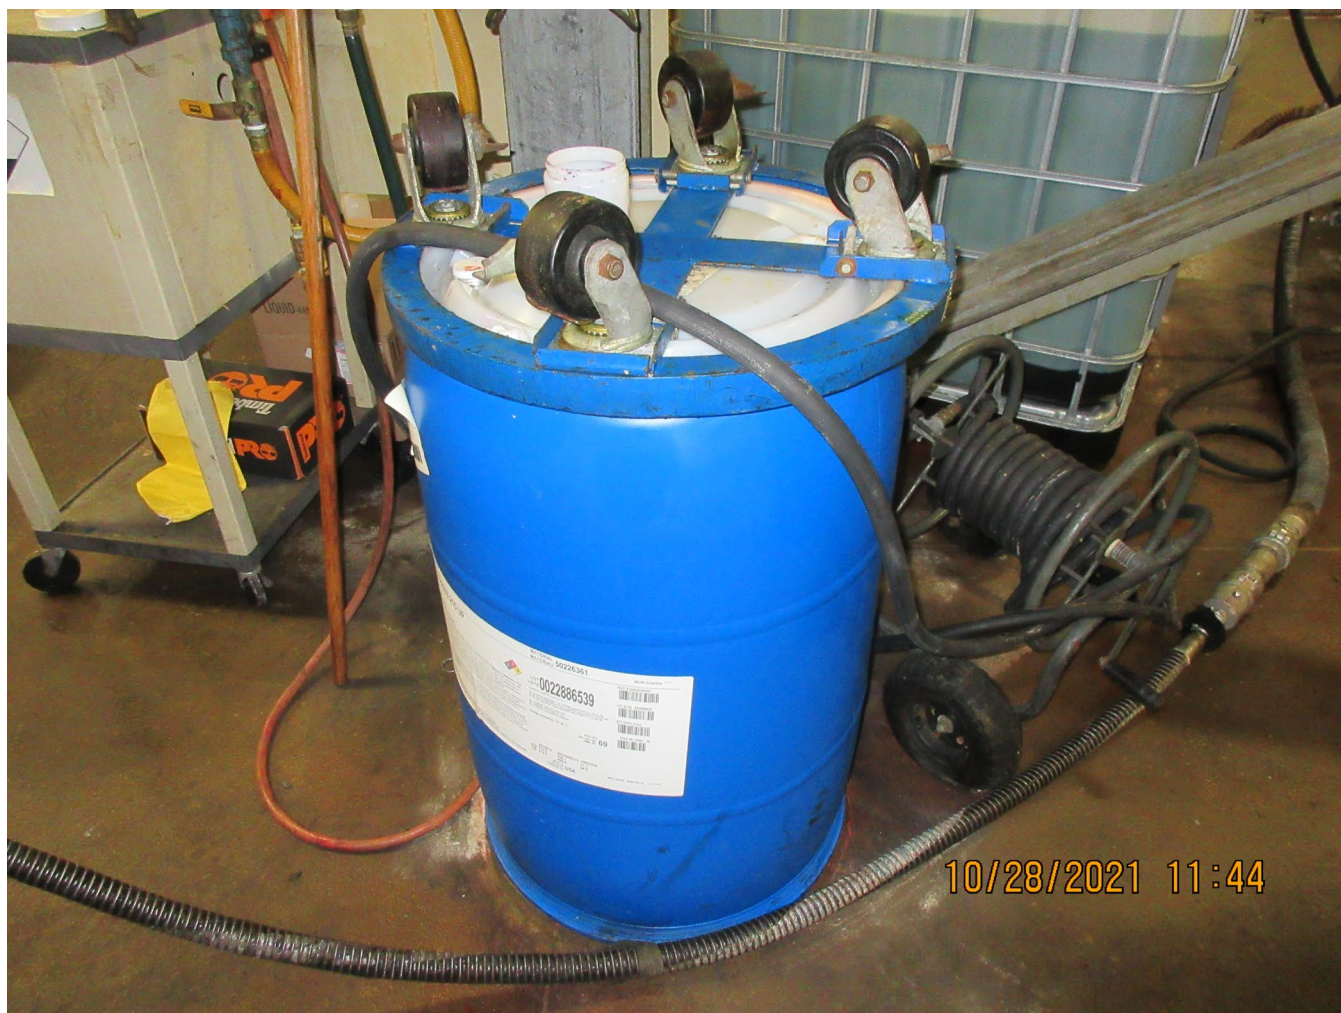
This SAA was located in Car Brite Water Filling Area. One 55-gallon drum of hazardous waste rags (Photo 19) destined for disposal was observed in this area at the time of the inspection. The container was not labeled at the time of the inspection.

**Photo 19 - Container of hazardous waste rags in SAA # 10**

**Pursuant to 11 Miss. Admin. Code Pt. 3, R. 1.3 [40 C.F.R. § 262.15(a)(5)(ii)], which is a condition of the SAA Permit Exemption, a generator is required to mark or label its containers(i) with the words “Hazardous Waste” and (ii) with an indication of the hazards of the contents.**

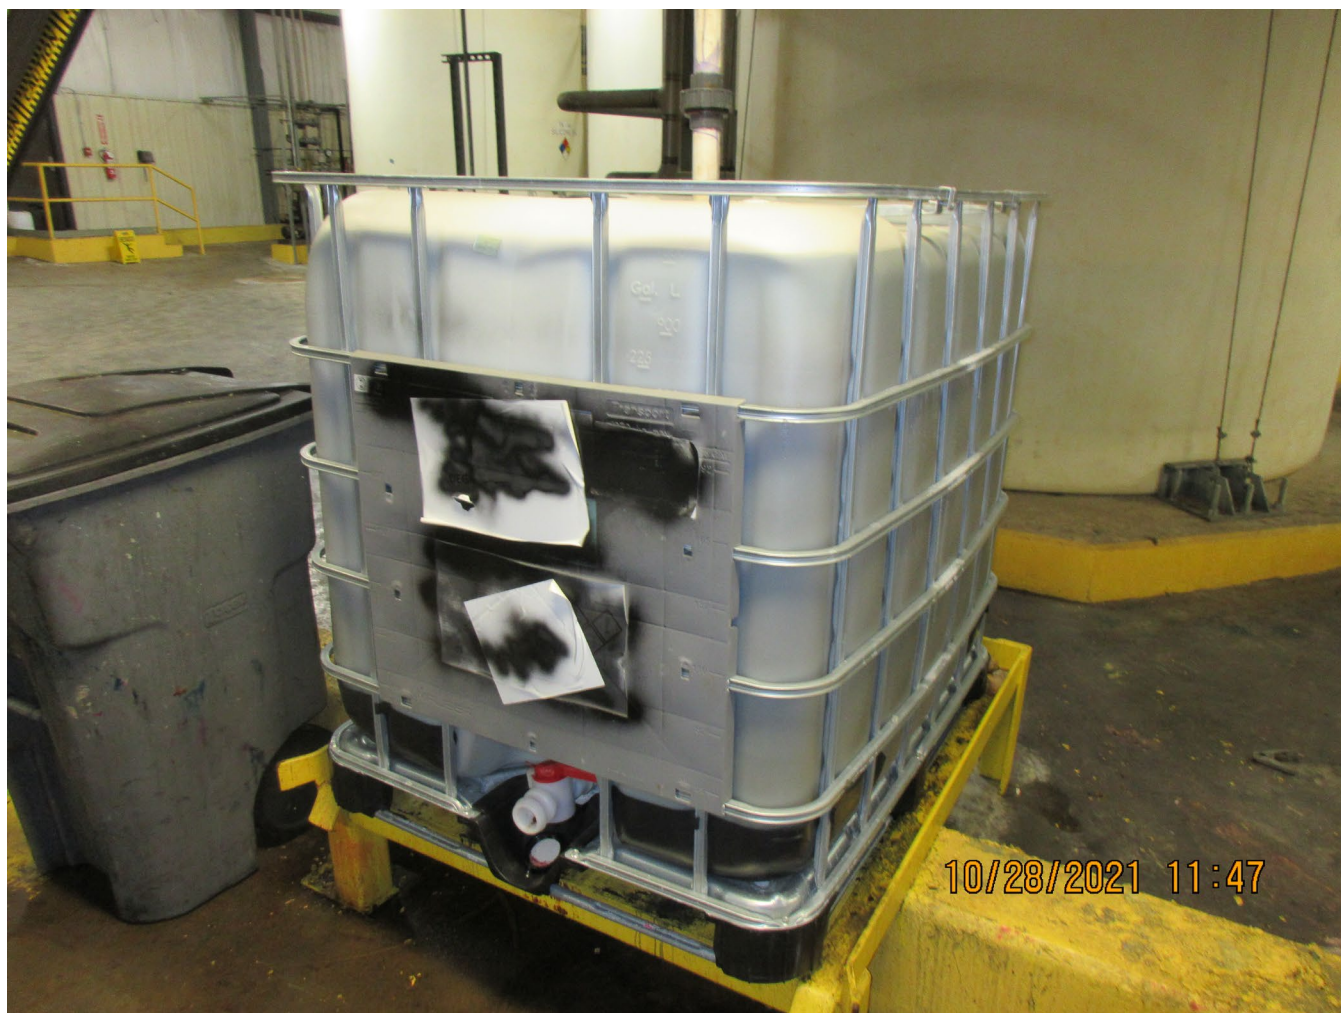
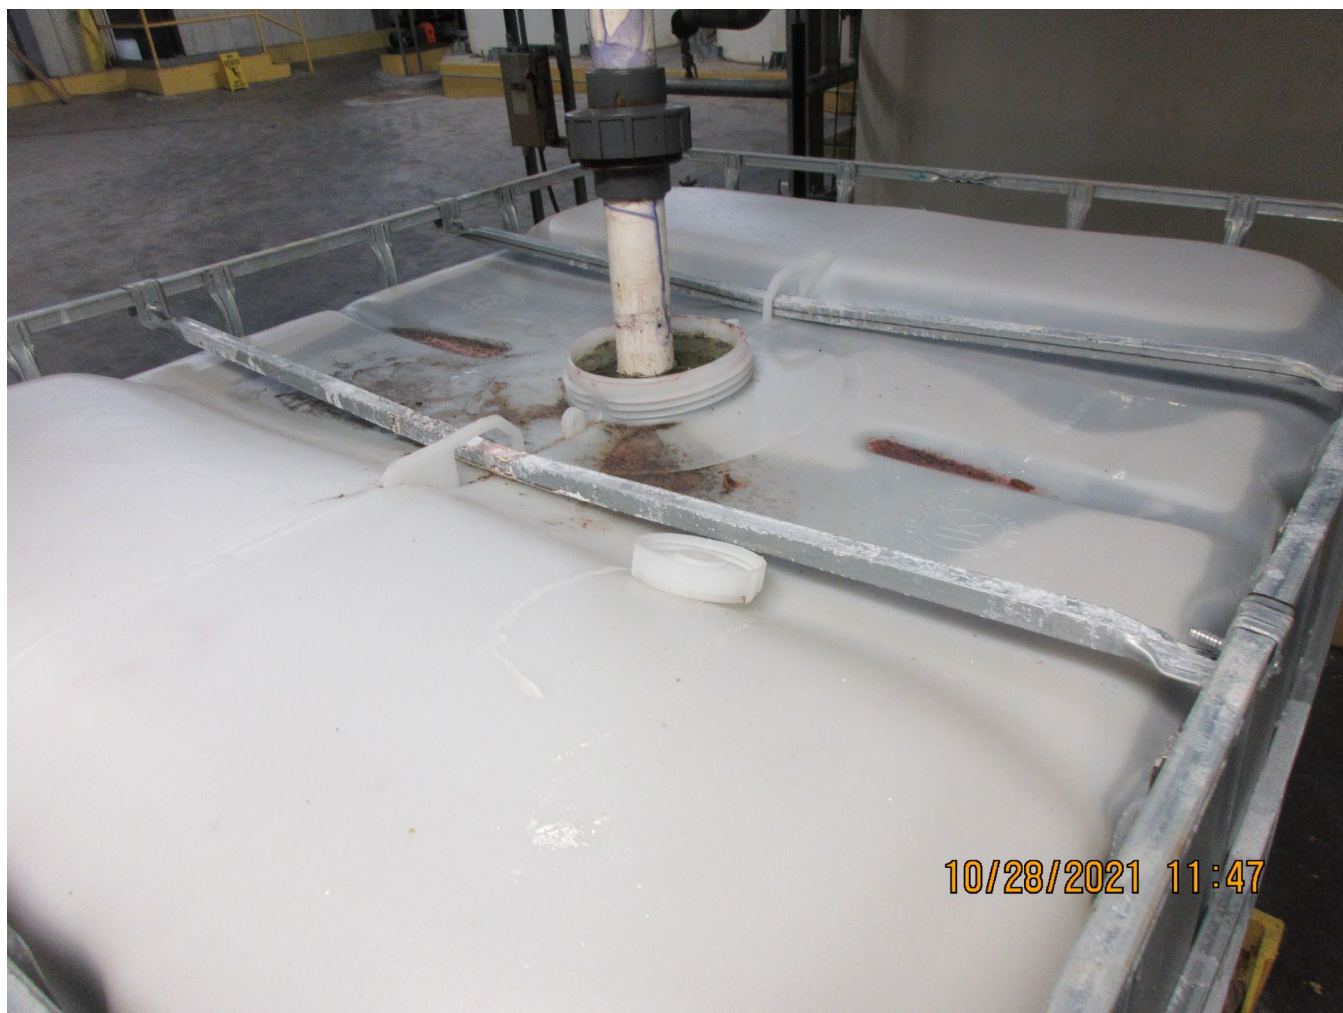
This SAA was located in the Car Brite storage area. One 265-gallon plastic tote of nonhazardous mop water was observed in this area (Photos 20 and 21). The wastewater resulted from cleaning the floor of a blending platform. No hazardous wastes were observed in this area at the time of the inspection.

**Photo 20 – Tote of nonhazardous mop water in SAA # 11 (Blending Platform Area)**

**Photo 21 - Tote of nonhazardous mop water in SAA # 11 (Blending Platform Area)**

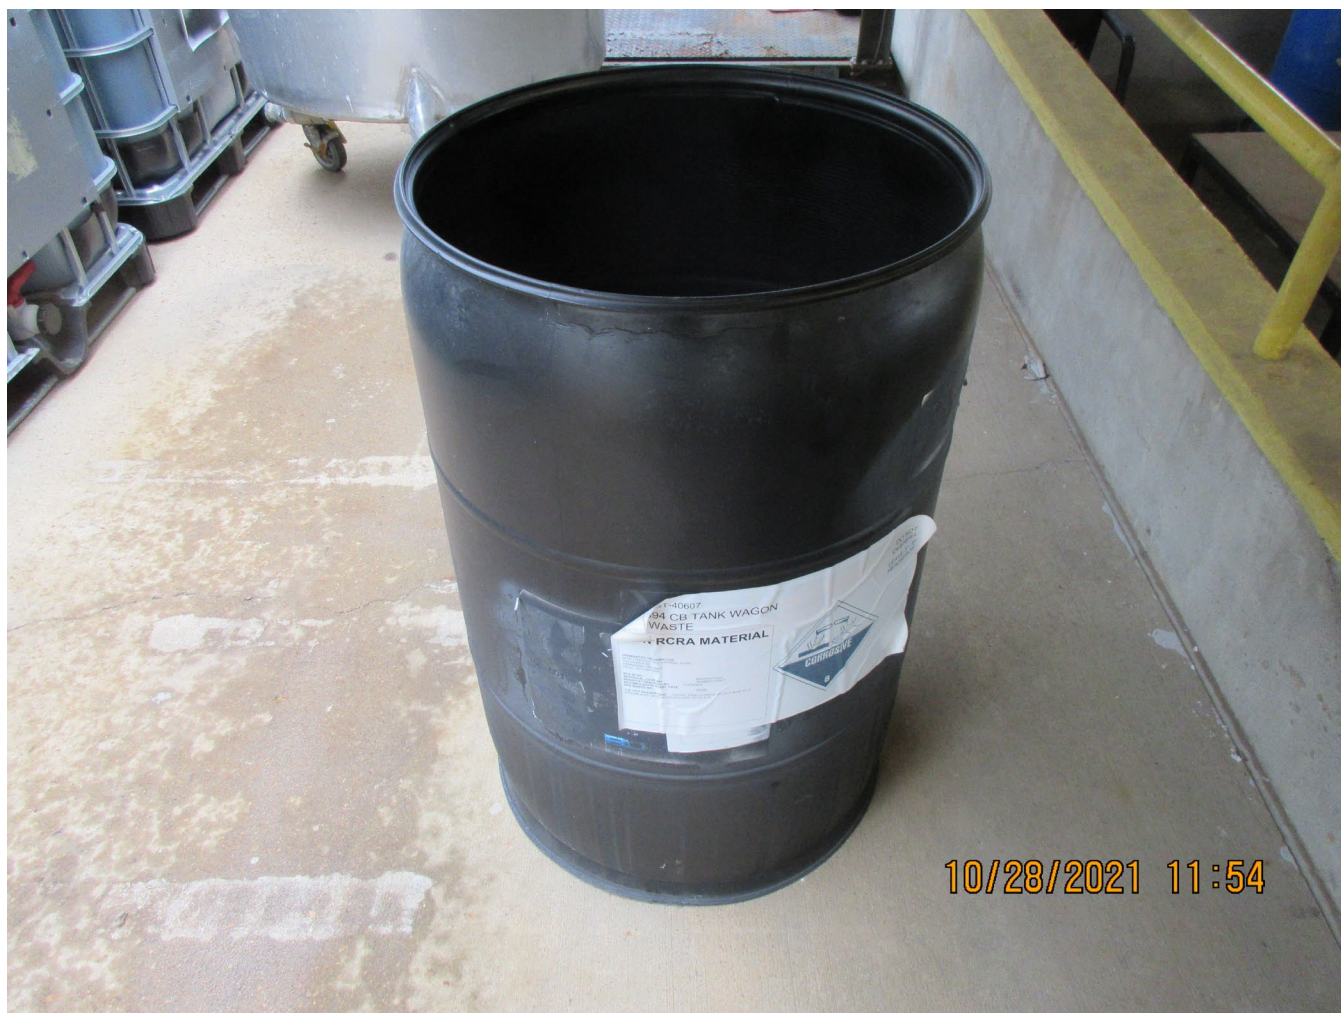
This SAA was located in the Car Brite tanker unloading area. One 55-gallon drum of nonhazardous PPE equipment was observed in this area (Photo 22). The PPE equipment used by employees during off-loading operations. No hazardous wastes were observed in this area at the time of the inspection.

**Photo 22 – Container of nonhazardous PPE in SAA # 12**

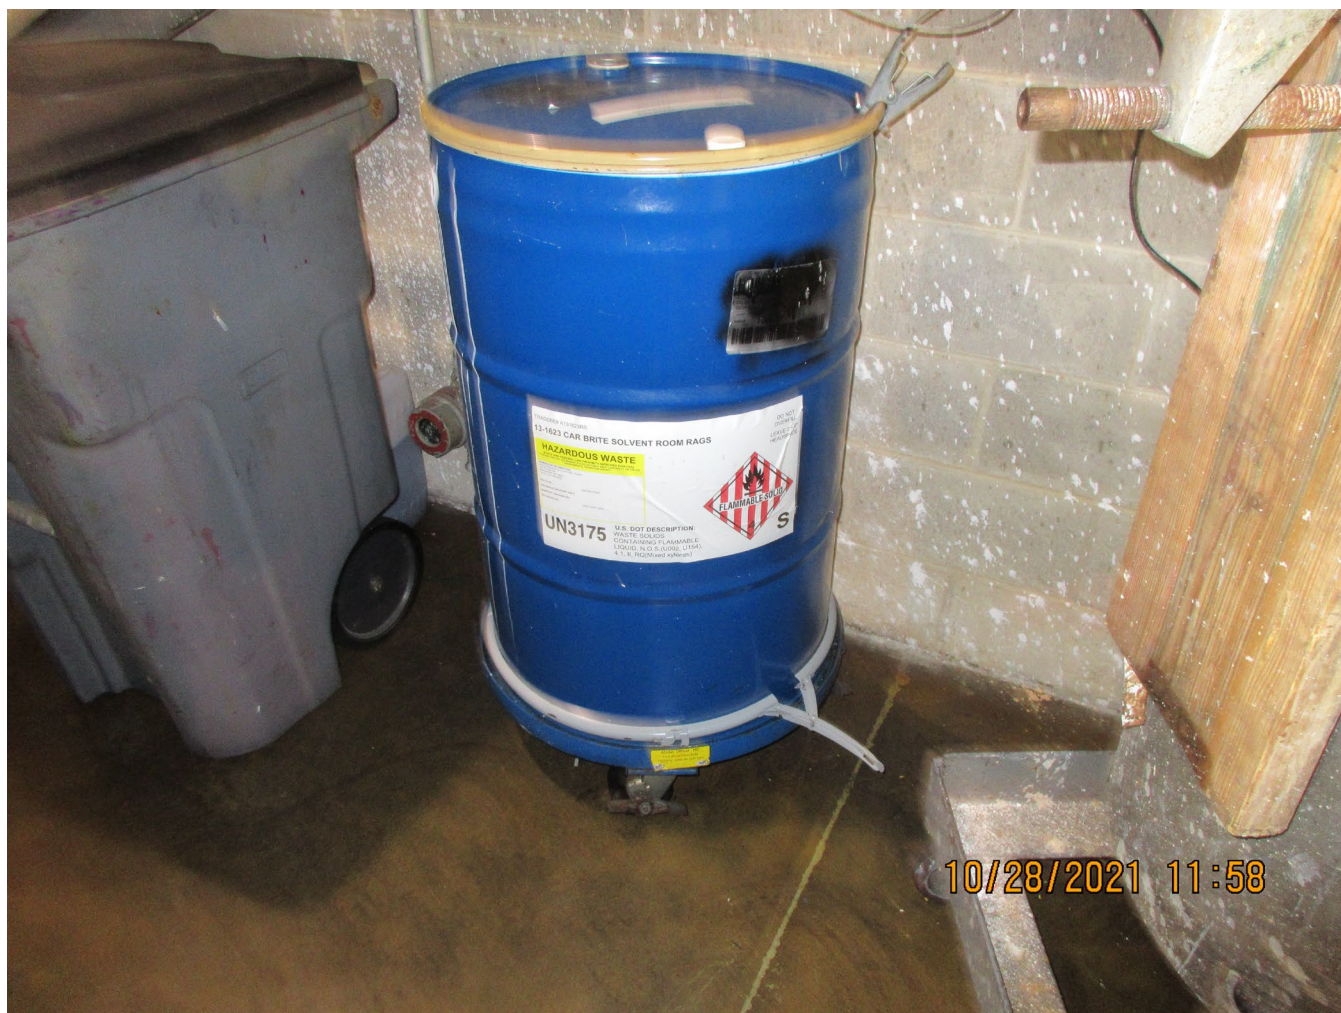
This SAA was located in the Car Brite solvent room. One 55-gallon drum of hazardous waste rags (Photo 23) destined for disposal was observed in this area at the time of the inspection.

**Photo 23 – Container hazardous waste rags in SAA # 13 (Solvent Room)**

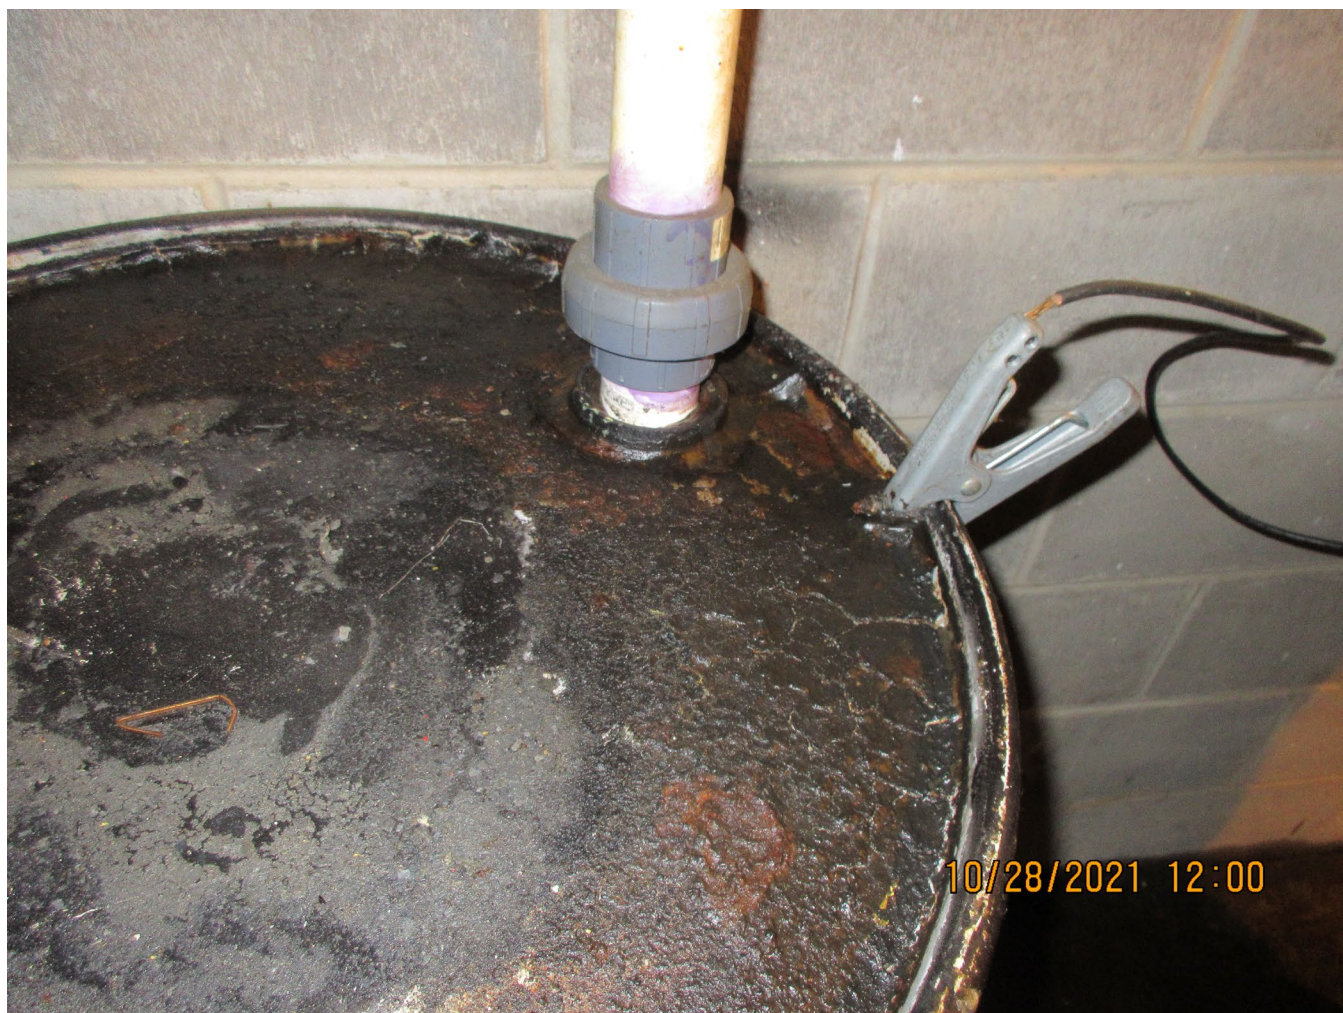
This SAA was also located in the Car Brite solvent room. One 55-gallon drum of hazardous solvents and wax was observed in this area. The container was observed to be open at the time of the inspection as the fill pipe into the containers bung was not sealed (Photos 24 and 25).

**Photo 24 – Unsealed container hazardous waste in SAA # 14 (Solvent Room)**

**Photo 25 - Container hazardous waste in SAA # 14 (Solvent Room)**

**Pursuant to 11 Miss. Admin. Code Pt. 3, R. 1.3 [40 C.F.R. § 262.15(a)(4)], which is a condition of the SAA Permit Exemption, a generator is required to keep containers of hazardous waste closed at all times during accumulation, except when adding, removing, or consolidating waste; or when temporary venting of a container is necessary for the proper operation of equipment, or to prevent dangerous situations, such as build-up of extreme pressure.**
