**NEICVP1510E02**  
**Replacement Report**

**NEIC CIVIL INVESTIGATION REPORT**

EVRAZ Rocky Mountain Steel  
Pueblo, Colorado

**Investigation Dates:**  
June 12-28, 2023

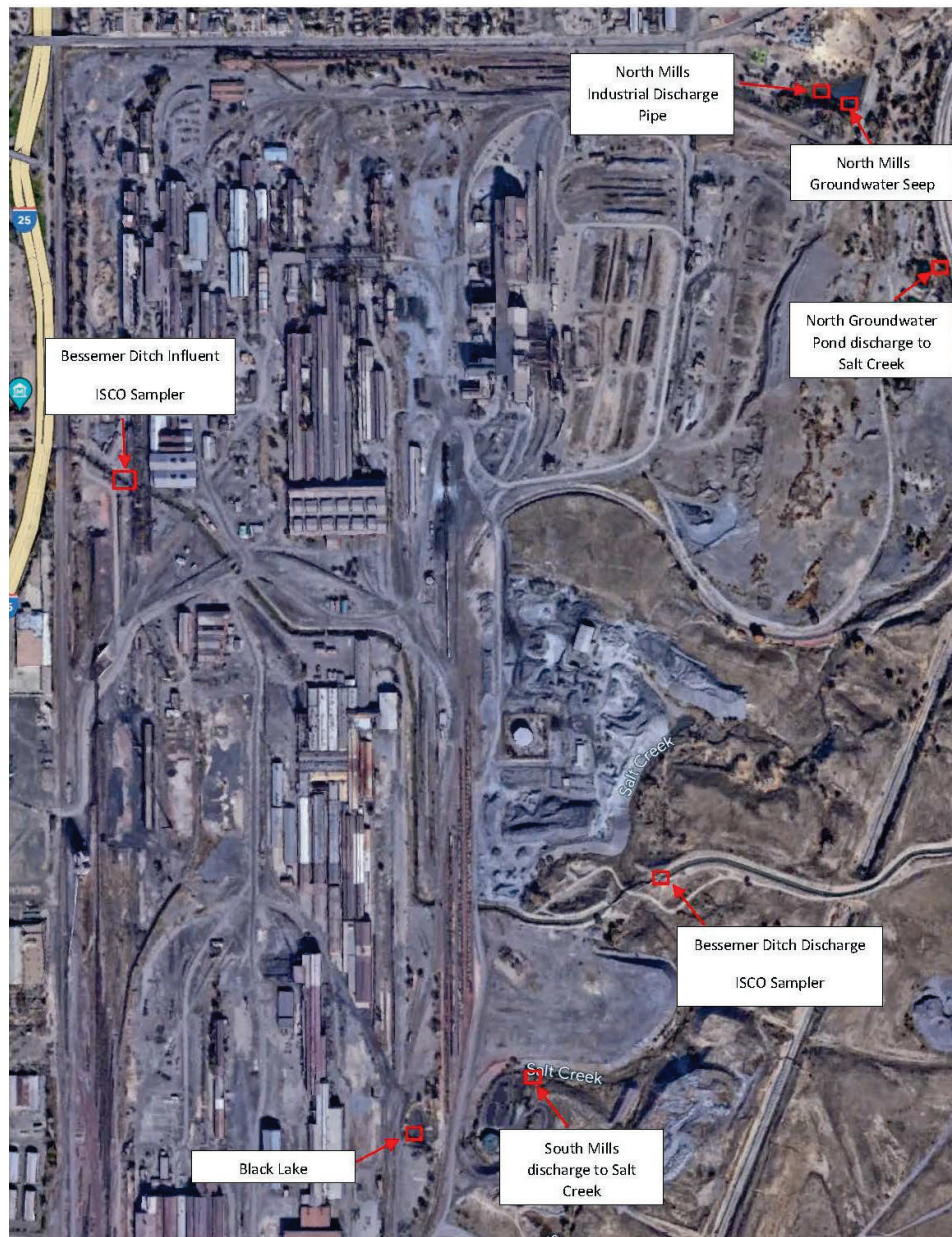
**Figure 1. A satellite image of the EVRAZ facility indicating the approximate sampling locations on June 27-28, 2023.**

On June 27, 2023, NEIC inspectors arrived at the facility at 8:00 a.m. to collect samples from the locations discussed with facility representatives during the closing conference on June 16, 2023. **Figure 1** is a map of the EVRAZ facility indicating the approximate sampling locations.
