Subject: November 14, 2022, SSO Inspection Trip Report for City of Cahokia Heights

Purpose: NPDES SSO Inspection Trip Report

Facility: Cahokia Heights, Illinois

Dates of Inspection: November 14, 2022

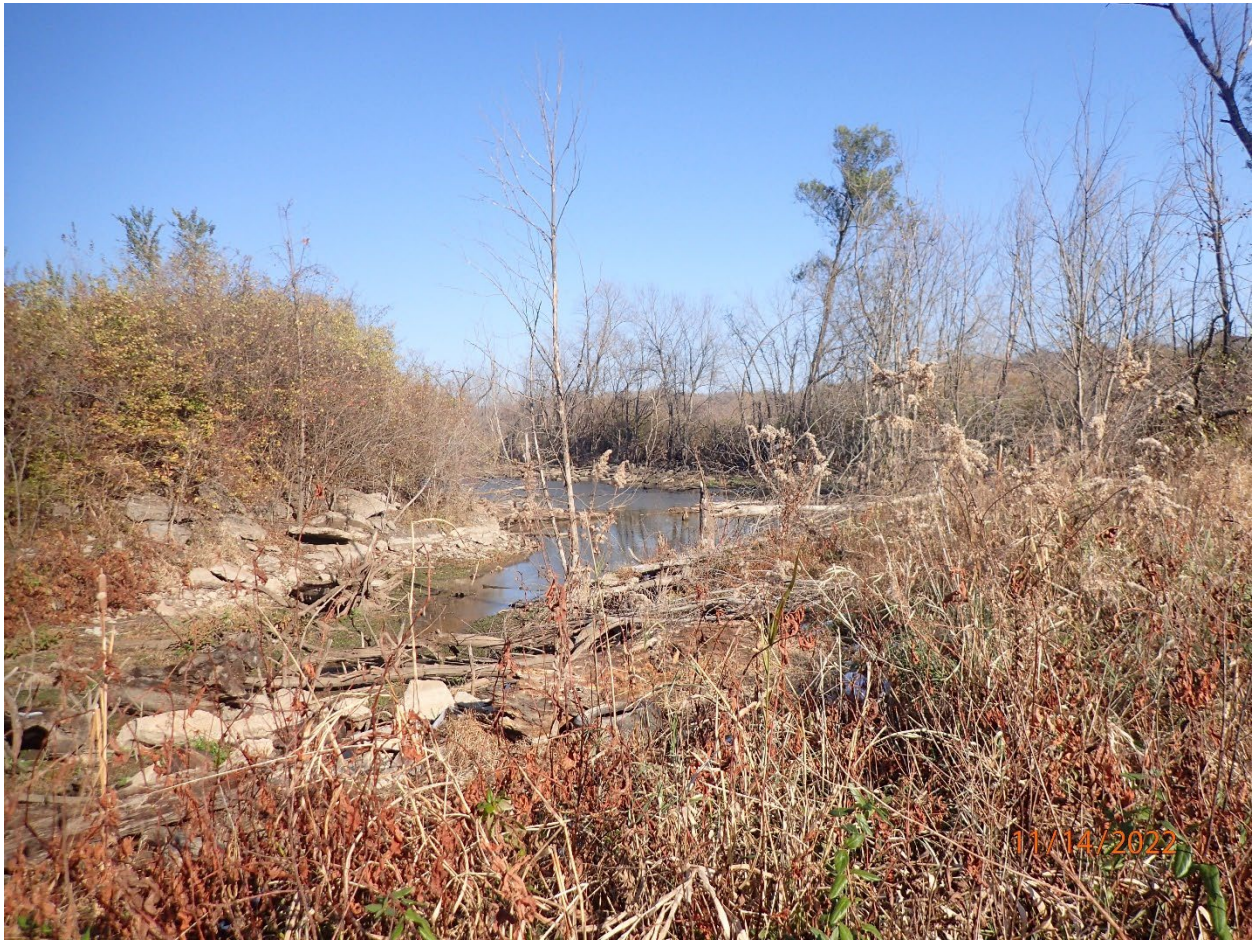
1: PB140086.JPG

EPA also observed that the water level in the marsh area to the northeast of the lift station was low. EPA observed many used tires in the marsh.

Description: The marsh area to the northeast of the Lady of Snows Lift Station.

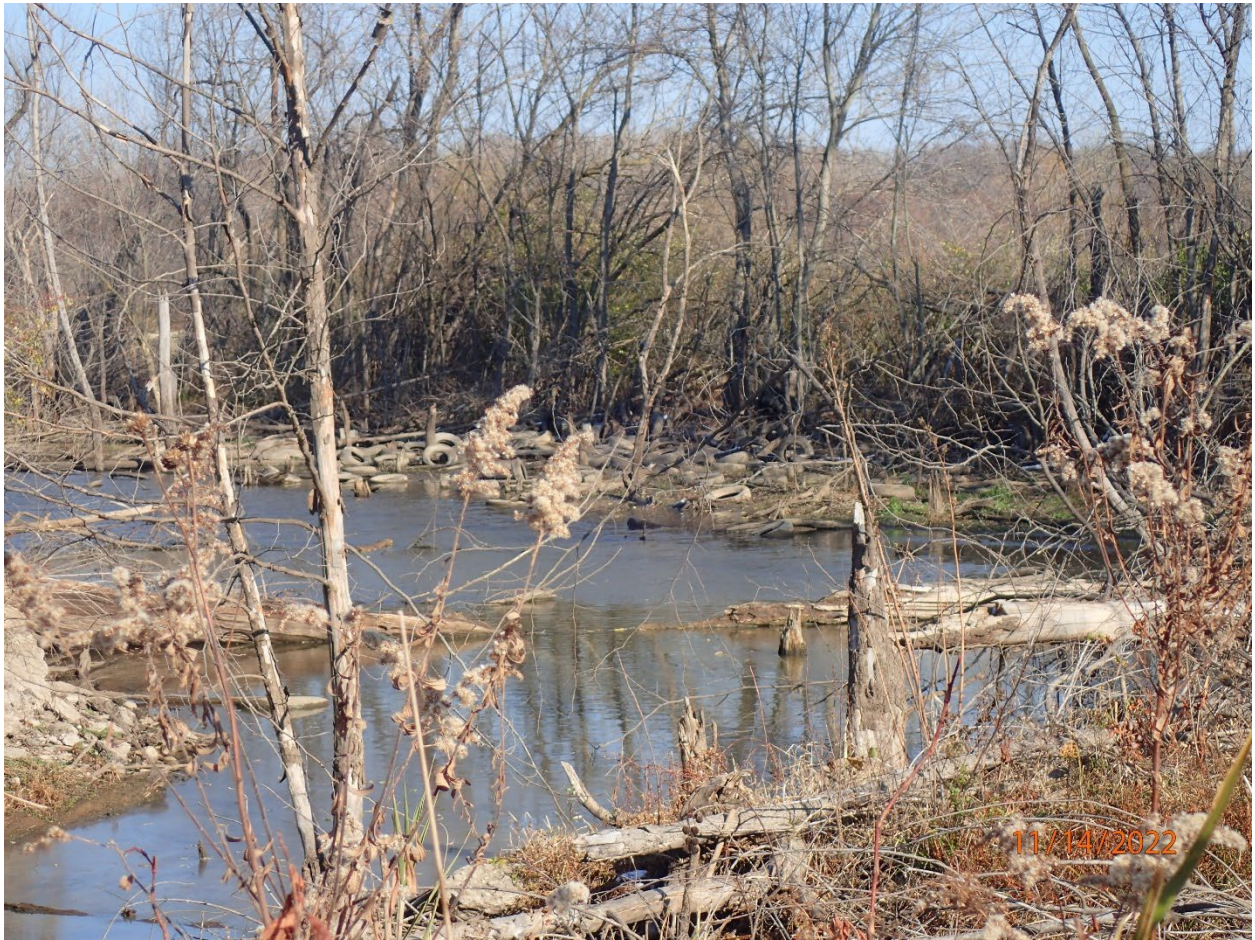
2. PB140087.JPG

Description: Photo zoomed in to show the used tires in the marsh.

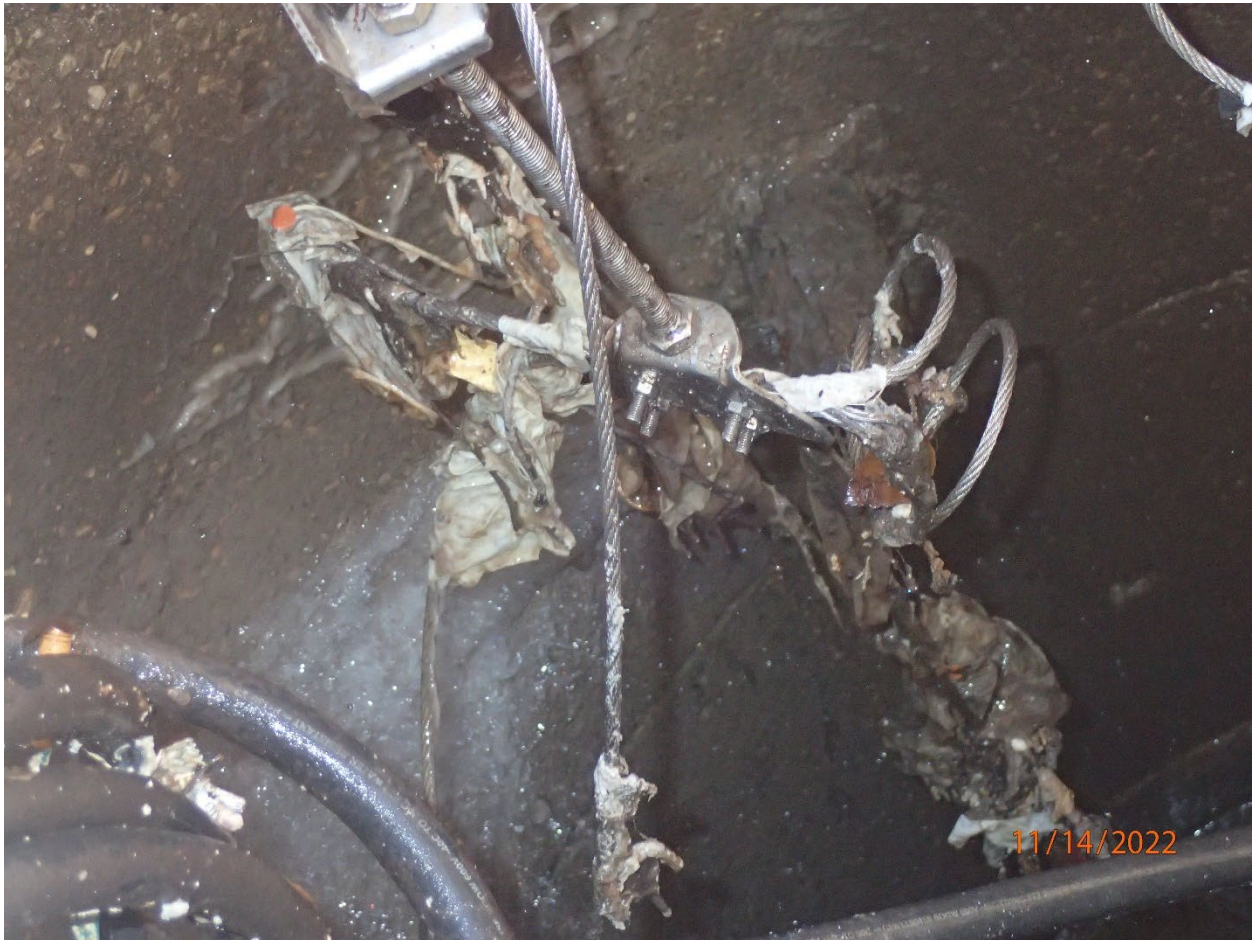
3. PB140088.JPG

EPA inspectors arrived at Lift Station #57 at 1:51 P.M. This lift station is a former Centreville lift station and is located at 4200 Missouri Avenue and is currently known as Cahokia Heights lift station #57. The lift station was not overflowing but EPA observed that the force main pipe inside the wet well was broken and spraying water inside the wet well. This caused the pump to be continuously running. EPA notified the City's sewer department. EPA observed that the fencing around the lift station and the wet well was not secured.

Description: Inside the wet well of the #57 Lift Station, a force main pipe was broken and spraying water inside the wet well. This caused the pump in the lift station to run continuously.

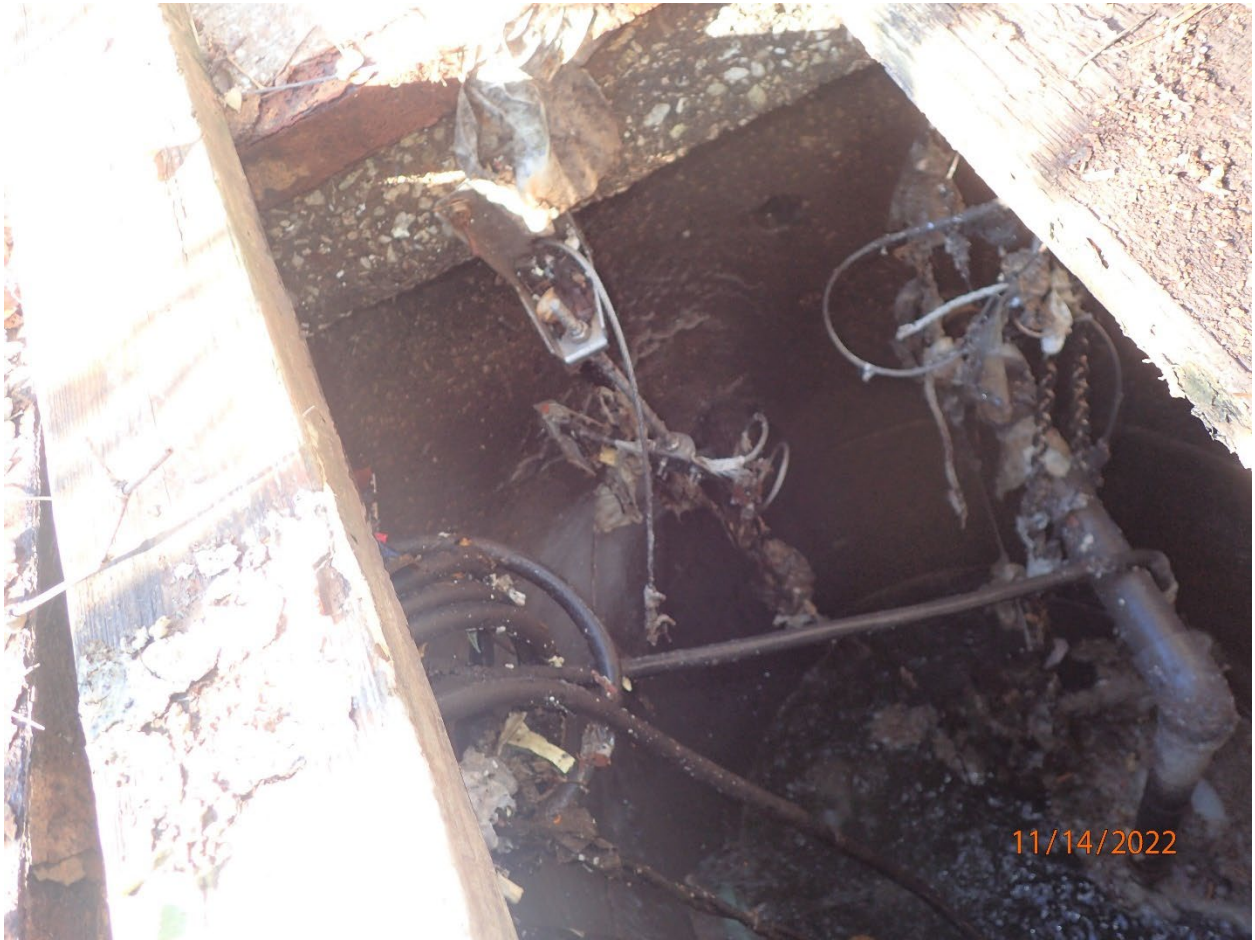
4. PB140089.JPG

Description: Inside the wet well of the #57 Lift Station, a force main pipe was broken and spraying water inside the wet well. This caused the pump in the lift station to run continuously.

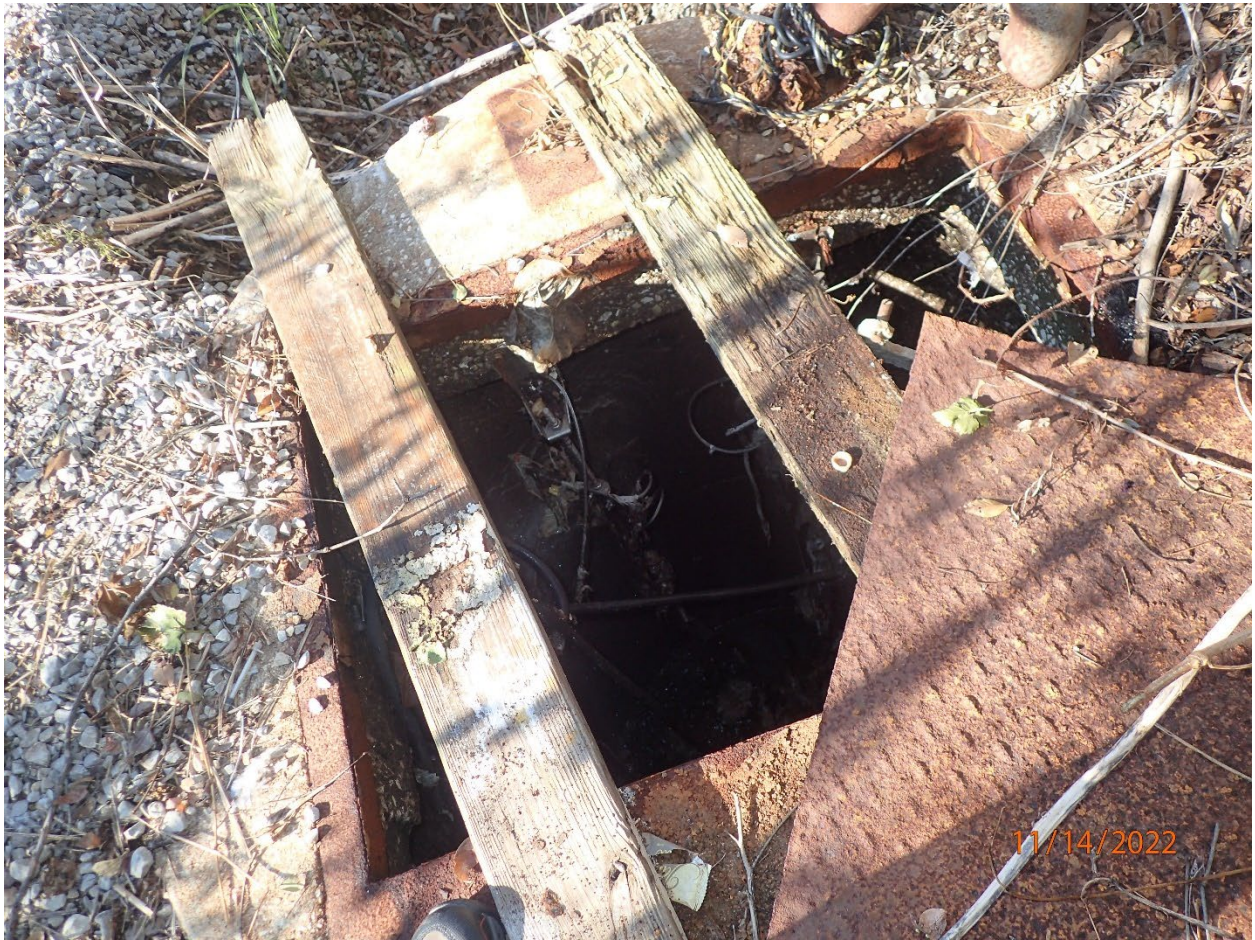
5. PB140090.JPG

Description: Inside the wet well of the #57 Lift Station, a force main pipe was broken and spraying water inside the wet well. This caused the pump in the lift station to run continuously. Additionally, the wet well was not secured.

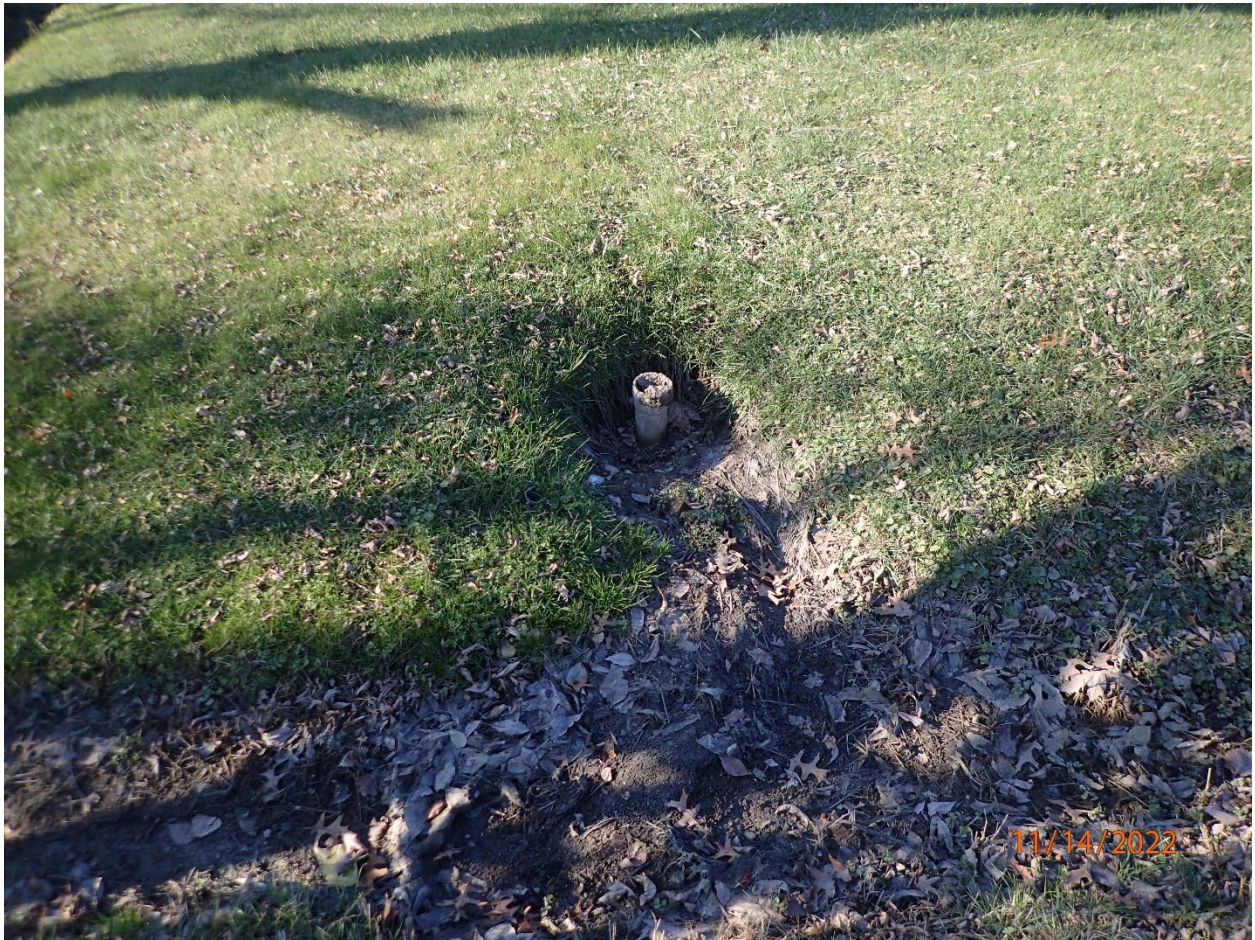
6. PB140091.JPG

EPA inspectors arrived at the cleanout overflow location on North 82nd Street at 2:03 P.M. The cleanout was not discharging. EPA observed toilet paper on top of the cleanout pipe.

Description: The cleanout on North 82nd Street was not flowing on the day of the recon inspection. Note the toilet paper on the top of the pipe.

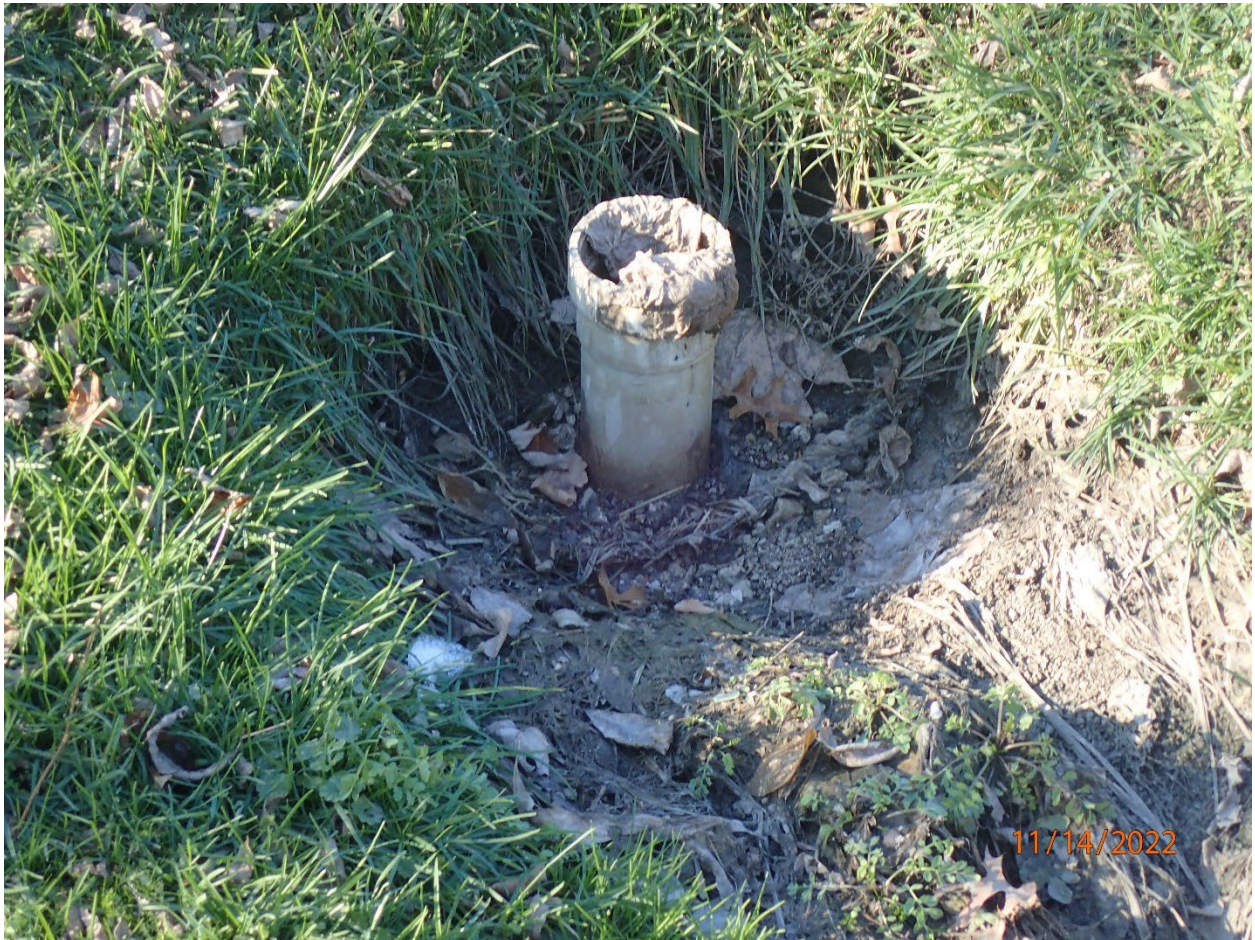
7. PB140092.JPG

Description: The cleanout on North 82nd Street was not flowing on the day of the recon inspection. Note the toilet paper on the top of the pipe.
