## RCRA Compliance Branch INSPECTION REPORT

| <b>Inspection Date(s):</b> | 6/22/2023 | <b>Inspection Announced:</b> No |
| <b>Facility or Site Name:</b> | Frequency Electronics | |
| <b>RCRA ID Number:</b> | NYD001321611 | |

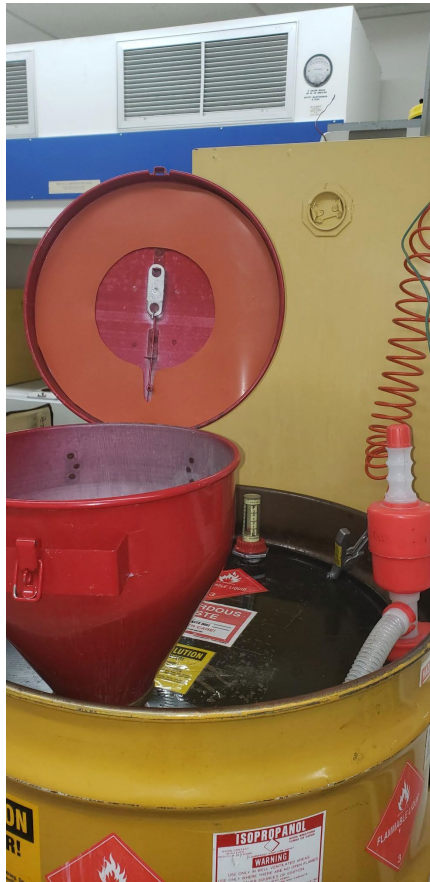
- One 75-gallon drum that contained hydrogen peroxide and ammonium peroxide which were labeled and closed.
- One 75-gallon drum that contained D001 (isopropyl alcohol) waste that was labeled, grounded and the funnel on top of the drum had no gasket; therefore, it was not closed.

1. Pursuant to 6 NYCRR § 373-3.9(d)(1), management of containers. (1) A container holding hazardous waste must always be closed during storage, except when it is necessary to add or remove waste.
  - a. At the time of the inspection, there were one 75-gallon drum containing D001 waste (isopropyl alcohol) located in the high rail area that had a funnel but there was no gasket, therefore it was not closed.
  - b. At the time of the inspection, there were one 75-gallon drum containing D001 waste (isopropyl alcohol) located in the crystal prep area that had a funnel but there was no gasket, therefore it was not closed.

(Figure 1: Shows a funnel with a gasket on top of a 55-gallon drum.)

On August 4, 2023, Mr. Montano followed up in an email regarding the area of concerns. Mr. Montano attached to the email a photo showing a gasket attached to the funnel (Figure 1).

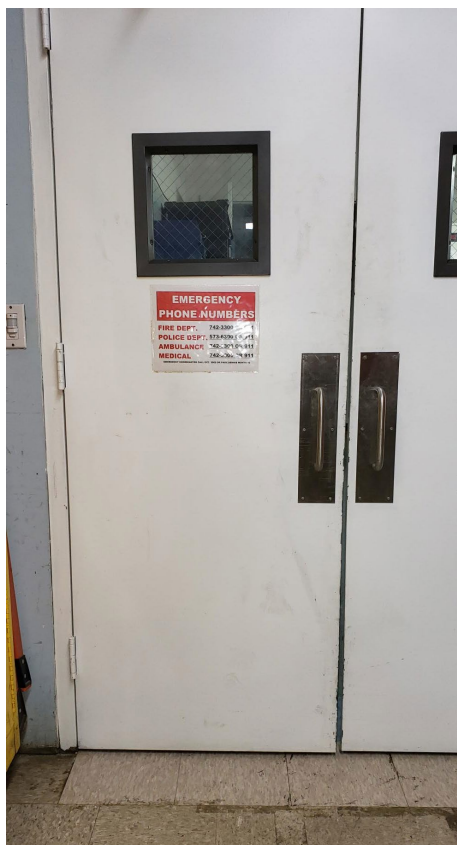
Mr. Montano explained that this central storage area contained liquid hazardous waste. The central storage area had a fire extinguisher present but there was no phone number listed in case of an emergency. The hazardous waste observed was as follows:

2. Pursuant to 6 NYCRR § 372.2(a)(8)(iii)(e)(2)(i) The name and phone number of the emergency coordinator must be posted next to the telephone.
  - a. At the time of the inspection, there were no name and phone number posted near the three central storage areas.

(Figure 3: Phone numbers located on the liquids central storage area door.)

On August 3, 2023, Mr. Montano followed up in an email regarding the area of concerns. Mr. Montano stated: “Here is the emergency telephone numbers along with the locations of the inspection logs. The photos come first then the location of the inspection logs.”

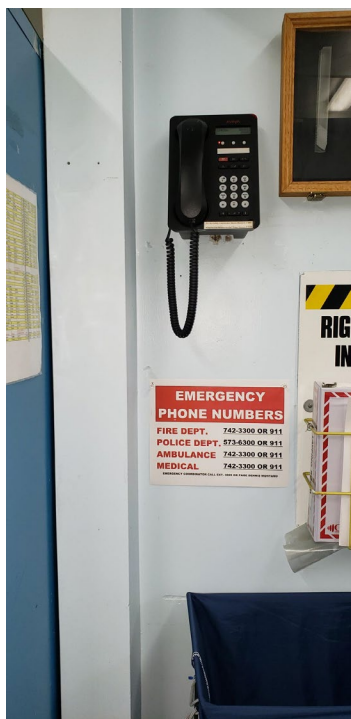
Mr. Montano explained that this central storage area contained solid hazardous waste. The central storage area had a fire extinguisher present but there was no phone number listed in case of an emergency. The facility representative stated that the facility conducts weekly inspections. The hazardous waste observed was expired materials (epoxies) and lab packs kept in the original container.

(Figure 4: Phone numbers located inside of the solids central storage area).
