ASTEN HILL MANUFACTURING COMPANY

PENNSYLVANIA MANUFACTURERS' ASSOCIATION
CASUALTY INSURANCE COMPANY
SAFETY ENGINEERING DEPARTMENT

ASTEN HILL MANUFACTURING COMPANY
Philadelphia, Pennsylvania

In response to a request from Mr. D. R. Holmes, General Superintendent and Mr. John McCormick, Plant Engineer of the above named plant a survey was made in each of the areas of this plant to determine the concentrations of dust existing in the atmosphere at these areas. This survey was started in February 1957 and samples were taken intermittently until July 1957.

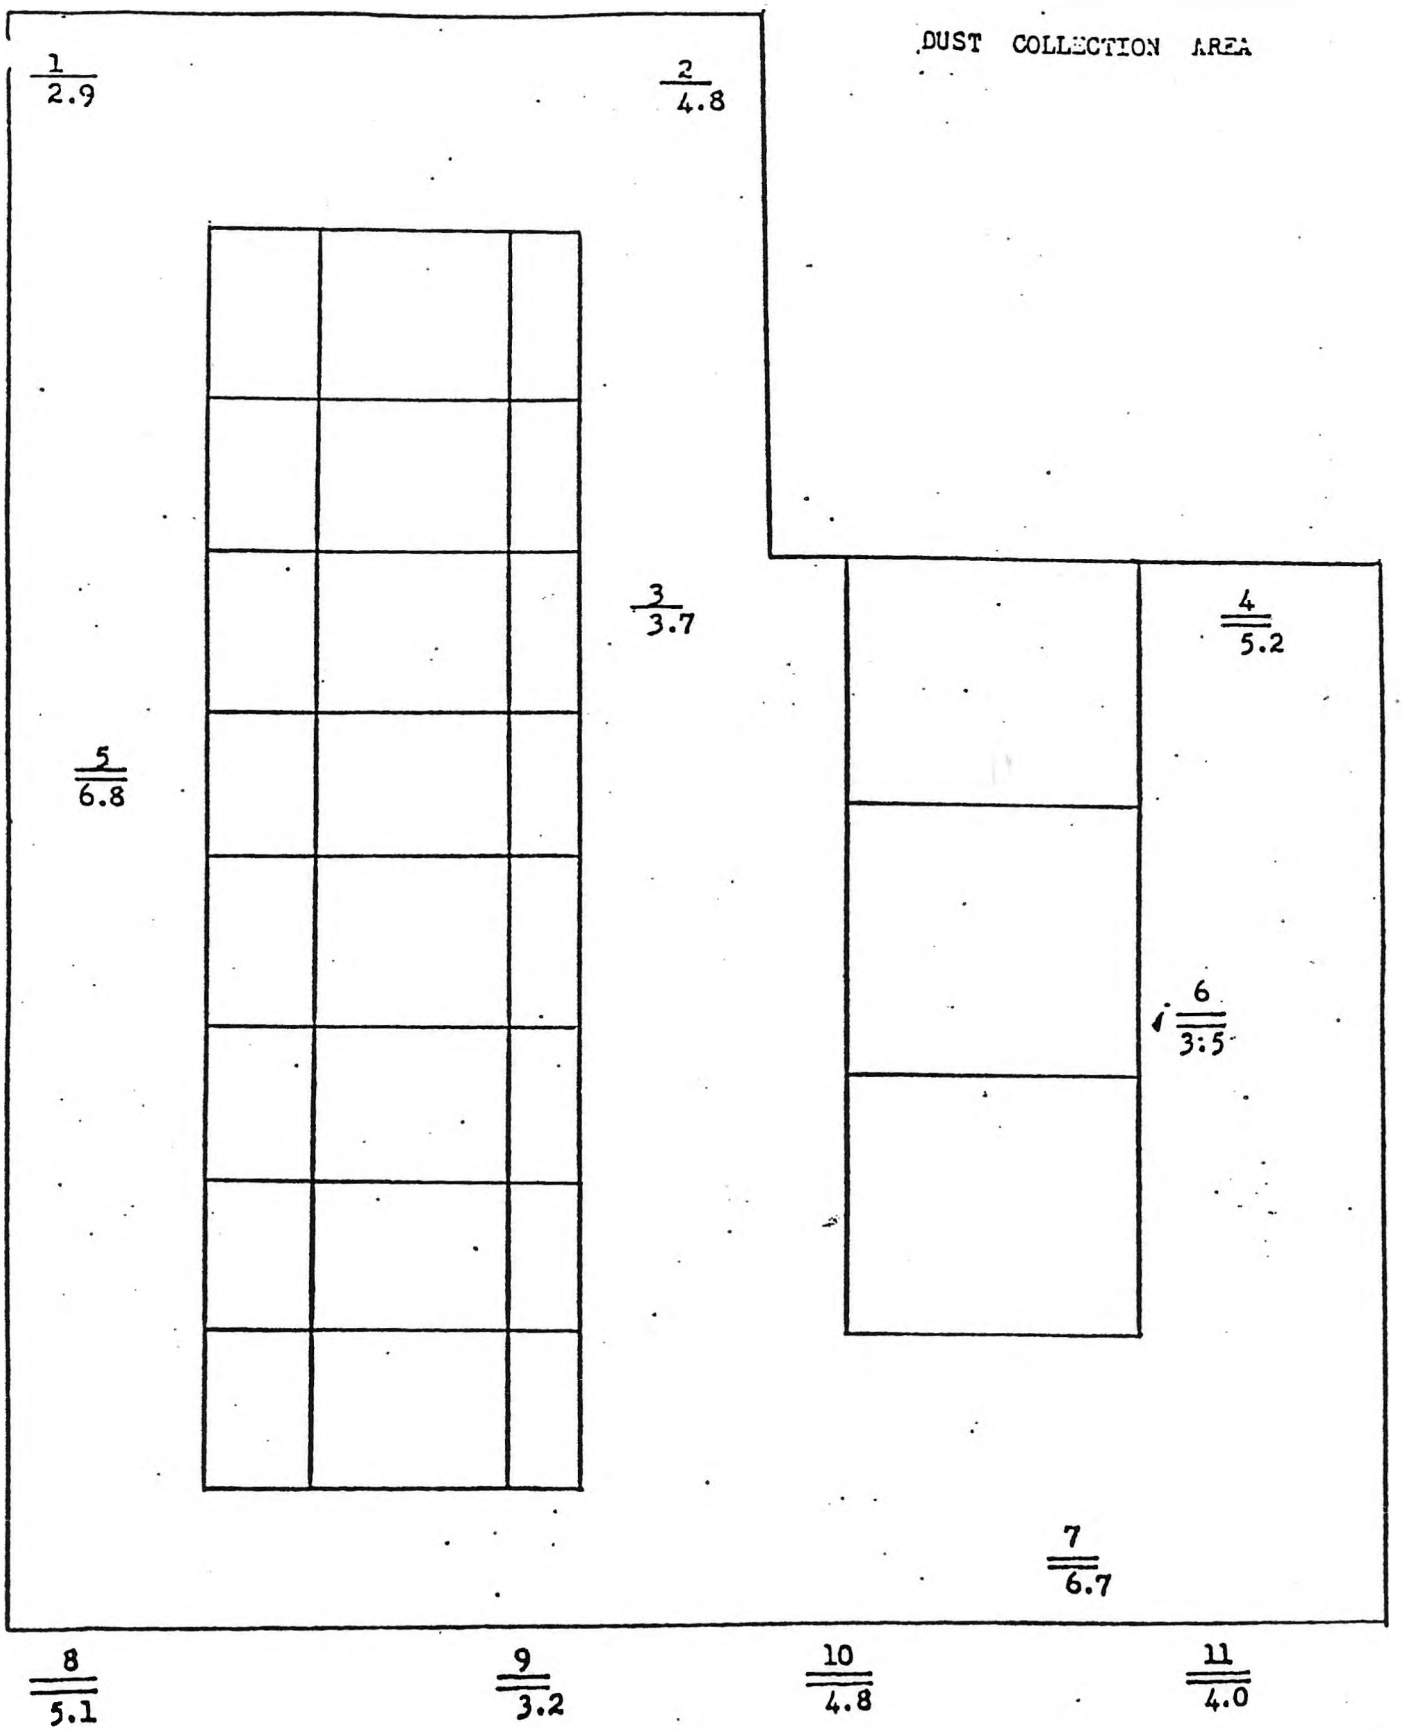
DUST COLLECTION AREA

This area is enclosed on three sides by walls but opens on the other side to the picking and blending rooms. Dust collectors take up most of the area of the room itself.but there are passage ways through and around the collectors. The bottoms of the collectors have access doors from which the "fly" is removed. The fly (a combination of cotton and asbestos) is either gathered in storage piles in the area or bagged. With the exception of the times when the fly is being handled or transported this room should offer no excessive exposure to anyone in this area. Judging from some samples taken elsewhere in the plant when the "fly" is transported or bagged it is possible for dust samples in excess of the maximum allowable concentration to exist. However, the range of dissemination of this dust is small so as to expose only the operator of the task. It is also true that these tasks are performed only intermittently, thereby only part of a man's time would be required by this operation. Therefore, it is doubtful if the man performing this operation is exposed to excessive dust when an average exposure for a 40 hour work week is considered.

Sample No.	Location	Dust Conc. in millions of particles per cubic foot of air. 30 minutes sampling	10 minutes sampling	Remarks
1	Dust Collection Area		2.9	Rear of room (No bagging)
2	"		4.8	" "
3	"		3.7	Center of room "
4	"	5.2		Corner of room "
5	"	6.8		Center of room " East
6	"	3.5		" " West
7	"	6.7		Near asbestos blender
	Average	5.2	3.8	
	Over-all Average	4.5

Maximum allowable concentration for asbestos dust is 5 millions of particles per cubic foot.

However, to remove any doubt of an excessive exposure, an approved type respirator may be used when the fly is being moved or bagged. It is believed that this would adequately reduce the exposure in this room to insure safe working conditions.

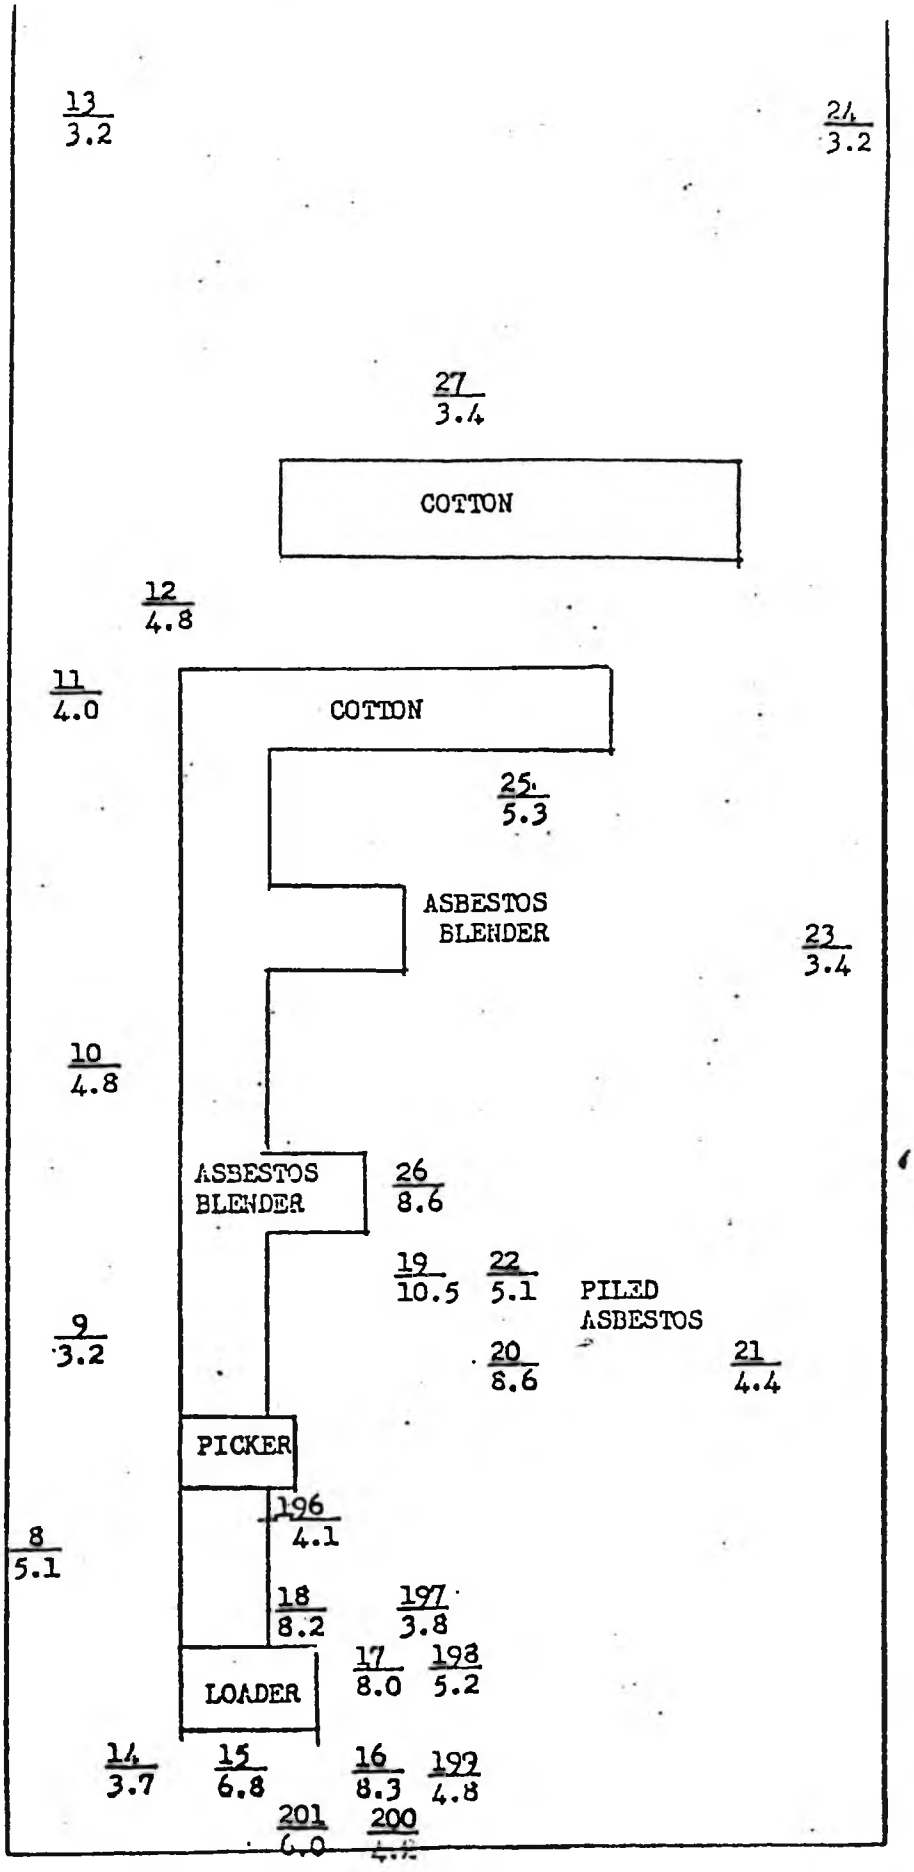
BLENDING ROOM

On the first day this room was surveyed, samples taken at all areas with the exception of the picker and loader area and another area where piled asbestos fly was being shoveled from one location to another, were found to be below the maximum allowable concentration of 5 million particles of asbestos dust per cubic foot.

Trouble with the final picker had developed previous to the sampling and a large pile of asbestos was being hand fed into the production line immediately before the final picker. Samples No. 8, 15 to 18 inclusive, were taken at or near this operation. These samples were found to average 7.3 millions of particles of this dust per cubic foot. Subsequent samples #196 to #201 each taken on a different day indicated a lower concentration than that found on the first day. These samples were found to average 4.5. It is believed that this latter average (4.5) is a more acceptable indication of the average dust count at this operation. The first samples (average 7.3) were included so as to show the concentrations which may develop when piled asbestos is handled.

Other samples (No. 19, 20 and 26) indicated that when the piled asbestos is handled concentrations in excess of 5 million particles may exist in the air.

As a result of all the samples taken it is doubtful if any of the men in this department are exposed to excessive dust when a 40 hour work week is considered. However, as indicated short term exposures exceeding the accepted limit may occur. It is believed that the use of a respirator during those periods would adequately insure safe conditions.

Sample No.	Location	Dust Conc. in millions of particles per cubic foot of air.		Remarks
		30 minutes sampling	10 minutes sampling	
8	Picker & Blender	5.1		Behind truck loader
9	"		3.2	Behind picker
10	"		4.8	Behind blender
11	"	4.0		Behind picker
12	"		4.8	Between cotton & picker
13	"		3.2	Corner of picker room
14	"		3.7	At bin truck and picker
15	"	6.8		"
16	"	8.3		"
17	"	8.0		"
18	"	8.2		"
19	"	10.5		At asbestos blender - shoveling piled asbestos
20	"		8.6	Piles asbestos - shoveling piled asbestos
21	"		4.4	Area near cards
22	"		5.1	At asbestos pile
23	"		3.4	Area near cards
24	"		3.2	"
25	"	5.3		At cotton blender - shoveling
26	"		8.6	At asbestos blender - "
27	"	3.4		At cotton picker
196	Picker & Loading Truck		4.1	Taken on different day
197	"		3.8	Taken on separate day
198	"		5.2	Taken on separate day
199	"	4.8		"
200	"		4.2	"
201	"	6.0		"
Average		6.4	4.5	
Total Average		5.4		
Average	Hand fed Operation	7.3		#8 & #15 to #18

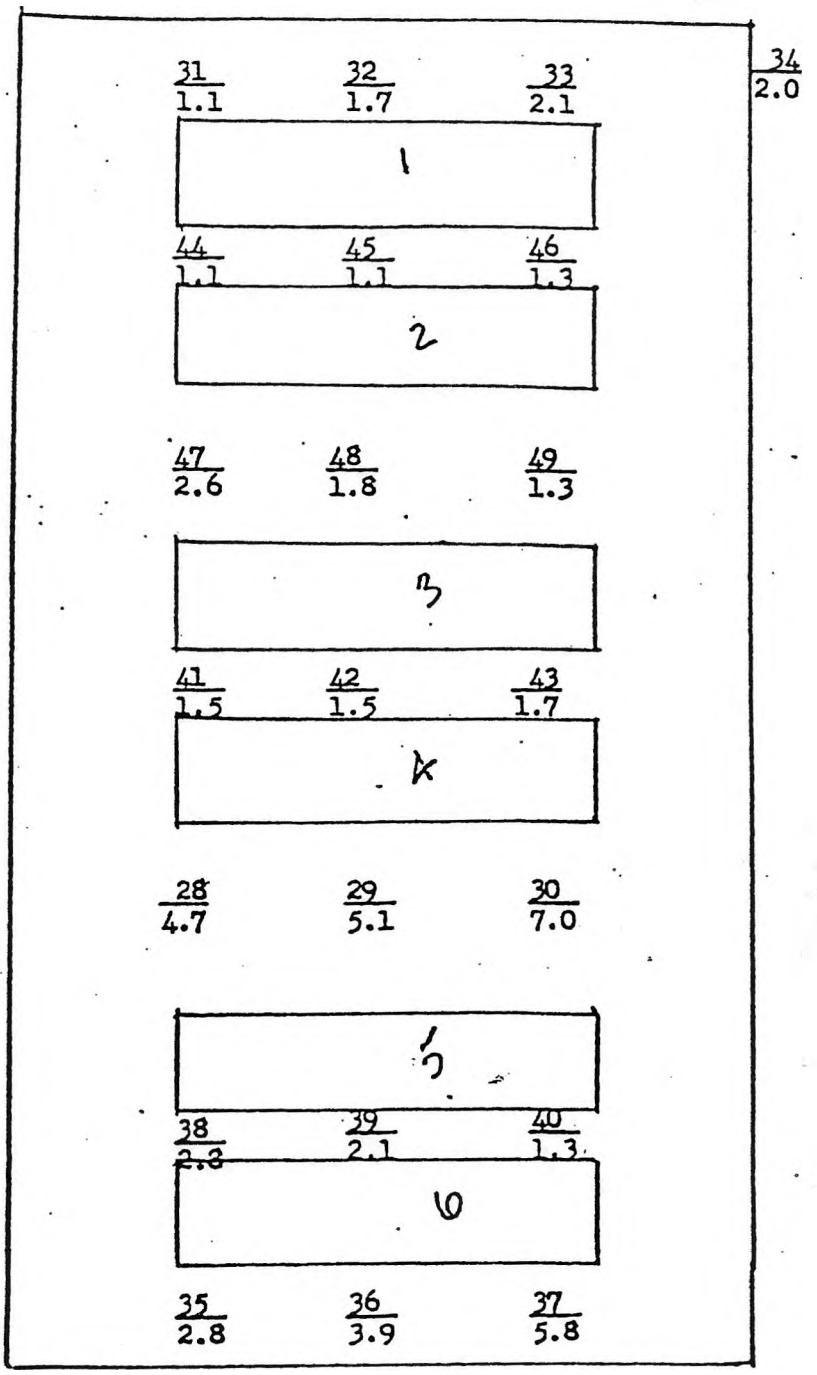
CARD ROOM

The card room is open on two sides one of which faces the picking room, the other, the twisting room. Samples taken in this room average below the threshold limit of 5 million particles. Samples No. 28, 29 and 30, where concentrations showed, 4.7, 5.1, and 7.0 respectively, were taken on the day that the high concentrations at the picker were found and "fly" shoveling was being done in an adjacent area. It is believed that these represent an exaggerated rather than a normal condition. Samples No. 35, 36 and 37 were higher than most of those taken throughout the room. It is believed that the dust concentrations found in this area may be due somewhat to its nearness to the truck loading operation in the picker room.

Little difference was noted from the dust concentration average from one side of the cards to the other.

Sample No.	Location	Dust Conc. in millions of particles per cubic foot of air.		Remarks
		30 minutes sampling	10 minutes sampling	
28	Card Room	4.7		Feed end
29	"	5.1		Center
30	"	7.0		Tale off end
31	"	1.1		Feed end
32	"	1.7		Center
33	"	2.1		Take off end
34	"		2.0	At desk
35	"	2.8		Feed end
36	"	3.9		Center
37	"	5.8		Take off end
38	"		2.8	Feed end
39	"		2.1	Center
40	"		1.3	Take off end
41	"		1.5	Feed end
42	"		1.5	Center
43	"		1.7	Take off end
44	"		1.1	Feed end
45	"		1.1	Center
46	"		1.3	Take off end
47		2.6		Feed end
48		1.8		Center
49		1.3		Take off end
Average		3.3	1.6	
Total Average		2.5		
Average Picker Side		2.4		
Average Center Side		2.5		
Average Take Off Side		2.9

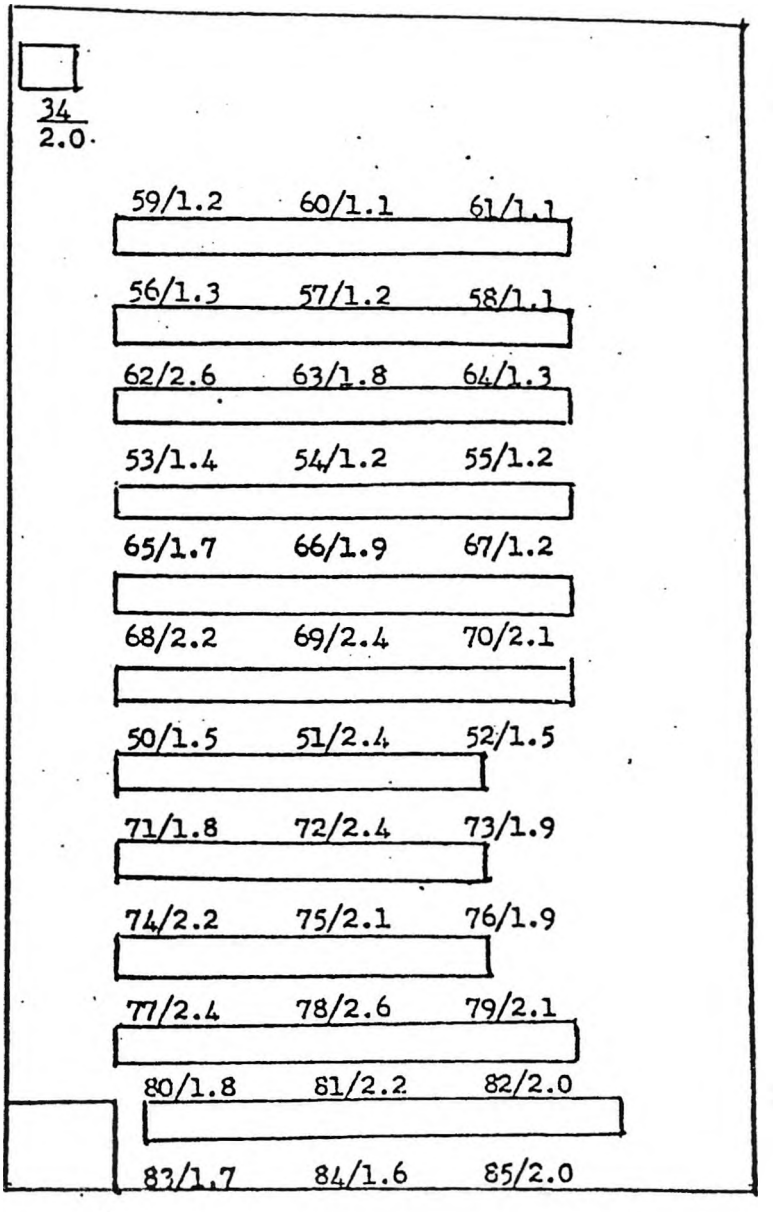
TWISTING ROOM

Samples were taken between each of the twisters and at three different points laterally. The dust concentrations found were low and were consistant throughout the entire area.

Sample No.	Location	Dust Conc. in millions of particles per cubic foot of air.		Remarks
		30 minutes sampling	10 minutes sampling	
50	Twisting Room	1.5		Card side
51	"	2.4		Center
52	"	2.1		Wall side
53	"		1.4	Card side
54	"		1.2	Center
55	"		1.2	Wall side
56	"		1.3	Card side
57	"		1.2	Center
58	"		1.1	Wall side
59	"		1.2	Card side
60	"		1.1	Center
61	"		1.1	Wall side
62	"	2.6		Card side
63	"	1.8		Center
64	"	1.3		Wall side
65	"		1.7	Card side
66	"		1.9	Center
67	"		2.1	Wall side
68	"		2.2	Card side
69	"		2.4	Center
70	"		2.1	Wall side
71	"		1.8	Card side
72	"		2.4	Center
73	"		1.9	Wall side
74	"	2.2		Card side
75	"	2.1		Center
76	"	1.9		Wall side
77	"	2.4		Card side
78	"	2.6		Center
79	"	2.1		Wall side
80	"		1.8	Card side
81	"		2.2	Center
82	"		2.0	Wall side
83	"		1.7	Card side
84	"		1.6	Center
85	"		2.0	Wall side
34			2.0	At desk
Average		2.1	1.7	
Total Average		1.9

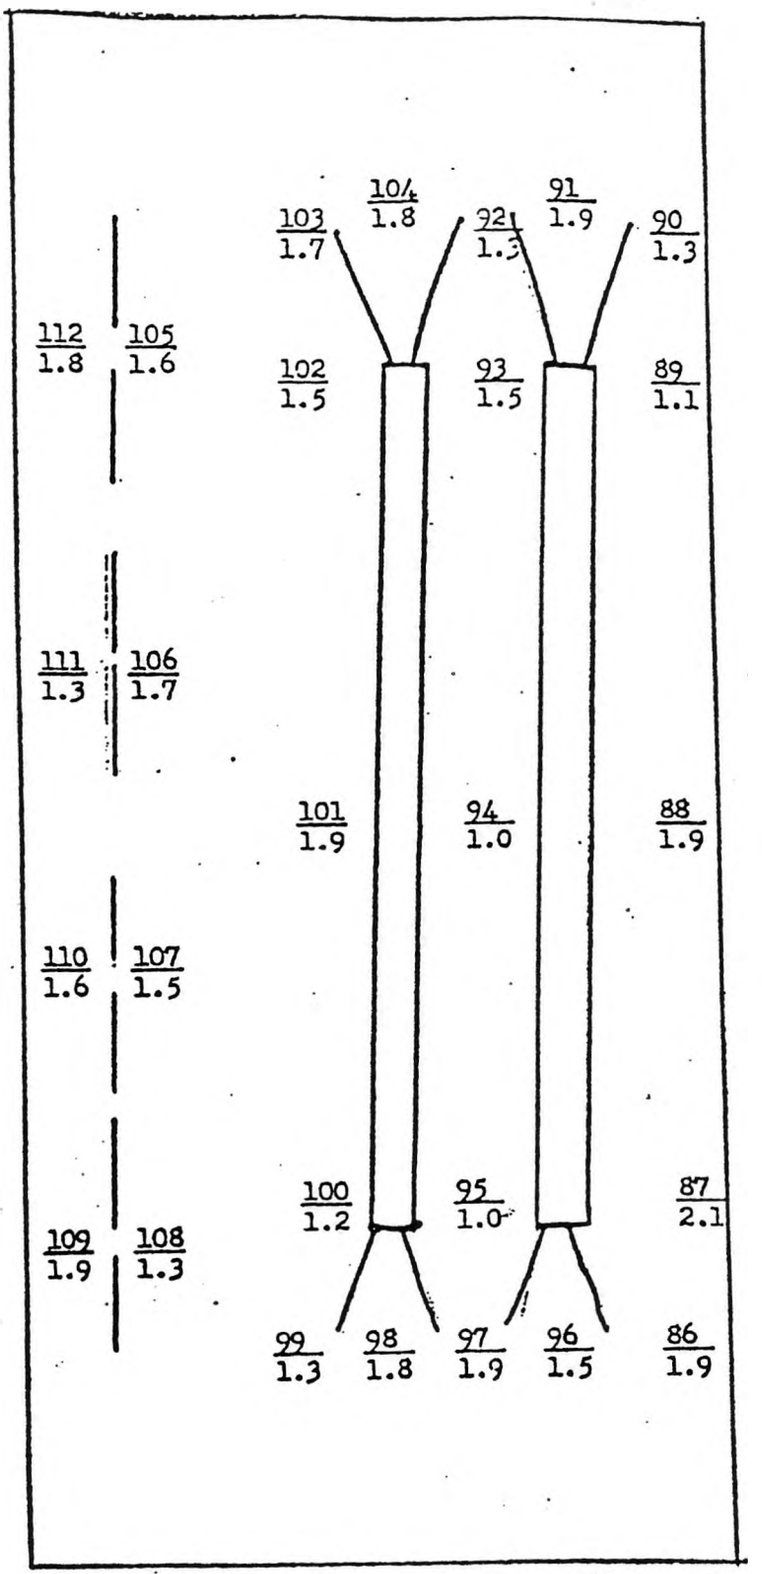
OVENS AND UNIVERSAL WINDERS

Dust samples taken in these two areas were low and as in the twisting room were consistant throughout both of the areas.

Sample No.	Location	Dust Conc. in millions of particles per cubic foot of air.		Remarks
		30 minutes sampling	10 minutes sampling	
86	Ovens		1.9	Feed end at operator
87	"		2.1	" oven
88	"		1.9	Center
89	"		1.1	Take off end (oven)
90	"		1.3	"
91	"	1.9		"
92	"		1.3	"
93	"	1.5		" (oven)
94	"	1.0		Center
95	"	1.0		Feed end
96	"	1.5		"
97	"		1.9	"
98	"	1.8		"
99	"		1.3	"
100	"		1.2	" (oven)
101	"		1.9	Center
102	"		1.5	Take off end
103	"		1.7	"
104	"	1.8		"
105	Universal Winders		1.6	Front universal winders
106	"	1.7		"
107	"		1.5	"
108	"	1.3		"
109	"		1.9	Rear universal winder at operator
110	"	1.6		"
111	"		1.3	"
112	"	1.8		"
Average		1.5	1.6	
Total Average		1.6		
Average Ovens		1.5		
Average Winders		1.6

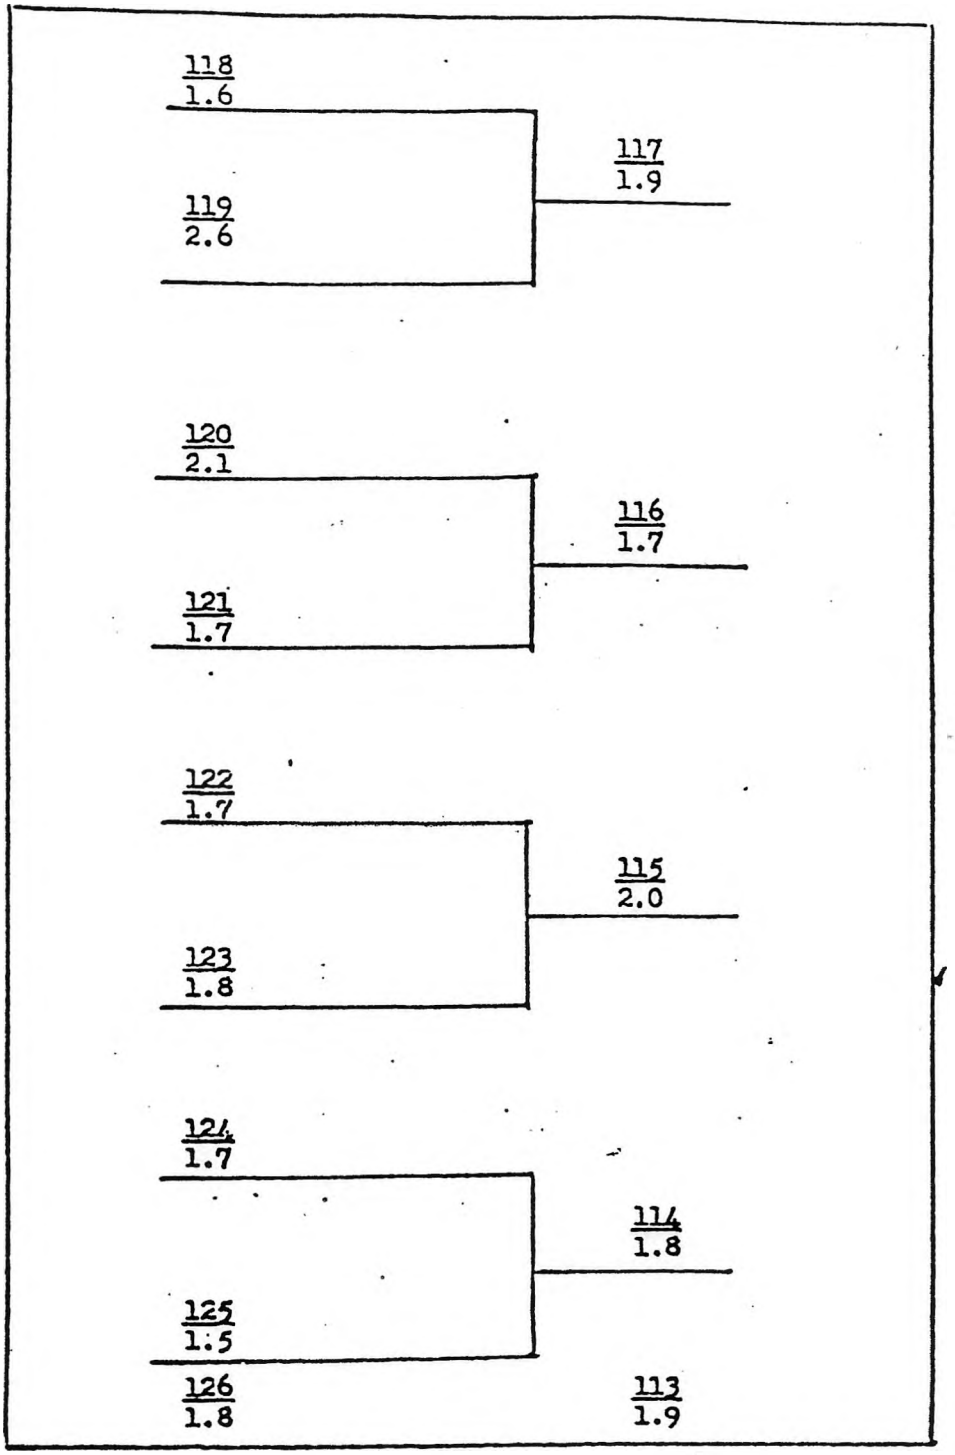
WARPERS

The dust concentrations found in this department were low and were all below the accepted threshold limit of 5 million particles of dust per cubic foot. Because of a partial reduction of ventilation brought about by a vent in one of the ventilating ducts, on the day of the sampling conditions may even be better in this area under normal ventilation conditions.

Sample No.	Location	Dust Conc. in millions of particles per cubic foot of air.		Remarks
		30 minutes sampling	10 minutes sampling	
113	Warpers		1.9	At winder
114	"	1.8		"
115	"	2.0		"
116	"	1.7		"
117	"		1.9	"
118	"		1.6	At spools
119	"		2.6	"
120	"	2.1		"
121	"		1.7	"
122	"		2.0	"
123	"		1.8	"
124	"	1.7		"
125	"		1.5	"
126	"		1.8	"
Average		1.9	1.8	
Total Average		1.9		
Average rear Spool		1.9		
Average winder		1.9

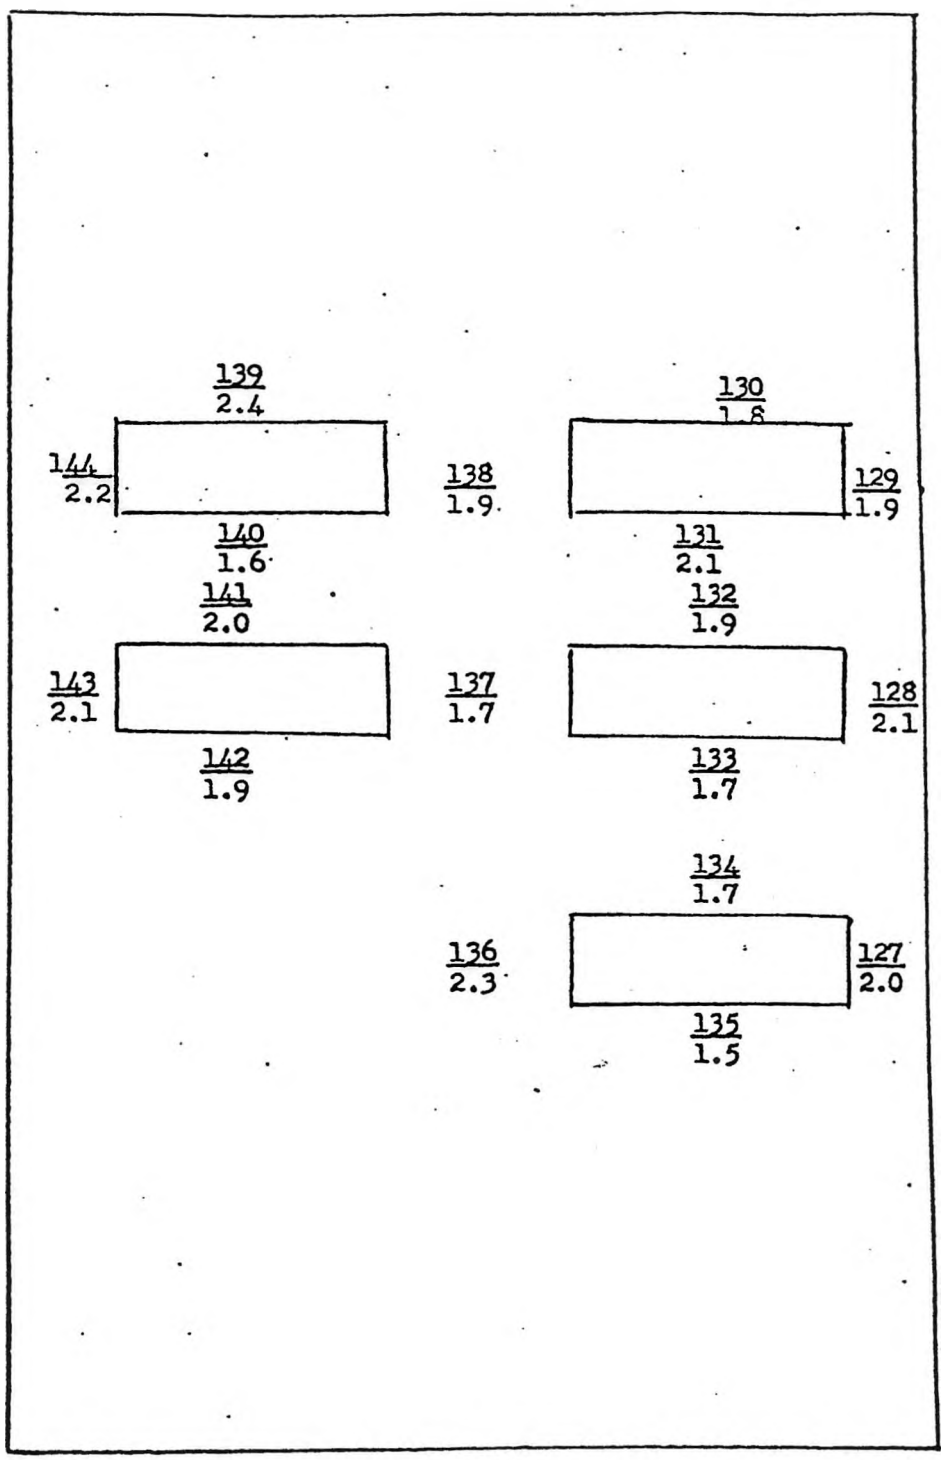
BOBBIN WINDERS

This area was sampled on the same day as the warper area, and the same condition concerning the ventilation is true here also. However, all the samples taken indicated low concentrations of dust for this area.

Sample No.	Location	Dust Conc, in millions of particles per cubic foot of air.		Remarks
		30 minutes sampling	10 minutes sampling	
127	Bobbin Winders		2.0	Oven side of winders
128	"	2.1		"
129	"		1.9	"
130	"		1.8	Side of winders
131	"		2.1	"
132	"		1.9	"
133	"		1.7	"
134	"		1.7	"
135	"		1.5	"
136	"		2.3	Between winders
137	"	1.7		"
138	"	1.9		"
139	"		2.4	Side of winders
140	"		1.6	"
141	"	2.0		"
142	"		1.9	"
143	"	2.1		Weaving side of winders
144	"		2.2	"
Average		2.0	1.9	
Total Average		2.0

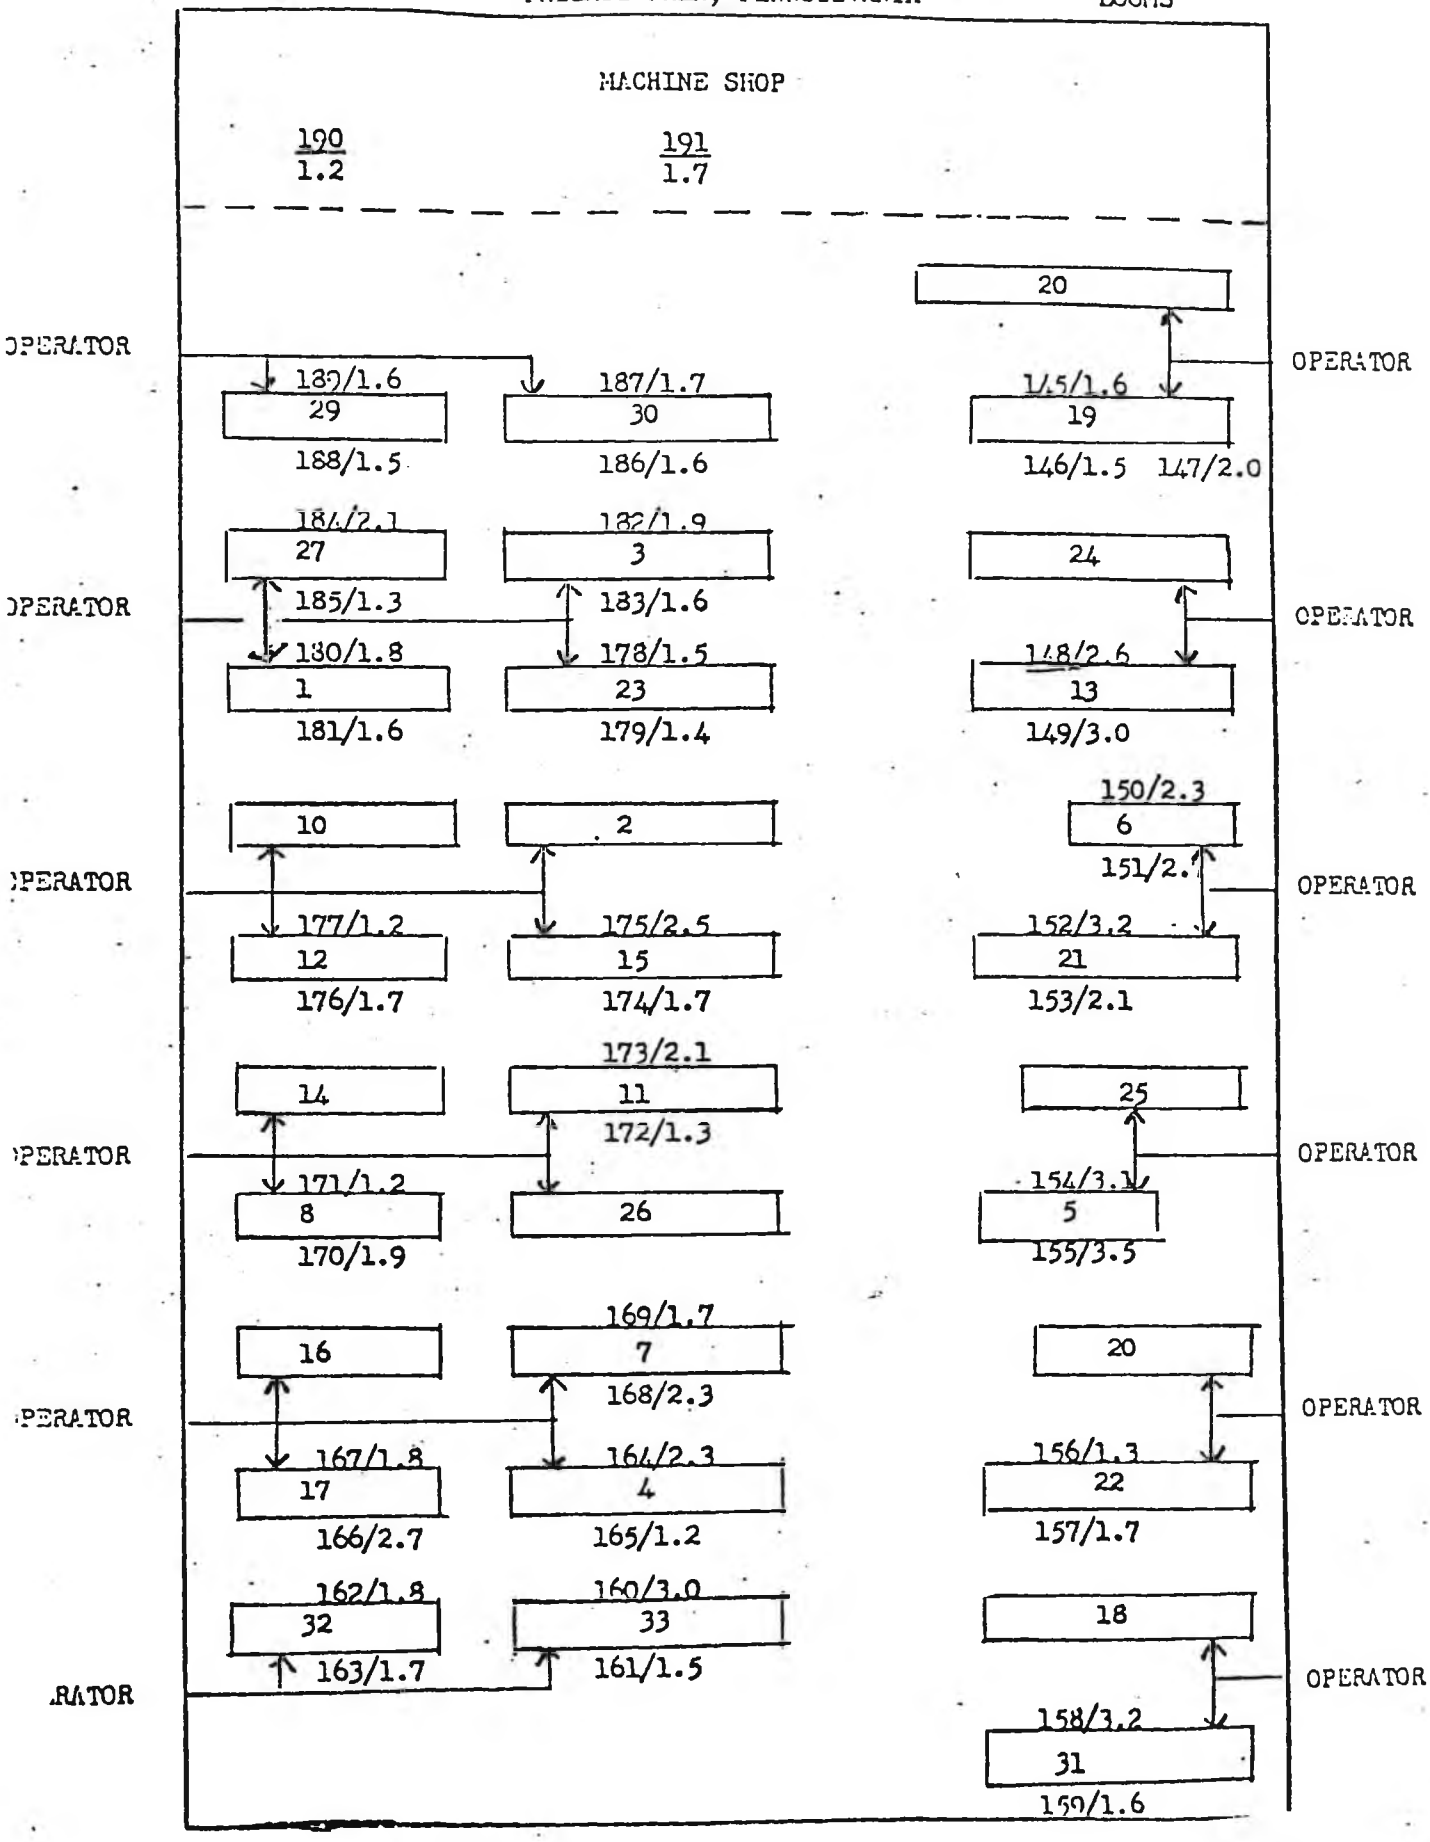
PHILADELPHIA, PENNSYLVANIA LOOMS

The samples taken in this room were all below the maximum allowable concentration of 5 million particles of asbestos dust per cubic foot.

The concentration found at the operators level did not differ from those found at the rear of the looms or the general air samples. Samples were found to be slightly higher in this room than the few previous areas, but it is believed that the size of the room and the increased activity would probably account for this difference.

Dust concentrations found in the machine shop area were also quite low.

Sample No.	Location	Dust Conc. in millions of particles per cubic foot of air.		Remarks
		30 minutes sampling	10 minutes sampling	
145	Loom #19		1.6	Operators side
146	"	1.5		Rear
147	"	2.0		"
148	Loom #13		2.6	Operators side
149	"		3.0	Rear
150	Loom #6	2.3		Rear
151	"		2.7	Operators side
152	Loom #21		3.2	Operators side
153	"	2.1		Rear
154	Loom #5		3.1	At operator
155	"	3.5		Rear
156	Loom #22		1.3	Rear
157	"	1.7		At operator
158	Loom #31	3.2		At operator
159	"		1.6	Rear
160	Loom #33	3.0		Rear
161	"		1.5	At operator
162	Loom #32		1.8	Rear
163	"		1.7	At operator
164	Loom #4	2.3		At operator
165	"		1.2	Rear
166	Loom #17	2.7		Rear
167	"		1.8	At operator
168	Loom #7		2.3	At operator
169	"		1.7	Rear
170	Loom #8	1.9		Rear
171	"		1.2	Operators side
172	Loom #11		1.3	Operators side
173	"	2.1		Rear

Sample No.	Location	Dust Conc, in millions of particles per cubic foot of air		Remarks
		30 minutes sampling	10 minutes sampling	
174 175	Loom #15 "	2.5	1.7	Rear Operators side
176 177	Loom #12 "		1.7 1.2	Rear Operators side
178 179	Loom #23 "	1.5	1.4	Operators side Rear
180 181	Loom #1 "		1.8 1.6	Operators side Rear
182 183	Loom #3 "		1.9 1.6	Rear Operators side
184 185	Loom #27 "		2.1 1.3	Rear Operators side
186 187	Loom #30 "	1.7	1.6	Rear Operators side
188 189	Loom #29 "		1.5 1.6	Rear Operators side
190 191	Machine Shop	1.2 1.7		
Average		2.4	2.1	
Average " "	Operators side Rear side Machine Shop	2.3 2.1 1.5		Operators side Rear side Machine shop

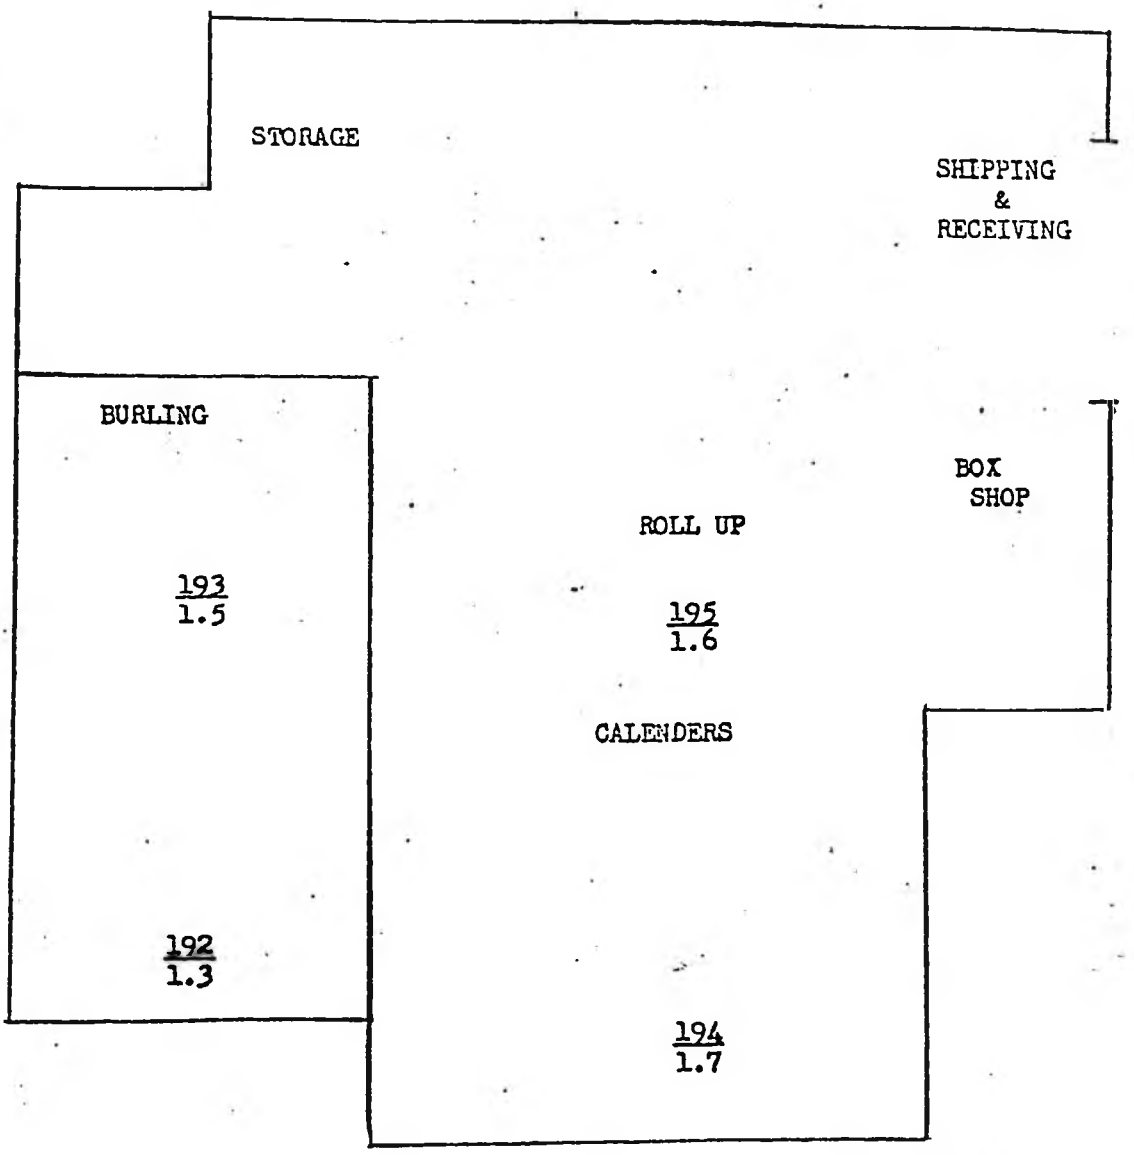
BURLING AND CALENDER AREA

All of the samples taken in these two rooms indicated concentrations of l less than two million particles of dust per cubic foot. Additionally it is believed that the asbestos content of this dust should be low. Consequently, it is believed that there is no exposure to asbestos in these areas.

Sample No.	Location	Dust Conc. in millions of particles per cubic foot of air		Remarks
		30 minutes sampling	10 minutes sampling	
192	Burling Room	1.3		Bench working
193	"	1.5		Roll inspection
194	Calender Room	1.7		Center of calenders
195	"	1.6		Near roll up
Average	Burling Room	1.4		
	Calender Room	1.7
