Subject: Underground Storage Tank(s) for: Puma Pollyberg Service Station
Located at: 68, 69 and 70 Dronningens Gade, U.S. Virgin Islands 00802
Facility ID Number: 201014
ICIS Number: 3601550659

Underground Storage Tank (UST) Inspection Form

Inspector Observation Report

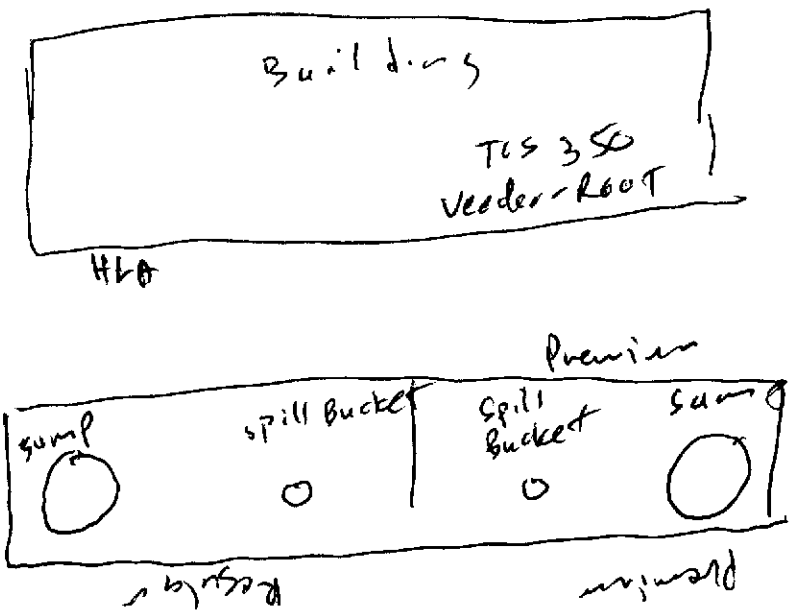
SITE DRAWING

(1) Both spill buckets are with liquid

(2) Regular liquid was not at the lowest point

(3) Both sumps got liquid sensors

(4) Per contractor HLA was not working

(5) No jumpers in the dispensers

(1) Designate of class A and B operator - training certificate came from EPA rather than USVI DPNR requirements
(2) need to create a list of operators
(3) Overfill alarm is not alarm - no light or sound per contractor - need to FIX ASAP
(4) no record for annual test of release Detection components
(5) pipes at the dispensers need jumper(s) - to have proper monitoring
(6) remove and properly dispose liquid in the spill buckets
(7) liquid sensors in Reg Tank needs to relocate to the lowest point
