McWANE CAST IRON PIPE CO.

REPORT ON CORROSION COMPLAINT AT PORT SULPHUR, LA.

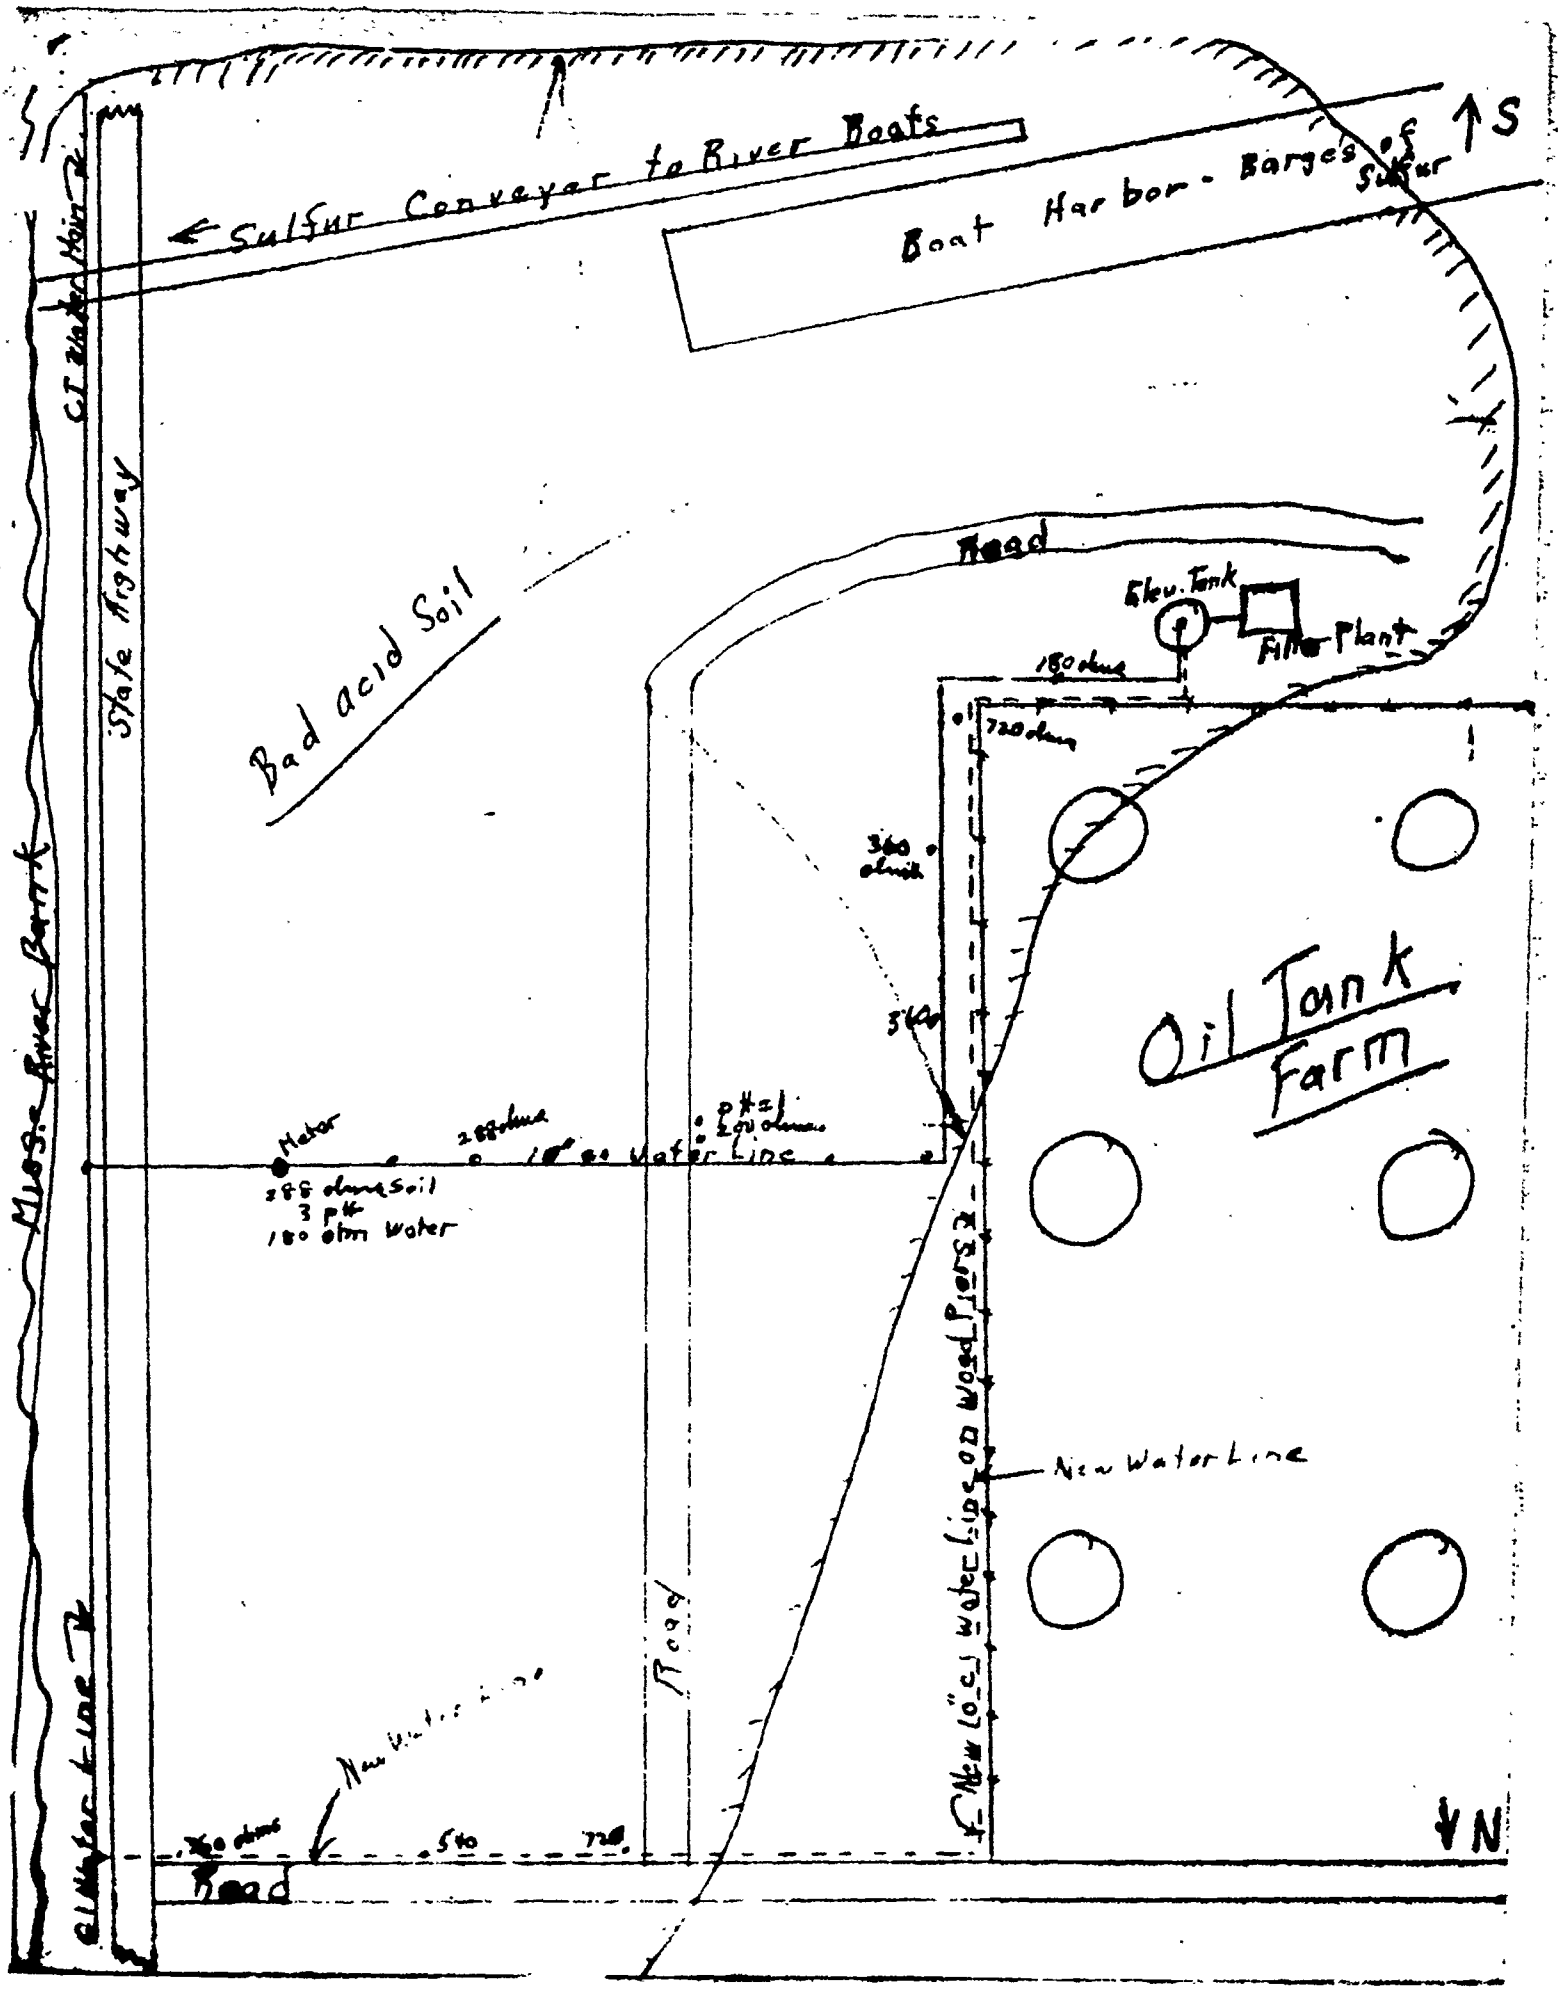
The 10" main has failed on three or four locations with severe interruptions to the water service for the entire area, as this is the main supply feeder.

A study of the soil showed that it was just about as corrosive as it is possible to find. The acid content on the surface of the ground in some spots had a pH of 1 which is practically pure acid. The water in the ditch had a pH of 3. Several pH tests indicated, as was plainly visible, that sulphur was freely mixed with the soil and very acid conditions were the order of the day. Electrical resistivity tests showed readings as low as 90 ohms cm^3. The average range was from 300 to 400 ohms cm. The best reading on the entire area was 720 ohms. The Azide test for sulfides was positive on all cases.

The soil conditions along this 1800 ft. of pipe are very bad and a short life would be expected. The trouble started in the

Sulfur Conveyor to River Boats
Boat Harbor - Barges of Sulfur
S
C.T. Water Main
State Highway
Bad acid Soil
Road
Elev. Tank
Filter Plant
180 ohms
720 ohms
360 ohms
360
Oil Tank Farm
Meter
288 ohms
pH=1
200 ohms
10" Water Line
288 ohms Soil
3 pH
180 ohm Water
Miss. River Bank
New Water Line
New 10" C.I. Water Line on Wood Piers
Road
New Water Line
C.I. Water Line
360 ohms
540
720
Road
N

I would suggest that the pipe line be replaced or relocated. The new pipe line should be installed above ground on creosote piers of 10" x 10" with at least 2½ ft. in the ground. The pipe should be securely strapped to the top of each pier, one pier for each length of pipe so that there will be no room for longitudal movement. At the ends of the lines and wherever there is a change in direction, the pipe should be securely tied together with steel rods and anchor clamps. After the pipe is installed, it should be given a good coating of bitumastic paint #50.

I am attaching a sketch of the present and proposed route of the 10" pipe line.
