EMISSION INVESTIGATION

Date of Incident:	March 8, 1972 4:00 A.M. and 6:00 A.M.
Location:	Department 246, Distillation Column
Kind of Emission:	Aroclor
Result of Emission:	Sprayed Aroclors in cone shaped pattern Southeast of column to points at least 100 yards from column. No complaints received.
Cause of Emission:	Loss of cooling on column condenser resulting from 4:00 AM Incident - Electrical failure 6:00 AM Incident - City water make-up pump not started after electrical failure. No means available to stop emission once it starts when power is off.
Investigating Committee:	Virgil Brawley Clarrie Buckley Jim Grant Gerald McRaven Ed Stewart, Chairman

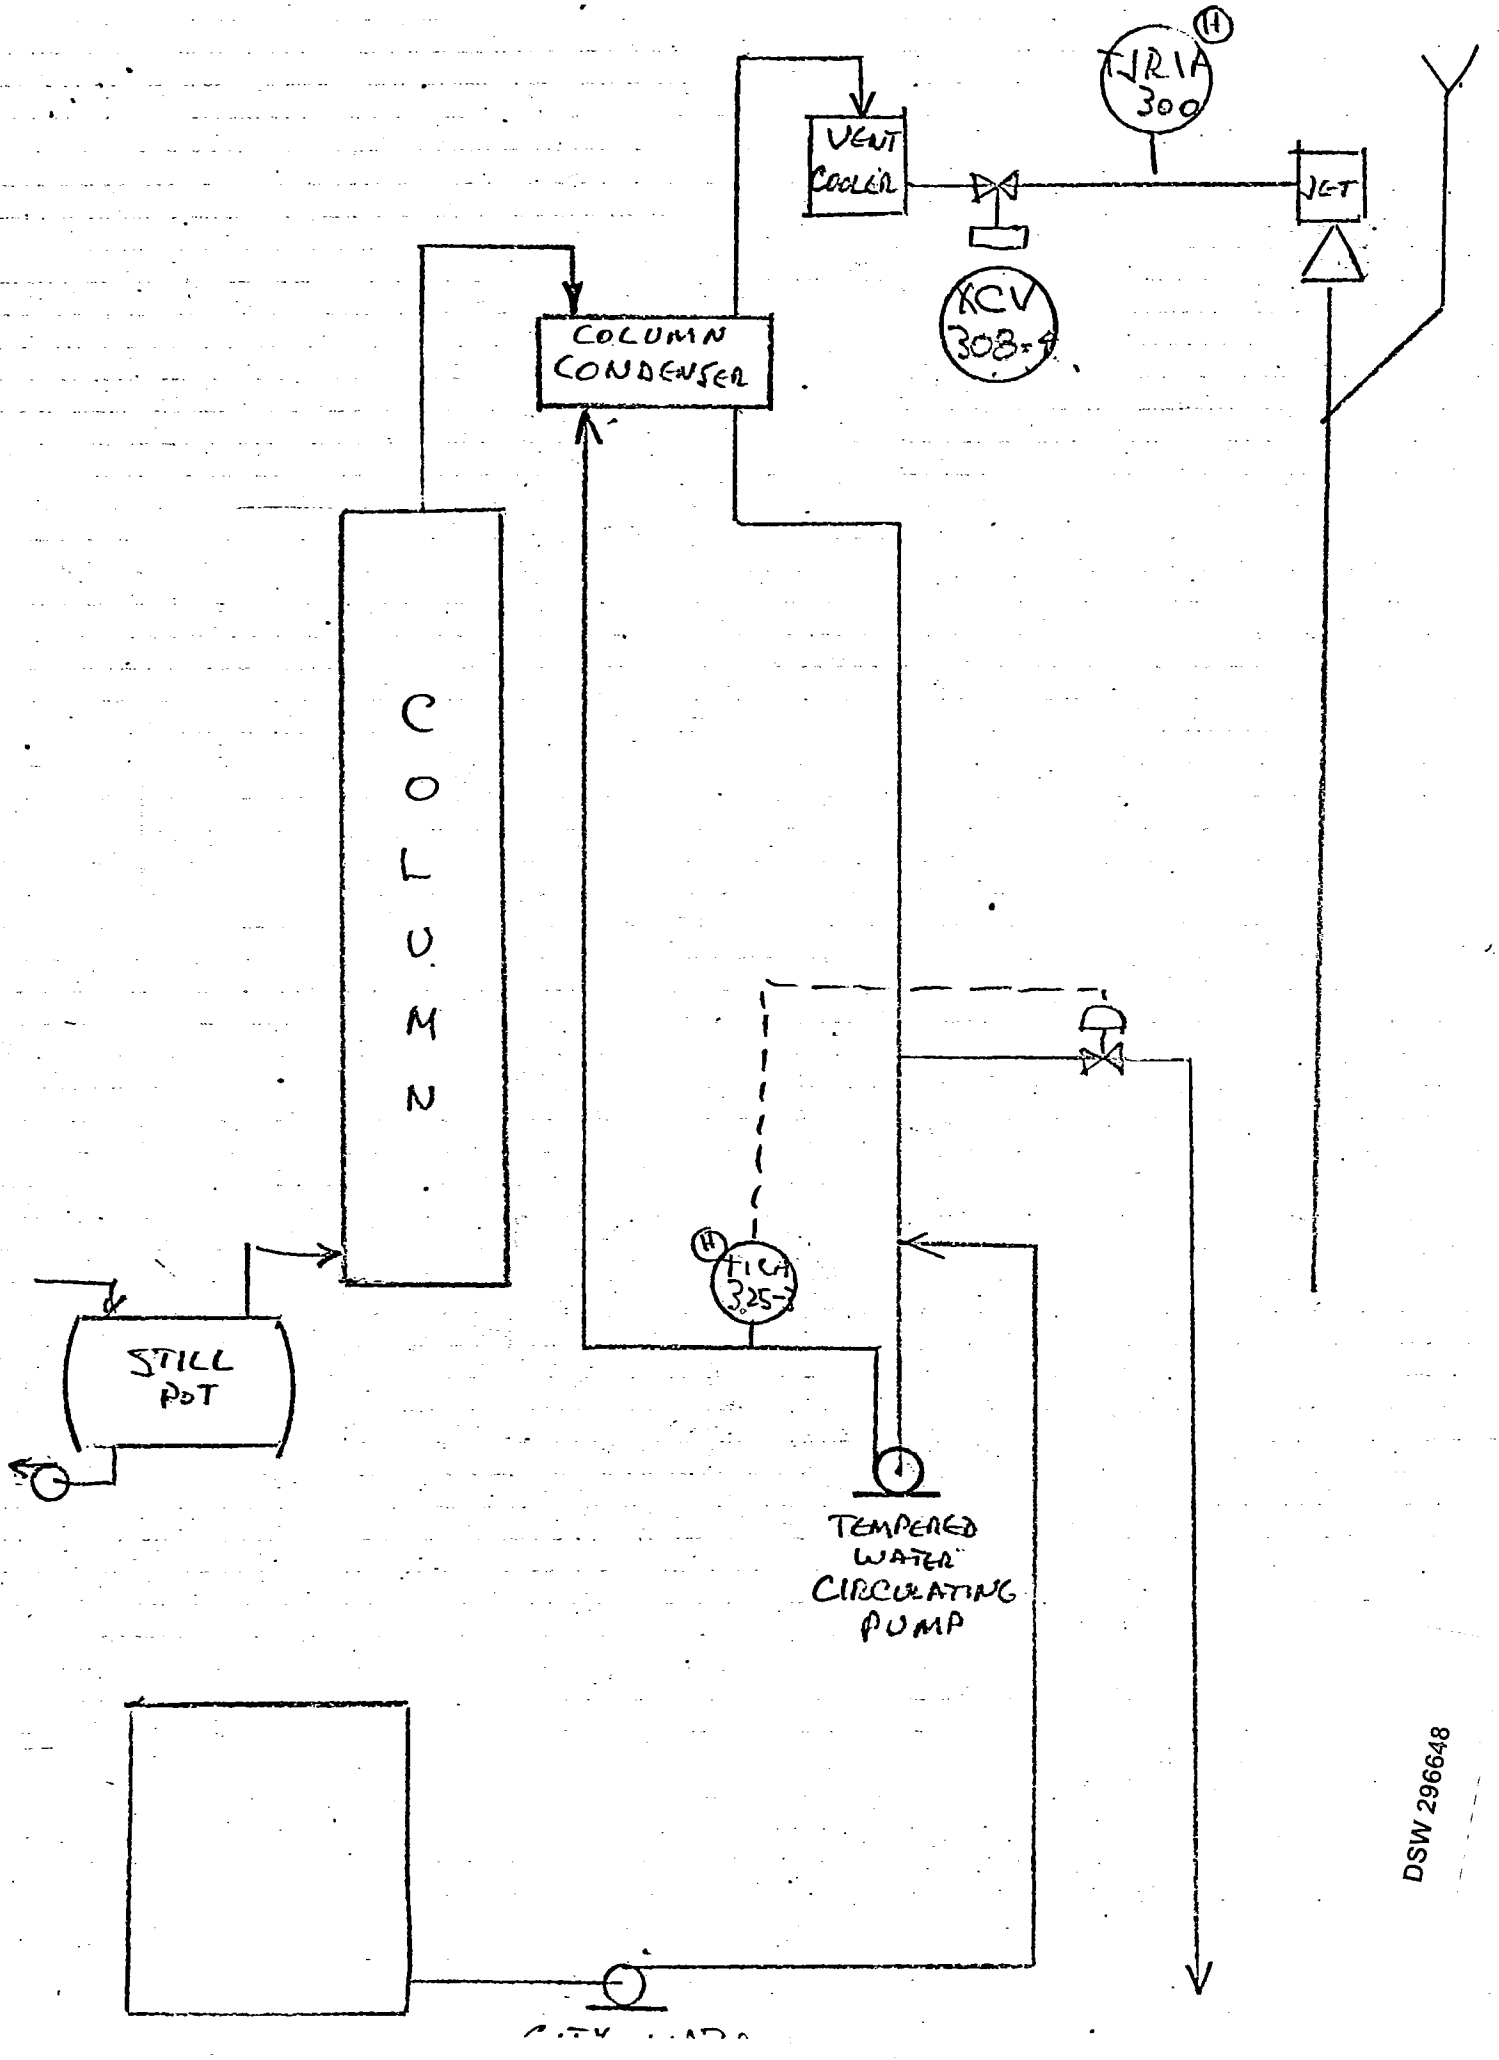
The emission was caused by a loss of cooling water at the column condenser. There is a heat sink in the column and an immediate decrease in pressure in the column, both of which will tend to result in continued generations of vapors even though the external source of heat has been removed. Without cooling water on the condenser some vapors will pass uncondensed through the condenser, the vent cooler, the jets and into the atmosphere. Although there is a valve in the vent line it fails in the open position on electrical failure, and there is no way to immediately stop the vapors during an electrical failure. See sketch.

TIRIA 300
VENT COOLER
VGT
KCV 308-4
COLUMN CONDENSER
COLUMN
TICA 325-3
STILL POT
TEMPERED WATER CIRCULATING PUMP
DSW 296648

The emissions can be stopped by closing the valve between the vent cooler and the jet. This can be done with minor electrical changes and can be done safely. This was reviewed with Dale Schillinger and Walter Howard of CED.

1. Alter the vent valve (XV 308-4) to close on electrical failure.
