THE RAYBESTOS DIVISION OF RAYBESTOS-MANHATTAN, INC.

Bridgeport, Conn.

The following report is a study of the dust conditions in the Bridgeport and Stratford, Conn. plants of the Raybestos-Manhatten, Inc. and was conducted in June, 1935. This survey is supplementary to the survey made in February and March, 1930.

The Bridgeport Plant

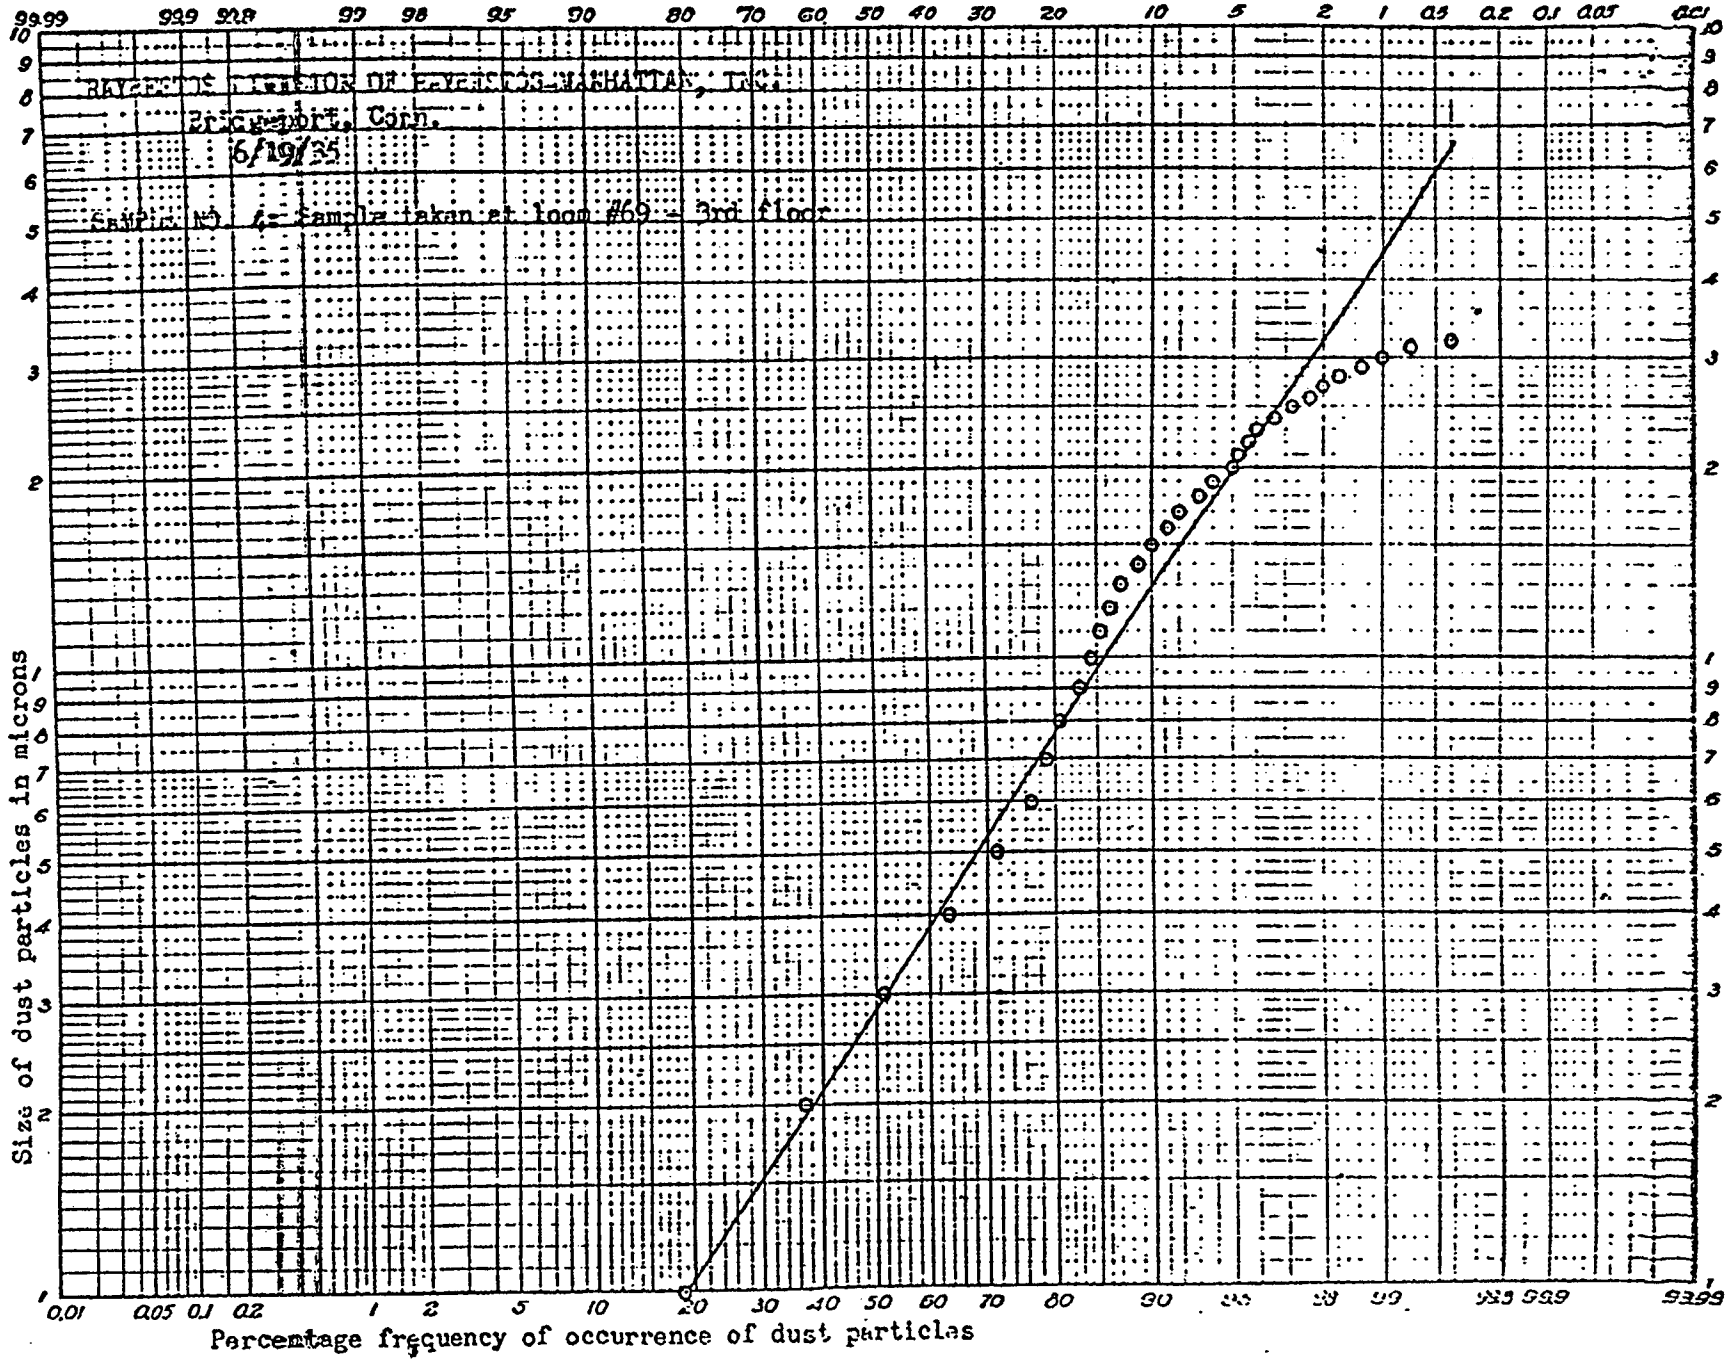
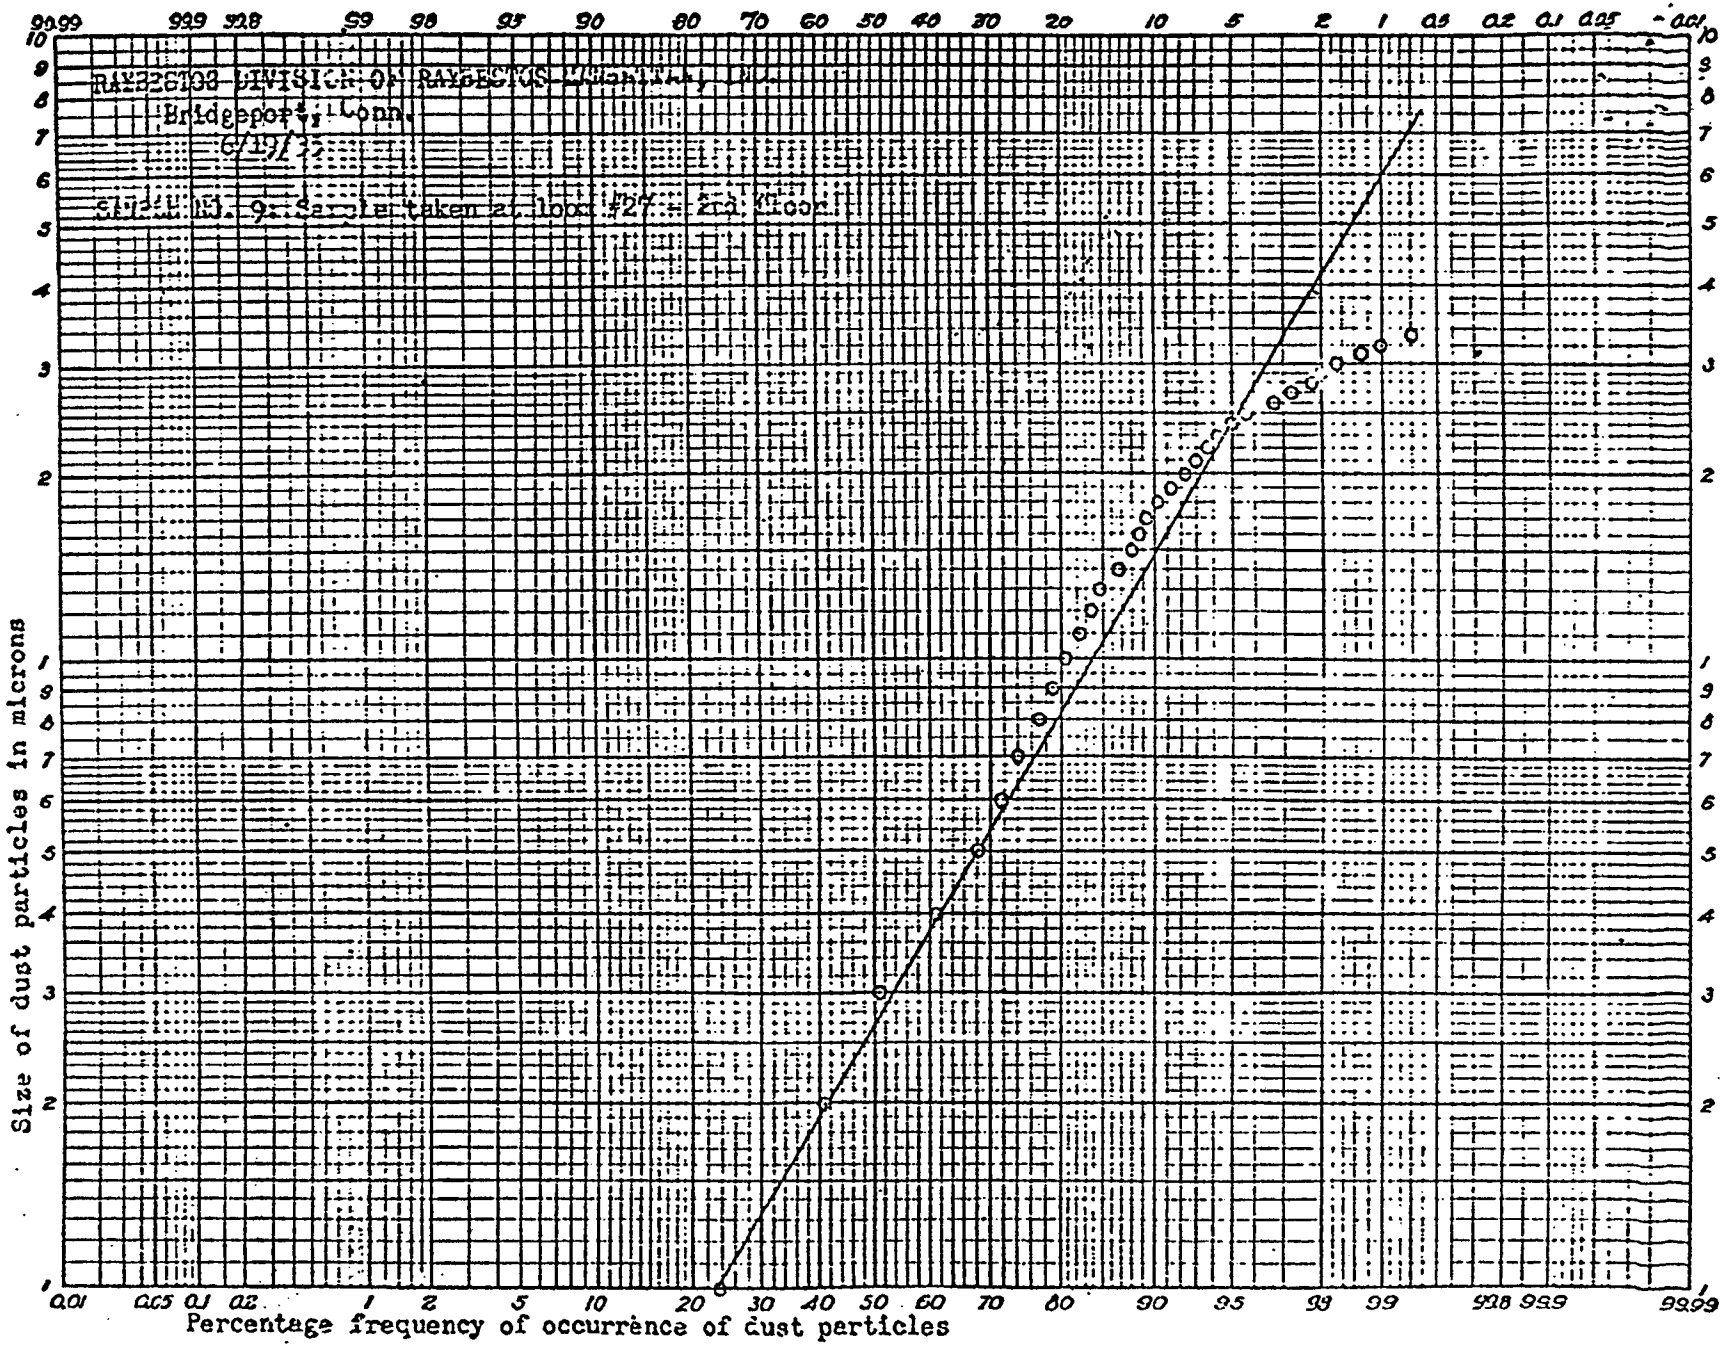
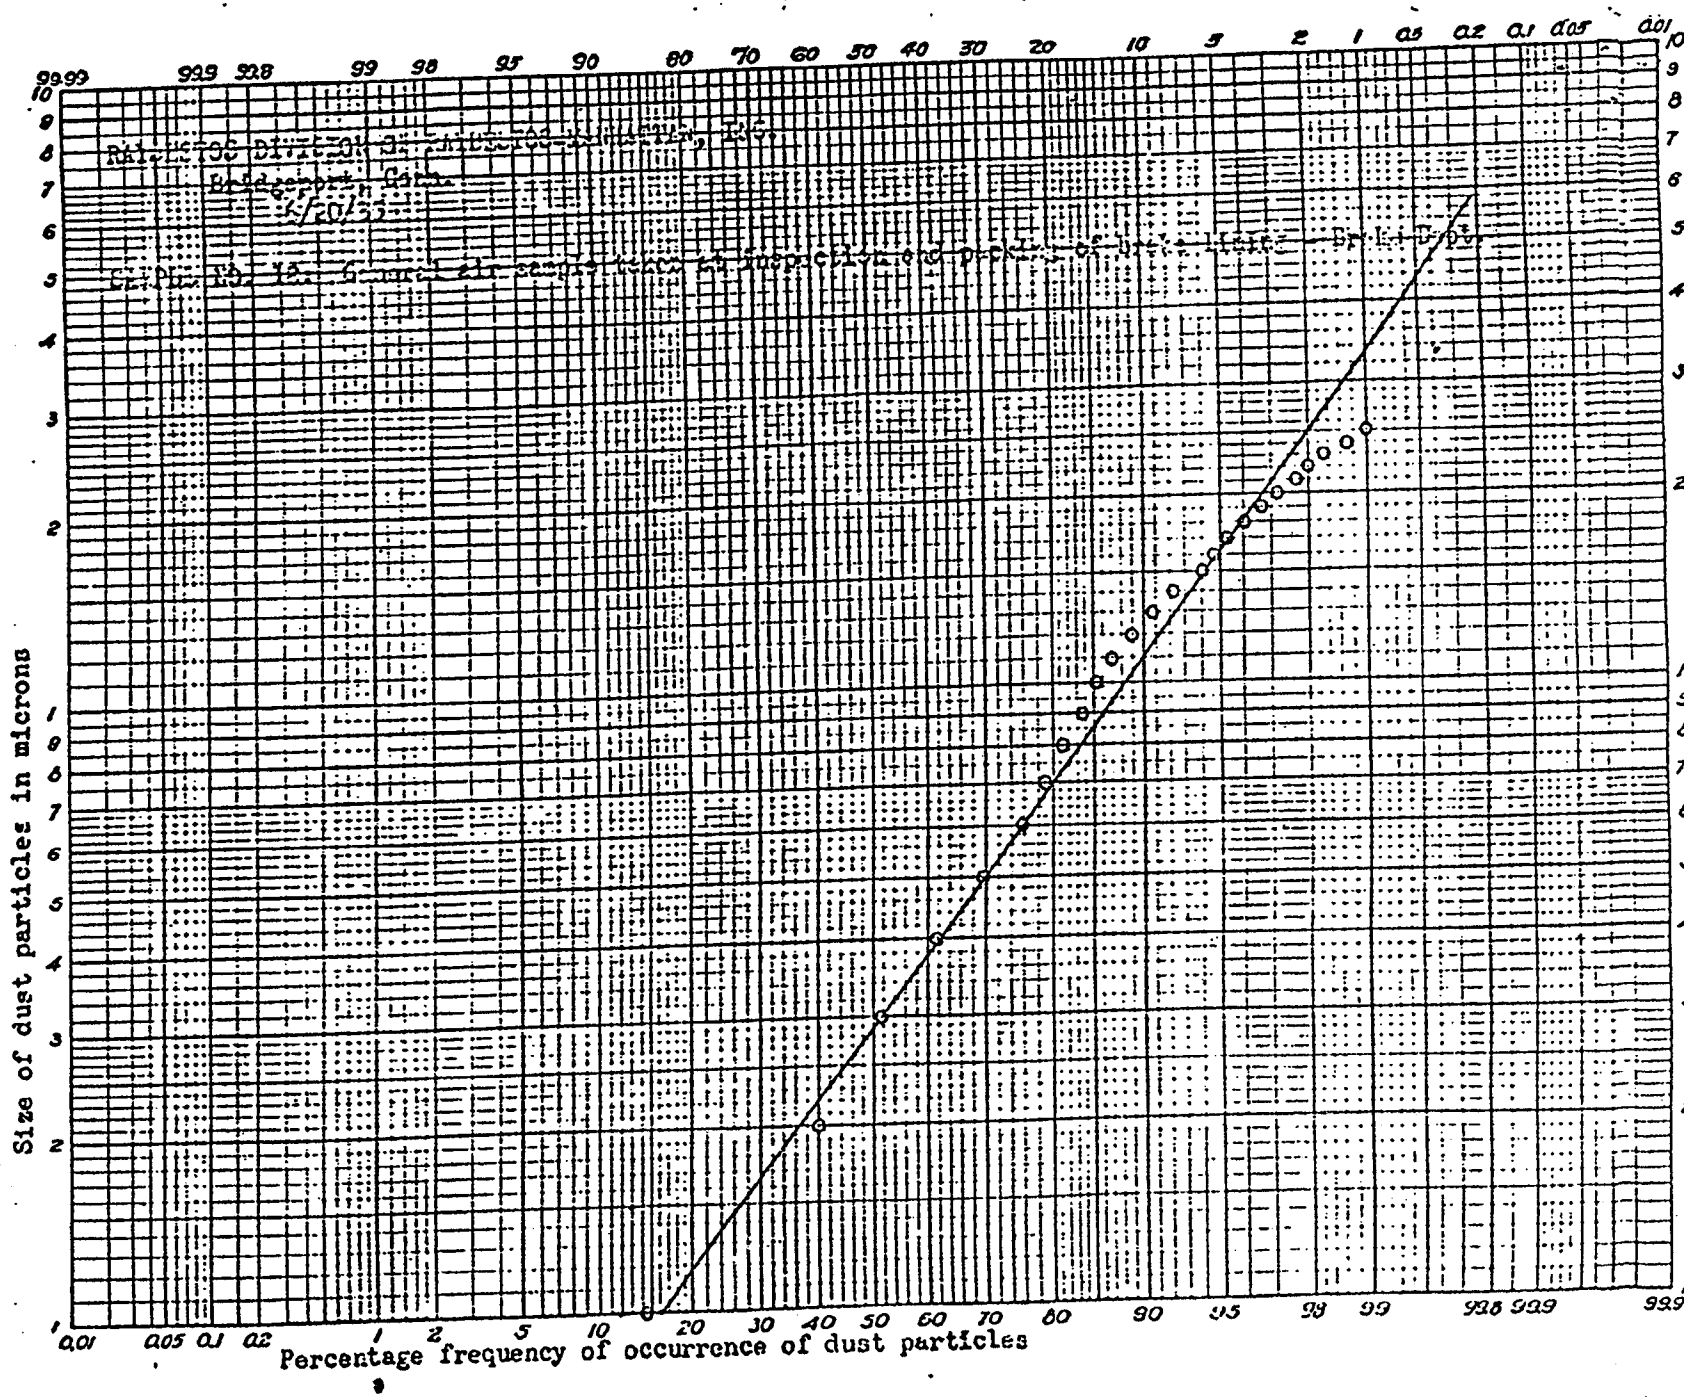
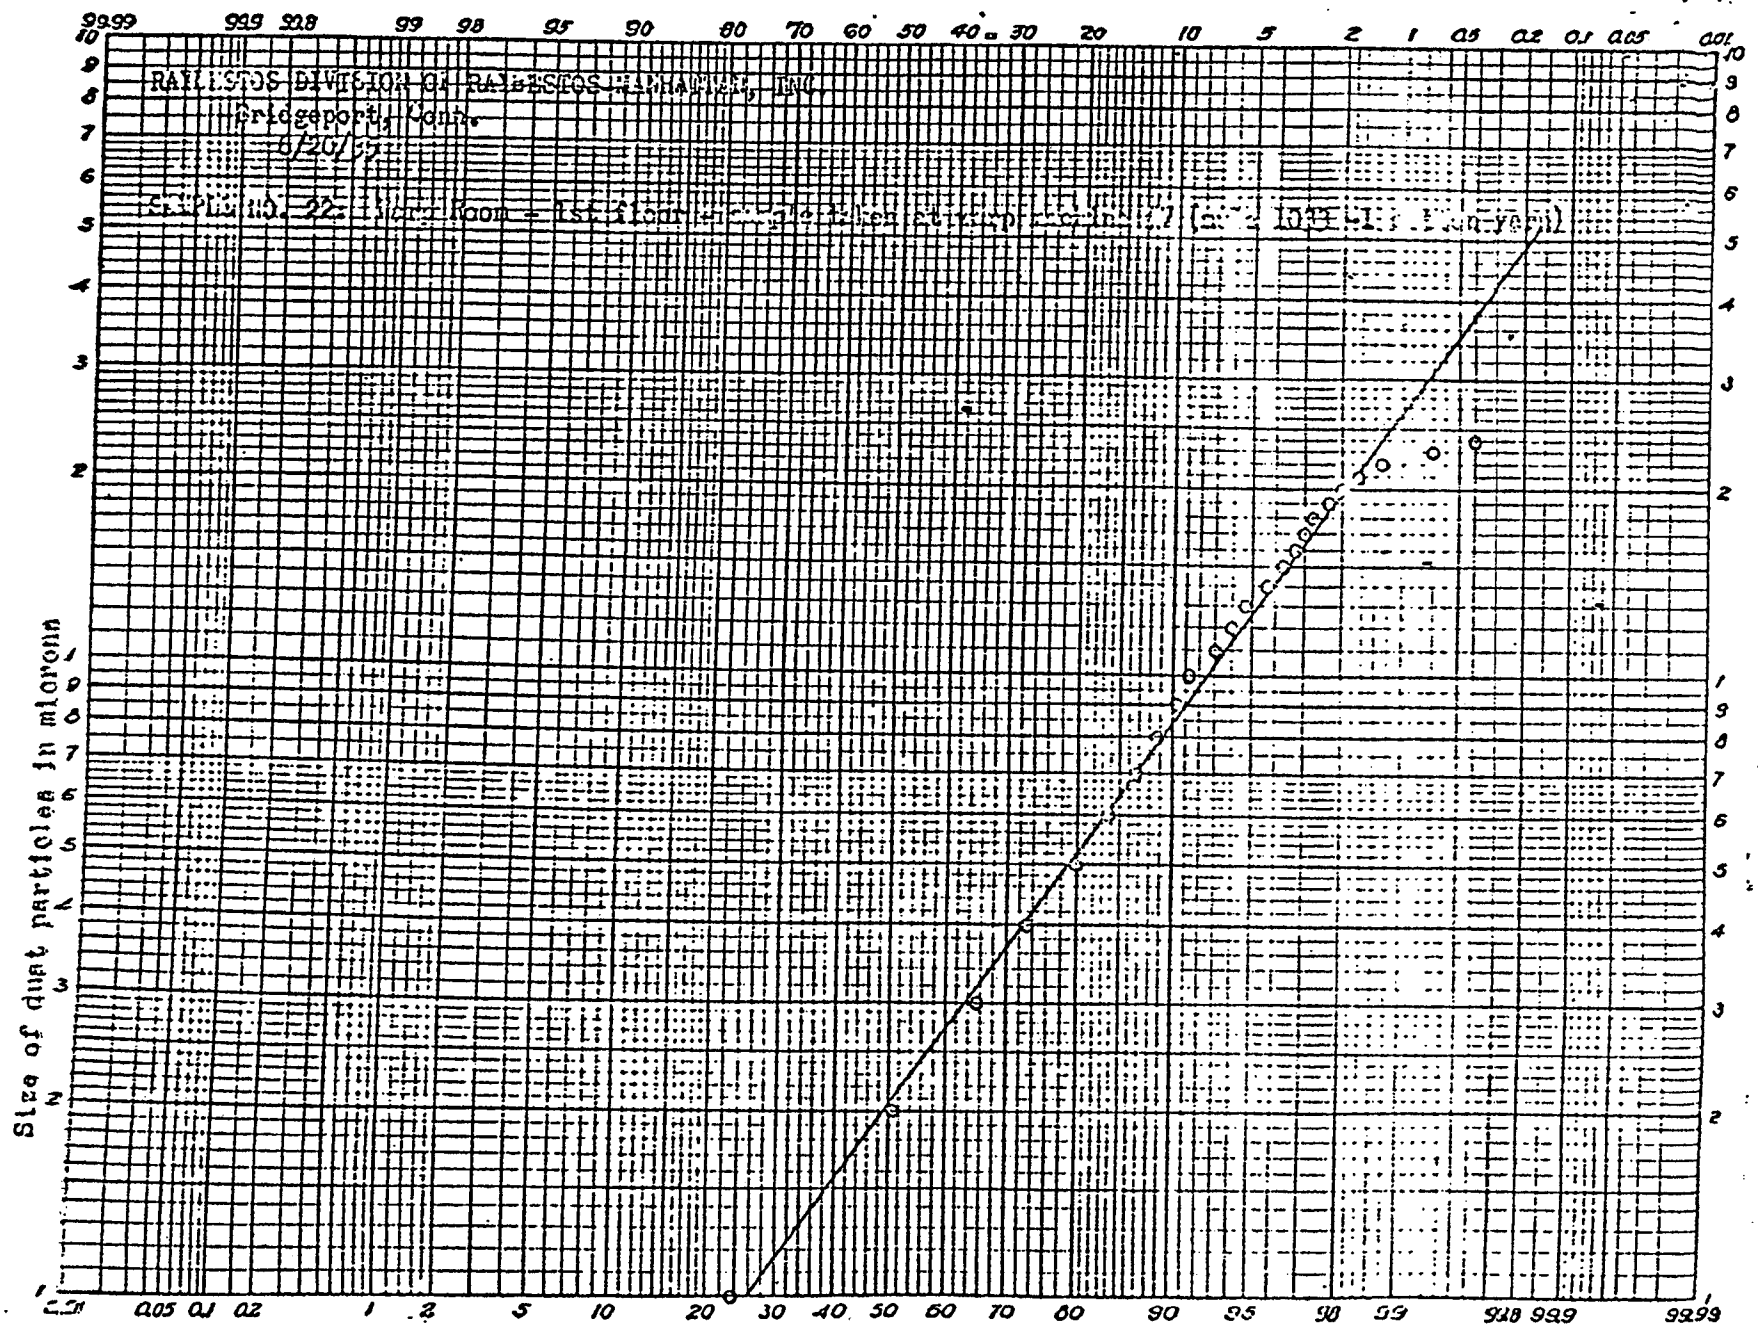
Comparative Data of 1930 Survey and 1935 Survey

Bridgeport Plant	Millions of Particles per cu. ft. of Air Sampled			
	1930		1935	
3rd floor				
Between looms #60 and 61	1,380,000	8	6,100,000	41
" " #70 and 71	1,000,000	6	5,500,000	33
Average of 3rd floor counts	1,950,000	14	5,700,000	35
2nd floor				
Average of 2nd floor counts	2,970,000	18	5,700,000	35
1st floor - warp room				
Average of counts	4,685,000	28	3,100,000	18

All of the dust counts in this plant show less than ten million particles per cubic foot of air sampled. While these counts are not considered as dangerous concentrations, they are much higher than on the previous survey made in 1930, with the exception of those in the warp room. All but four of the looms have been moved to different locations since the first survey. A check of the records would show a comparison of the type of yarn used and rate of production at the time of the two surveys.

Sample #15, taken at the inspection table on the second floor shows the highest count. The concentration at this point could be decreased materially by the proper exhaust equipment. The present system is not designed properly to take care of the dust generated.

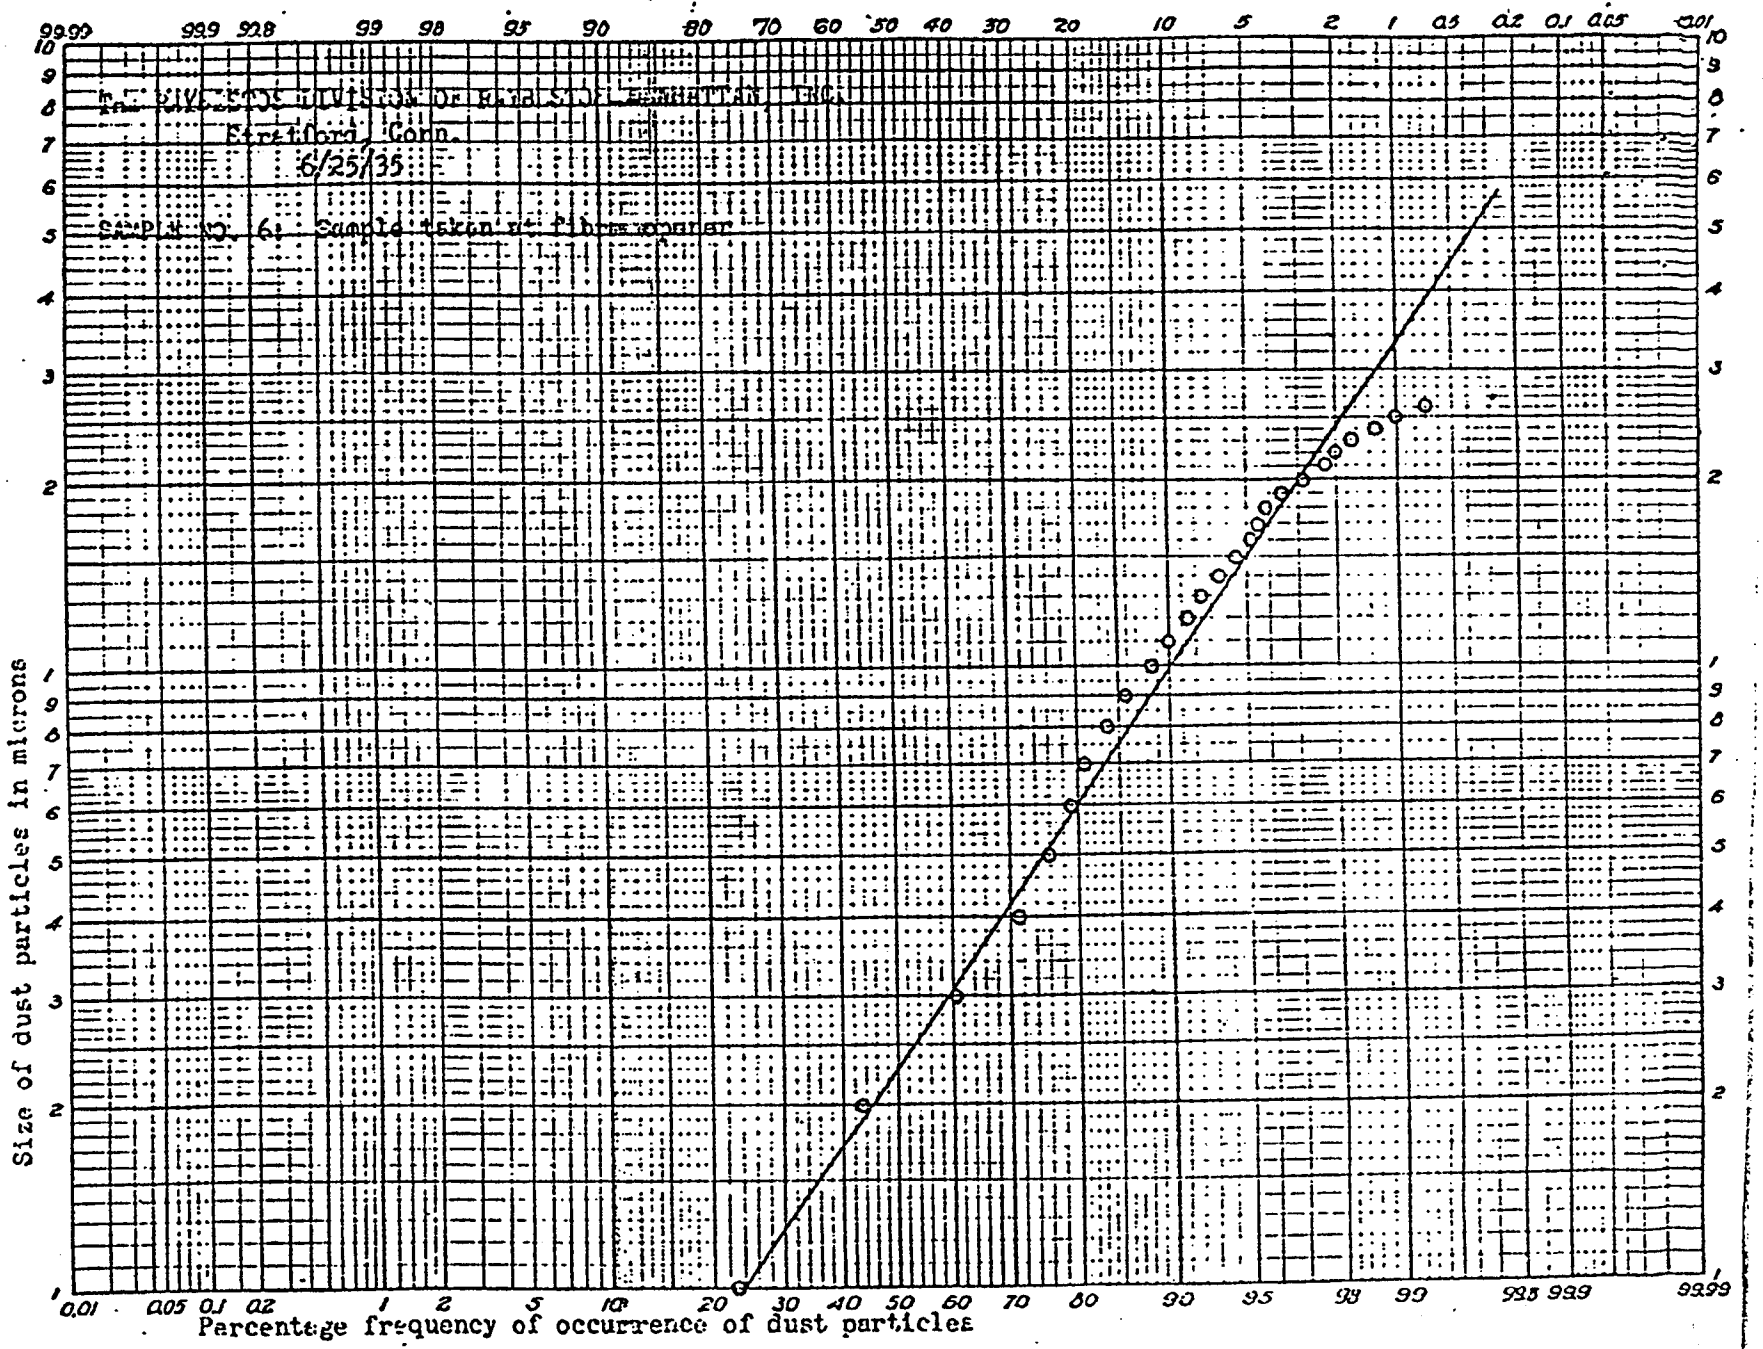
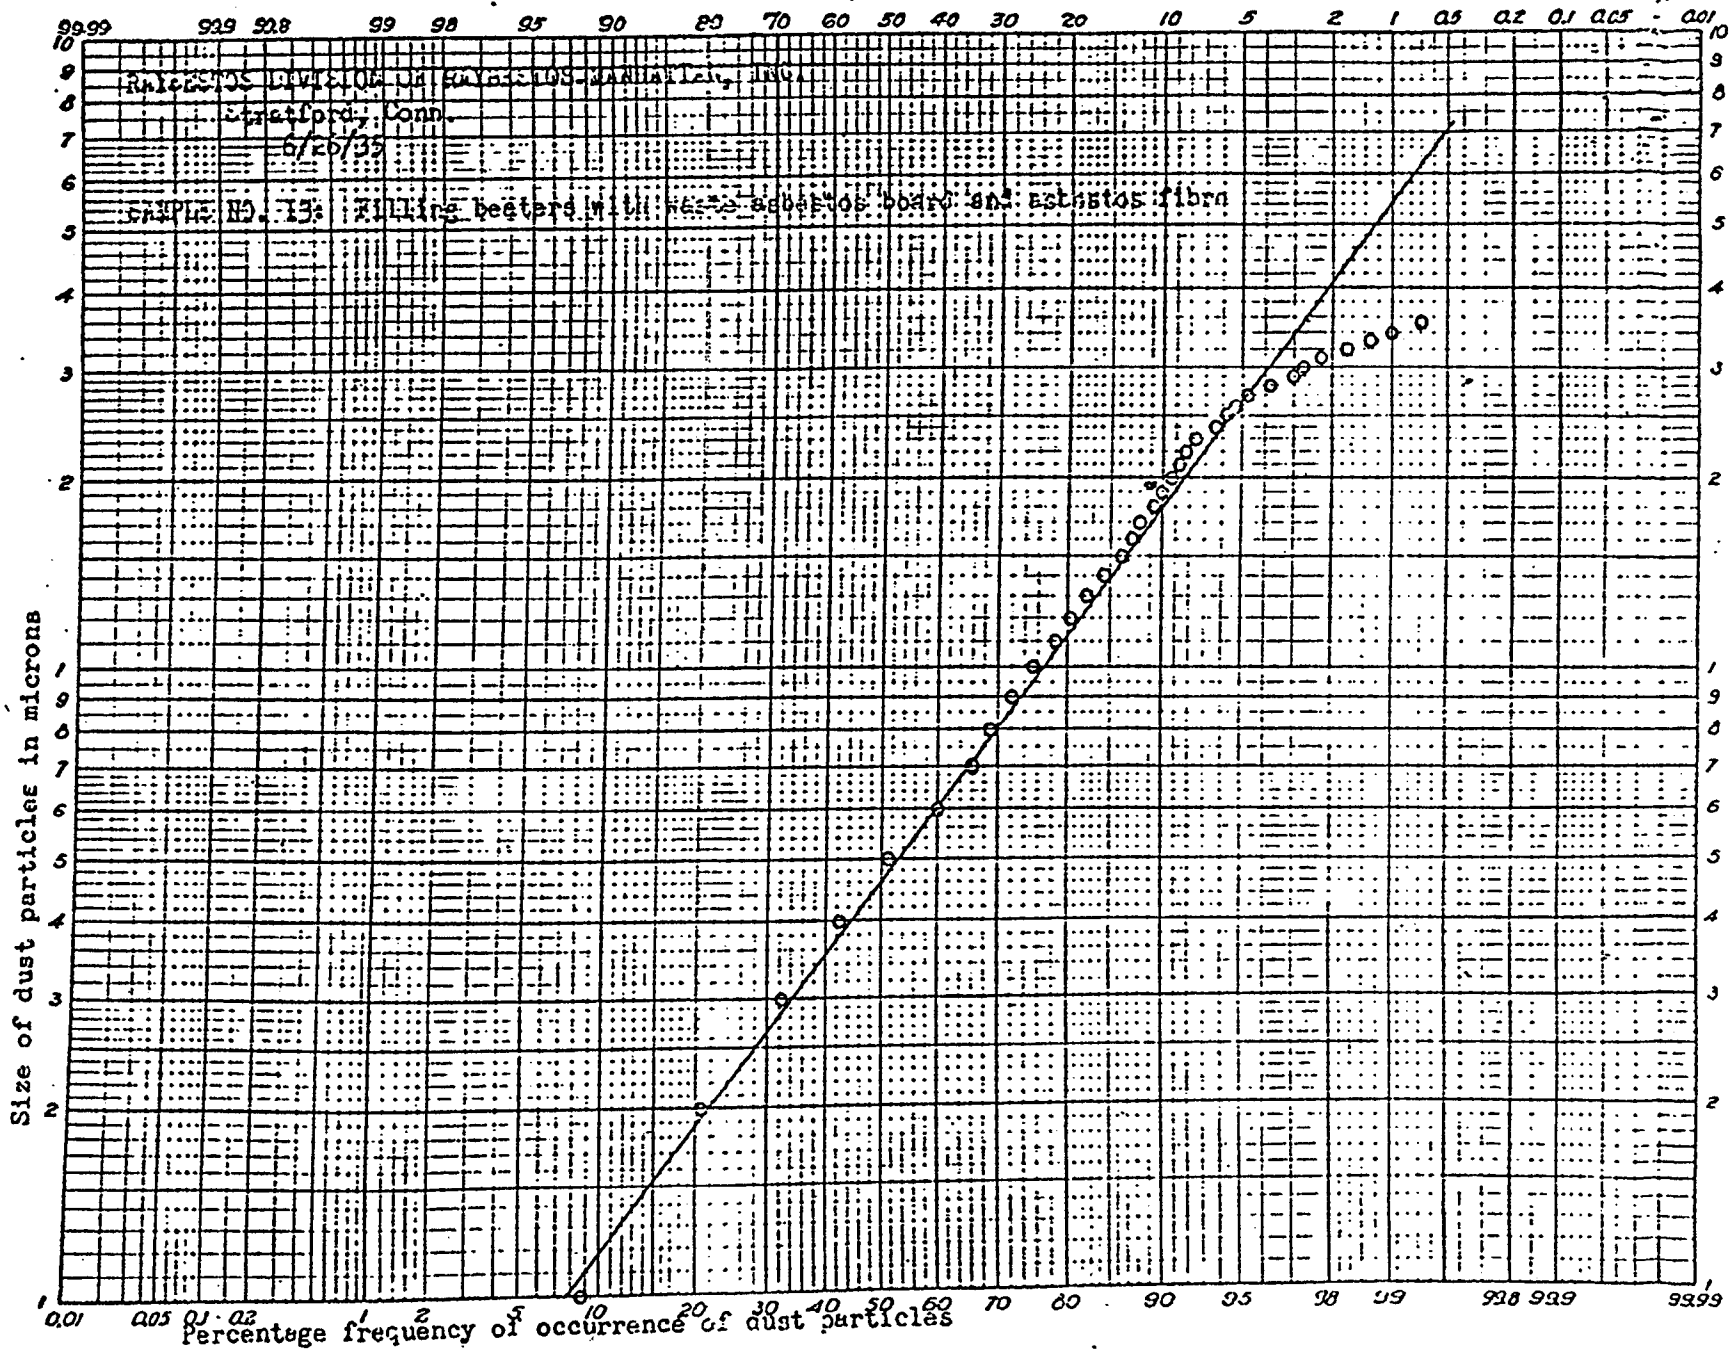
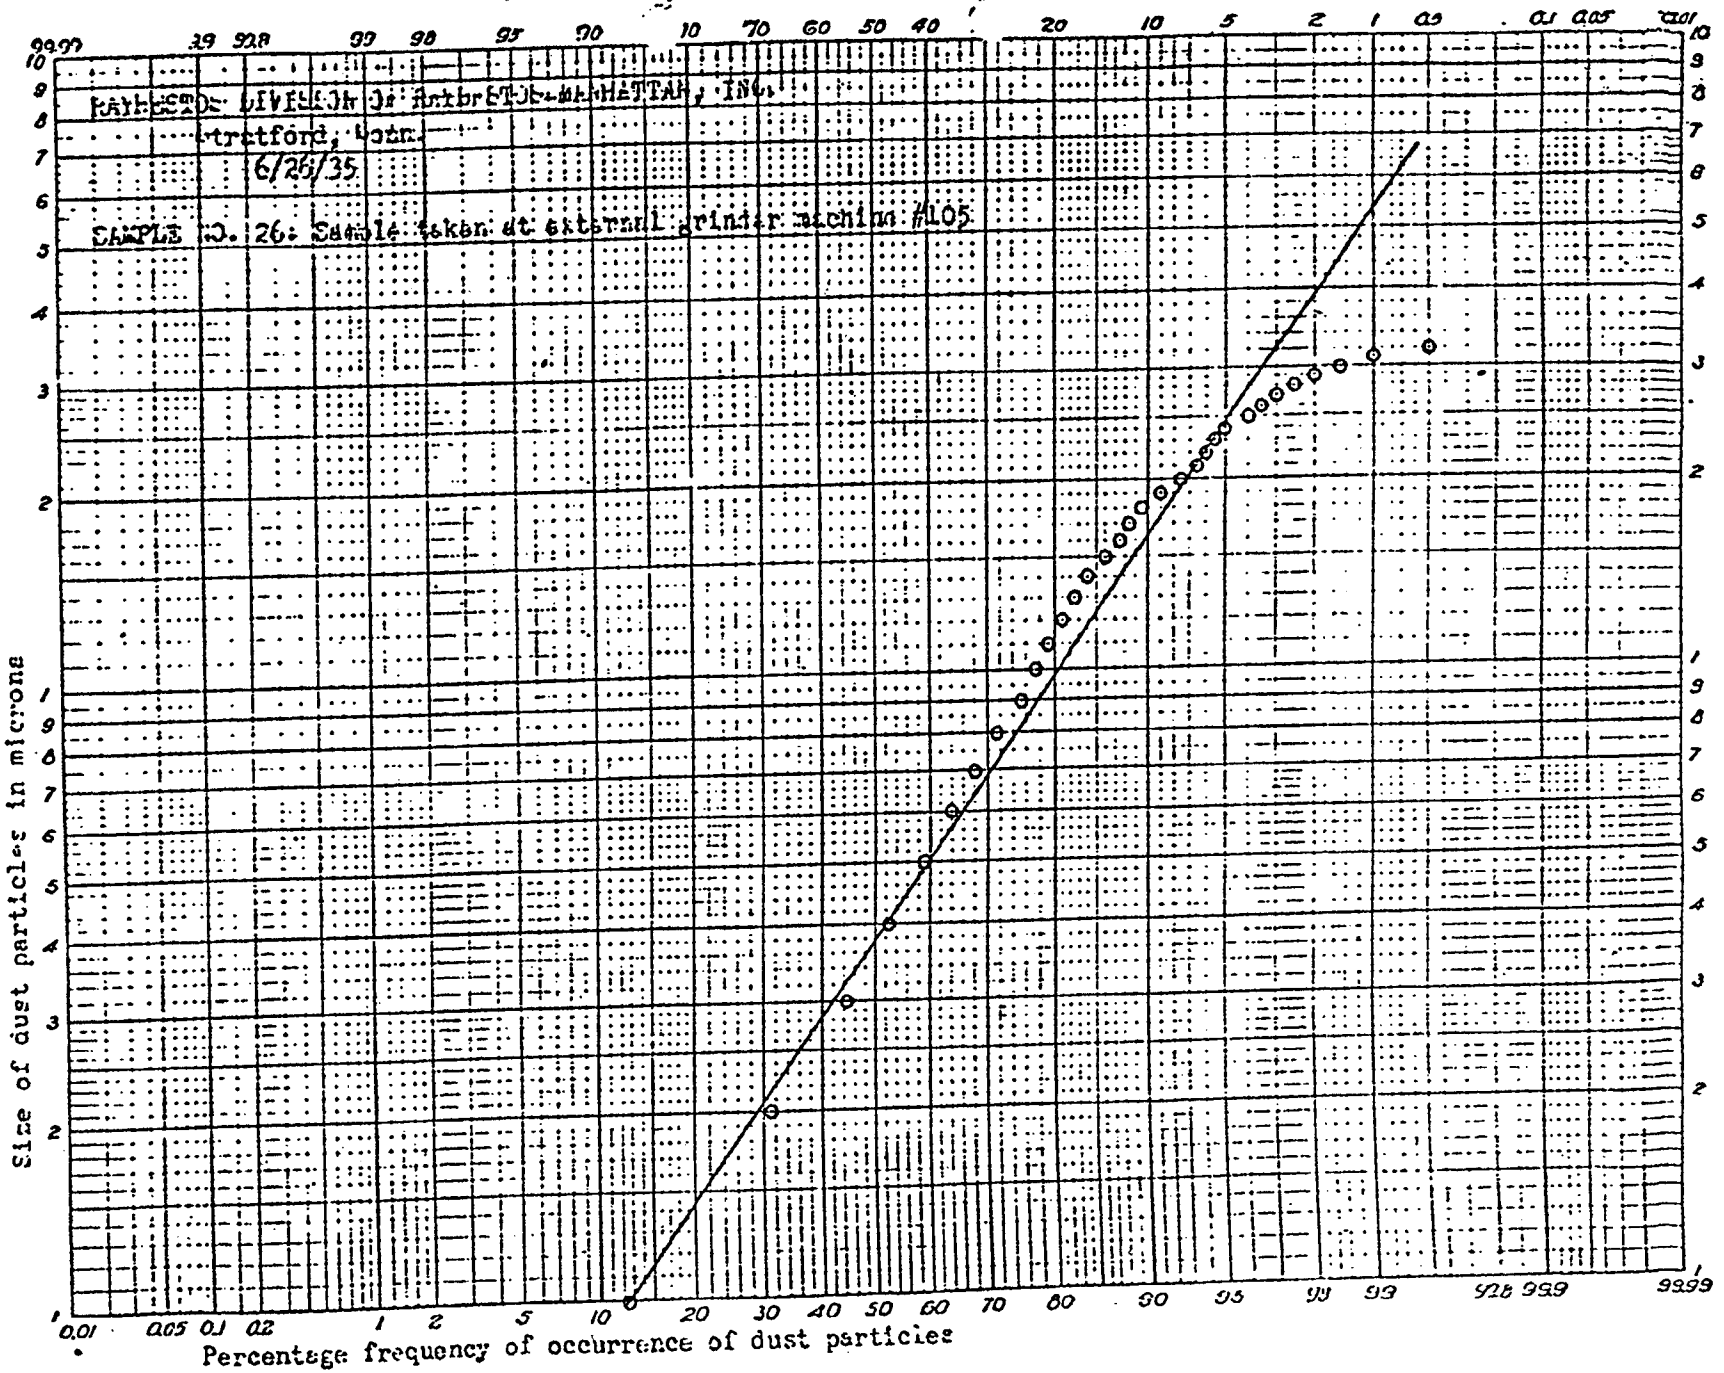
Comparative Data of 1930 Survey and 1935 Survey

1930	1935
Cincinati grinder	655,000	1,400,000
Filling beaters	529,000	1,400,000
