Gulf Science and Technology Company

FOLLOW-UP
INDUSTRIAL HYGIENE SURVEY
Of
CHINA GULF PLASTICS CORPORATION

October 1979

R. T. CHENG, PhD., P.E.
Regional Industrial Hygiene Director
Gulf Science & Technology Company

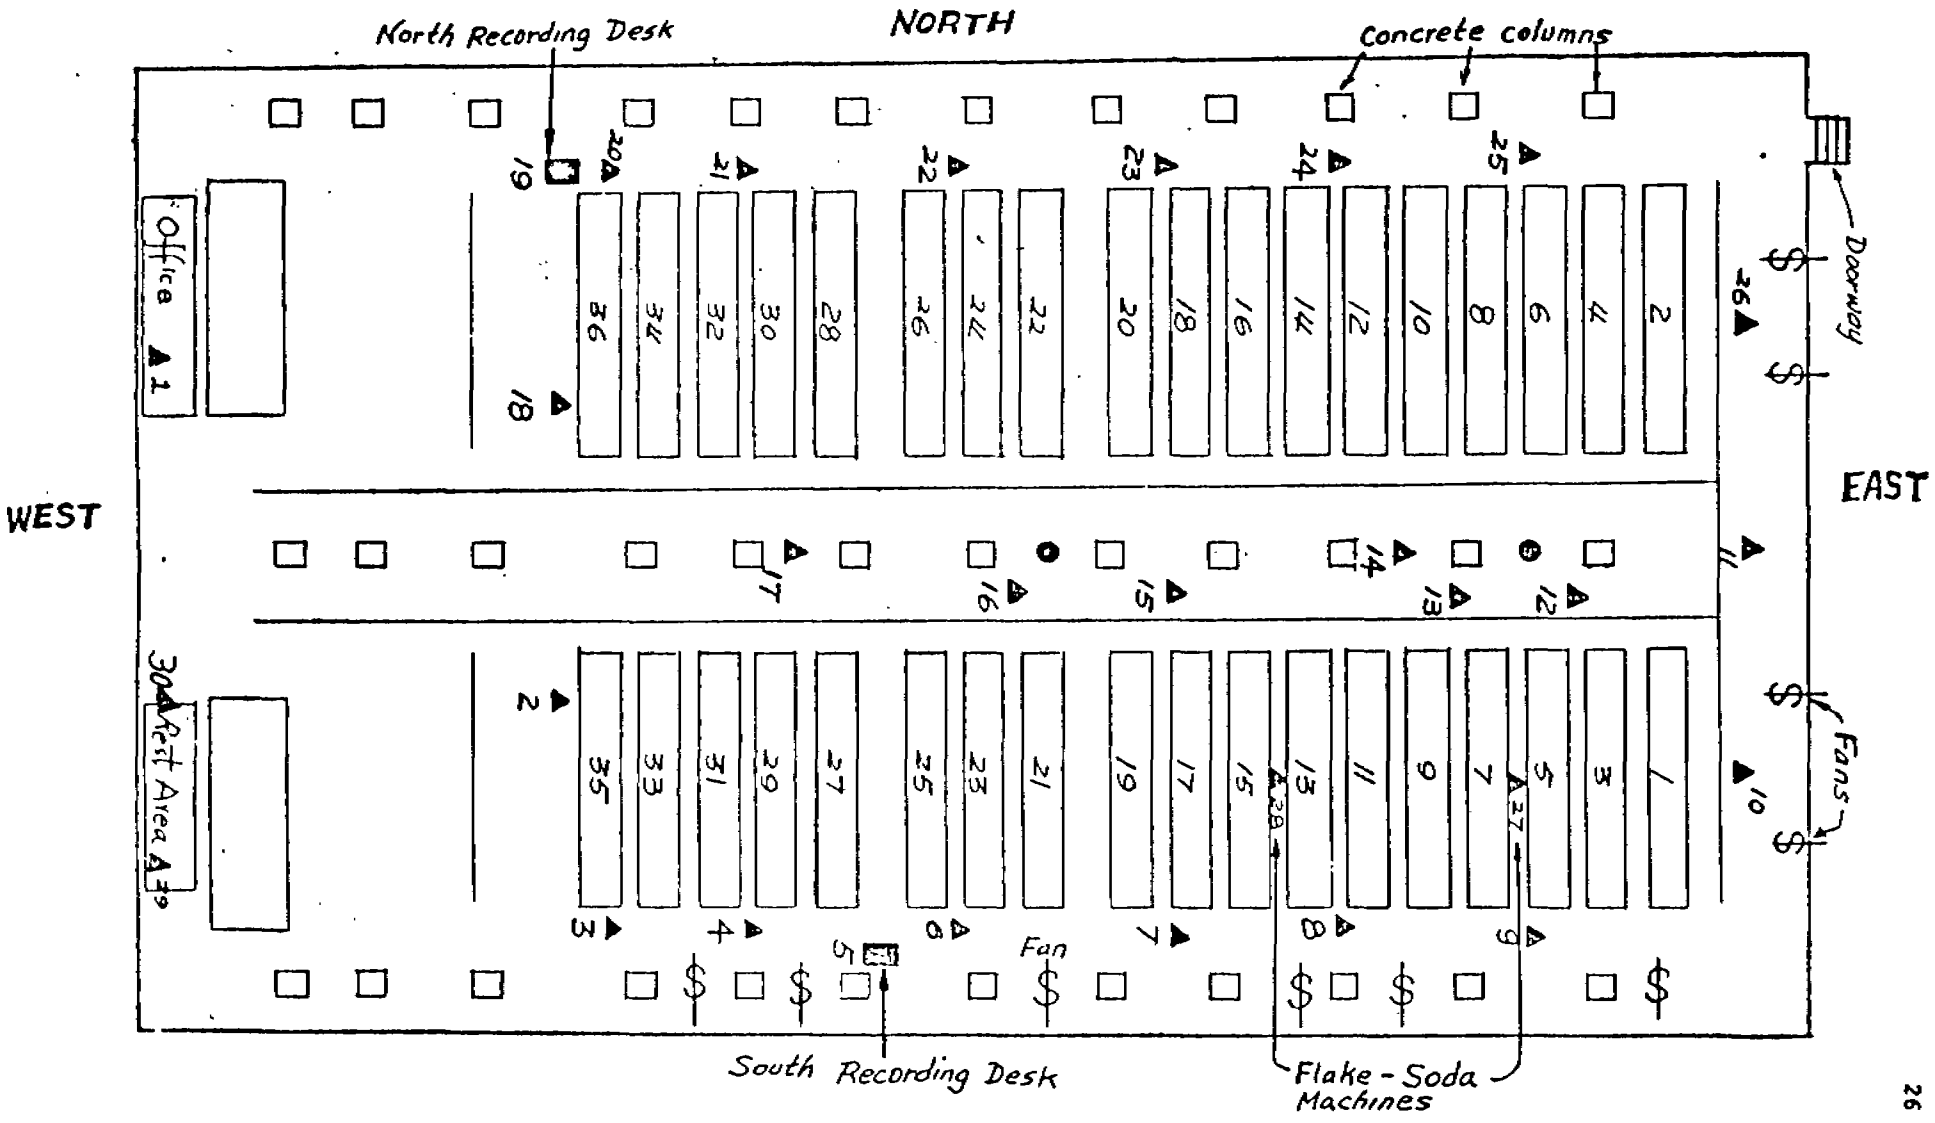
Figure 1 - Mercury Vapor Monitoring Points at Chlor-Alkali Plant

Several long-term personal air samples were collected from Chlor-Alkali Plant workers on October 17th and 18th, 1979, with Jerome Gold-Film Mercury Vapor dosimeters. The dosimeters were attached to the shirt collar of the workers so that the air samples represented breathing zone time-weighted average exposures. Table VII summarizes the survey results. Two workers were found to be overexposed to mercury vapor. One was the flake caustic soda machine operator, and the other was the mercury spills recovery man. Both of them spent lengthy working hours in the basement of the cell room where mercury vapor concentrations exceeded the TLV. Analyst Mr. Y. S. Chang's exposure of 0.047 $^{mg}/_{m^3}$ was somewhat higher than expected. He might have worked very closely at the opened end-boxes of the mercury cells, or he might have spent some time in the basement.

The working conditions in the basement have not been improved appreciably since 1974. The excessive mercury concentrations were due to leaks and spills of mercury from the cell room above. The air in the basement was hot and humid due to poor air circulation. It is recommended again that the caustic soda manufacturing operation be moved out of the basement.

Further reduction of workplace mercury vapor concentrations can be achieved by utilizing the wall-mount exhaust fans. Move the fans to the southeast corner of the east wall would be most beneficial since air circulation there was inadequate.

For temporary, short-duration exposures to high mercury vapor concentrations such as during mercury recovery, cell maintenance, or for caustic soda machine operator, it is suggested that mercury vapor respirators be worn by the workers. Substantial protection can be provided by disposable 3M Brand Mercury Vapor Respirator #8707.
