DOCUMENT DESCRIPTION: Internal Report - Union Carbide - Airborne Fiber Counts in a Consumer Spackling and Drywall Replacement Installation Project

AIRBORNE FIBER COUNTS

A CONSUMER SPACKLING

DRYWALL REPLACEMENT INSTALLATION PROJECT

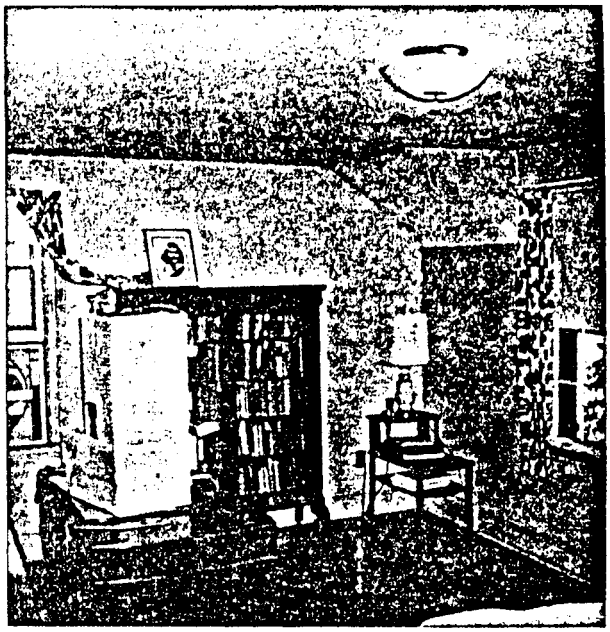
2 (a) Sample location for spackling operation.

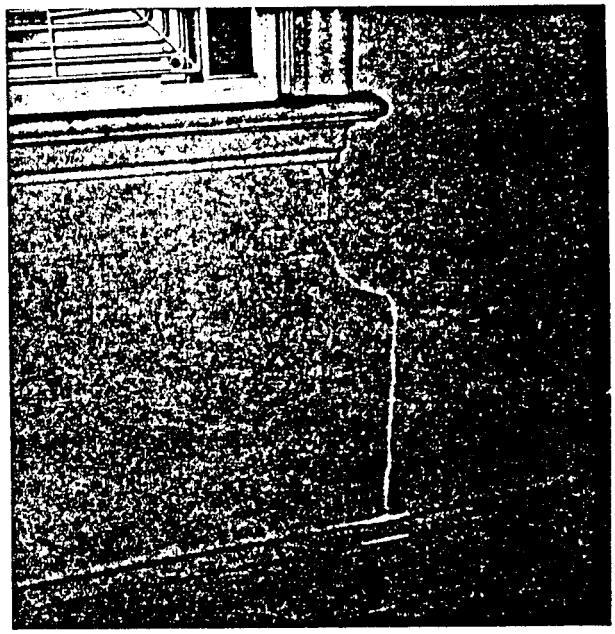
Spackling: The preparation for this operation is illustrated in Figures 2 (a) and (b). The room, ~11' x 18', had three cracks about 18' long running from the lower corners of two windows to the baseboard. Shifting of an entire ceiling section had left a large crack ~3' long in the ceiling below the corner. There were also about 6' of smaller cracks adjacent to this plus an area about 8" x 8" that needed to be filled in to a depth of about 1/8" to conform to the ceiling contours.

2 (b) Wall crack ready for application of spackling compound.

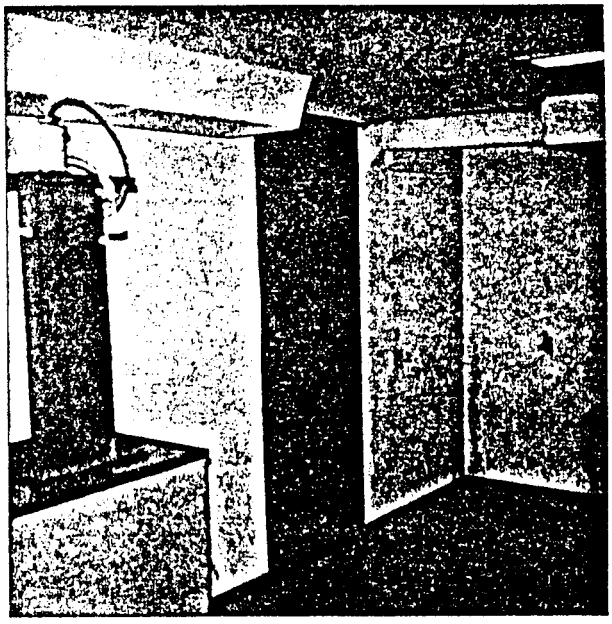
Drywall Removal and Replacement: The drywall replacement involved one wall, ~11' long, of a cellar recreation room. The old drywall was first torn out as illustrated in Figure 2 (d). This was accomplished by breaking enough of the board with a hammer to allow access with a pry bar. It was observed during the operation that the tape adhered strongly to the boards and could be pulled off in long sections. There was little or no observed tendency for the joint material to come off the board or powder. The large pieces of drywall were carried outside. The smaller pieces and other dust and debris were swept up with a pan and brush and deposited in the trash barrel shown.

2 (c) Sample location for drywall replacement.

2 (d) Removal of old drywall.

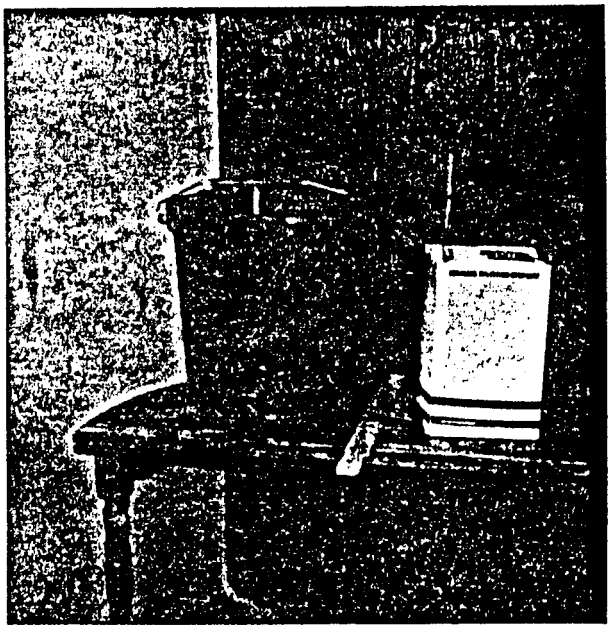
3 (a) Tape-joint compound used.

3 (b) Wet-out of compound.

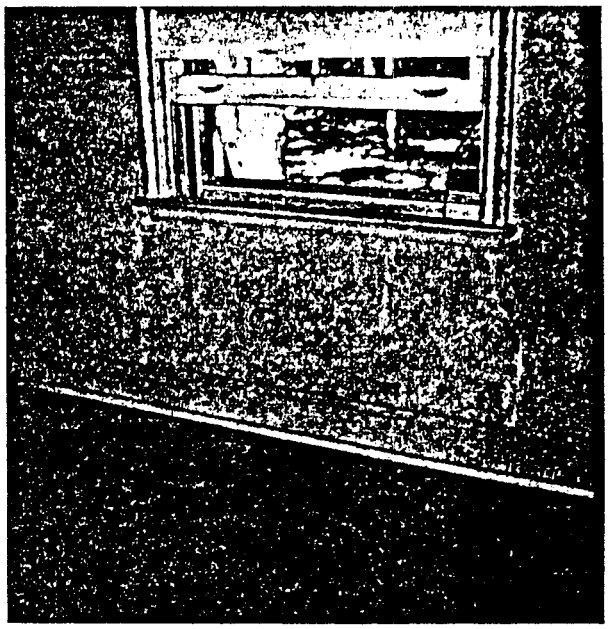
4 (a) Finished wall crack.

4 (b) Finished wall cracks.
