VISIT REPORT

HAINAUT-SAMBRE
6090 Couillet
Belgium.

STATEMENT TO RESPOND TO PRESS OR OTHER EXTERNAL INQUIRIES CONCERNING PCB SPILLAGE INTO A CANAL ENTERING THE RIVER SAMBRE

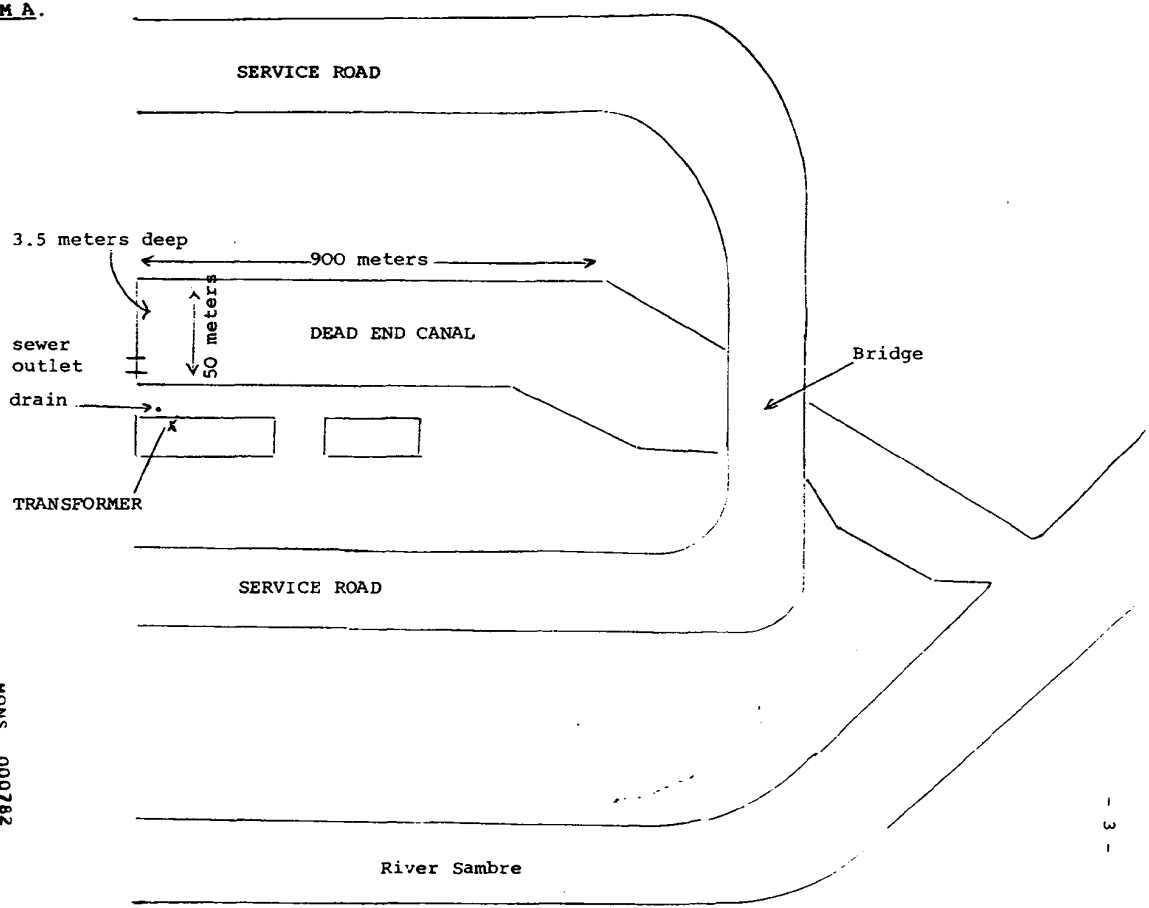
DIAGRAM A.

The transformer exploded on April 22, 77 and was split open vertically splashing fluid on walls. 2000 liters of the estimated 2600 litres content of the transformer found its way into the drain and subsequently into the dead end canal alongside.

Dr. Mullier now took us to visit the canal site (see diagram A). Also present were Mr. Caulier and Mr. Nicholas. We advised Dr. Mullier to have all sand, rags, earth, etc. contaminated with PCB to be collected in drums for disposal in the approved manner. We also suggested to Dr. Mullier that Monsanto would be willing to test water samples collected by ACEC to determine PCB content.
