ALCOA INDUSTRIAL HYGIENE SAMPLING DATA SHEET

Date 1 May 1989 | Plant Code Pgh, 2 Allegheny Center

Monitoring For asbestos | Sampled By L.L. Rippey | Analytical Lab EHL

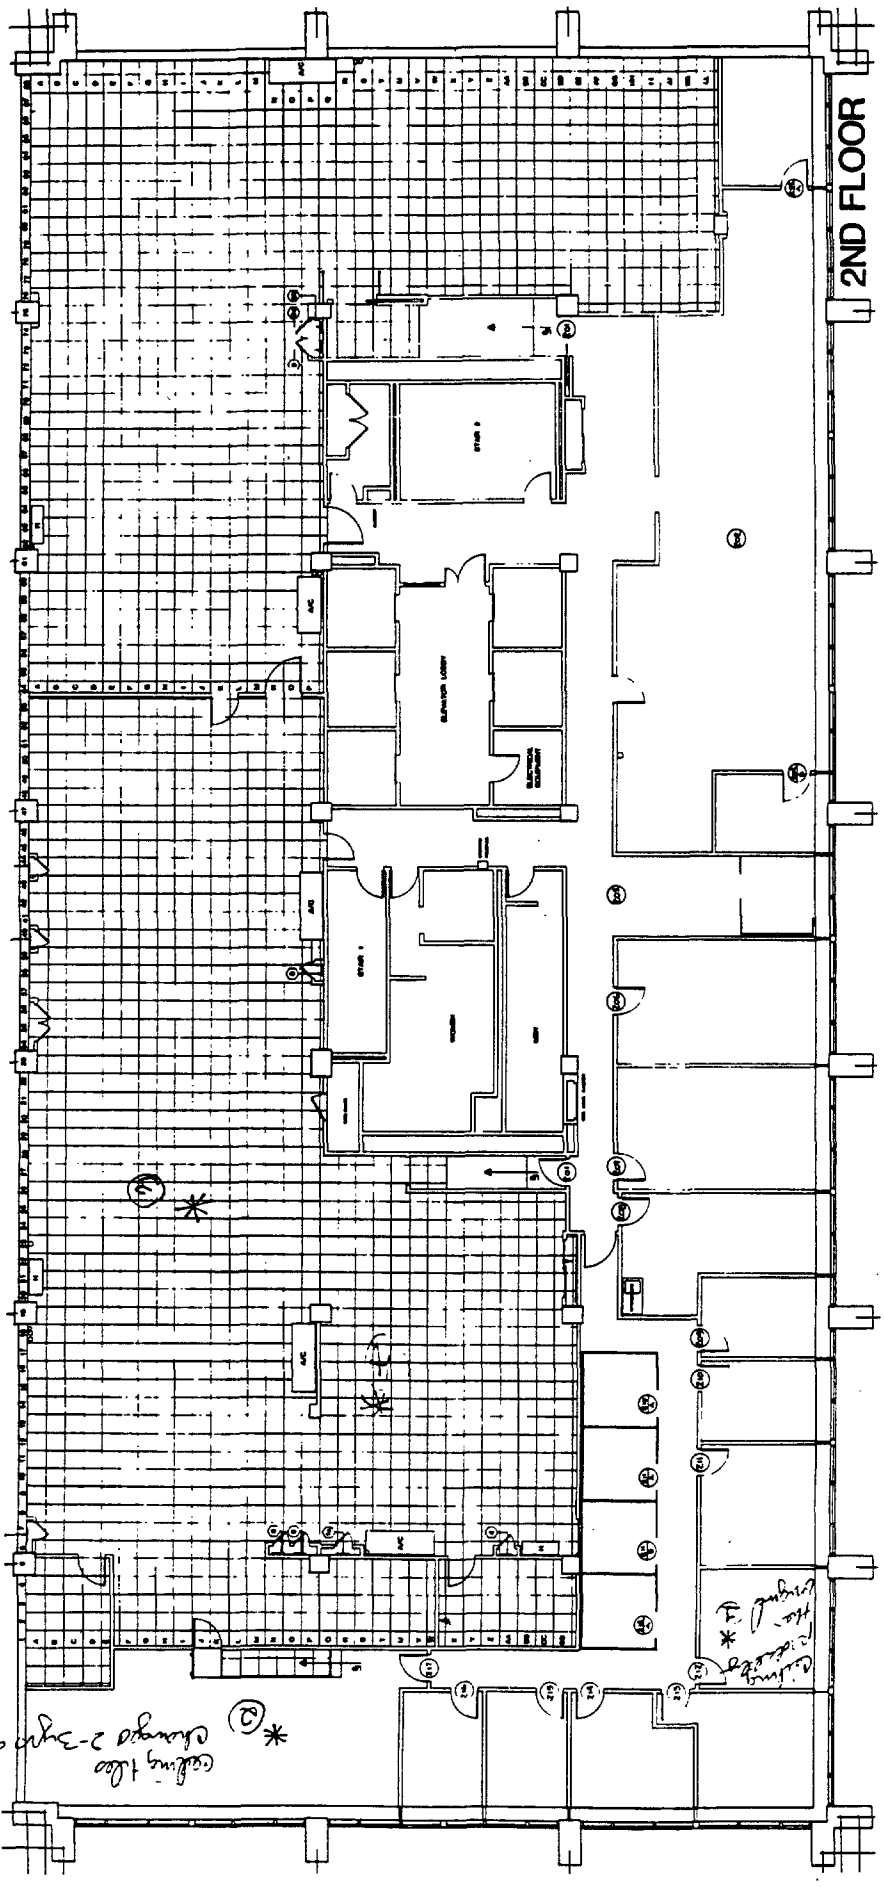
2ND FLOOR

Sample No.	Tasks:	Comments:
(1)	Settled dust Room 212 above dropped ceiling	– area undisturbed, original ceiling
(2)	" " Room 217 " "	" " " "
(3)	" " Room 201 " "	by return air duct
(4)	" " Room 201 " "	" in vicinity of insulated pipes, recent work performed on chilled water pipes

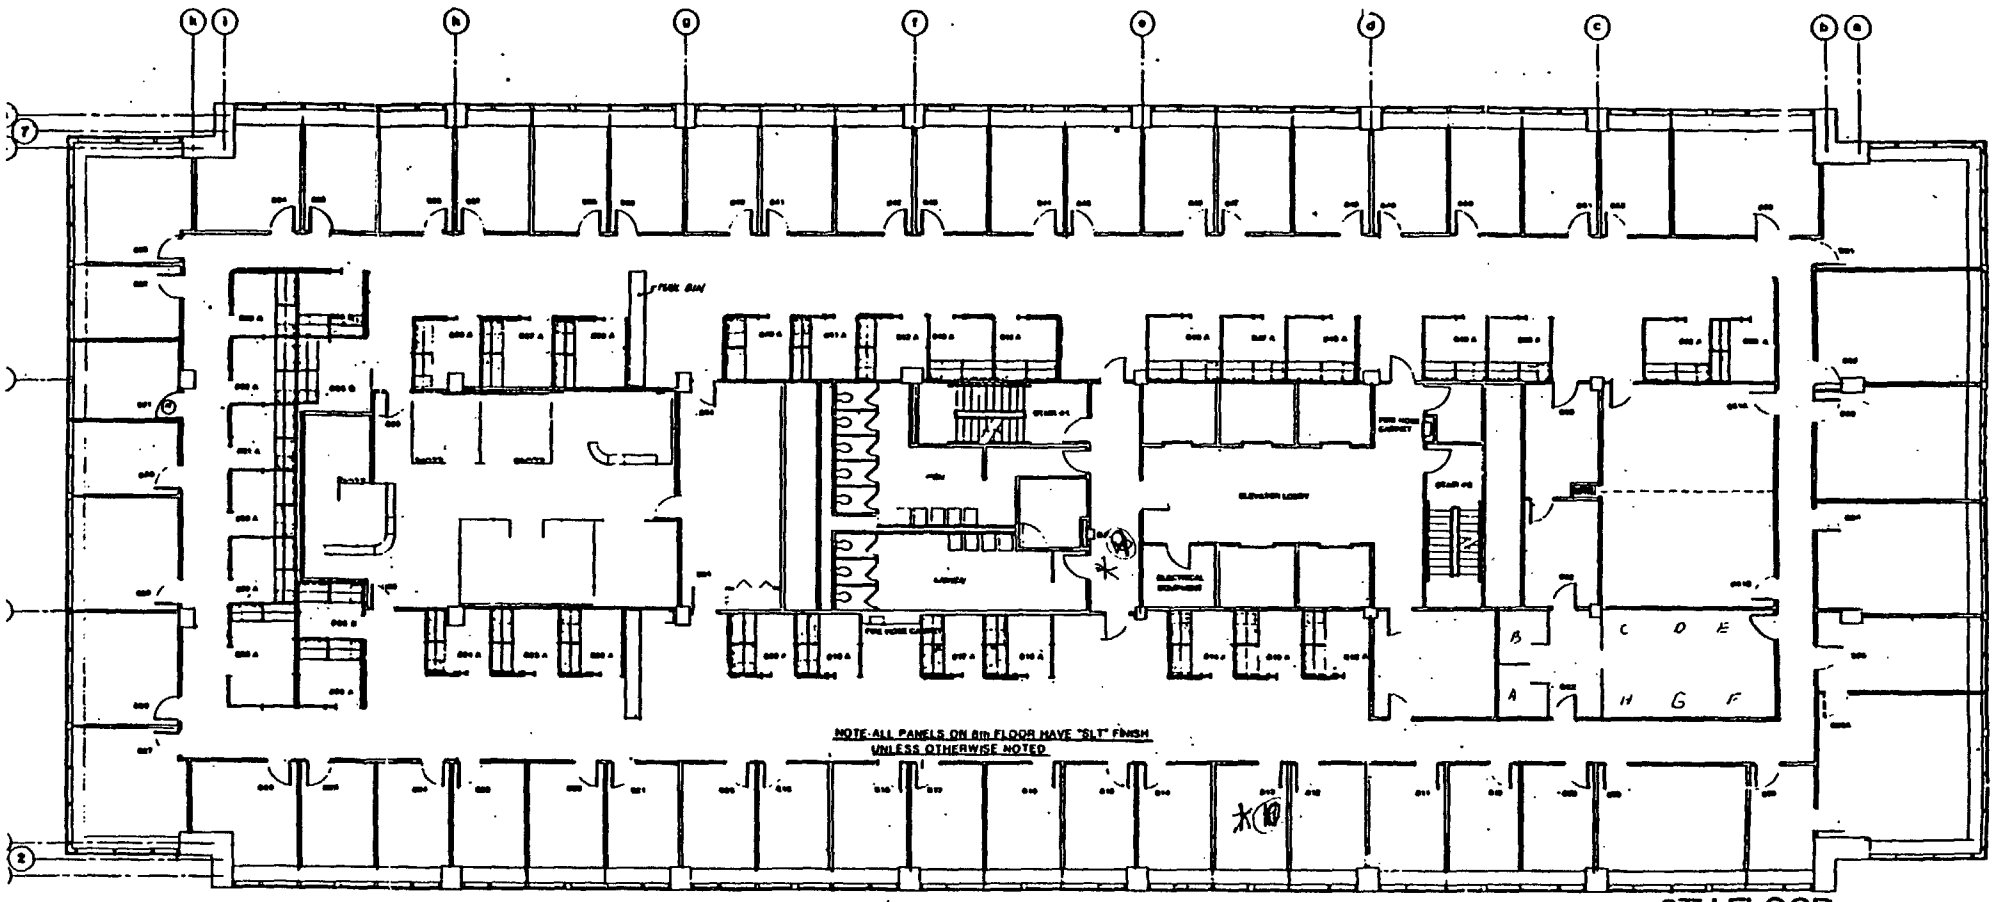
8TH FLOOR

8th floor hallway
Room 813 undisturbed area
12th floor hallway
outside room 1255 where hole was ~~drilled~~ cut through asbestos coated decking for installation of electrical box

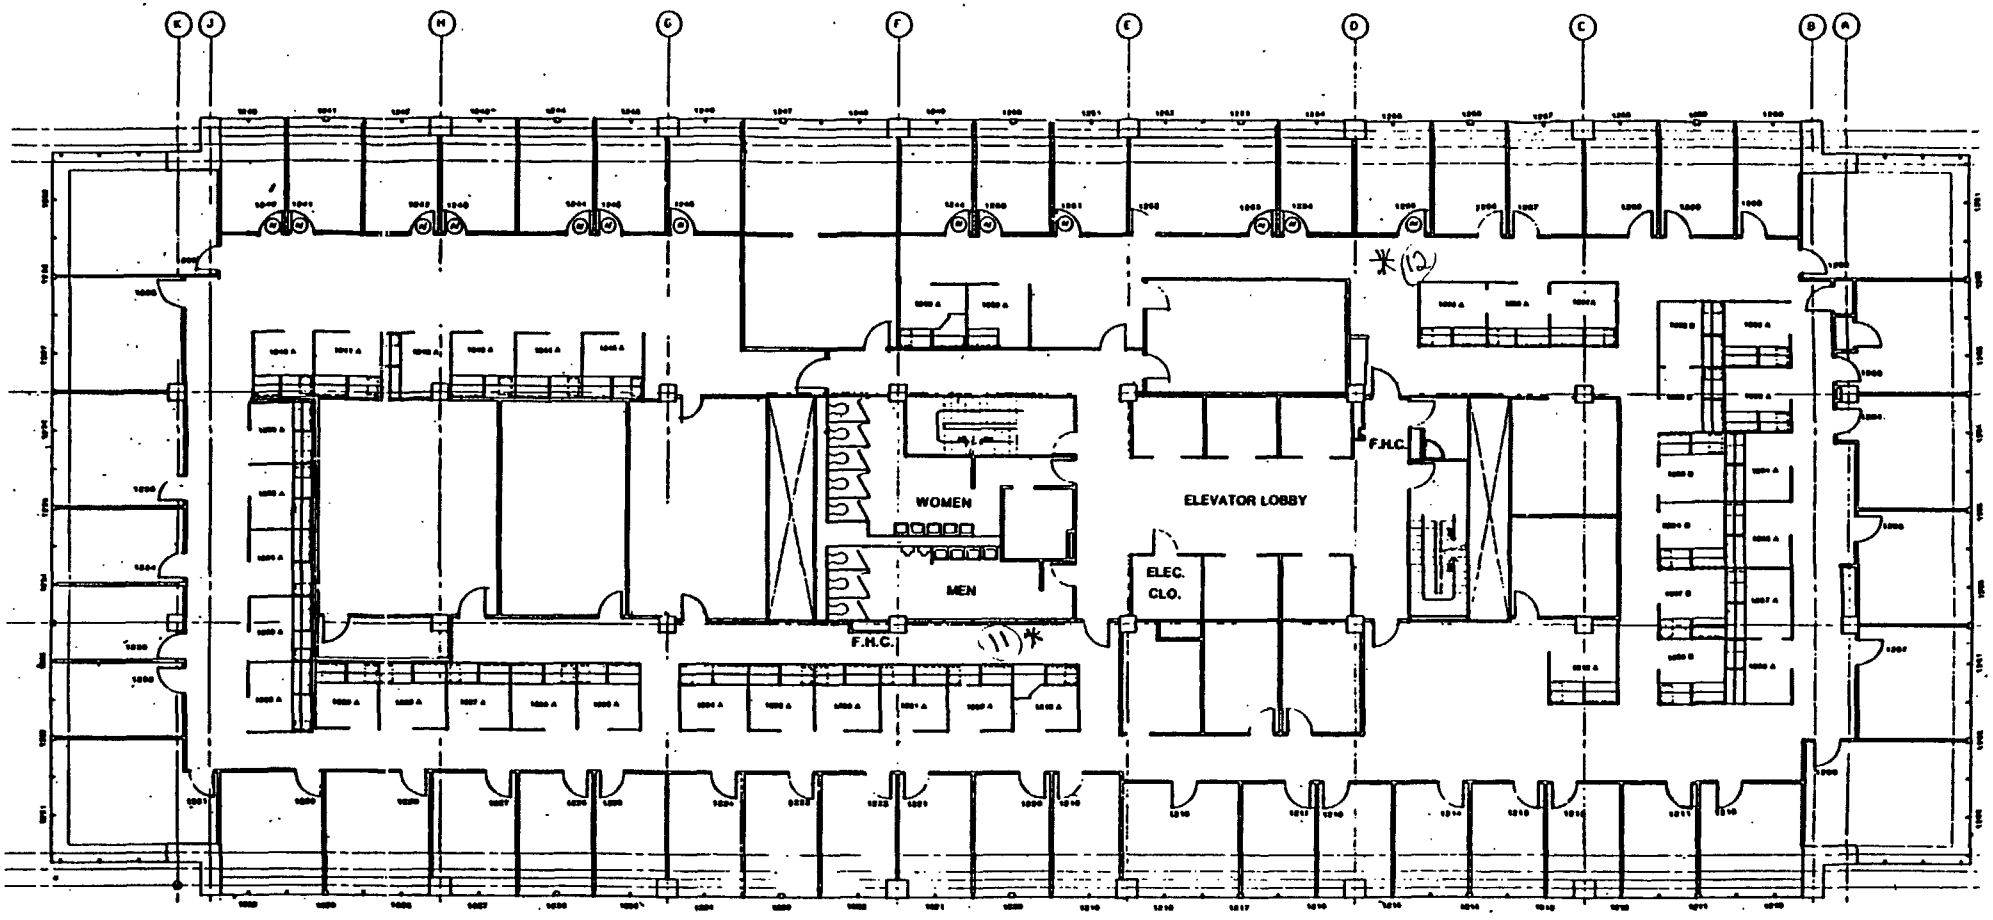
12th FLOOF

Asbestos insulated pipes
Sprayed on material on decking, I beams, jr beams

disturbances noted include:

- installation of clips to suspend heavy wiring from I beams in above dropped ceiling space
- drilling through decking to install electrical box
- installation of fire wall that intersected with decking of floor above
- material above suspended ceiling in areas where has ~~to~~ been disturbed is laying in small pieces on top of tiles.
- HVAC appears to be within ducts rather than be insulated in area above ceiling however this is inconsistent with info. from Schneider Engineers Allegheny Cty. Asbestos assessment report
