Subject Insulation Block Dust Survey
Construction Insulation Shop
Plant 511

INDUSTRIAL HYGIENE SURVEY

Construction Insulation Shop - Building 511-2018

Report 63-IH-3-G-1

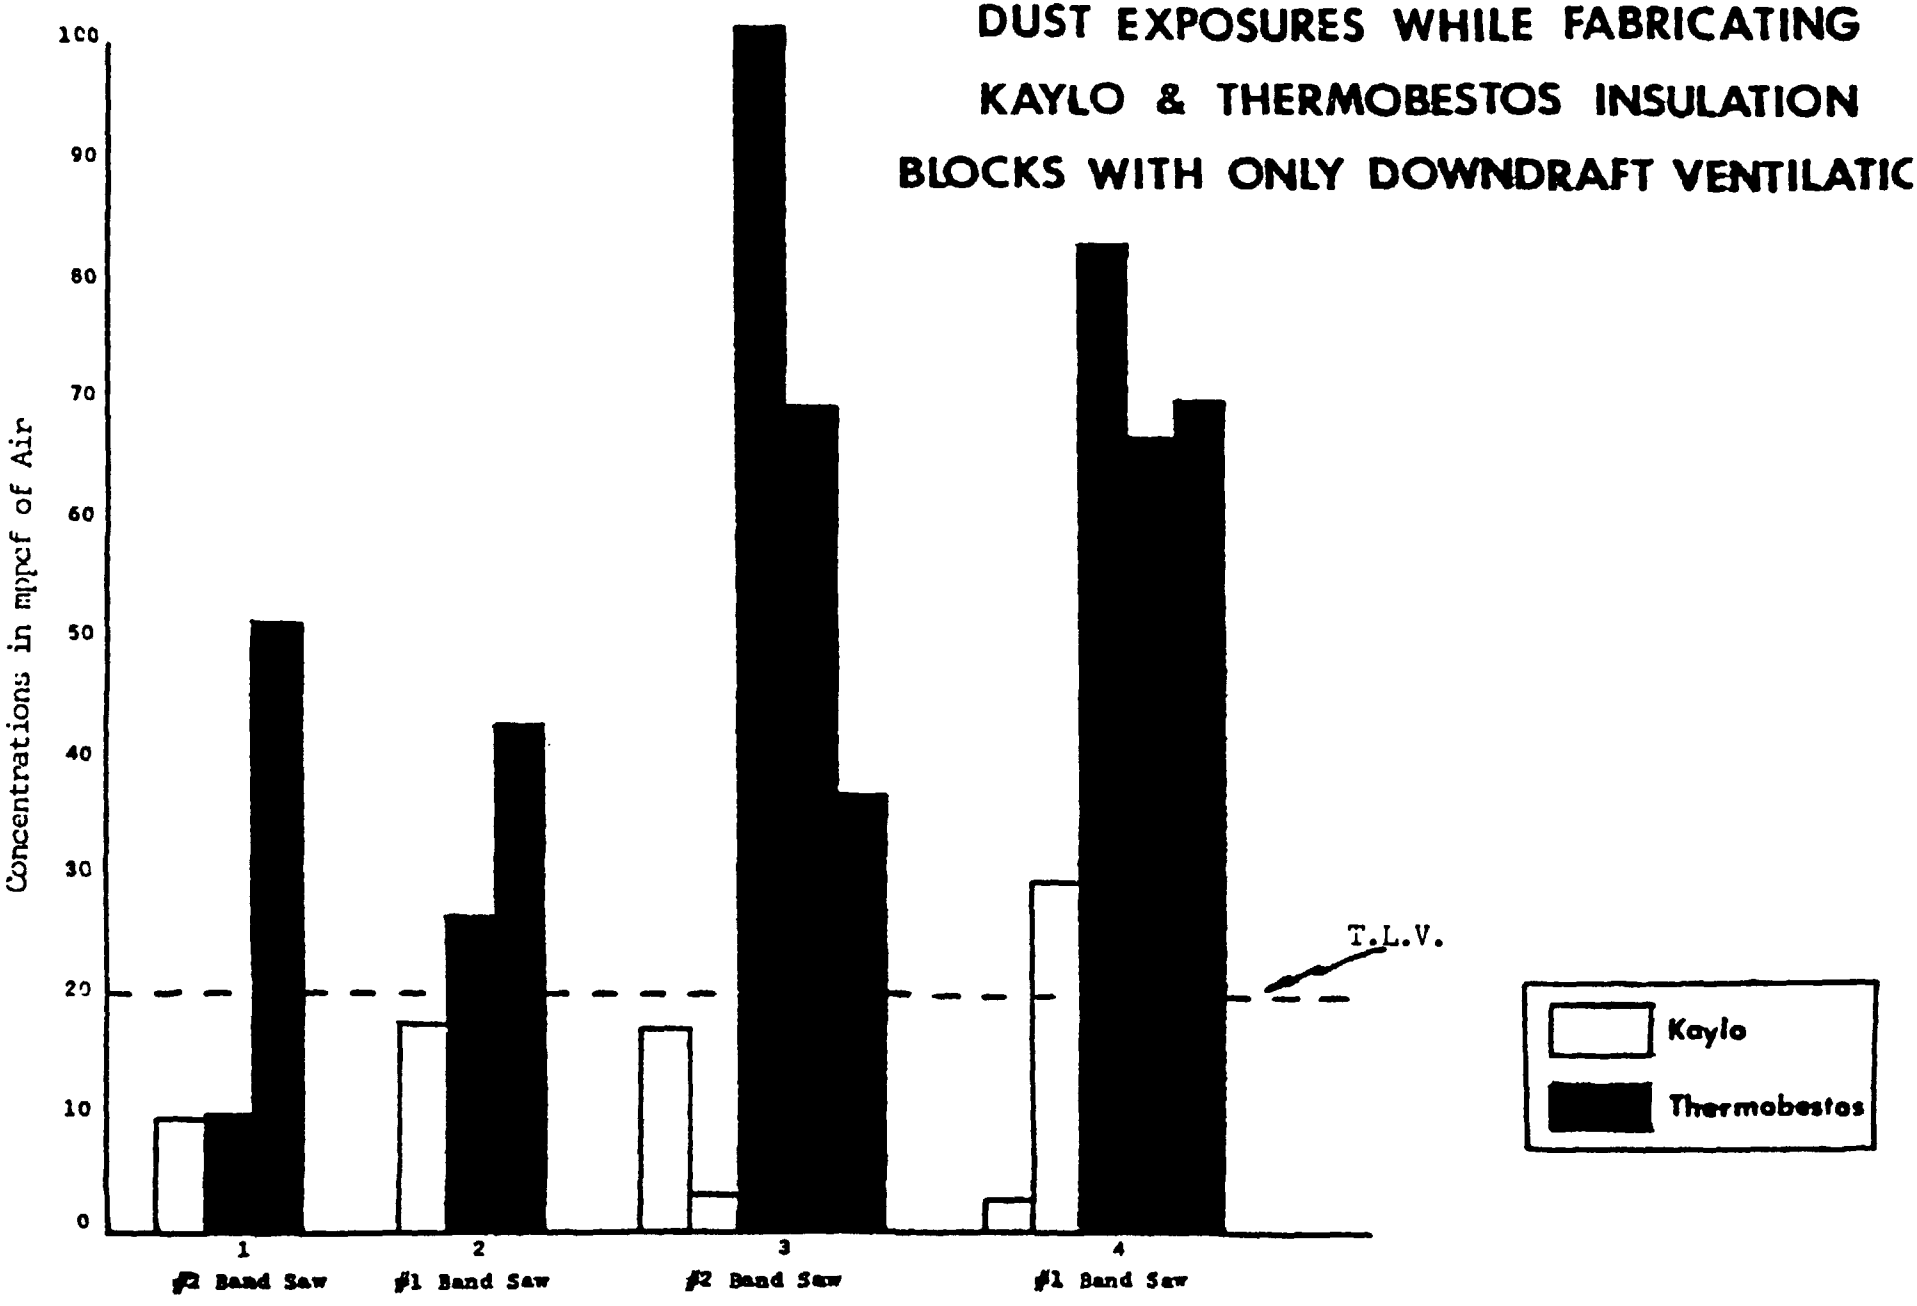
GRAPH NO. 1

1. "Thermobestos" insulation blocks should not be fabricated when using only the original downdraft exhaust ventilation.

2. "Kaylo" insulation blocks could be fabricated safely when using only the original downdraft exhaust ventilation if existing leaks, observed on the #1 band saw, are corrected.

3. "Kaylo" insulation blocks definitely may be safely fabricated when using the entire exhaust ventilation facilities now available, i.e., hoods above the blocks as well as below.

DUST EXPOSURES WHILE FABRICATING KAYLO & THERMOBESTOS INSULATION BLOCKS WITH ONLY DOWNDRAFT VENTILATIC

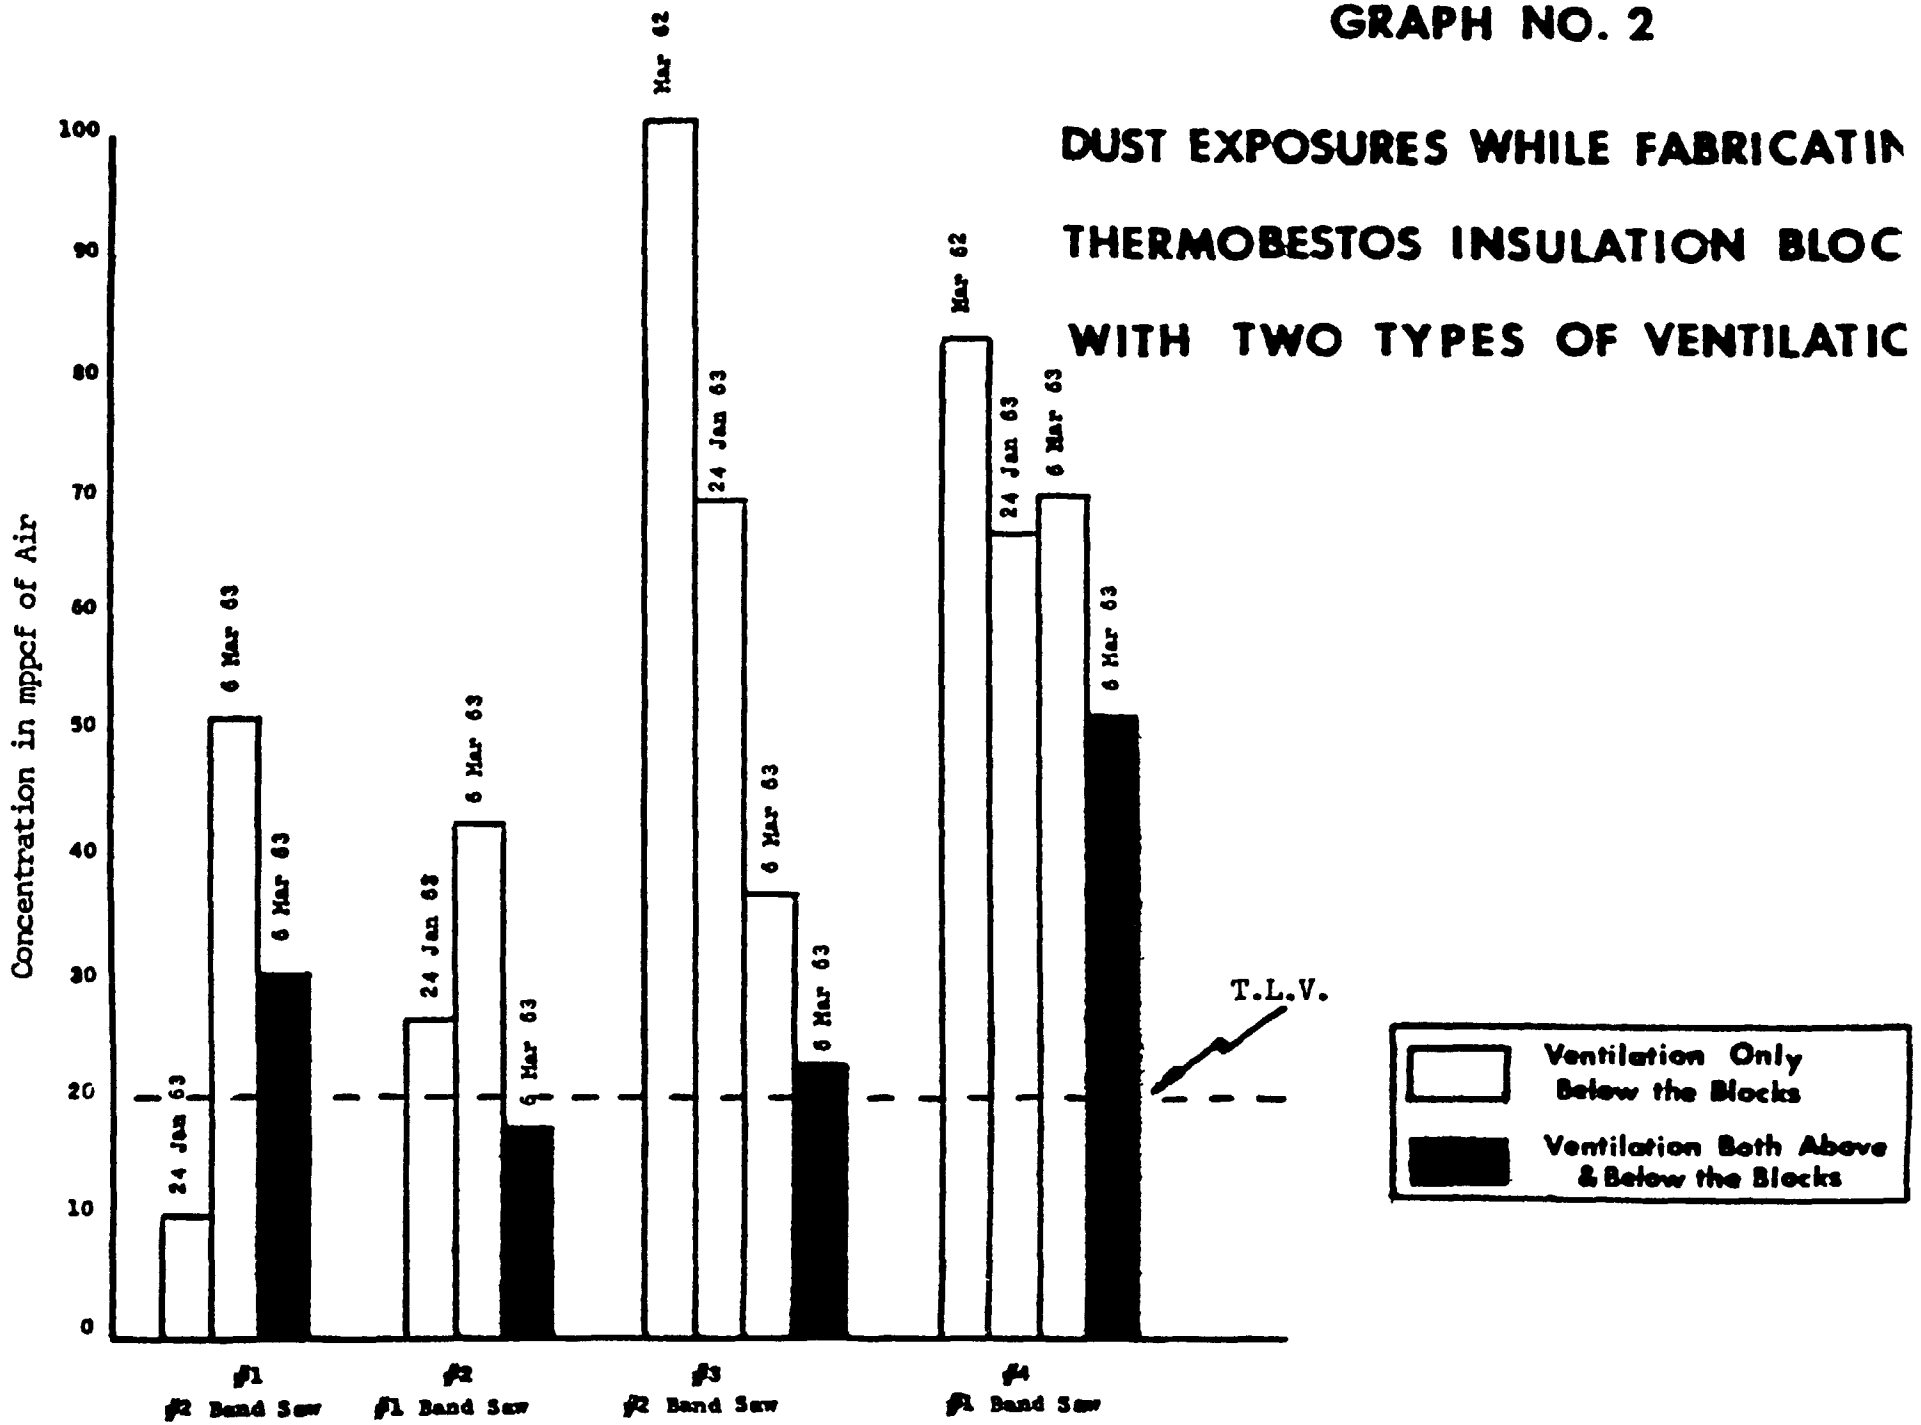
GRAPH NO. 2

1. Methods of handling "Thermobestos" blocks (preparatory to sawing) and scraps (after sawing) contribute greatly to specific individual exposures as demonstrated by the following facts:

a. The fabrication process, which always begins at the #2 band saw with the simple cutting of each 18" x 36" x 4" block into three smaller blocks about 18" x 12" x 4", is normally the least dusty of all the fabrication operations as revealed by the samples taken on 24 Jan 1963

b. However, on 6 Mar 1963, this operation was revealed as being one of the dustiest, regardless of the ventilation being used.

c. There was only one major variable between the samples taken on the two dates, i.e., the method of handling the blocks preparatory to sawing. Consideration of the procedure used on these dates reveals: (1) that on 24 Jan 1963, the blocks were rolled up to the saw after having been removed from their shipping cartons and stacked on a "dolly" for easy individual removal and (2) on 6 Mar 1963, the blocks were not removed from their shipping cartons until needed by the worker. A large amount of dust is produced when blocks are removed individually from the cartons as a result of the natural abrasion produced when one block is pulled over the surface of the other. Consequently, the dust concentrations on this date at this location were greater than normal.

2. The supplementary overhead ventilation (added since the time of the preceding two reports) does successfully reduce the dust exposures. However, it does not reduce "Thermobestos" dust exposures to within safe acceptable limits when cutting radii.

DUST EXPOSURES WHILE FABRICATIN THERMOBESTOS INSULATION BLOC WITH TWO TYPES OF VENTILATIC

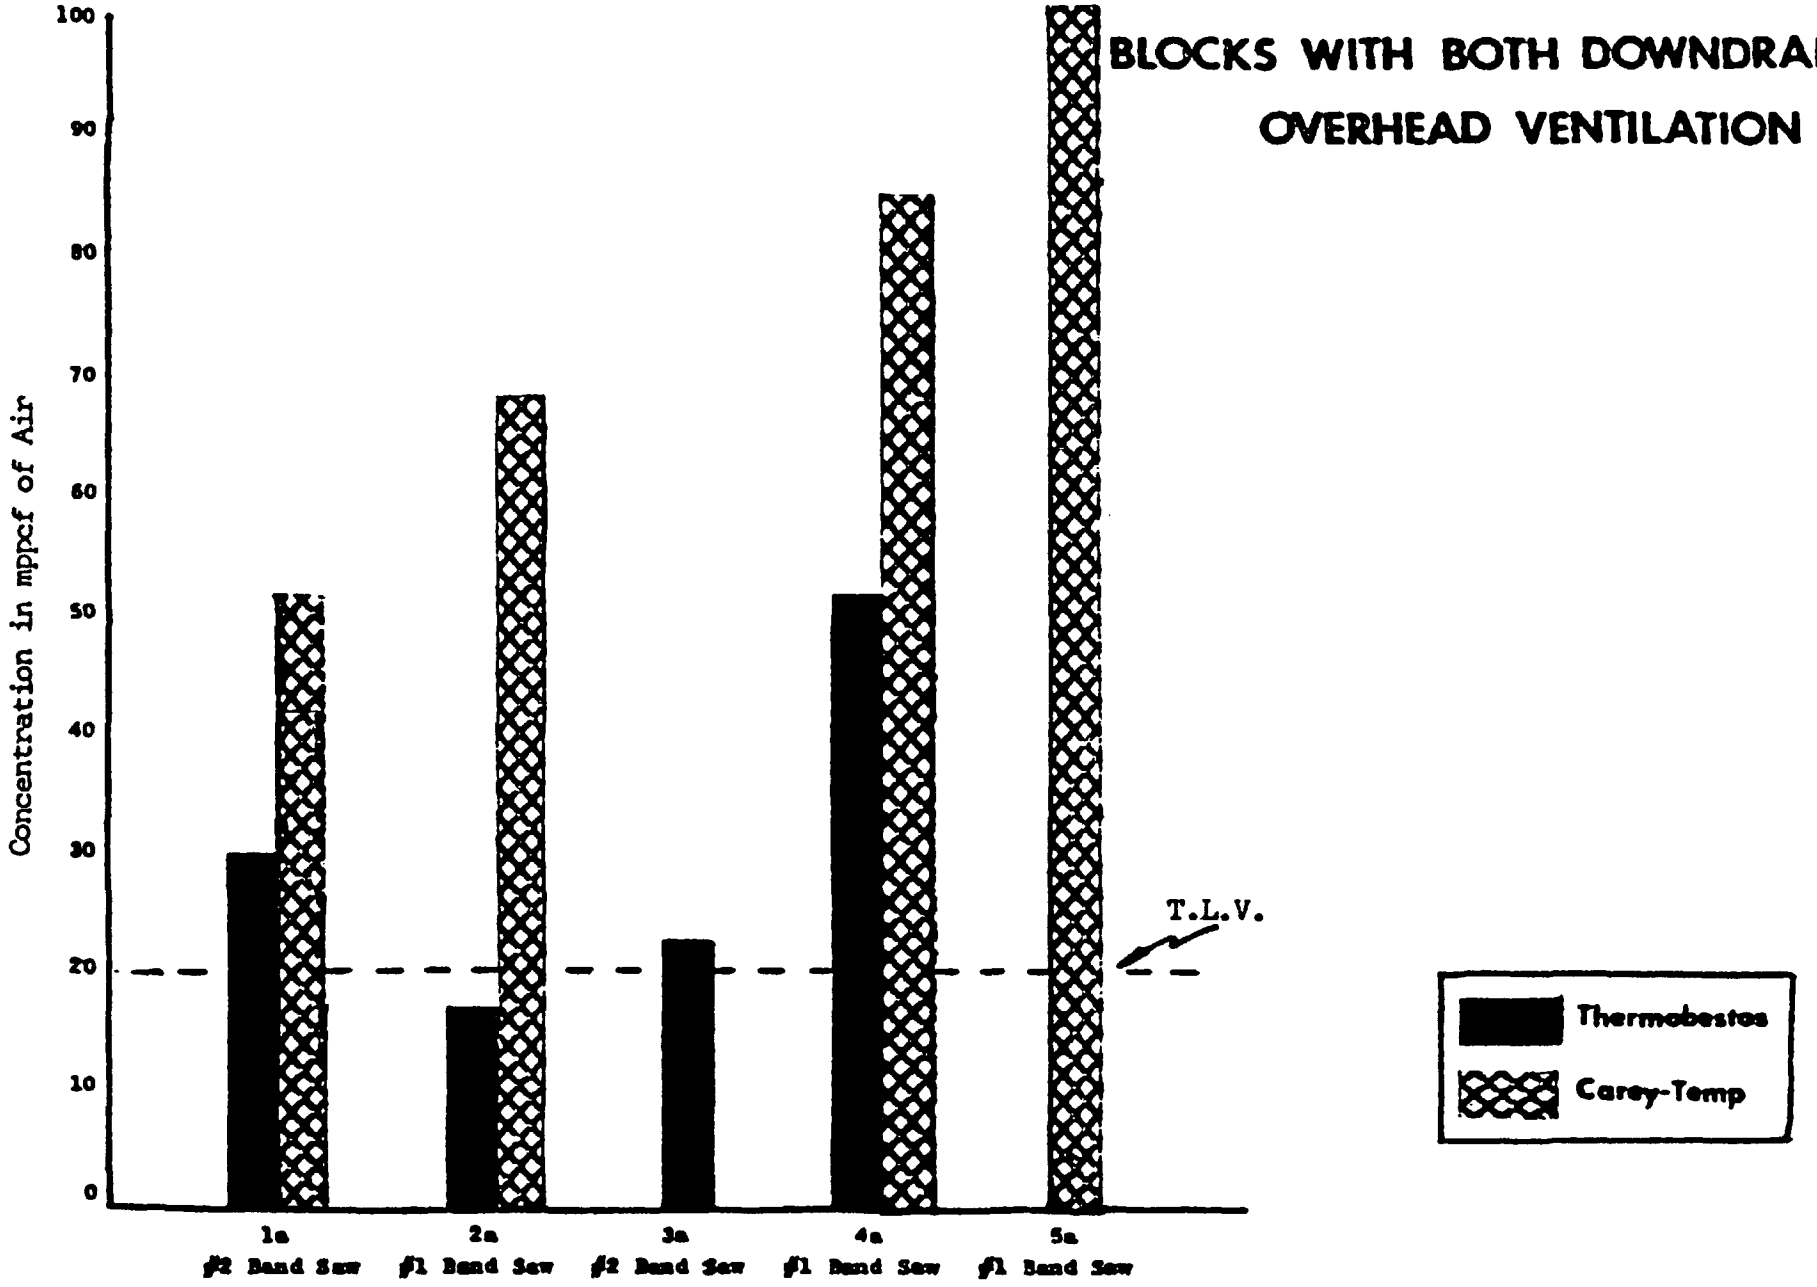
CHART NO. 6

1. "Carey-Temp" dust concentrations for each exposure was substantially greater than the comparable "Thermobestos" dust concentrations and in excess of even the most lenient TLV established for human exposures, i.e., 50 mppcf of air.

2. The existing exhaust ventilation system as installed on both band saws is incapable of reducing the dust hazard, associated with the fabrication of "Carey-Temp", to within safe acceptable limits, i.e., 20 mppcf of air.

DUST EXPOSURES WHILE FABRICATING THERMOBESTOS & CAREY-TEMP INSULATIC BLOCKS WITH BOTH DOWNDRAFT ANI OVERHEAD VENTILATION

1. Do not fabricate 18" x 36" x 4" "Carey-Temp" or "Thermobestos" insulation materials unless:

a. The atmospheric dust problem can be reduced to below 20 mppcf of air through the use of improved ventilatibn techniques or repairs to the existing system, or

b. The manufacturers of the two makes of insulation materials are able to produce a product which will not release, upon fabrication with a band saw, dust concentrations in excess of 20 mppcf of air.
