INDUSTRIAL HYGIENE SURVEY
Evaluation of Atmospheric Dust Conditions at the Construction Insulation Shop
Table #1
Atmospheric Dust Concentration Data
Collected When Using Only Partial
Ventilation, i.e., Only Below the Blocks

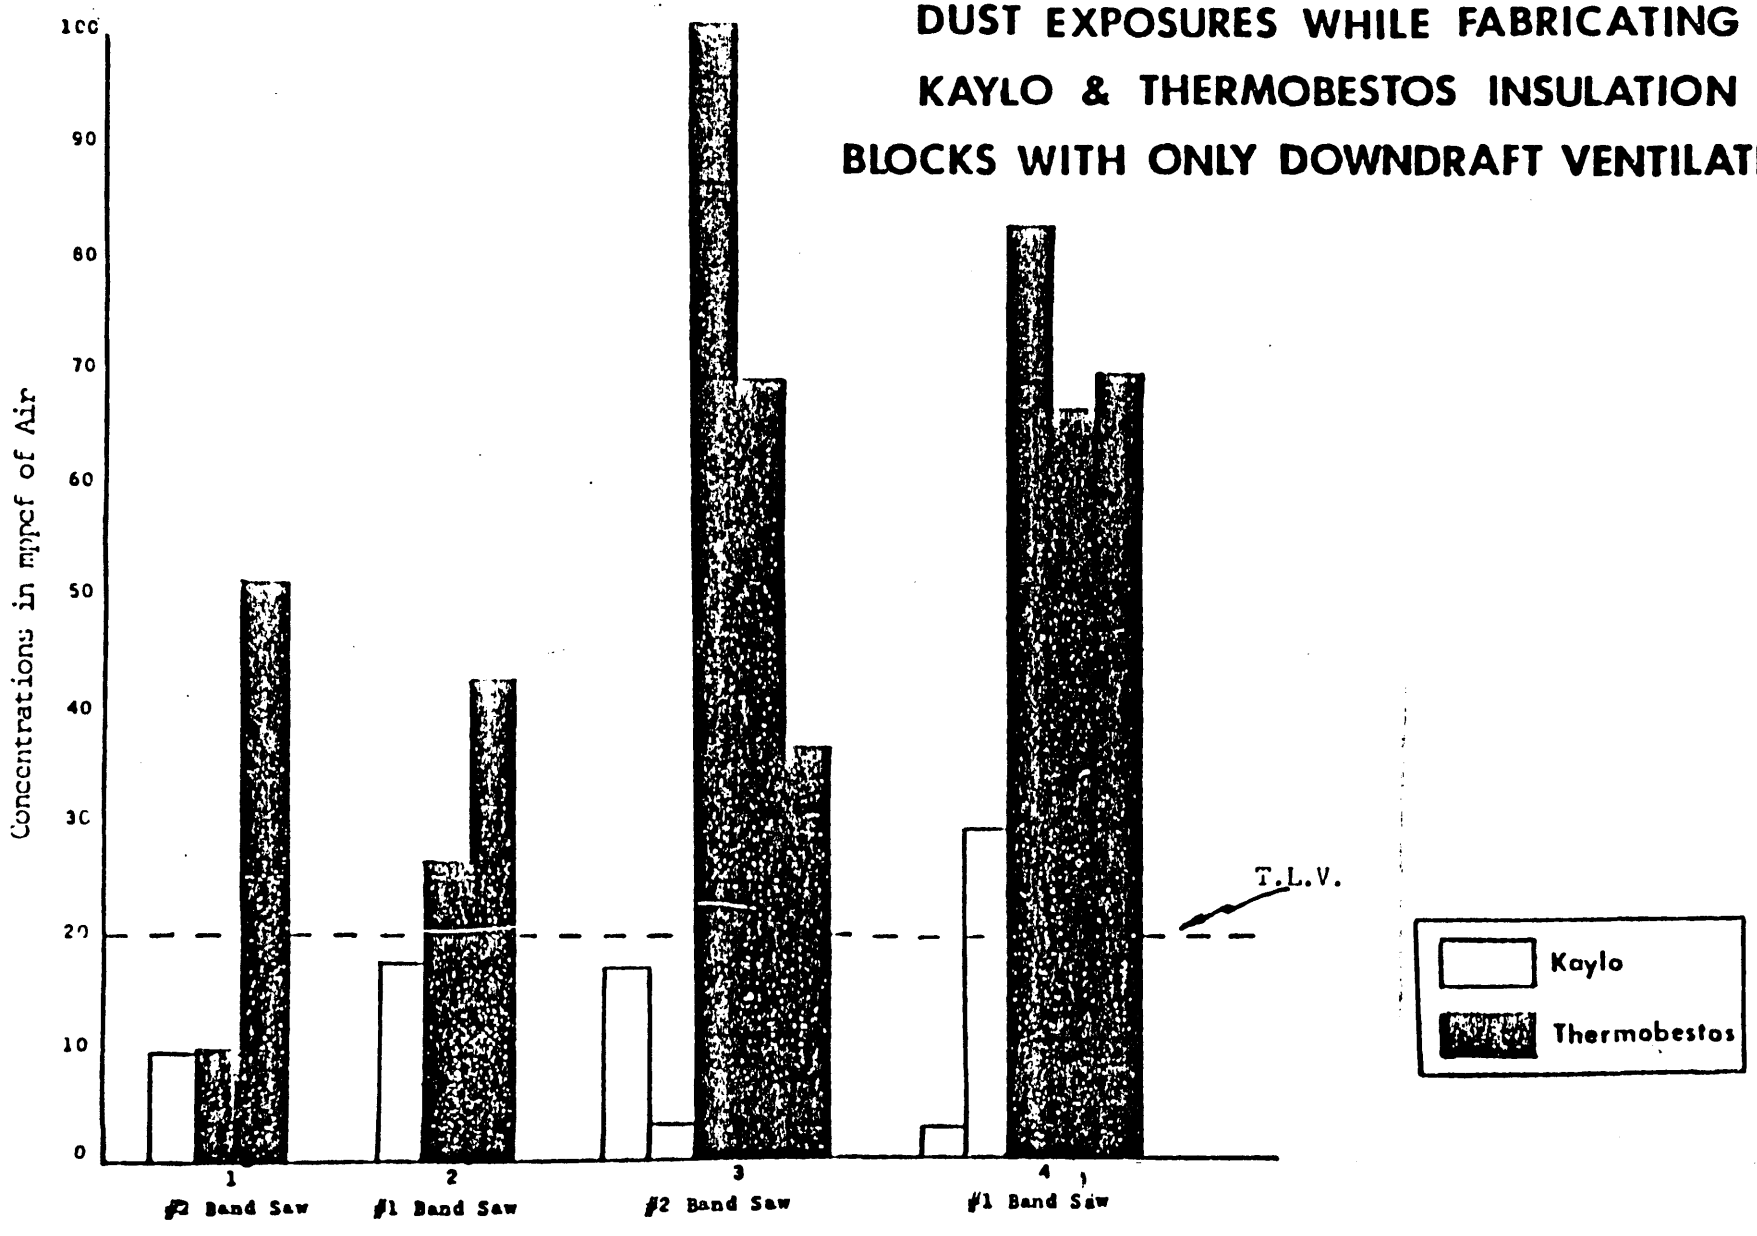
GRAPH NO. 1

Relative to dust exposures from Graph #1 & Tables on Pages 8 & 9:

1. "Thermobestos" insulation blocks should not be fabricated when using only the original downdraft exhaust ventilation.

2. "Kaylo" insulation blocks could be fabricated safely when using only the original downdraft exhaust ventilation if existing leaks, observed on the #1 band saw, are corrected.

3. "Kaylo" insulation blocks definitely may be safely fabricated when using the entire exhaust ventilation facilities now available, i.e., hoods above the blocks as well as below.

DUST EXPOSURES WHILE FABRICATING KAYLO & THERMOBESTOS INSULATION BLOCKS WITH ONLY DOWNDRAFT VENTILATIOI

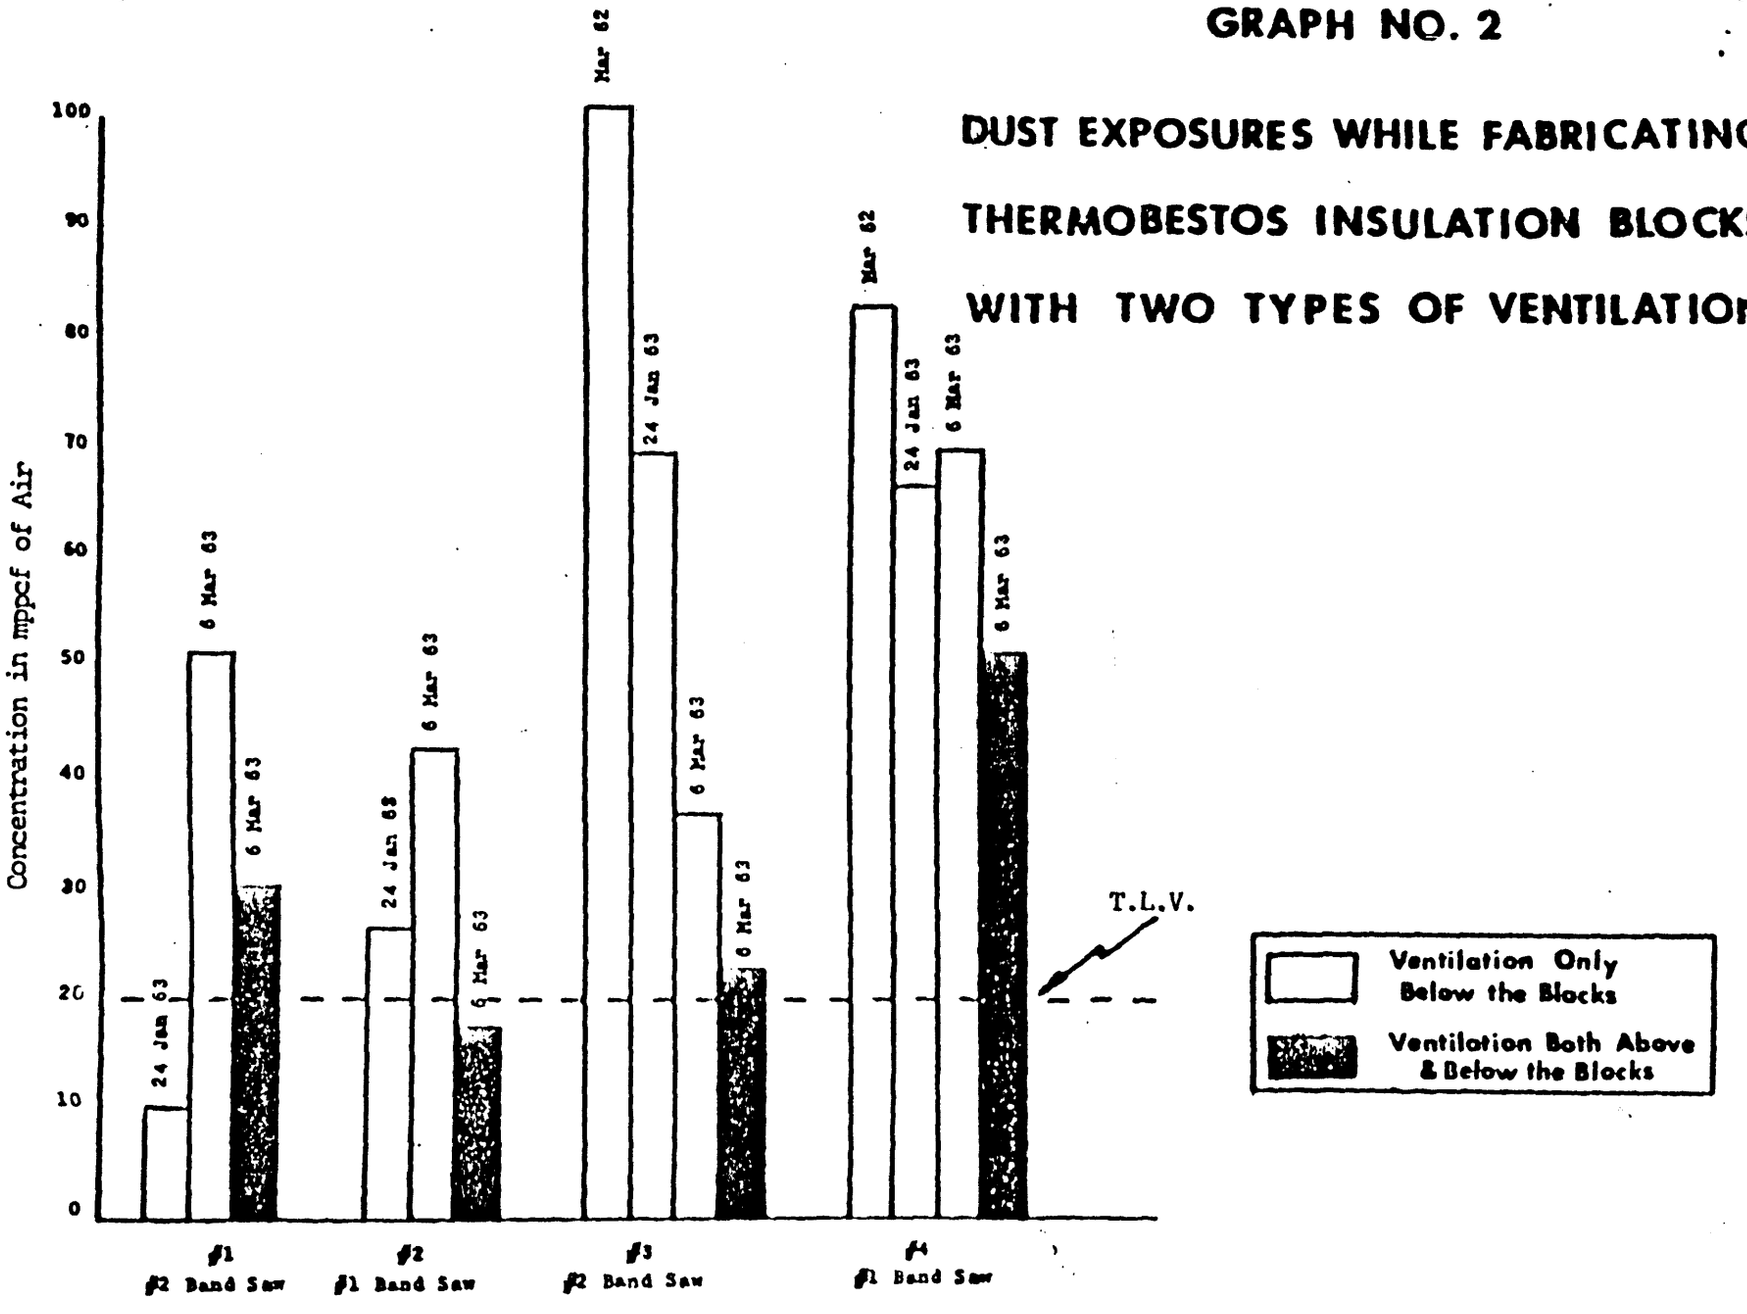
GRAPH NO. 2

From Graph #2 & Tables on Pages 8 & 9:

1. Methods of handling "Thermobestos" blocks (preparatory to sawing) and scraps (after sawing) contribute greatly to specific individual exposures as demonstrated by the following facts:

a. The fabrication process, which always begins at the #2 band saw with the simple cutting of each 18" x 36" x 4" block into three smaller blocks about 18" x 12" x 4", is normally the least dusty of all the fabrication operations as revealed by the samples taken on 24 Jan 1963.

b. However, on 6 Mar 1963, this operation was revealed as being one of the dustiest, regardless of the ventilation being used.

c. There was only one major variable between the samples taken on the two dates, i.e., the method of handling the blocks preparatory to sawing. Consideration of the procedure used on these dates reveals: (1) that on 24 Jan 1963, the blocks were rolled up to the saw after having been removed from their shipping cartons and stacked on a "dolly" for easy individual removal and (2) on 6 Mar 1963, the blocks were not removed from their shipping cartons until needed by the worker. A large amount of dust is produced when blocks are removed individually from the cartons as a result of the natural abrasion produced when one block is pulled over the surface of the other. Consequently, the dust concentrations on this date at this location were greater than normal.

2. The supplementary overhead ventilation (added since the time of the preceding two reports) does successfully reduce the dust exposures. However, it does not reduce "Thermobestos" dust exposures to within safe acceptable limits when cutting radii.

DUST EXPOSURES WHILE FABRICATING THERMOBESTOS INSULATION BLOCKS WITH TWO TYPES OF VENTILATION
