August 21, 1972
Review Copy

INCINERATION OF POLYCHLORINATED BIPHENYLS

A. F. Pier
Corporate Engineering Division
Monsanto Company
St. Louis, Mo.

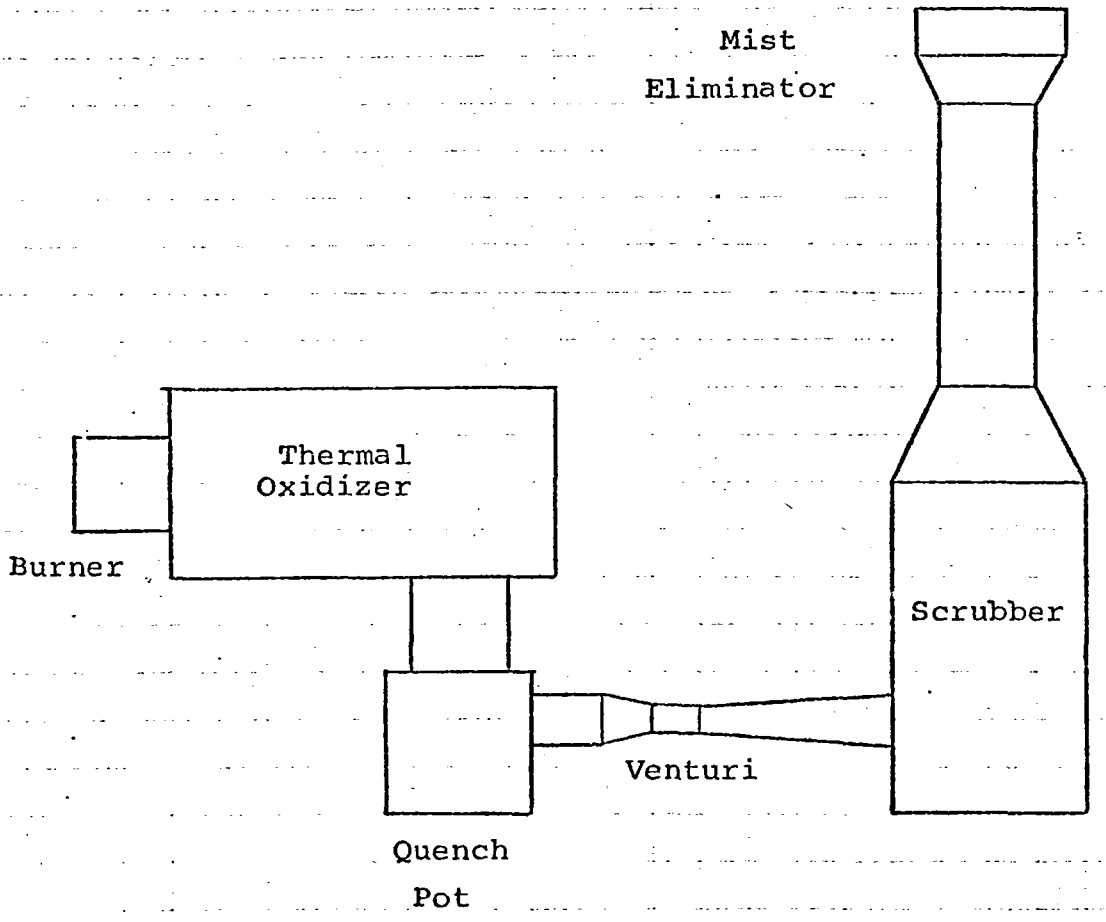
Fig. 2 - Oxidizer - Scrubber System

Based on the pilot plant results, a system to burn 1250 pounds per hour of PCB's was designed and installed at Monsanto's Sauget, Illinois, plant. The full scale system consists of a Thermal oxidizer, a quench pot, a Venturi scrubber to remove particulate, and a packed scrubber to remove HCl as shown in Figure 2. Water is used as the quenching and scrubbing liquor. The scrubber system was designed to meet the following requirements on emissions to the atmosphere:

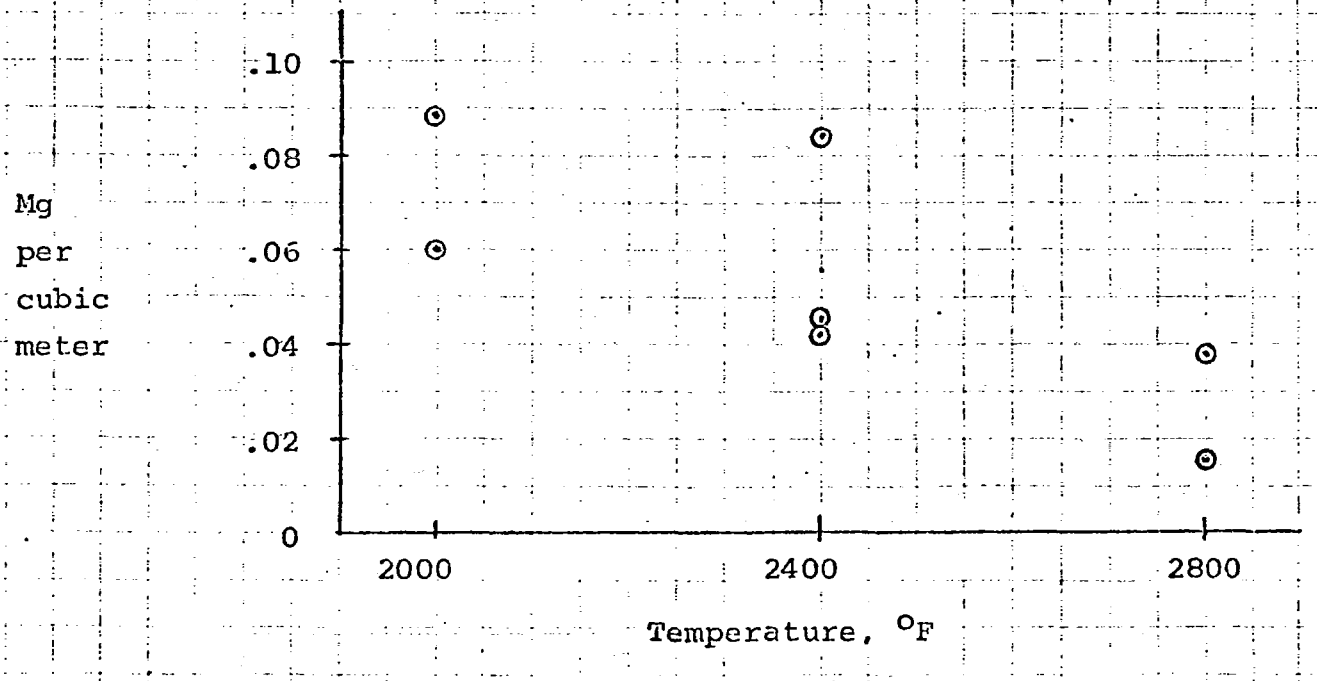
Fig. 1 - PCB in Flue Gas - Pilot Plant

Further tests on Aroclor 1260 were run in the John Zink pilot plant in May. The incinerator was operated at 2000, 2400, and 2800°F and at a residence time of 1.2 to 1.9 seconds. The results, shown in Figure 1, indicate that the unburned Aroclor decreases at the higher temperature. The levels of destruction were higher than those attained in the March test. The highest level of PCB measured in the flue gas (.089 mg per cu. meter) is equivalent to 99.9999% destruction of the Aroclor 1260.

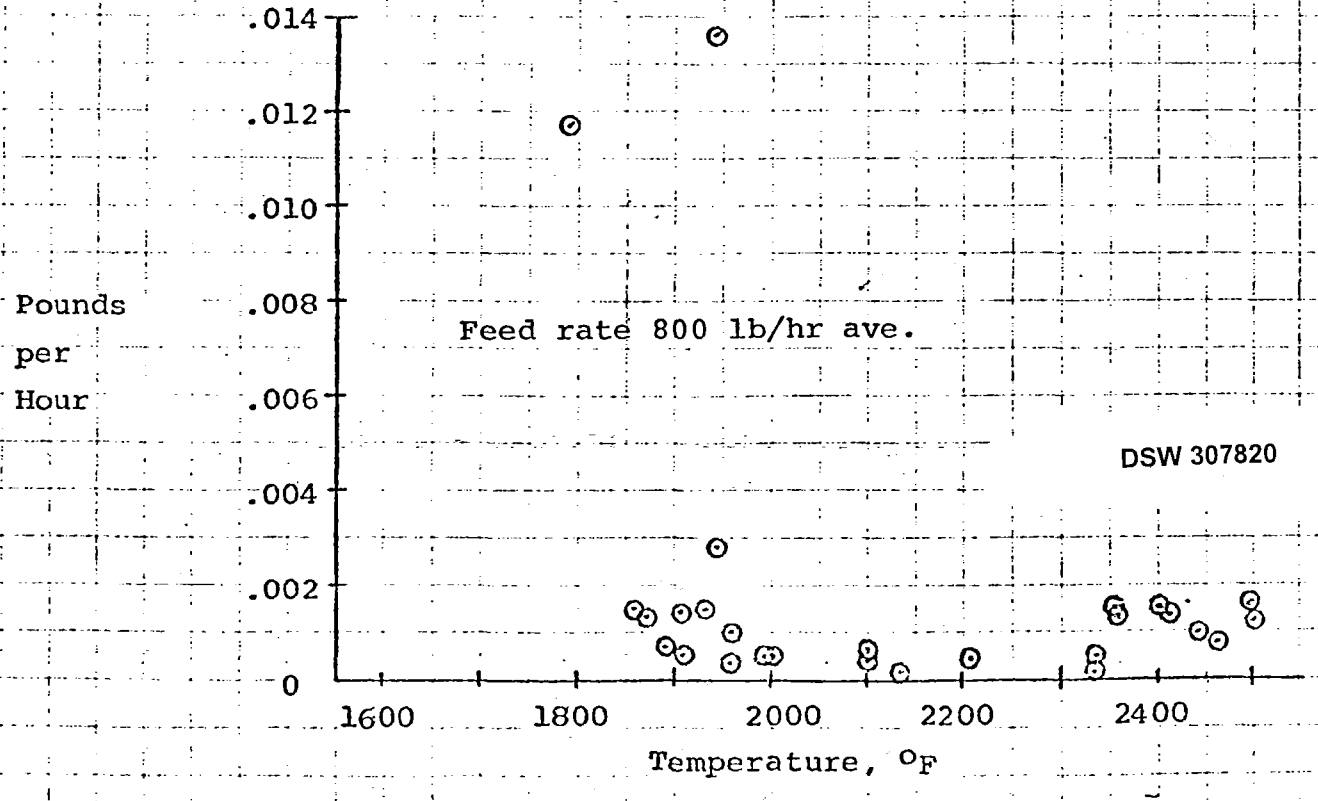
Fig. 3 - PCB in Flue Gas - Sauget Plant

Early in the operation of the incinerator system, the scrubber liquor and the scrubber off gas were monitored for PCB's to determine the level of destruction. Fig. 3 shows the relationship between the temperature in the oxidation chamber and the total quantity of undestroyed PCB leaving the oxidizer. The data indicate that at temperatures below 2000°F the quantity of undestroyed PCB may rise sharply and that there is no significant increase in destruction at temperatures above 2200°F. Current practice is to operate the oxidizer at 2200 to 2400°F. It should be noted that at normal operating temperatures, 99.9998% of the PCB's are destroyed. Even the highest sample encountered in the test is equivalent to 99.998% destruction.

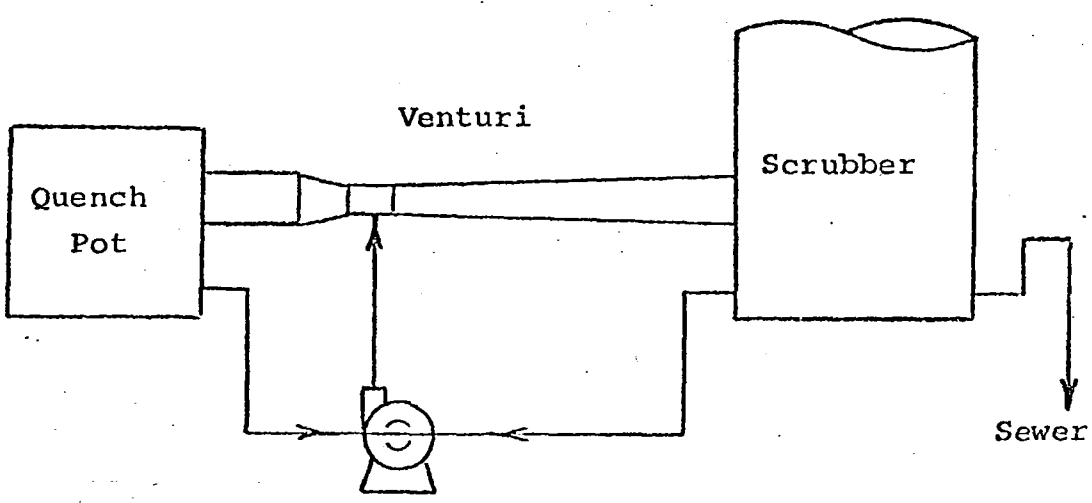
Fig. 5 - Scrubber Water System

The original lining was also eroded at the flue gas inlet nozzle. It was concluded that the erosion was caused by small particles spalled from the brick in the oxidizer and trapped in the water in the quench pot. In the original installation, water from the quench pot was used as make-up for the Venturi scrubber as shown in Fig. 5. Water containing the brick dust was accelerated to a high velocity in the Venturi scrubber and impinged on the wall of the packed scrubber column. The problem was solved quite simply by using water only from the bottom of the scrubber column to supply the Venturi.
