Monsanto

SUBJECT FINAL REPORT ON AROCLOR EMISSION INVESTIGATION

EMISSION INVESTIGATION

Date of Incident:	March 8, 1972 4:00 A.M. and 6:00 A.M.
Location:	Dept. 246, Distillation Column
Kind of Emission:	Aroclor
Result of Emission:	Sprayed Aroclors in cone shaped pattern Southeast of column to points at least 100 yards from column. No complaints received.
Cause of Emission:	Loss of cooling on column condenser resulting from: 4:00 A.M. Incident - Electrical failure 6:00 A.M. Incident - City water make-up pump not started after electrical failure. No means available to isolate vacuum jet to stop emission once it starts when power is off.
Investigating Committee:	Virgil Brawley Clarrie Buckley Jim Grant Gerald McRaven Ed Stewart, Chairman

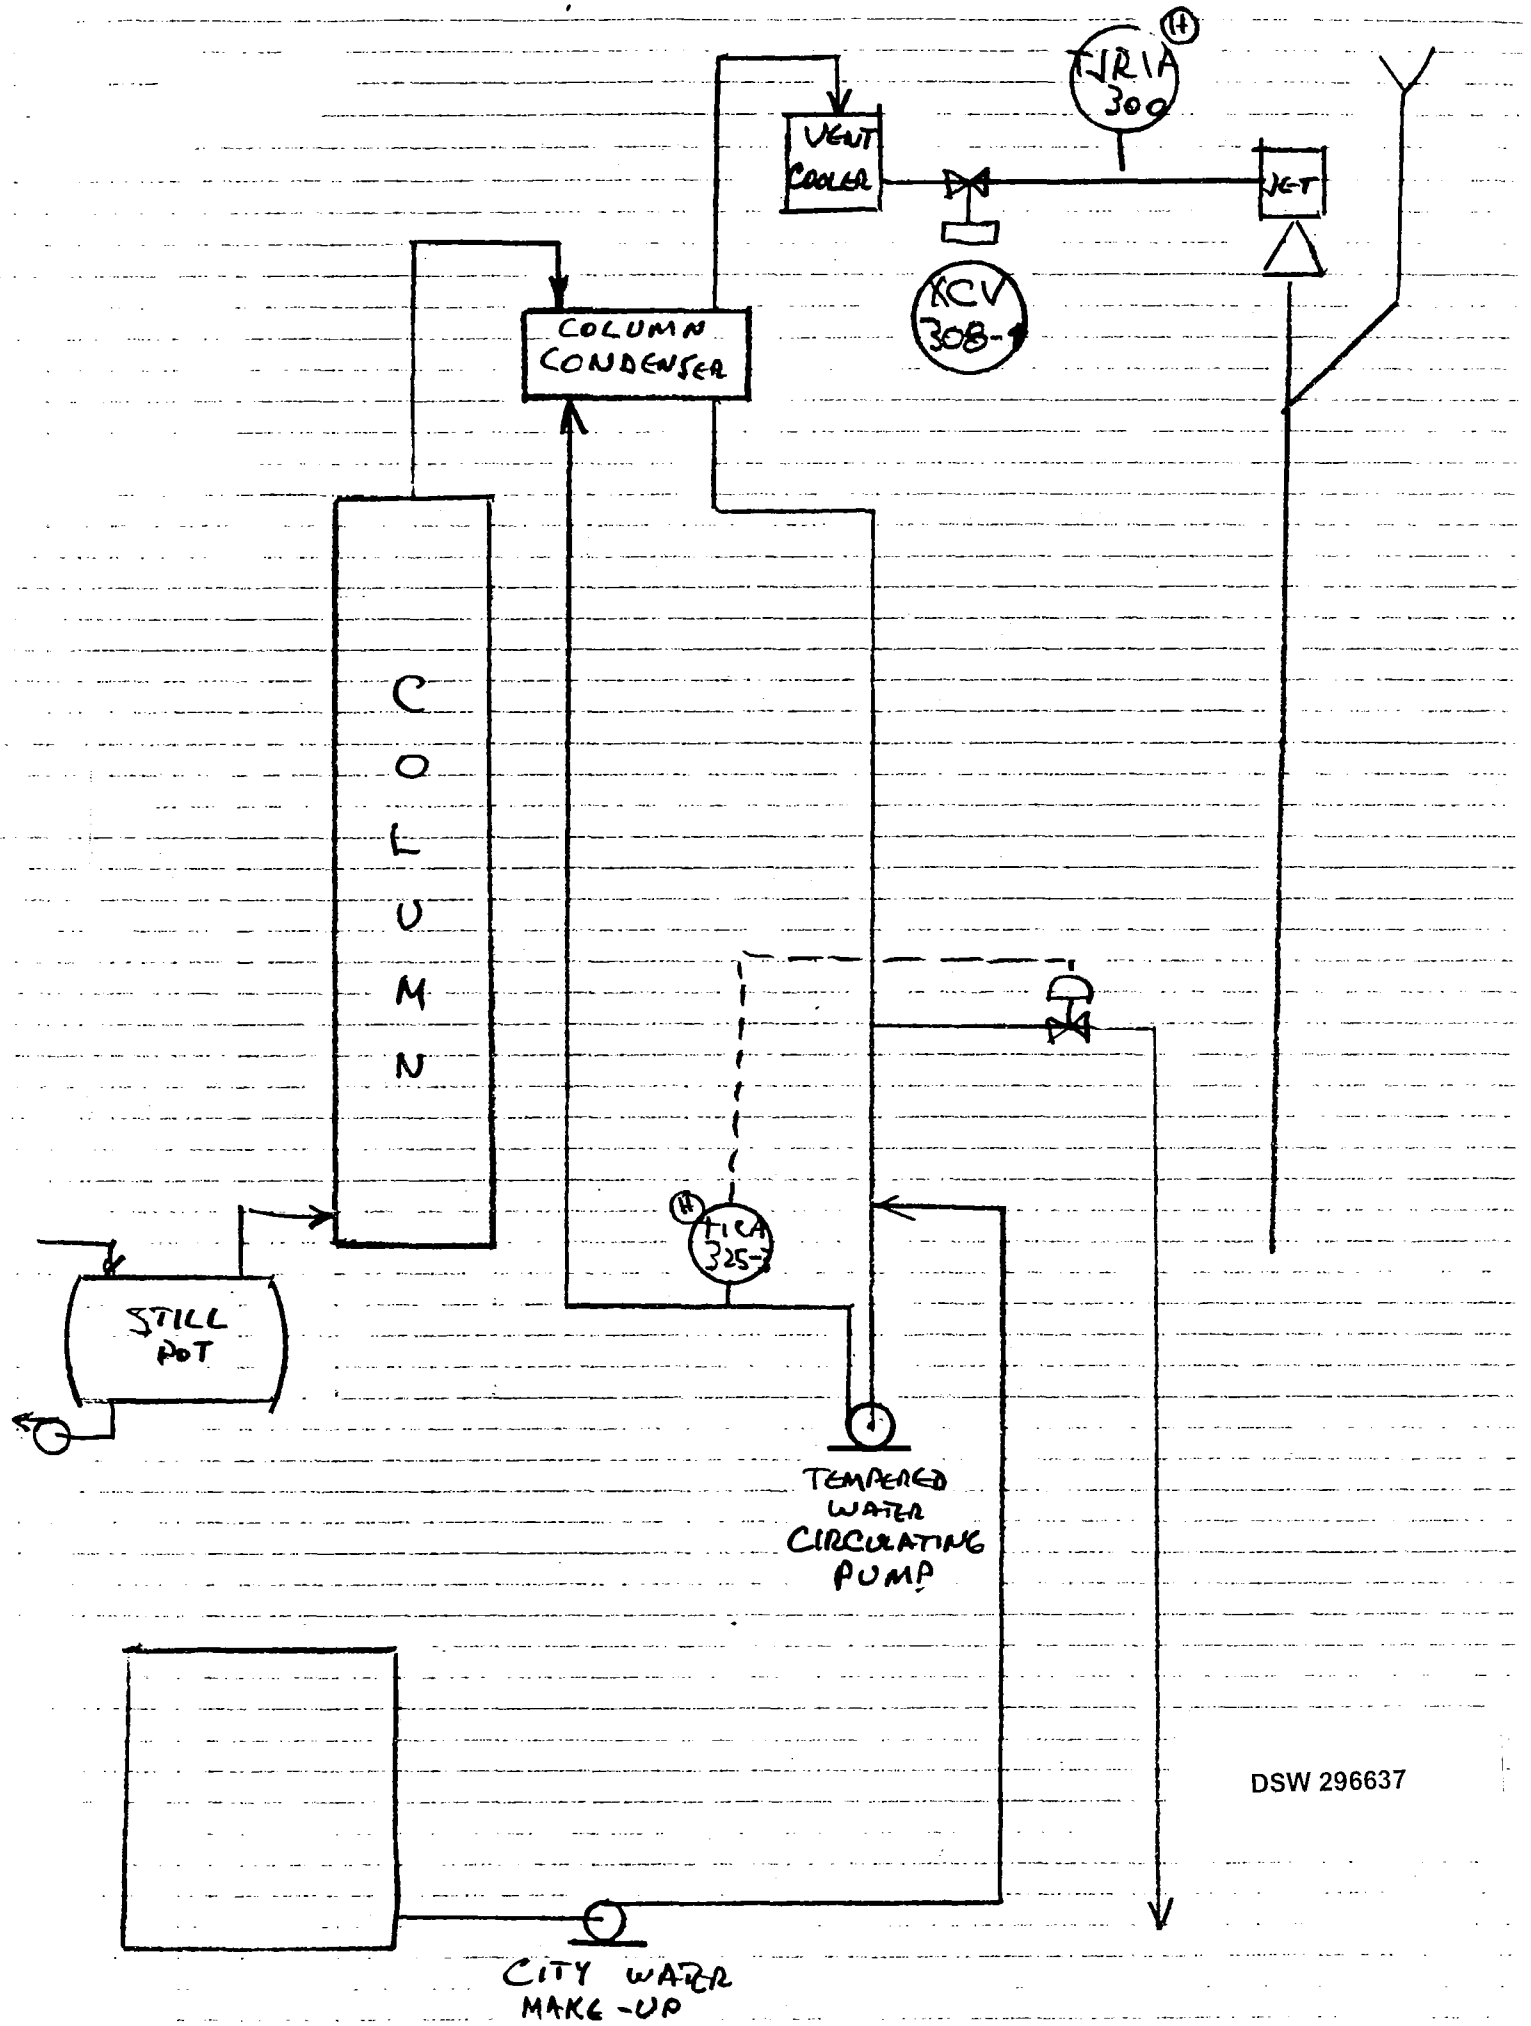
The emission was caused by a loss of cooling water at the column condenser. There will be a continued generation of vapors after the external source of heat has been discontinued because the column itself is a heat sink, and when refluxing stops there will be a further decrease in pressure which will promote boiling. Without cooling water on the condenser some vapors will pass uncondensed through the condenser, the vent cooler, the jets and into the atmosphere. Although there is a valve in the vent line it currently fails in the open position on electrical failure, and there is no way to immediately stop the vapors during an electrical failure. See sketch.

The emissions can be stopped by closing the valve between the vent cooler and the jet. This can be done with minor electrical changes to permit the valve to fail in the closed position on electrical failure. This can be done safely and was reviewed with Dale Schillinger and Walter Howard of CED.
