Beverly Port Marina – EPA Inspection 8/20/2024

08/20/2024
EPA Inspection

Beverly Port Marina

43 Water Street
Beverly, MA

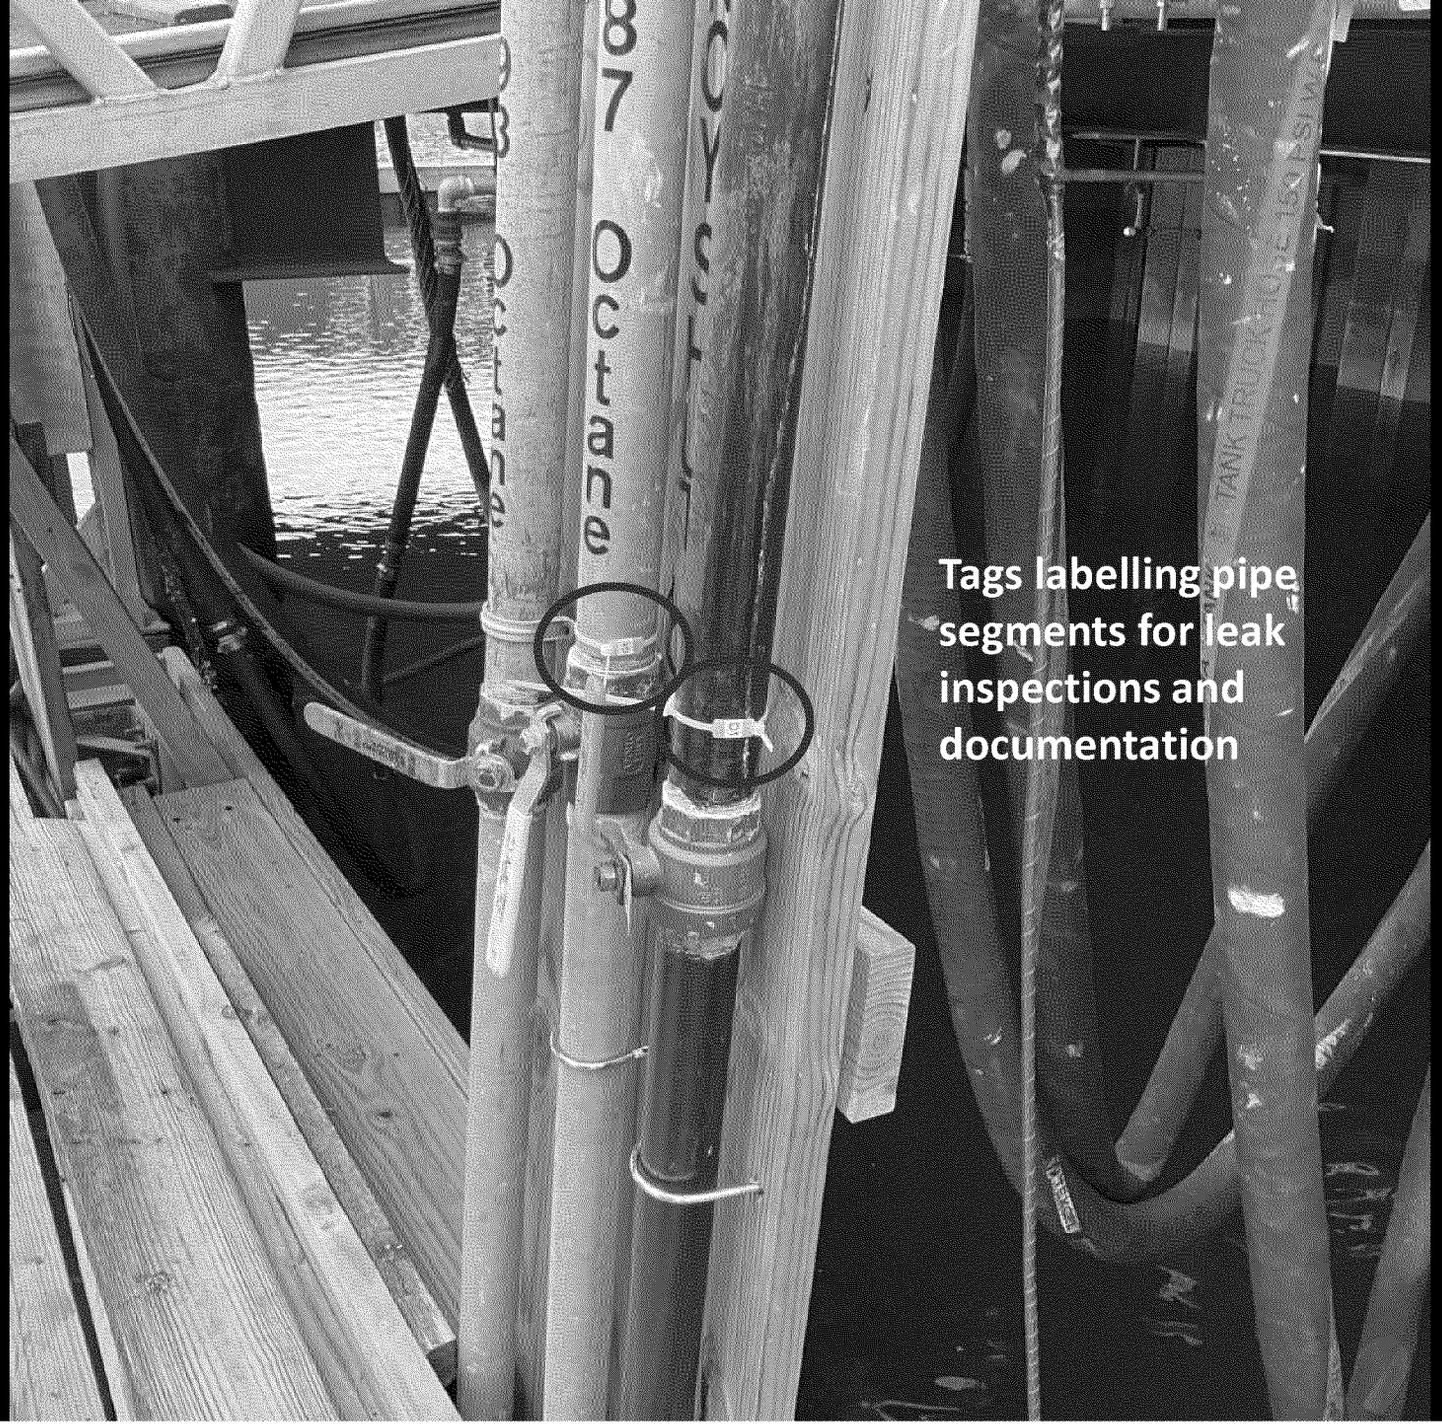
Tags labelling pipe segments for leak inspections and documentation

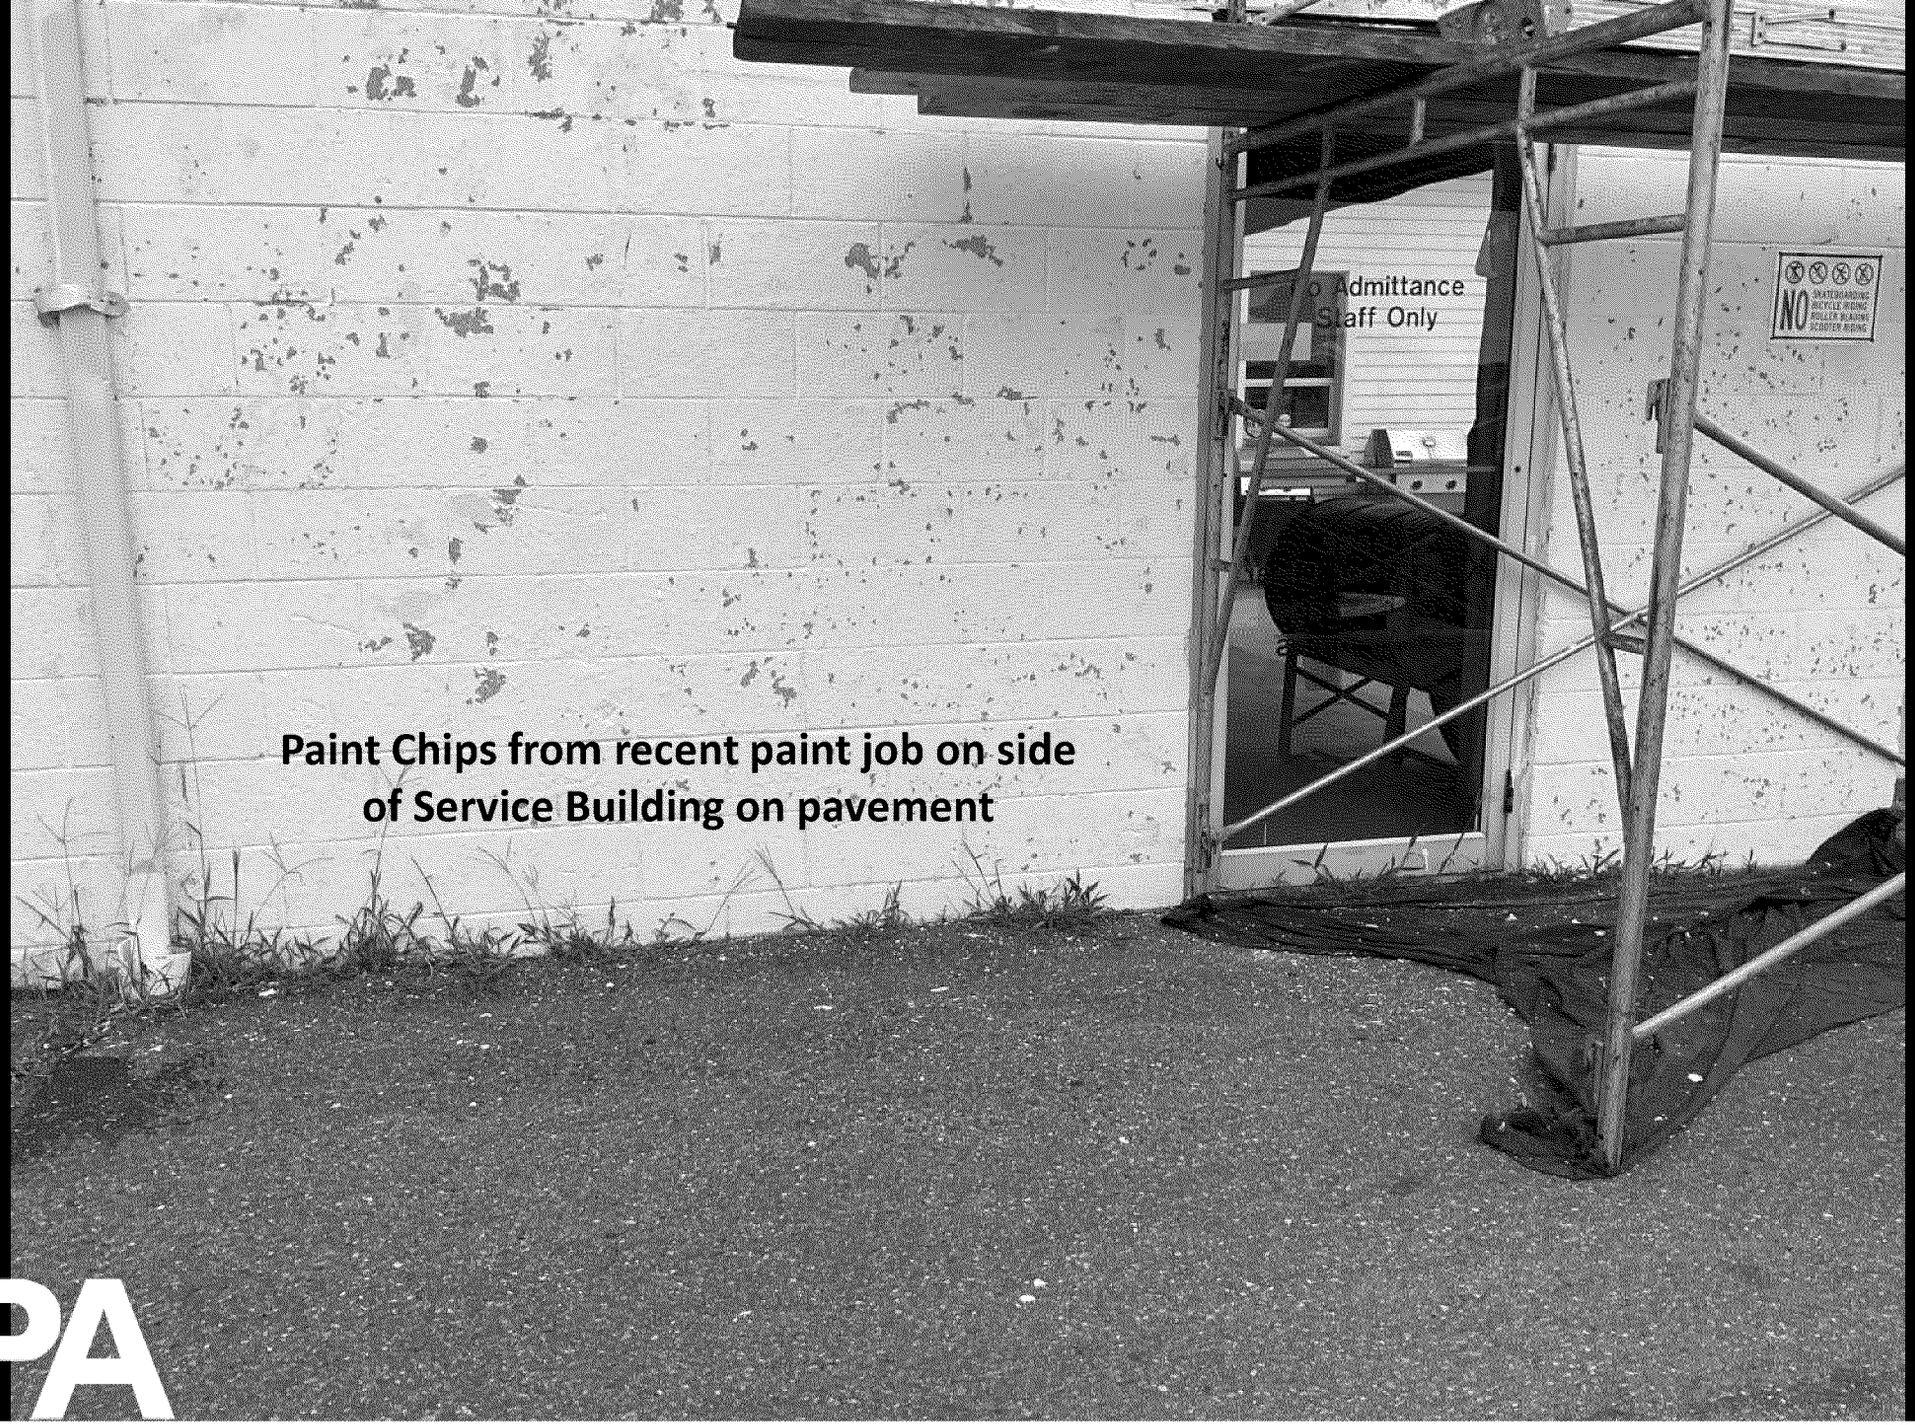
Paint Chips from recent paint job on side of Service Building on pavement

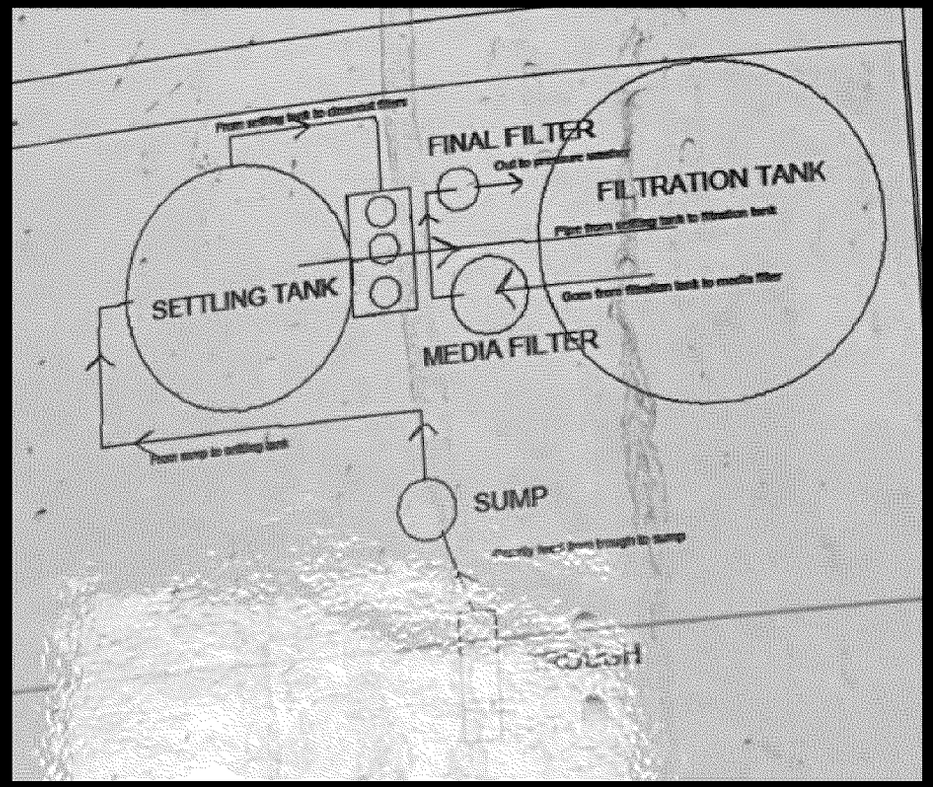
Outfall 005

Pressure wash water filtration and settling tanks
