DATE: 9-1-72 SUPERVISOR CONTACTED Bob Eden

DEPT. NO. 246

EQUIP. OR ITEM NO. 418

NAME OF EQUIPMENT INSP. No. 9 Continuous Chlorinator

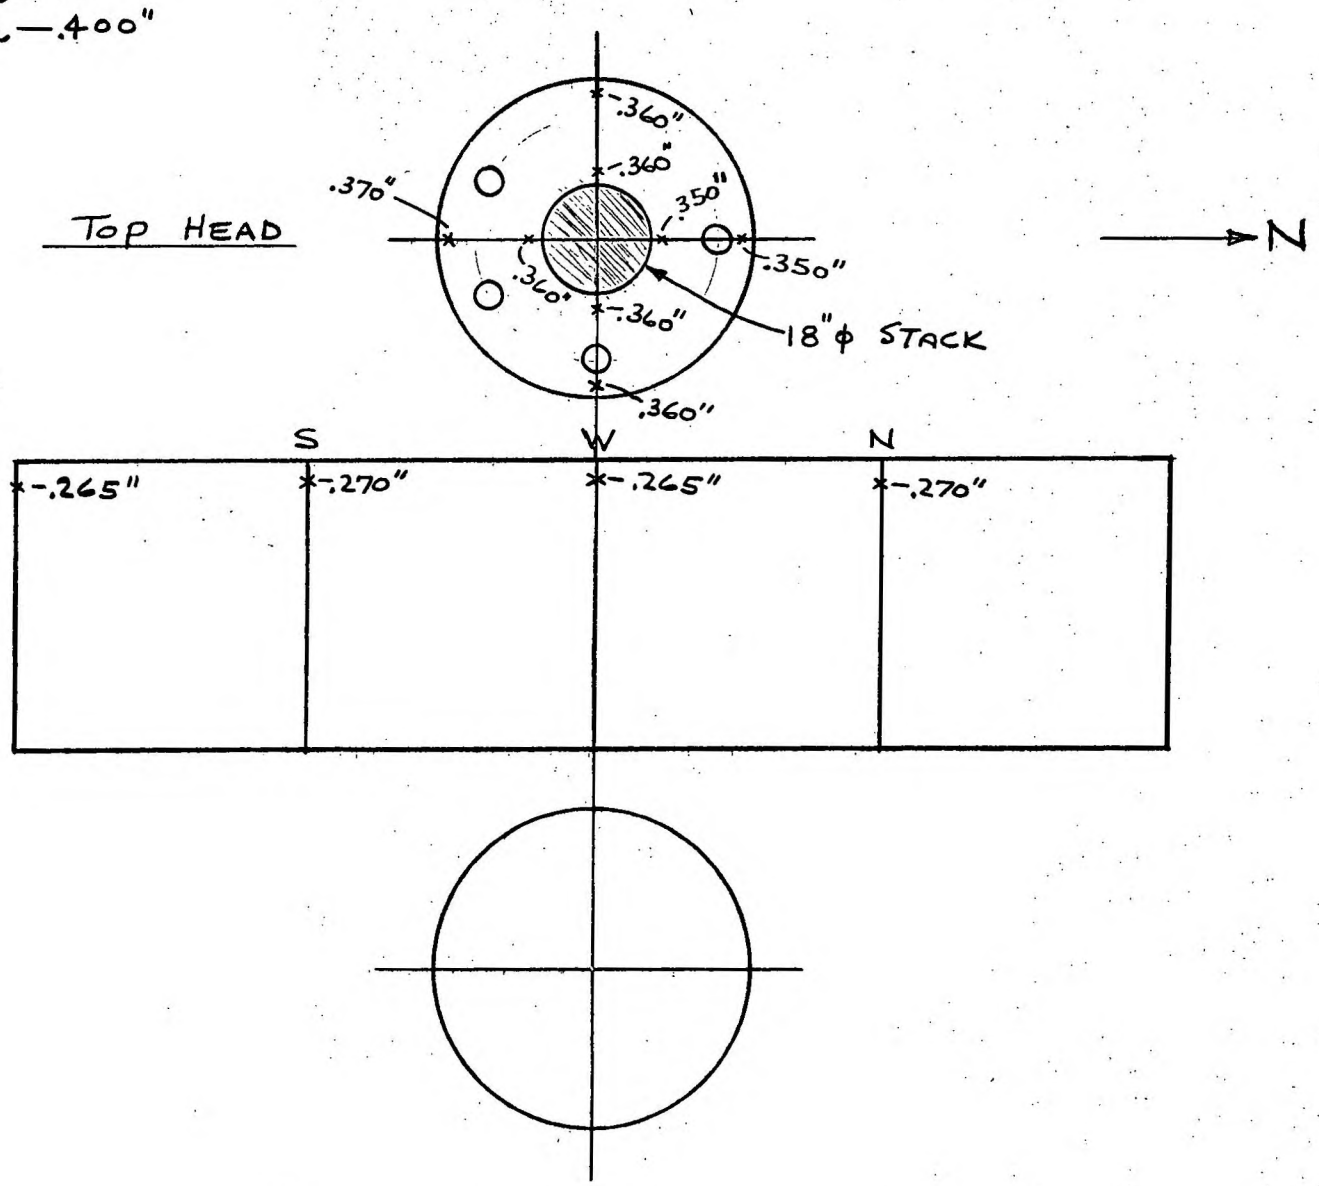
No. 9 CONTINUOUS CHLORINATOR

This No. 9 Continuous Chlorinator was visually inspected and thickness readings obtained on the exterior of the top head, stack, and upper sidewalls with the Sonoray instrument on 9-1-72. The readings obtained on the top head ranged from 0.350" to 0.370", on the stack, from 0.380" to 0.400" and on the upper sidewalls, from 0.265" to 0.270".

READINGS — 18"ϕ STACK (3" FROM BOTTOM)

NORTH ℄ — .385"
SOUTH ℄ — .400"
EAST ℄ — .380"
WEST ℄ — .400"

From an overall visual inspection and from the thickness readings obtained on the exterior of this chlorinator, it was found to be in good condition and acceptable for further service.
