[illegible] LEAD PRODUCTS [illegible]

"Lead lined acid [illegible] a [illegible] trabian plant [illegible] 19 years of [illegible] the lead and [illegible] are being [illegible]

CHEMICAL BULLETIN NO. 1
ACID ALUM REACTION TANKS
DATE: JULY 23, 1948

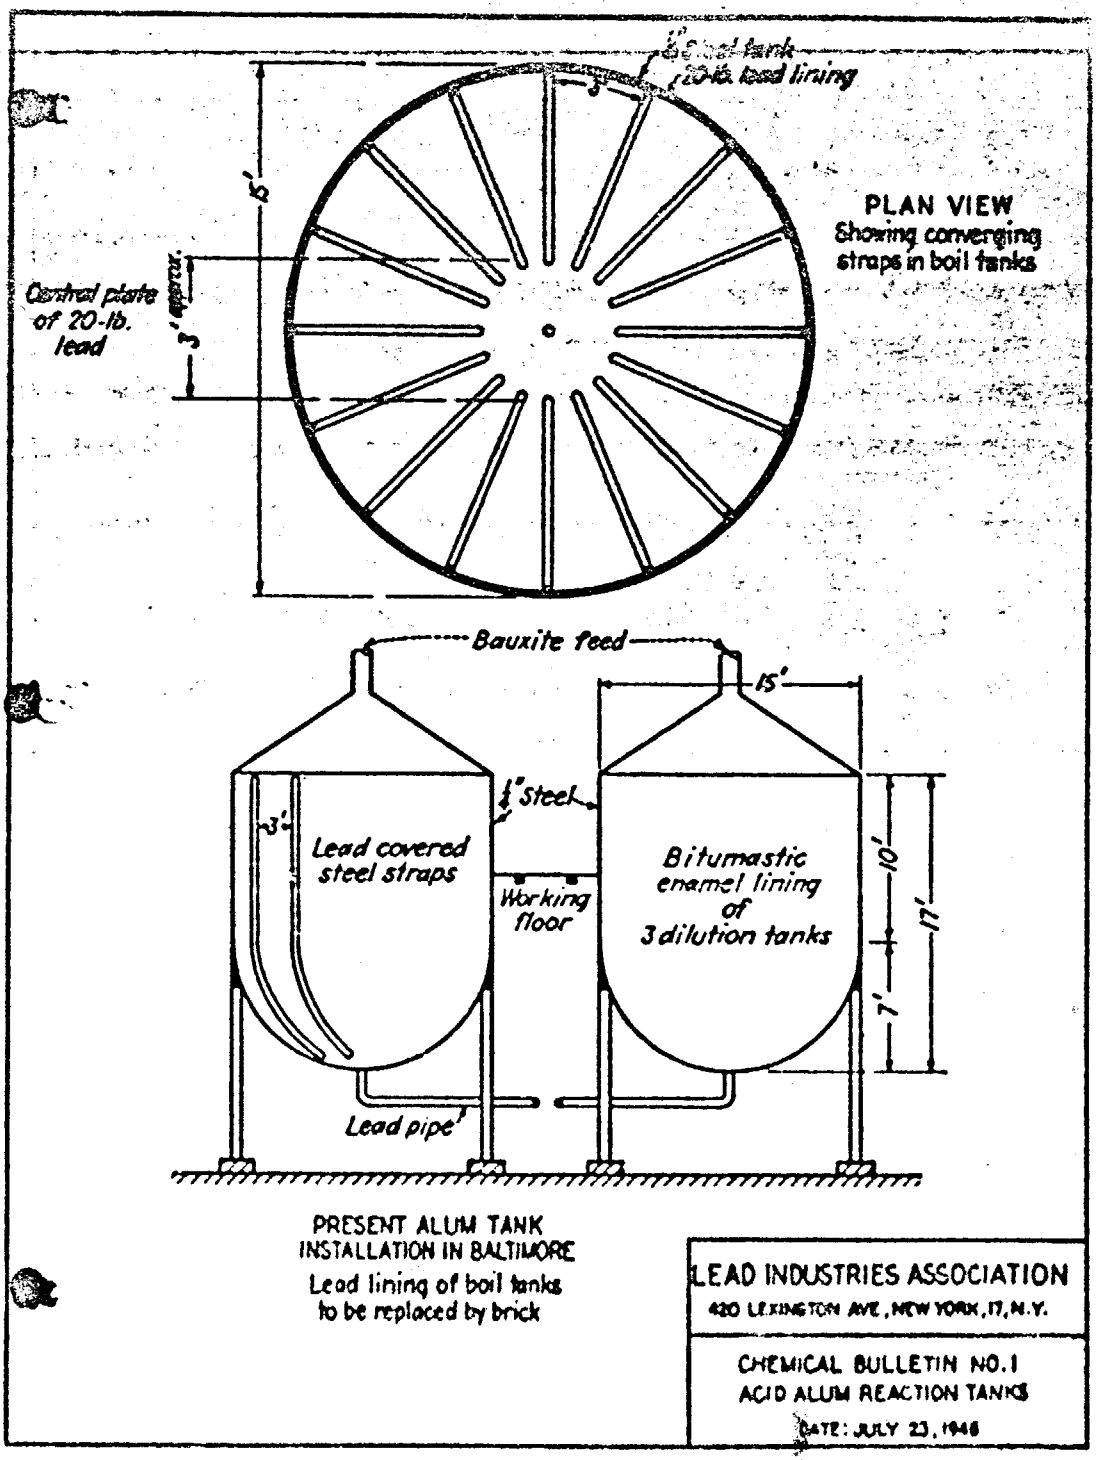
PRESENT LEAD INSTALLATION

The first drawing shows the last attempt that was made in 1938 to make lead linings give reasonable service in alum boiling tanks. Vertical straps were installed 36 in. apart with 20 lb. lead lining left unfastened at the top.

The leakage has occurred only around the lower edges of the vertical straps in the two reaction tanks. These two tanks were said to require as much maintenance as all the rest. The lead lining expands with heating and does not contract, leaving a buckled area of disturbed or "crazed" metal which is probably more readily corroded. The buckling movement of the lead would also tend to weaken the weld metal at the edge of the straps. The expanded metal shows up in the cylindrical portion of the tank as wrinkles and bulges between the straps; however, there is no leakage in this area. Leaks occur only in the bottom area and are always along a seam of welded metal. There is no question of failure through abrasive or chemical action on the lead itself.

The 1935 installations has served to date only under [illegible] straps and with constant repair. Vertical straps [illegible] in. apart were far from satisfactory as the lead [illegible] and [illegible] the temperature change of [illegible]. [illegible] Lead was tried during this period and was said to be [illegible] satisfactory.

Lead has a black eye at these two plants and probably others for failing to do the job. Actually it has not been given a proper test. If straps had been tried at a distance of 24 in., undoubtedly the increased length of service of the lead lining would more than offset the cost of additional straps.

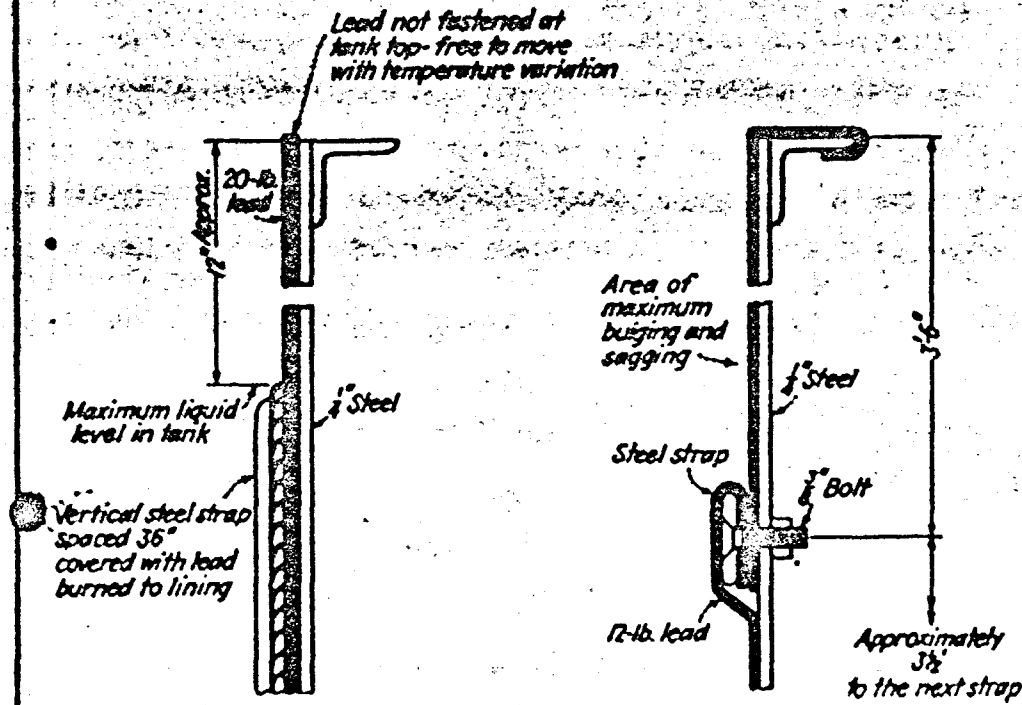
METHOD OF SUPPORTING LEAD AT TOP AND ALONG SIDES OF ALUM BOILING TANKS WHICH FAILED

In 1932, 12 lb. lead was installed with horizontal straps as shown in the second drawing. These straps were no more effective than the previous arrangement as they buckled and sagged with repeated heating cycles. The bottom construction retained the arrangement of eight straps converging toward the central disc.

The combination of 12-lb. lead with horizontal straps installed in 1932 failed in a year's time. Excessive sagging occurred in the sheet lead just above the horizontal straps and many of the bulges became too large to dress back into place. These had to be cut out and a new seam burned in. There were even horizontal cracks in the lead.

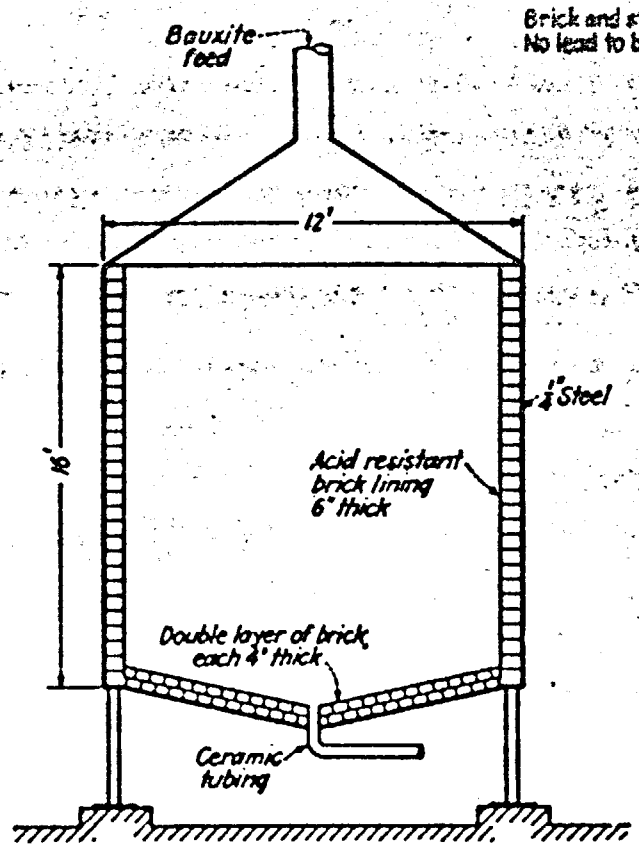
PROPOSED DESIGN FOR BOILING TANK IN FUTURE (1950) WASHINGTON FILTRATION PLANT

It is planned in Washington to build a new filtration plant about 1950. Designs for the alum tanks incorporate a shallow "V" bottom and show a brick lining with no mention of lead (see third drawing).

Brick and steel only
No lead to be used
