CHEMICAL BULLETIN NO. 7½

SUBJECT: "LEAD-SILVER ALLOY ANODES IN CATHODIC PROTECTION OF SHIPS"

Service Experience With

Lead-Silver Alloy Anodes in Cathodic Protection of Ships*

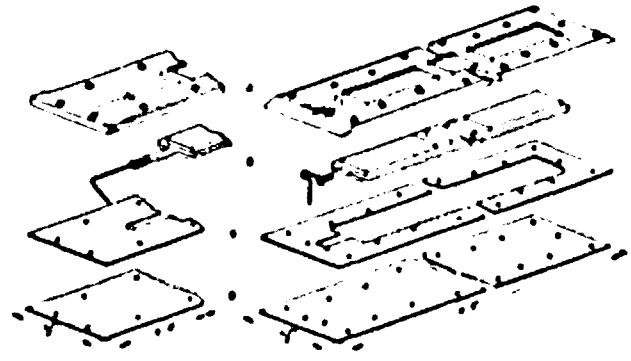
Figure 1—Exploded view of Mark I lead alloy anode. Cable connection for Mark II is same as left. A Bracket B Anode C Polychloroprene gasket D Backing plate

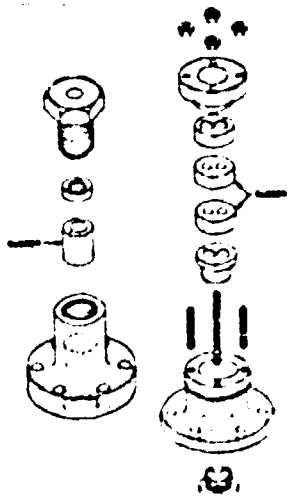
Glanding, Cofferdams and Standpipes. Single-bushed glands, as shown in Figure 4 were used for the Mark I anode cable and the double-bushed glands were used for the Mark II anode cable pairs. A spigot-ended backing pad was used with each type of gland. The pads were held in place by continuous welding, both on the inside and outside, to prevent water seepage between pad and plating.

Figure 4—Bipostle glands for anode cables

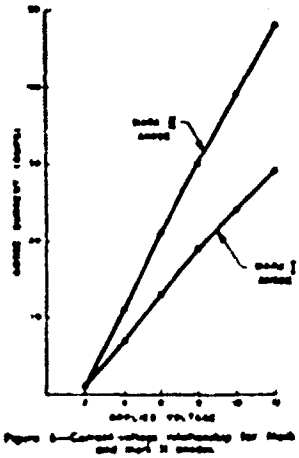
Previous experience with lead-silver anodes had indicated that the anode current density should exceed a minimum of 3 amp/sq ft to form a tight protective film that would prevent attack on the underlying metal and resultant shortening of the 10-year life expectancy of the anode. It was also known that the current density requirement of a freshly painted hull is low. For these reasons, some of the anodes were left unconnected on undocking the ship and a proposed schedule for making the connection was drawn up, so that the anodes in use were always delivering more than 3 amp/sq ft. Additional considerations in drafting the schedule were 1 maintenance of even current distribution over the hull with variations in current demand, 2 the maintenance of the optimum hull potential, 3 maintenance of the minimum supply voltage that would be compatible with other requirements, and 4 the current-voltage relationship of each anode as found immediately after undocking. Typical values for the latter are given in Figure 6.

Figure 6—Current-voltage relationship for Mark 1 and Mark II anodes

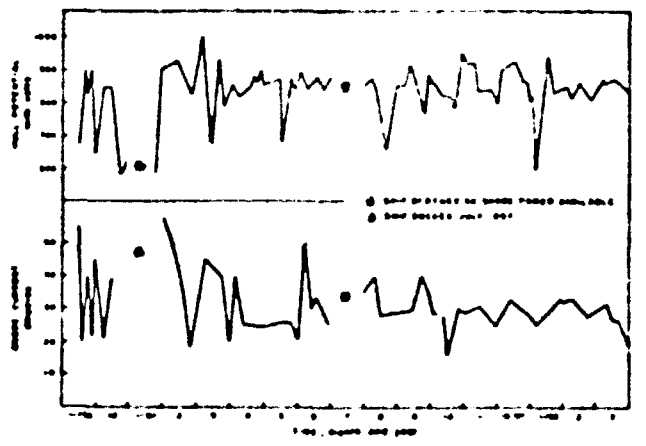
The graph of the current-hull potential relationship is shown in Figure 8. The current demand for protection of this ship was rather less than that required for similar destroyers using magnesium and steel anodes, because there was no large wastage of current near the anode, the plastic current shield had the effect of moving the anode array from the hull and, the rearguard stern anodes close to the propellers were used.

Figure 8—Relationship of anode current and hull potential with time.
