EMISSION INVESTIGATION

Date of Incident:	March 8, 1972 4:00 A.M. and 6:00 A.M.
Location:	Dept. 246, Distillation Column
Kind of Emission:	Aroclor
Result of Emission:	Sprayed Aroclors in cone shaped pattern Southeast of column to points at least 100 yards from column. No complaints received.
Cause of Emission:	Loss of cooling on column condenser resulting from: 4:00 A.M. Incident - Electrical failure 6:00 A.M. Incident - City water make-up pump not started after electrical failure. No means available to isolate vacuum jet to stop emission once it starts when power is off.
Investigating Committee:	Virgil Brawley Clarrie Buckley Jim Grant Gerald McRaven Ed Stewart, Chairman

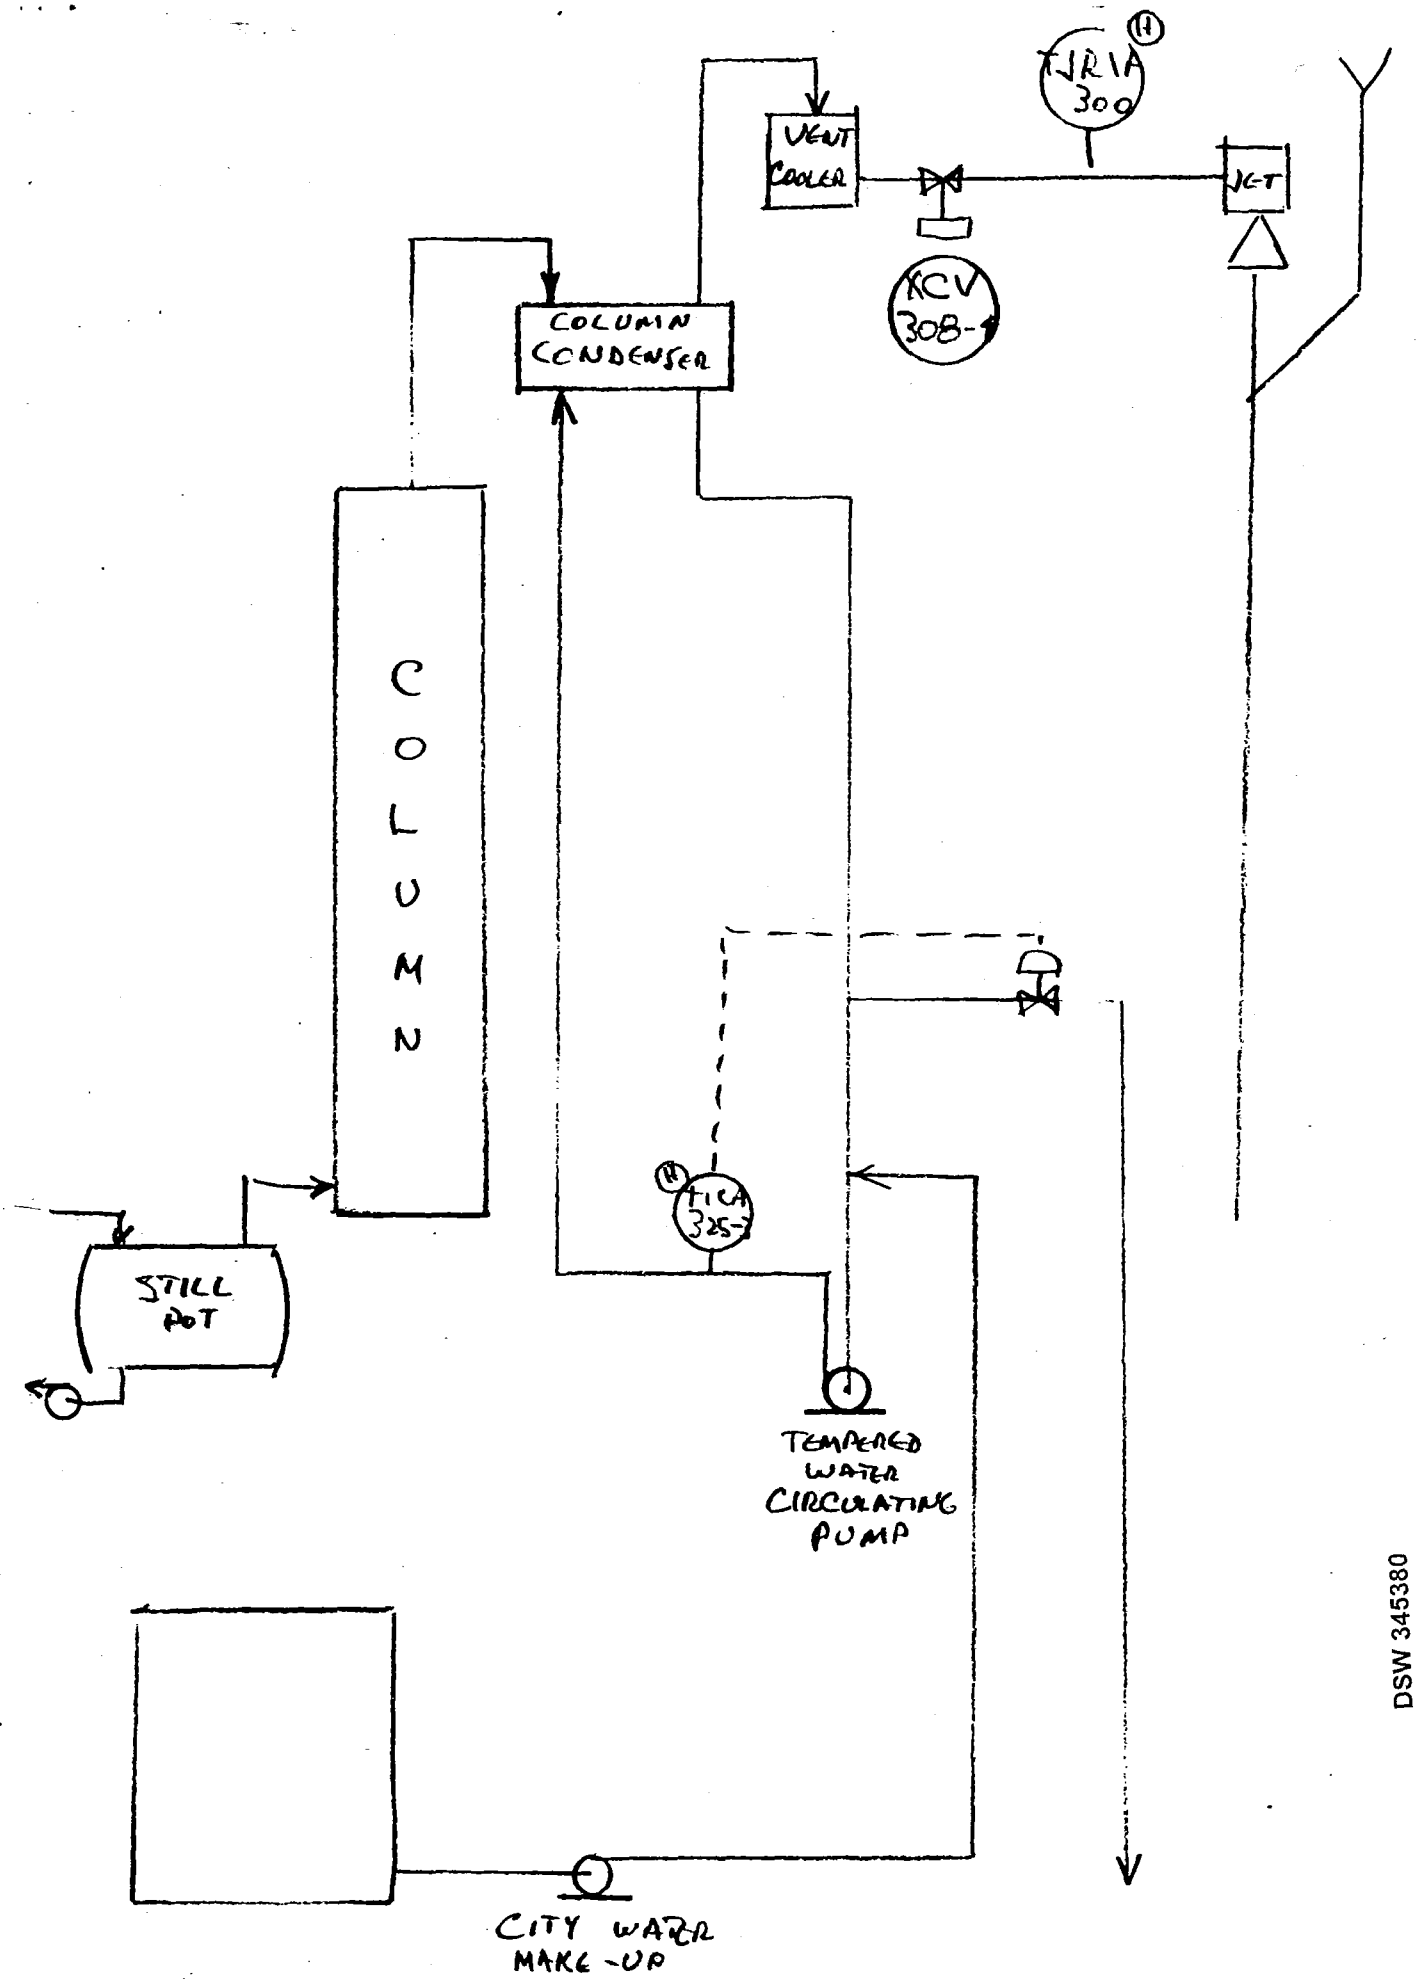
The emission was caused by a loss of cooling water at the column condenser. There will be a continued generation of vapors after the external source of heat has been discontinued because the column itself is a heat sink, and when refluxing stops there will be a further decrease in pressure which will promote boiling. Without cooling water on the condenser some vapors will pass uncondensed through the condenser, the vent cooler, the jets and into the atmosphere. Although there is a valve in the vent line it currently fails in the open position on electrical failure, and there is no way to immediately stop the vapors during an electrical failure. See sketch.

It is believed that after the first power failure all the water in the tempered water loop drained from the loop, and during this attempted start-up very little water was present. However, the power was on and the interlock functioned as design to cut the fires. The emission was stopped by the operator when he shut the valve in the vent line to the atmosphere after receiving a call from neighboring department.

The emissions can be stopped by closing the valve between the vent cooler and the jet. This can be done with minor electrical changes to permit the valve to fail in the closed position on electrical failure. This can be done safely and was reviewed with Dale Schillinger and Walter Howard of CED.

1. Alter the vent valve (XV 308-4) to close on electrical failure.
   (TSD & Maintenance EDC 4/1/72)

2. Install "open-close" switch for vent valve (XV 308-4) in the control room so operator can accuate when needed. To be interlocked with the furnace such that when closed the fires will be out.
   (TSD & Maintenance EDC 4/1/72)

4. Install alarm in control room on city water make-up pump that supplies column tempered water circulating system.
   (TSD & Maintenance EDC 4/1/72)
