RCRA Inspection Report

Fort Dearborn
103 Lumpkin Campground Road
Dawsonville, Georgia

November 28, 2023, 9:15 AM

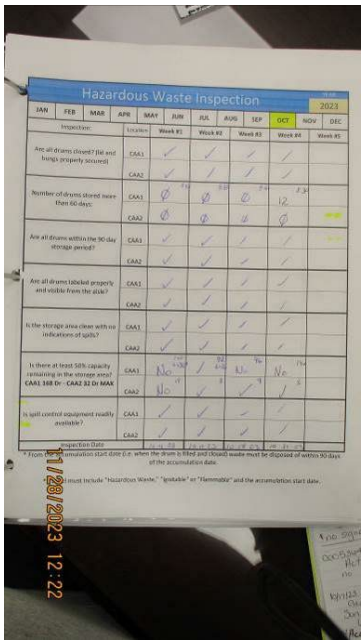
Figure 23: IMG_0243.JPG – Weekly Inspection Log

The inspectors reviewed Fort Dearborn's available records of inspections of the hazardous waste central accumulation area (CAA) for the past three years. The inspection log (Figure 23) includes a checklist to record observations about leaking containers and for deterioration of containers caused by corrosion or other factors. The inspection log should be updated to record observations about aisle space, visible container labels, legible container labels, complete container labels, closed lids and bungs, material on outside of container, rings tight, rings turned down, condition of containers, containers compatible with waste, container grounding, control of ignition sources, container stacking, container storage time, contents of containment units, housekeeping, emergency communication, fire extinguisher, spill response kit, and salvage drums. The records include the date of the inspection but must be updated to include the time, and the name, signature and initials of the employee conducting the inspection.
