INVESTIGATION OF POTENTIALLY HAZARDOUS BYPRODUCTS FORMED FROM PCB'S DURING THE ADELAIDE STREET TRANSFORMER FIRE

This report summarizes the efforts of the MOE Laboratory Services Branch and MOE Central Region to investigate the possibility of formation of toxic oxygenated compounds by the partial combustion of PCBs during the fire at 60 Adelaide Street, December 9th, 1977.

Laboratory Services Branch
February 9th, 1978.

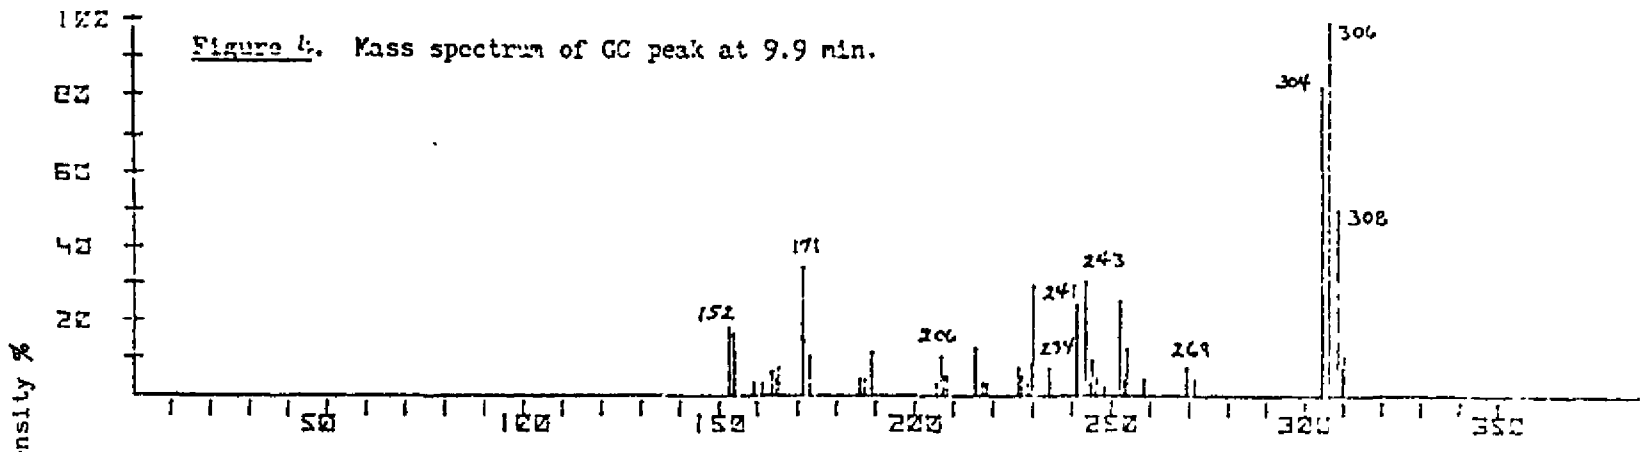
The soot extracts were shown to contain many polynuclear hydrocarbons which, in the full spectrum scanning mode, masked most of the other components present. However, one full confirmatory mass spectrum was obtained for an oxygenated product (Fig. 4). This spectrum gave an excellent match with published spectra for tetrachlorodibenzofuran (Fig. 5).

Figure 4. Mass spectrum of GC peak at 9.9 min.

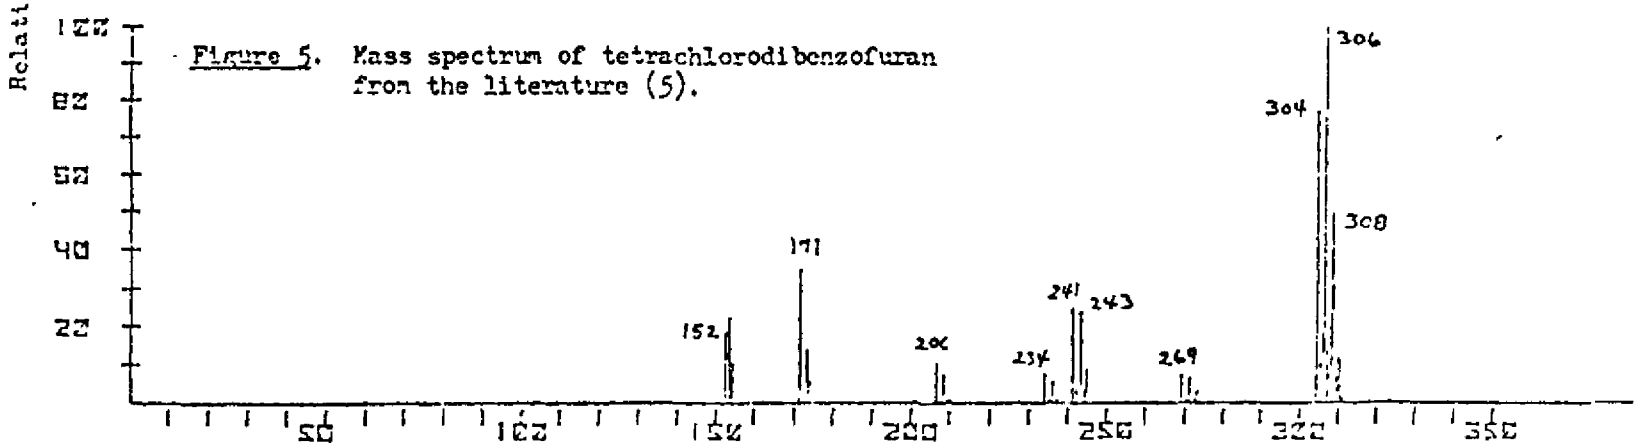
Figure 5. Mass spectrum of tetrachlorodibenzofuran from the literature (5).

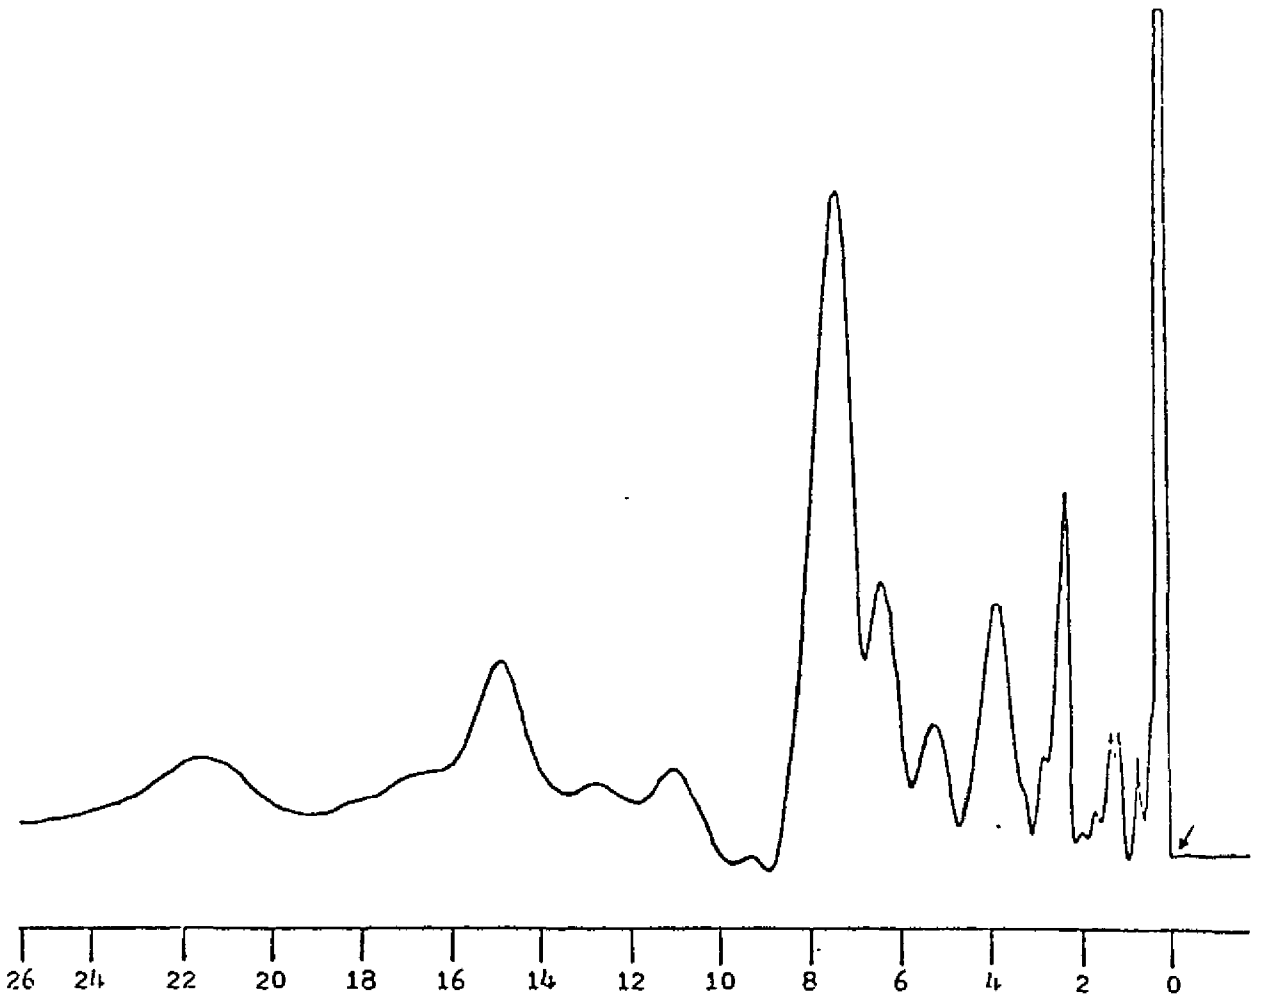
Analysis of Fraction 5 of the soot extract by GC revealed the presence of a number of components sensitive to electron capture detection and with retention times in the range expected for PCDFs and PCDDs. Figure 2 gives the chromatogram resulting from this GC/ECD analysis. Assignment of peak identities using GC only requires the use of authentic standards, which were not available at the time.

Figure 2. GC-ECD chromatogram of Fraction 5 of the soot extract.

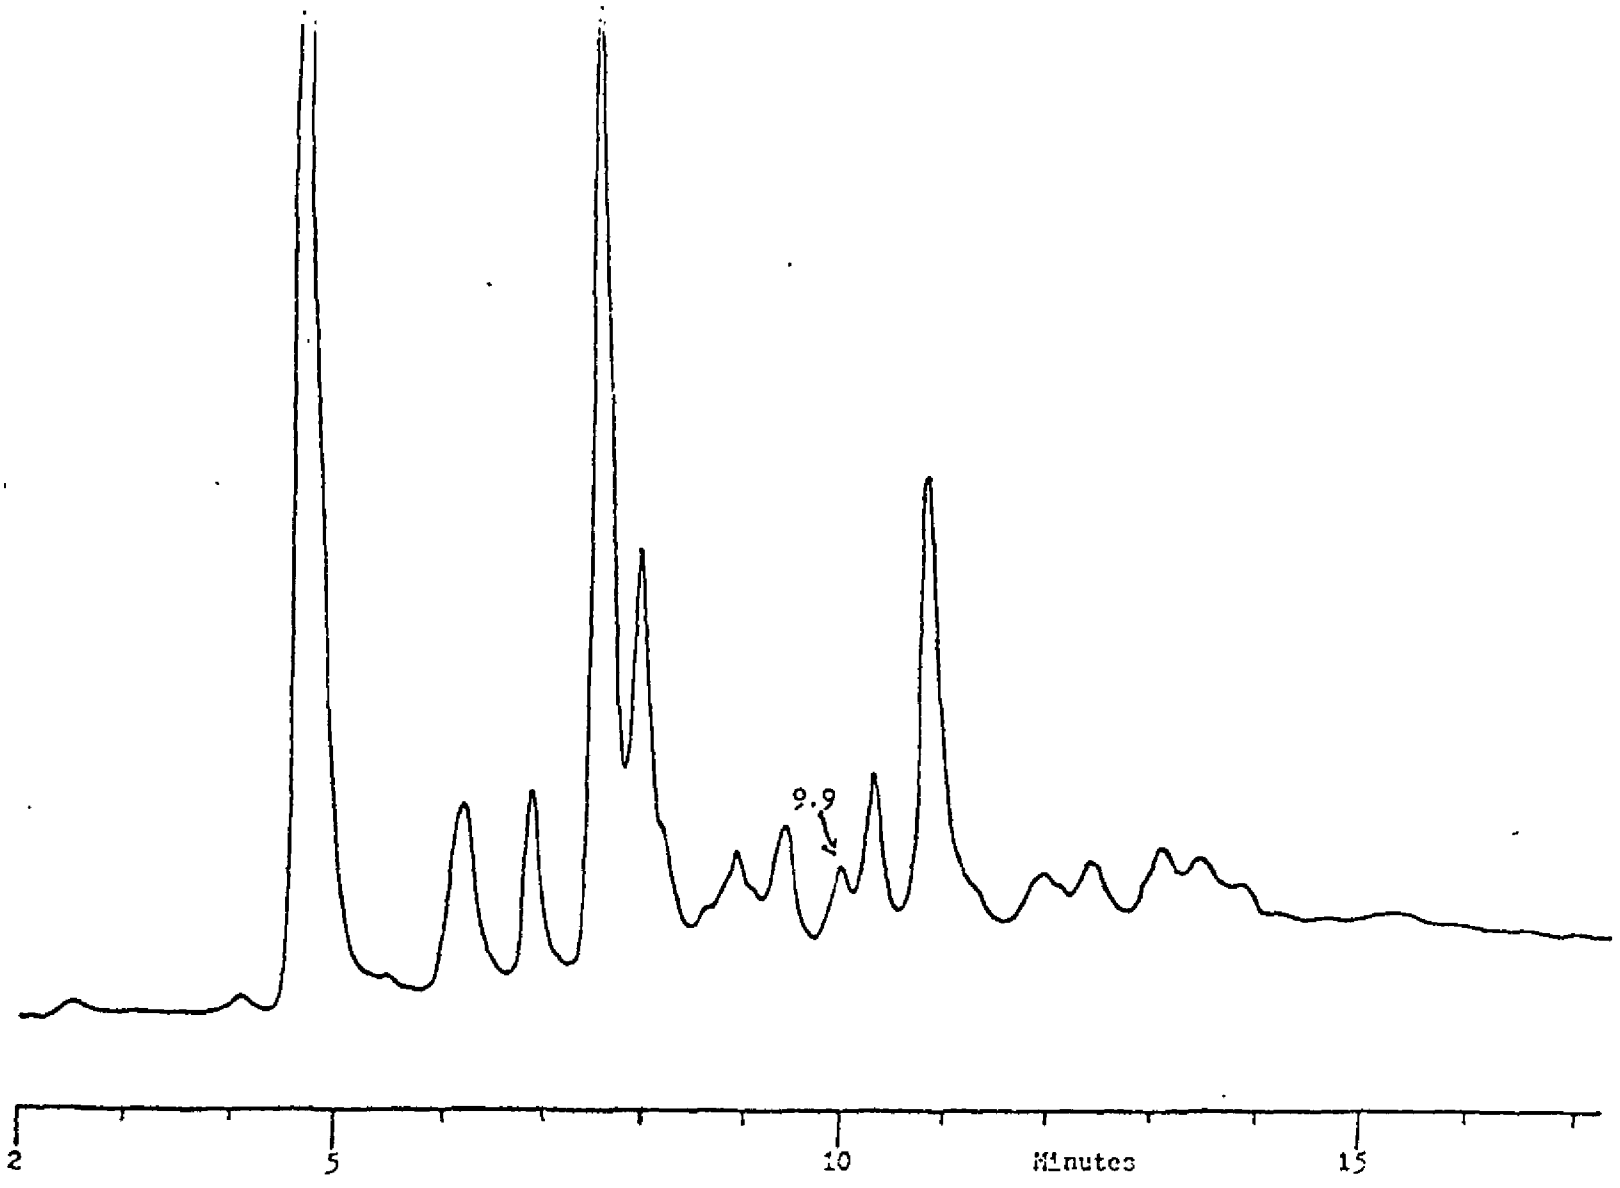
GC/MS analysis in the full spectrum scanning mode provided a great deal more information on the sample compositions. Figure 3 illustrates the total abundance chromatogram of Fraction 5. MOst of the peaks were determined to be polynuclear aromatic hydrocarbon (PAHs) by interpretation of spectra. It appears that the clean-up procedure was not selective enough to remove these substances. This is unfortunate because the spectra of the PAHs, which are in high concentrations, mask the spectra of any other components present. However, one peak with a retention time of 9.9 min, was well separated and gave the spectrum shown in Fig. 4. A search of the literature gave an almost perfect match with the spectrum of tetrachlorodibenzofuran illustrated in Figure 5. This is considered a positive identification.

Figure 3. GC/MS total abundance chromatogram of Fraction 5 of the soot extract. The peak marked with an arrow gave the spectrum illustrated in Figure 4.

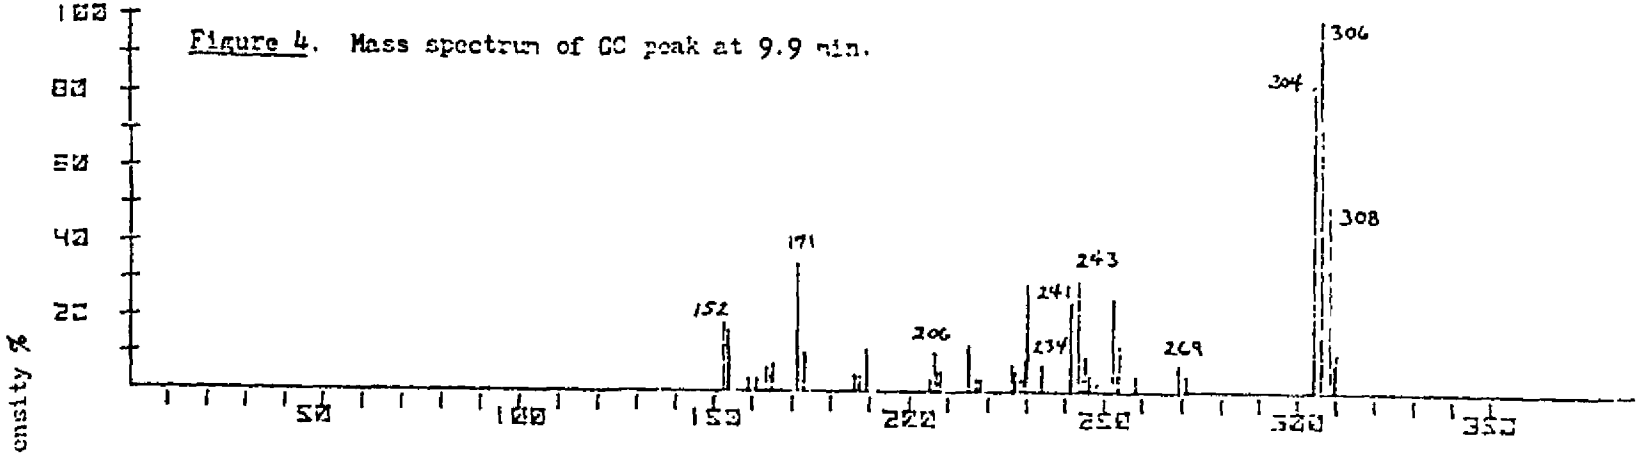
Figure 4. Mass spectrum of GC peak at 9.9 min.

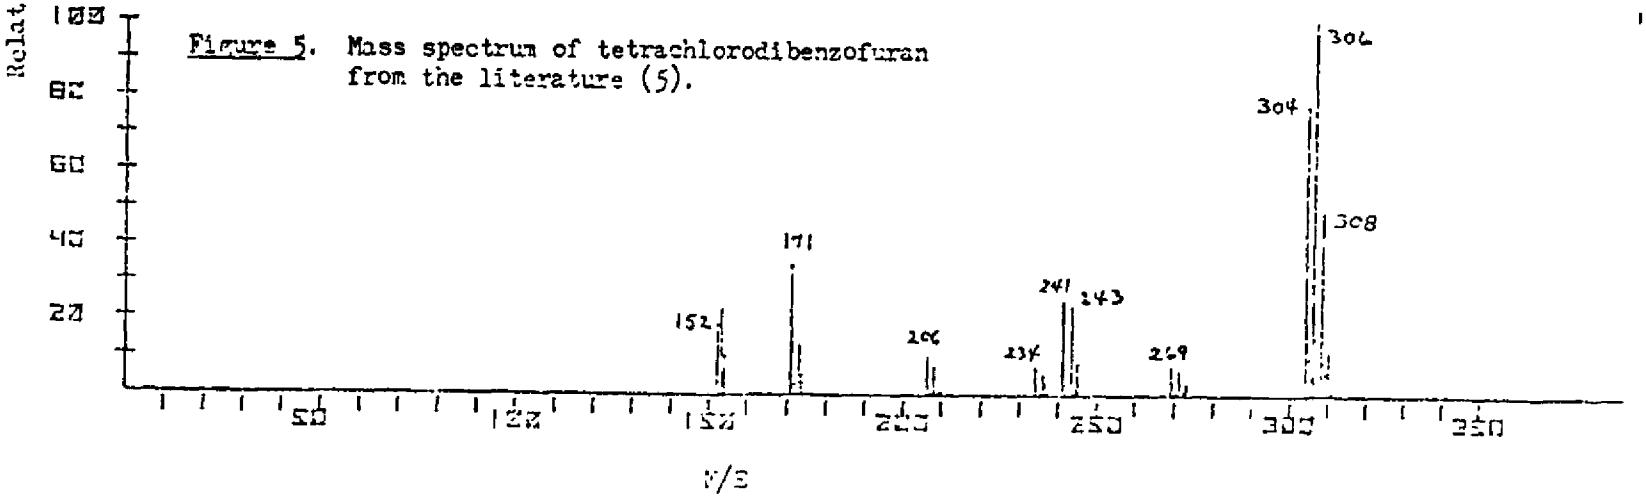
Figure 5. Mass spectrum of tetrachlorodibenzofuran from the literature (5).
