DOCUMENT DESCRIPTION: Industrial Hygiene Support - Insulation Dust Survey Construction Insulation Shop Plant 511 - with Internal Union Carbide Memo

INDUSTRIAL HYGIENE SURVEY

Construction Insulation Shop - Building 511-2018

Report 63-IH-3-G-1

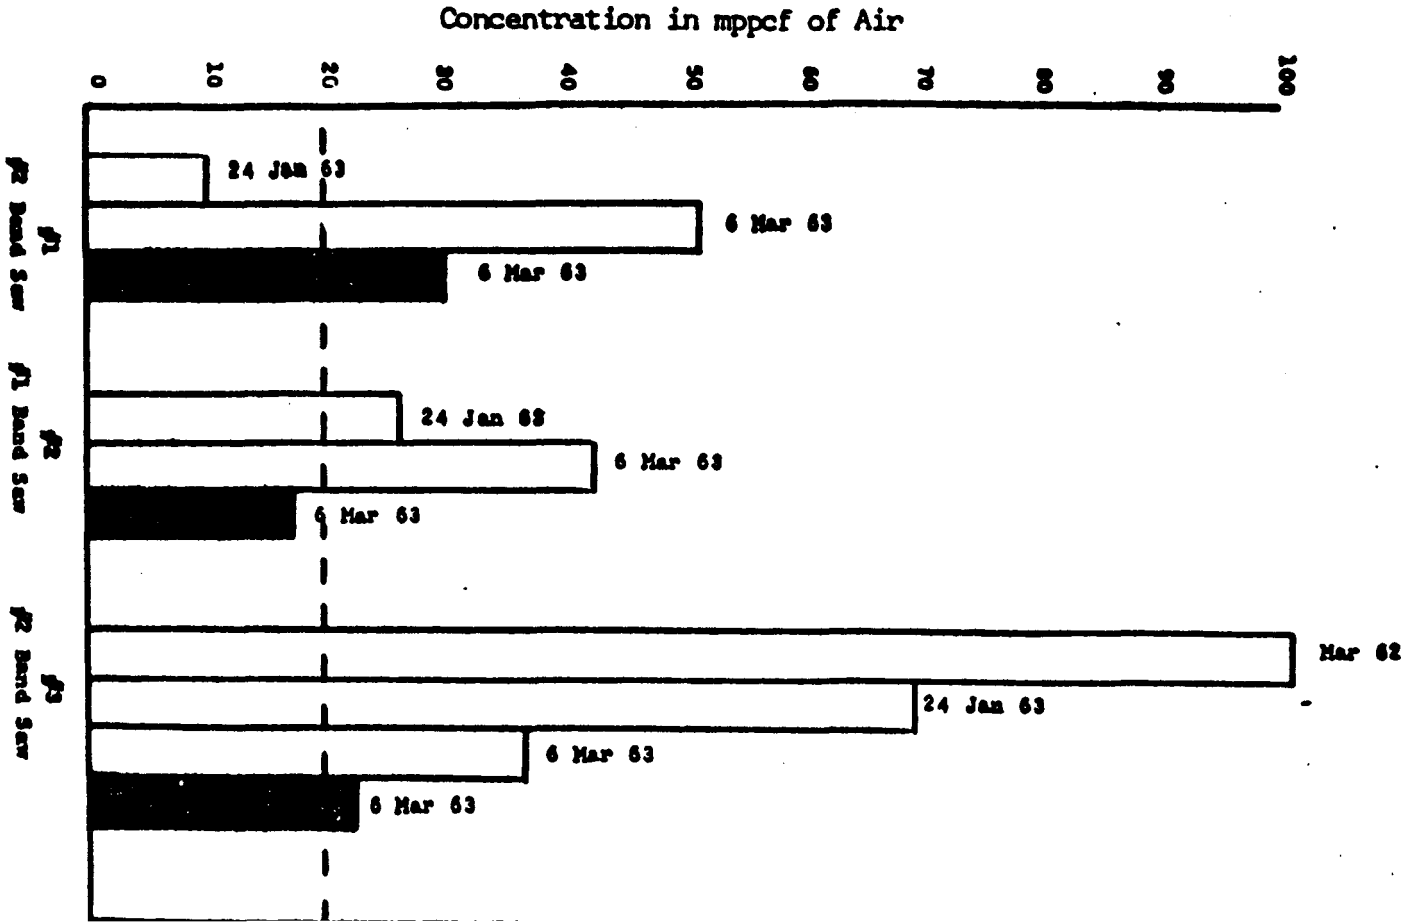
Table #4
Ventilation Rates on Two Band Saws

1. The duct velocity in the downdraft ventilation system on both band saws is far below the recommended value of 4000 fpm.

2. The duct velocity in the overhead ventilation system on both band saws is equal to or more than the recommended value of 4000 fpm.

3. The velocity in the downdraft ventilation systems for both band saws could be increased by patching all holes, leaks, etc., now in existence.

Date	Band Saw	Hood Being Checked	Description of Condition	Ventilation Rate in fpm
25 Feb 63	#2	Downdraft	Only Downdraft System in Operation	1500
6 Mar 63	#2	"	" " " " "	1450
25 Feb 63	#2	"	Downdraft & Overhead System in Operation	1200
6 Mar 63	#2	"	" " " " "	1200
25 Feb 63	#2	"	Every Hood in the System Open	950
6 Mar 63	#2	"	" " " " " "	900
25 Feb 63	#2	Overhead	Downdraft & Overhead System in Operation	6500
6 Mar 63	#2	"	" " " " " "	4800
25 Feb 63	#2	"	Every Hood in the System Open	4000
6 Mar 63	#2	"	" " " " " "	
25 Feb 63	#1	Downdraft	Only Downdraft System in Operation	2100
6 Mar 63	#1	"	" " " " "	1500
25 Feb 63	#1	"	Downdraft & Overhead System in Operation	1600
6 Mar 63	#1	"	" " " " " "	1150
25 Feb 63	#1	"	Every Hood in the System Open	1100
6 Mar 63	#1	"	" " " " " "	
25 Feb 63	#1	Overhead	Downdraft & Overhead System in Operation	5500
6 Mar 63	#1	"	" " " " " "	4500
25 Feb 63	#1	"	Every Hood in the System Open	4200

a. The atmospheric dust problem can be reduced to below 20 mppcf of air through the use of improved ventilation techniques or repairs to the existing system, or

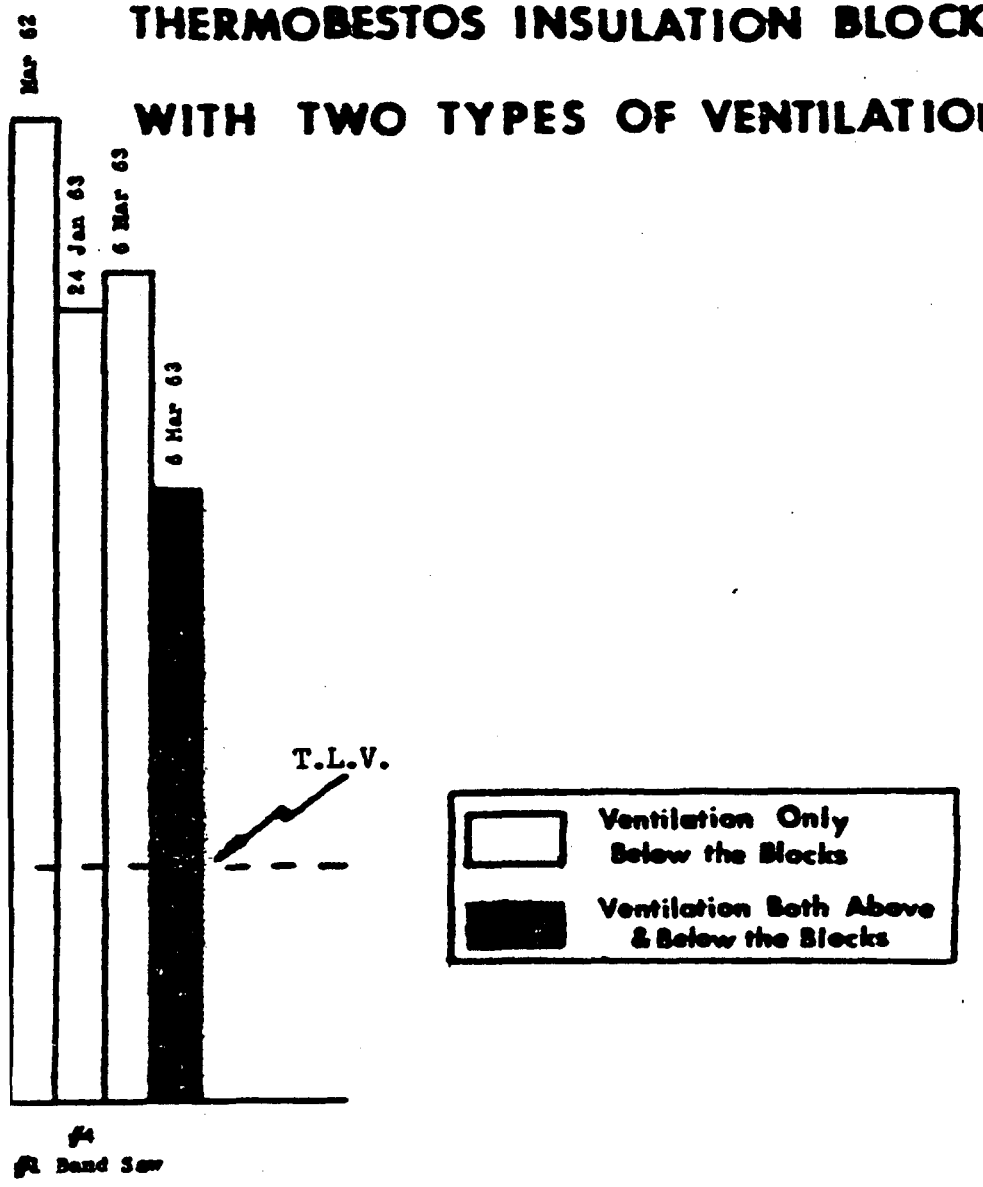
GRAPH NO. 1

1. "Thermobestos" insulation blocks should not be fabricated when using only the original downdraft exhaust ventilation.

2. "Kaylo" insulation blocks could be fabricated safely when using only the original downdraft exhaust ventilation if existing leaks, observed on the #1 band saw, are corrected.

3. "Kaylo" insulation blocks definitely may be safely fabricated when using the entire exhaust ventilation facilities now available, i.e., hoods above the blocks as well as below.

DUST EXPOSURES WHILE FABRICATING KAYLO & THERMOBESTOS INSULATION BLOCKS WITH ONLY DOWNDRAFT VENTILATION
