**Region 6 Compliance Assurance and Enforcement Division  
INSPECTION REPORT**

| Inspection Date(s): | 05/22/2018 | | |
| Company Name: | <b>Wolf Energy, Inc.</b> | | |
| Facility Name: | <b>Marmaduke Lease</b> | | |

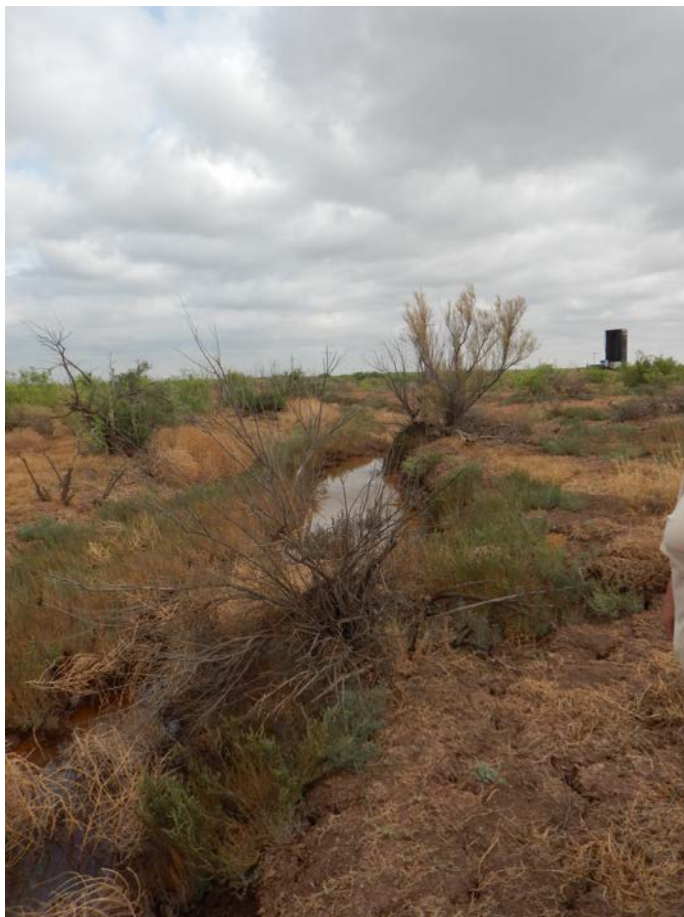
Photograph File Name: DSCN3526.JPG  
Date of Photograph: 05/22/2018  
Latitude: 31.680214 N  
Longitude: -103.640843 W  
Orientation: NW  
Map Datum: WGS-84  
Time of Photo: 10:07 AM  
Photographer: Carol Johnson  
Description:

This image shows approximately 540 feet downstream along Horseshoe Draw from the point of entry of produced water into the draw. We observed some dead vegetation here. We observed clear bed and bank in the draw here as well with some riparian vegetation.

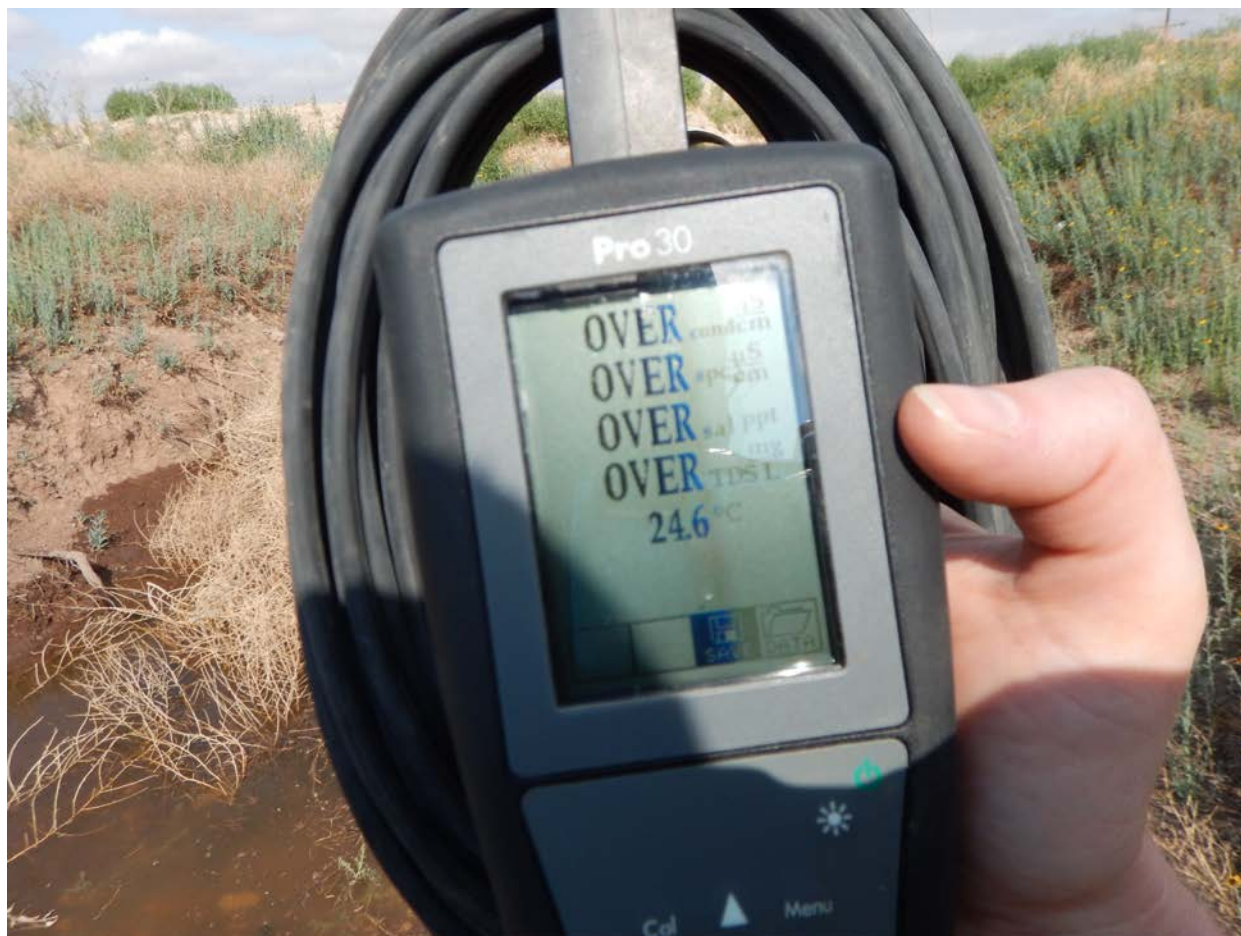
Photograph File Name: DSCN3541.JPG  
Date of Photograph: 05/22/2018  
Latitude: 31.679222 N  
Longitude: -103.639251 W  
Orientation: W  
Map Datum: WGS-84  
Time of Photo: 10:22 AM  
Photographer: Carol Johnson  
Description: This image shows approximately 0.23 miles downstream along Horseshoe Draw from the point of entry of produced water into the draw. A TDS reading was taken and the levels of TDS at this location were over the meter's capabilities to read Conductivity, Specific Conductance, salinity, and TDS.

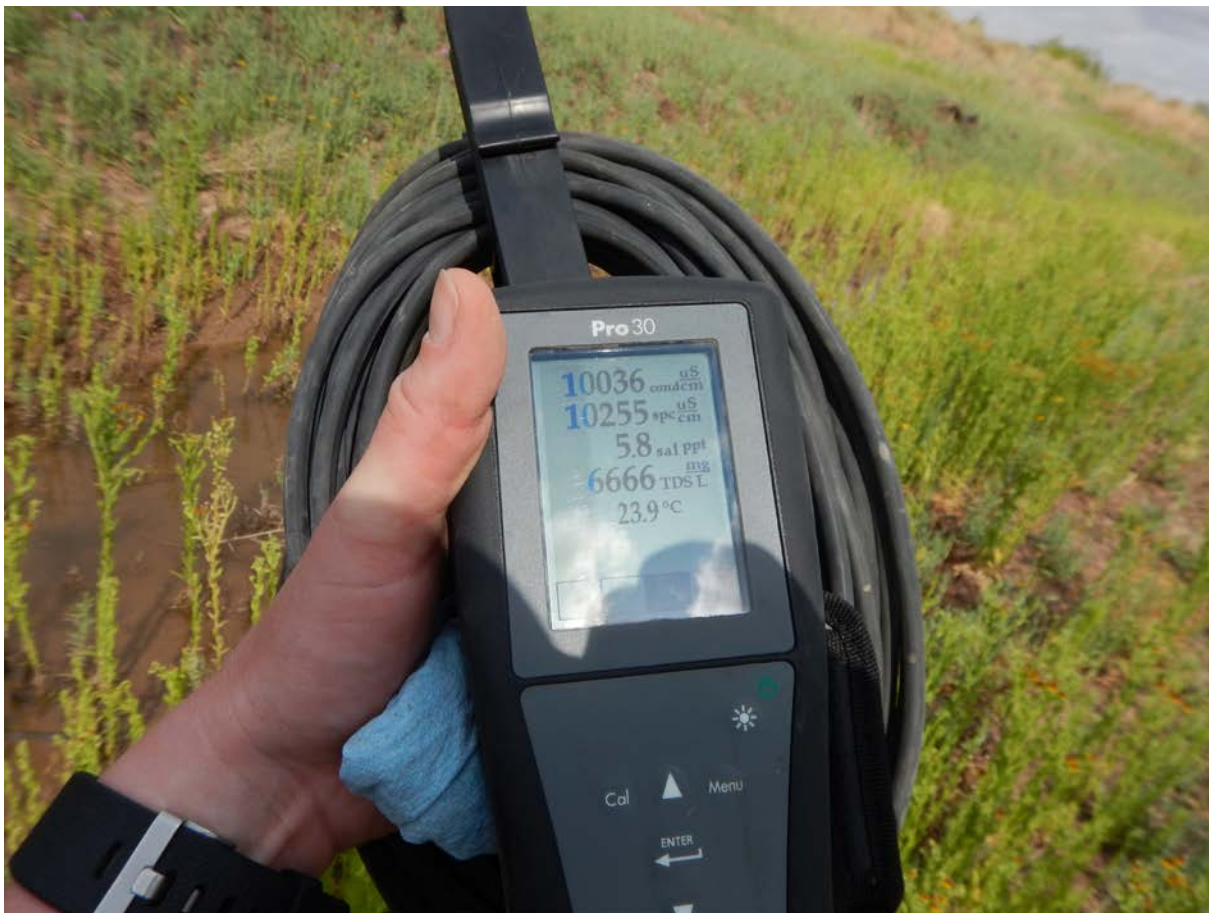
Photograph File Name: DSCN3544.JPG  
Date of Photograph: 05/22/2018  
Latitude: 31.677909 N  
Longitude: -103.636045 W  
Orientation: W  
Map Datum: WGS-84  
Time of Photo: 10:38 AM  
Photographer: Jeanne Eckhart  
Description: This image shows approximately 0.51 miles downstream along Horseshoe Draw from the point of entry of produced water into the draw. A TDS reading of 6,666 mg/L TDS was taken at this location. We observed banks and riparian vegetation in the draw at this location.

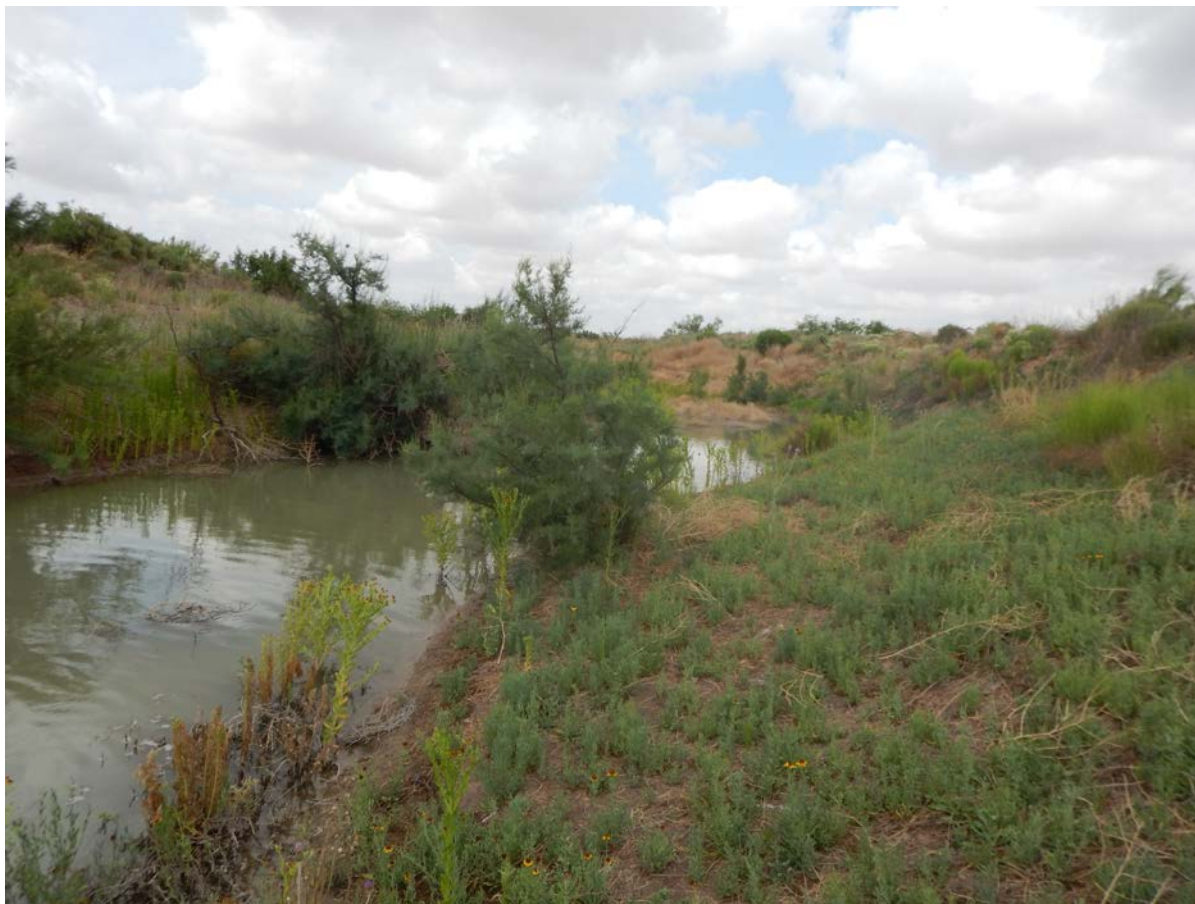
Photograph File Name: DSCN3564.JPG  
Date of Photograph: 05/22/2018  
Latitude: 31.678117 N  
Longitude: -103.634058 W  
Orientation: W  
Map Datum: WGS-84  
Time of Photo: 10:56 AM  
Photographer: Jeanne Eckhart  
Description: This image shows approximately 0.67 miles downstream along Horseshoe Draw from the point of entry of produced water into the draw. We observed banks and riparian vegetation in the draw at this location. At this location Horseshoe Draw merges with the Pecos River. Both waterbodies were flowing at the time of the inspection. This photo shows an upstream view of Horseshoe Draw at the confluence.

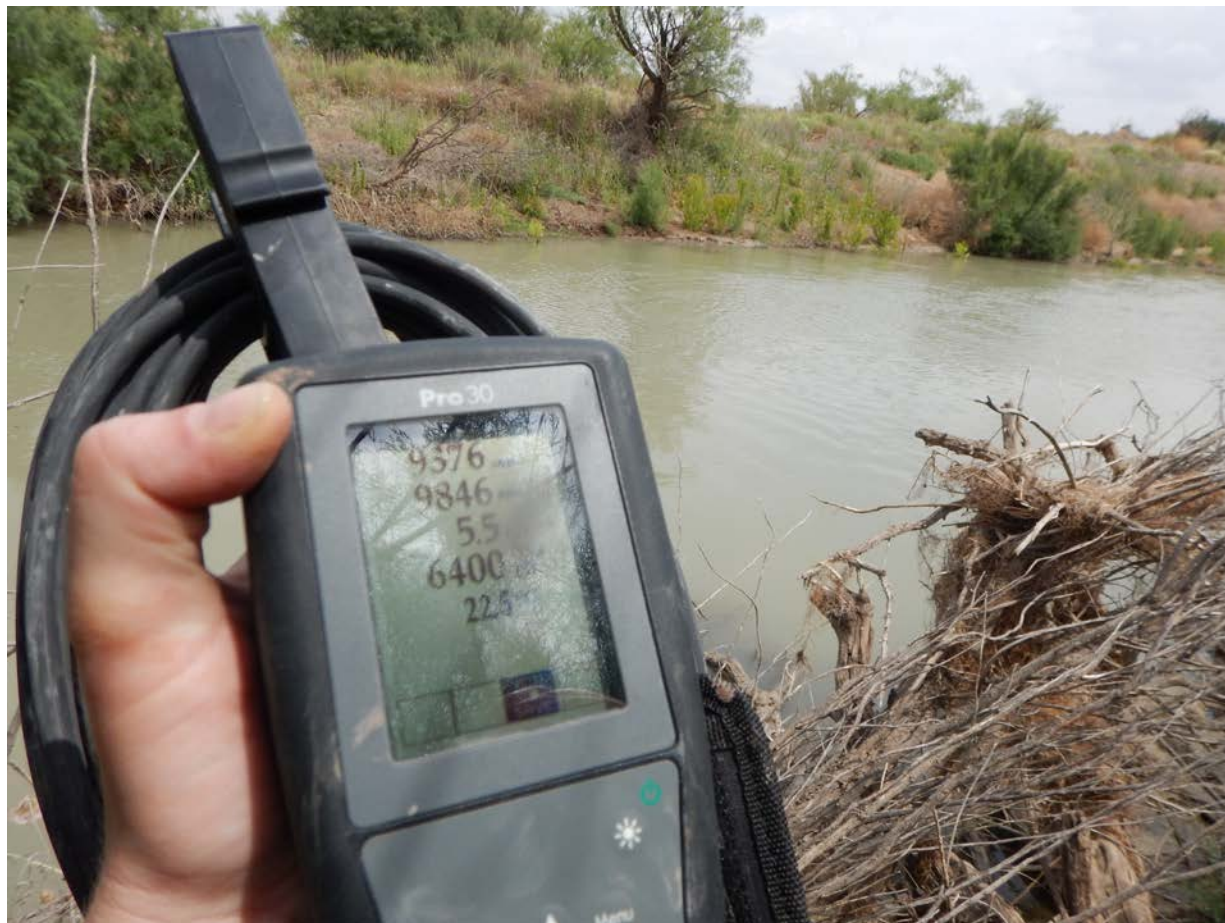
Photograph File Name: DSCN3586.JPG  
Date of Photograph: 05/22/2018  
Latitude: 31.673058 N  
Longitude: -103.630693 W  
Orientation: SE  
Map Datum: WGS-84  
Time of Photo: 12:18 PM  
Photographer: Jeanne Eckhart

Description: This image shows approximately 1.14 miles downstream from the point of entry of produced water into the draw. We observed banks and riparian vegetation in the draw at this location. The Pecos River was flowing strongly during the inspection. A TDS reading of 6,400 mg/L was taken at this location.

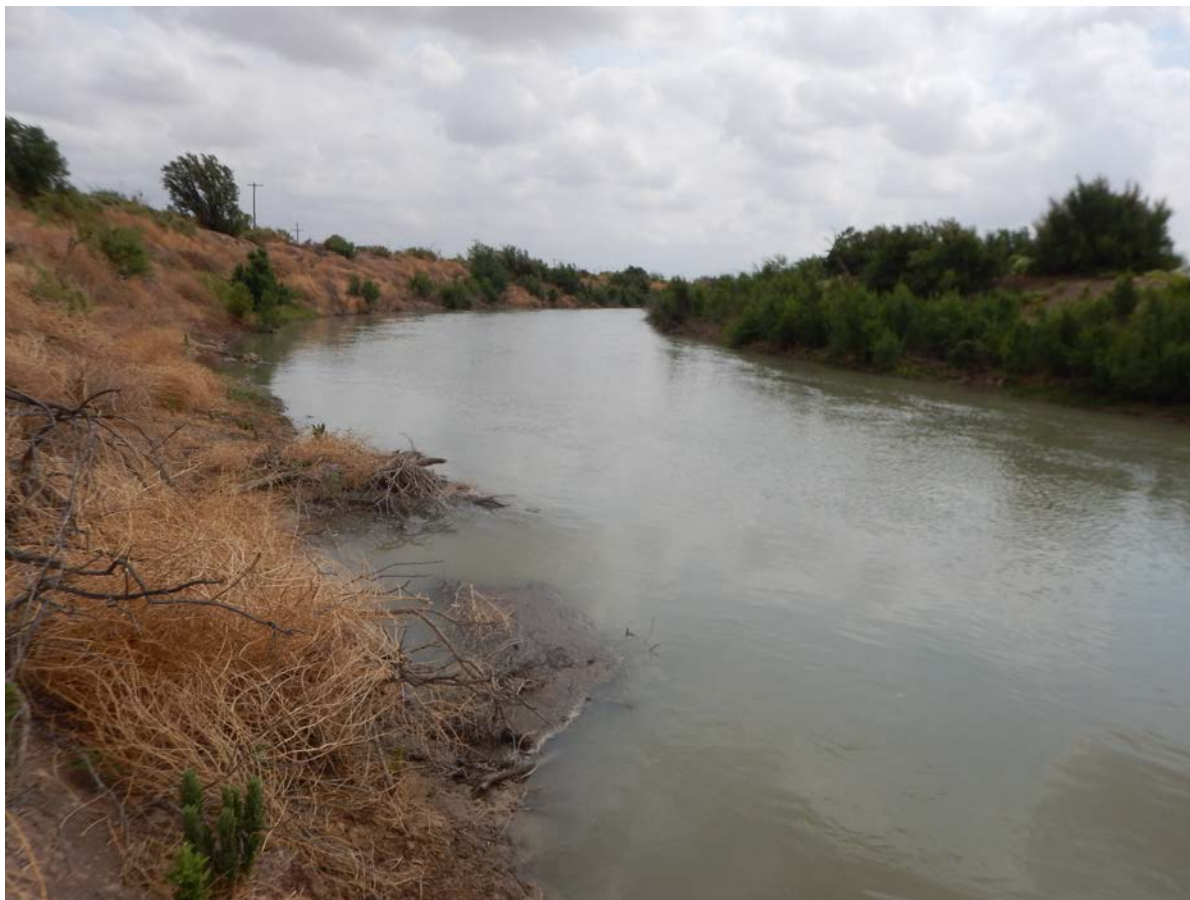
Photograph File Name: DSCN3566.JPG  
Date of Photograph: 05/22/2018  
Latitude: 31.689976 N  
Longitude: -103.636243 W  
Orientation: NE  
Map Datum: WGS-84  
Time of Photo: 11:32 AM  
Photographer: Jeanne Eckhart  
Description:

This image shows the Pecos River upstream approximately 1 mile upstream from the confluence of the Horseshoe Draw and Pecos River. The Pecos River was over 150 feet and approximately 5 feet deep. This image shows an upstream view on the Pecos River.

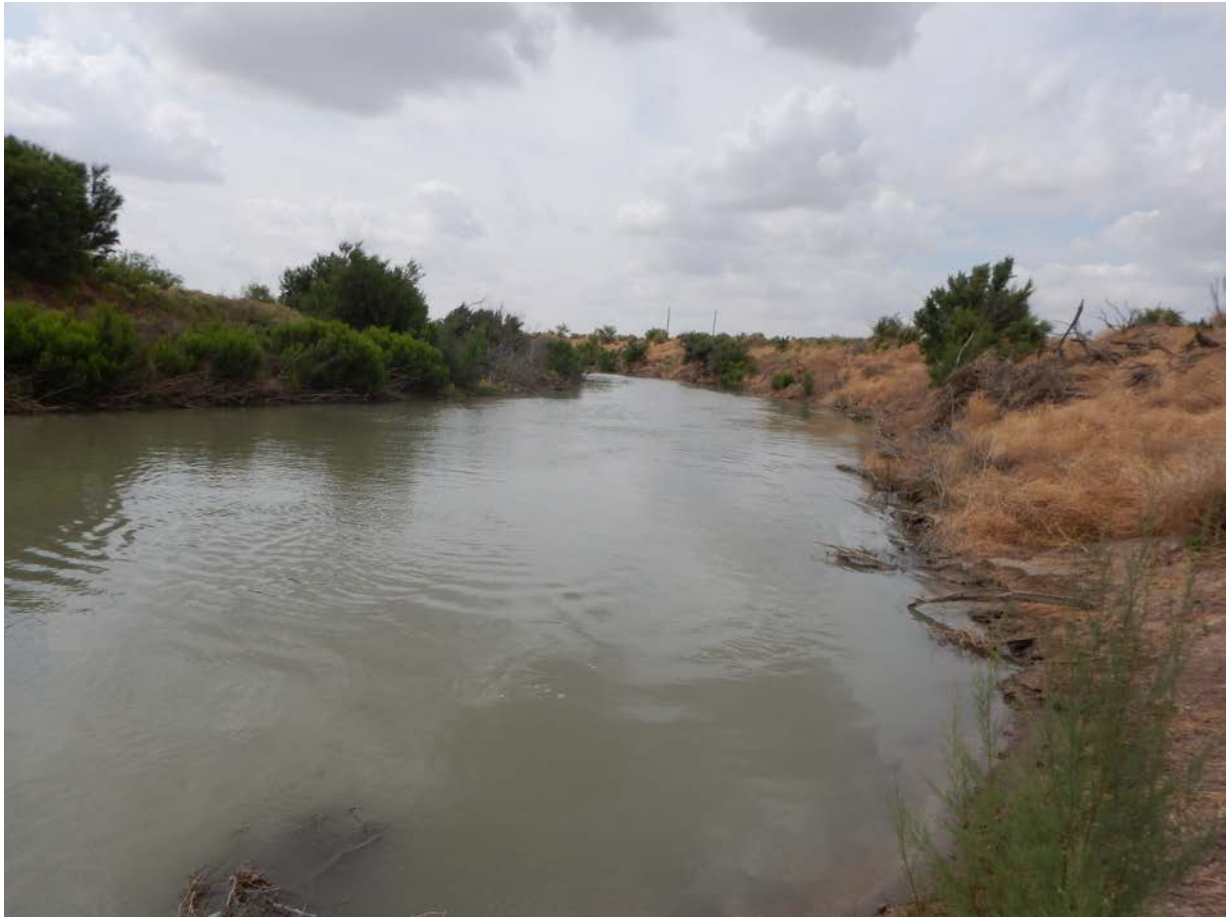
Photograph File Name: DSCN3567.JPG  
Date of Photograph: 05/22/2018  
Latitude: 31.689976 N  
Longitude: -103.636243 W  
Orientation: SE  
Map Datum: WGS-84  
Time of Photo: 11:32 AM  
Photographer: Jeanne Eckhart  
Description: This image shows the Pecos River upstream approximately 1 mile upstream from the confluence of the Horseshoe Draw and Pecos River. The Pecos River was over 150 feet and approximately 5 feet deep. This image shows a downstream view on the Pecos River.

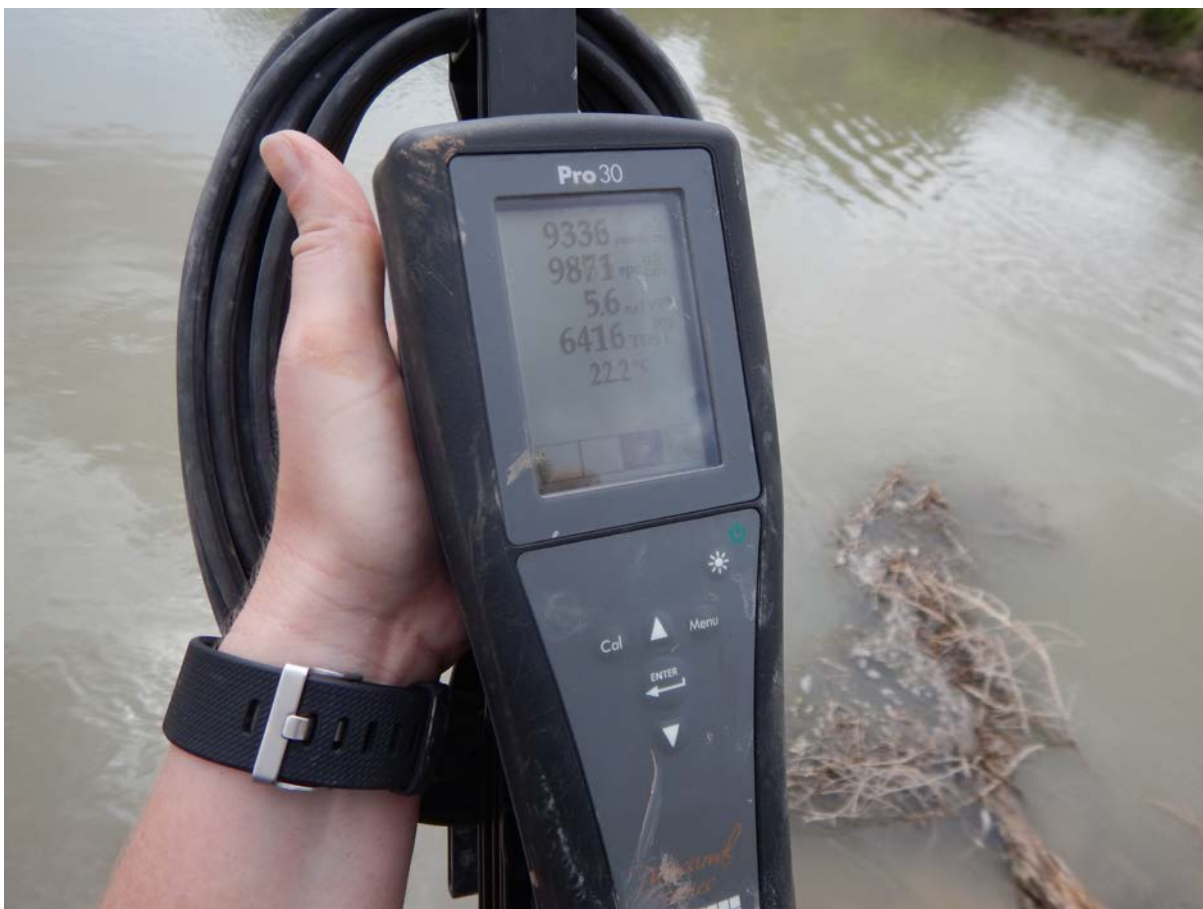
Photograph File Name: DSCN3566.JPG  
Date of Photograph: 05/22/2018  
Latitude: 31.689976 N  
Longitude: -103.636243 W  
Orientation: E  
Map Datum: WGS-84  
Time of Photo: 11:32 AM  
Photographer: Jeanne Eckhart  
Description:

This image shows the Pecos River upstream approximately 1 mile upstream from the confluence of the Horseshoe Draw and Pecos River. The Pecos River was over 150 feet and approximately 5 feet deep. A TDS reading of 6,416 mg/L was taken at this location.

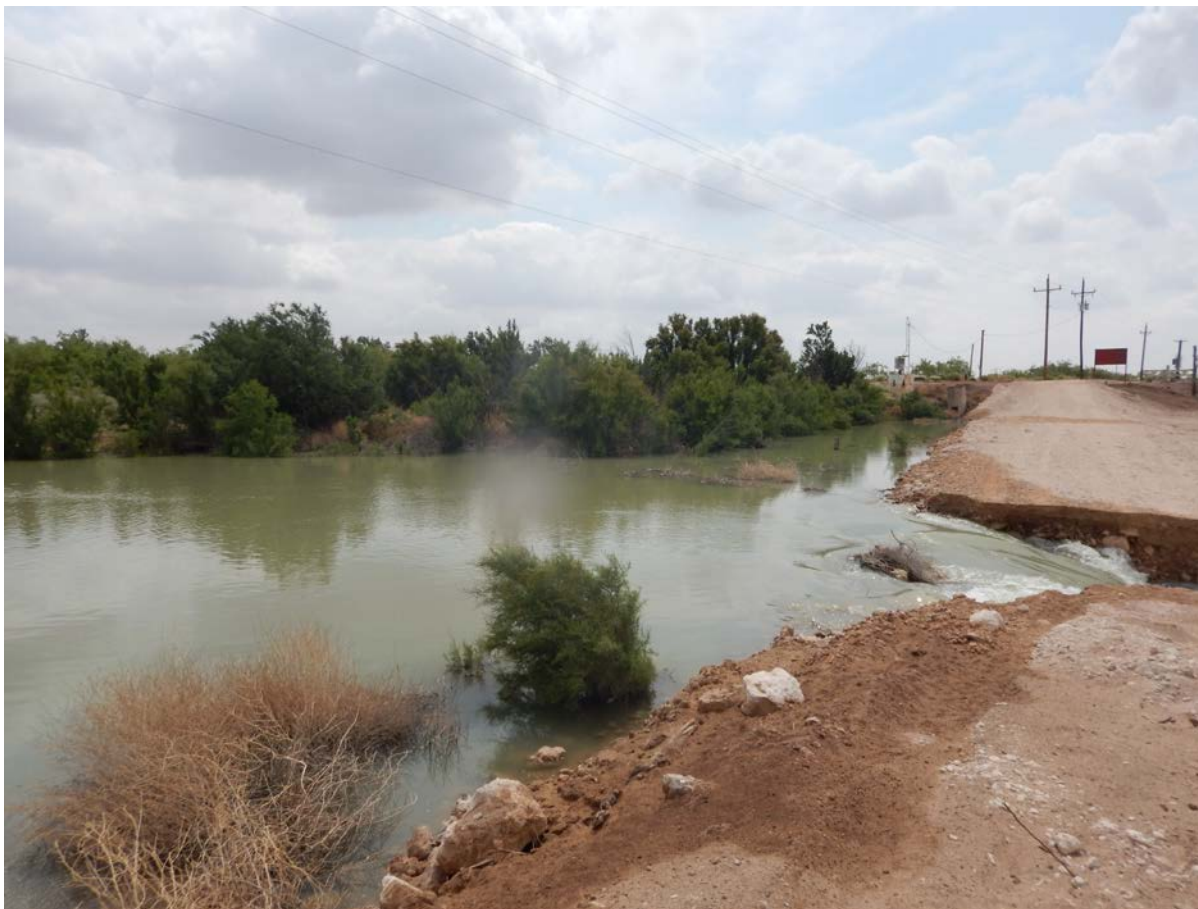
Photograph File Name: DSCN3570.JPG  
Date of Photograph: 05/22/2018  
Latitude: 31.689222 N  
Longitude: -103.621160 W  
Orientation: S  
Map Datum: WGS-84  
Time of Photo: 11:49 AM  
Photographer: Carol Johnson  
Description:

This image shows the Pecos River upstream approximately 2 miles upstream from the confluence of the Horseshoe Draw and Pecos River. The Pecos River had been dammed up at this location and the river had eroded through dam prior to the inspection.

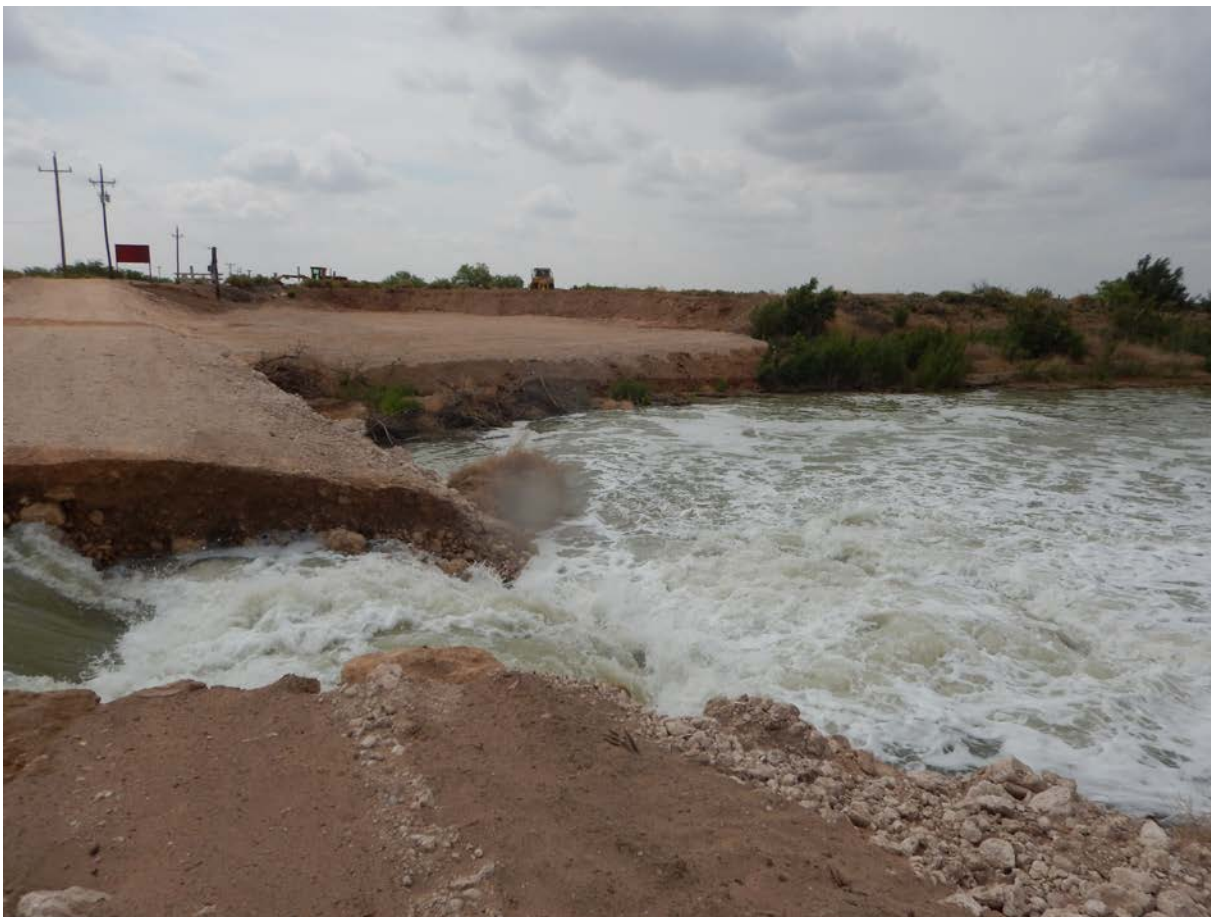
Photograph File Name: DSCN3585.JPG  
Date of Photograph: 05/22/2018  
Latitude: 31.689222 N  
Longitude: -103.621160 W  
Orientation: S  
Map Datum: WGS-84  
Time of Photo: 11:56 AM  
Photographer: Carol Johnson  
Description:

This image shows the Pecos River upstream approximately 2 miles upstream from the confluence of the Horseshoe Draw and Pecos River. The Pecos River had been dammed up at this location and the river had eroded through prior to the inspection.

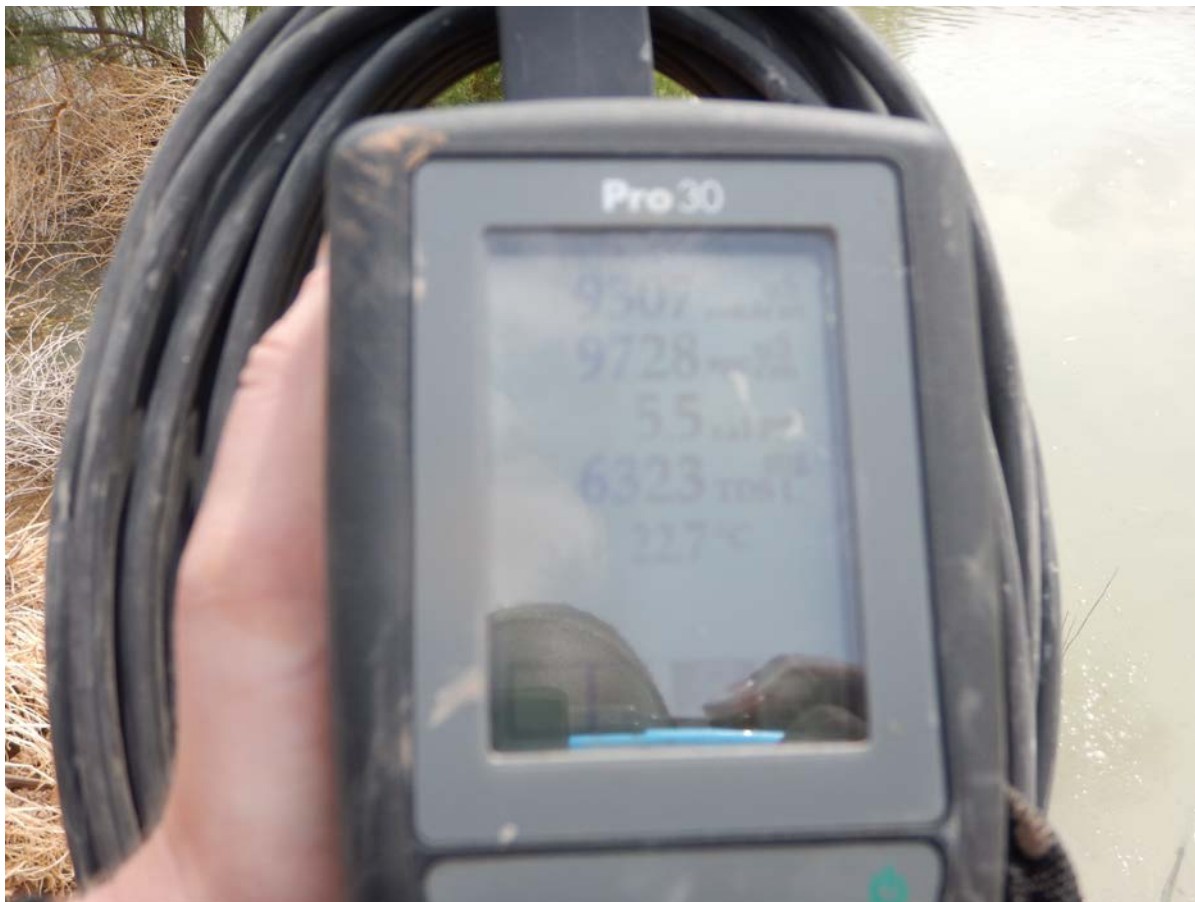
Photograph File Name: DSCN3582.JPG  
Date of Photograph: 05/22/2018  
Latitude: 31.689222 N  
Longitude: -103.621160 W  
Orientation: S  
Map Datum: WGS-84  
Time of Photo: 11:52 AM  
Photographer: Carol Johnson  
Description:

This image shows the Pecos River upstream approximately 2 miles upstream from the confluence of the Horseshoe Draw and Pecos River. The Pecos River had been dammed up at this location and the river had eroded through prior to the inspection. A TDS reading of 6,323 mg/L was taken at this location.
