**U.S. Environmental Protection Agency
Region 5**

Purpose: Clean Water Act National Pollutant Discharge Elimination System (NPDES)
Compliance Evaluation Inspection

Facility: Village of Mifflin WWTP
17 Maine Street
Mifflin, Ohio 44805

Inspection Date: May 3, 2022

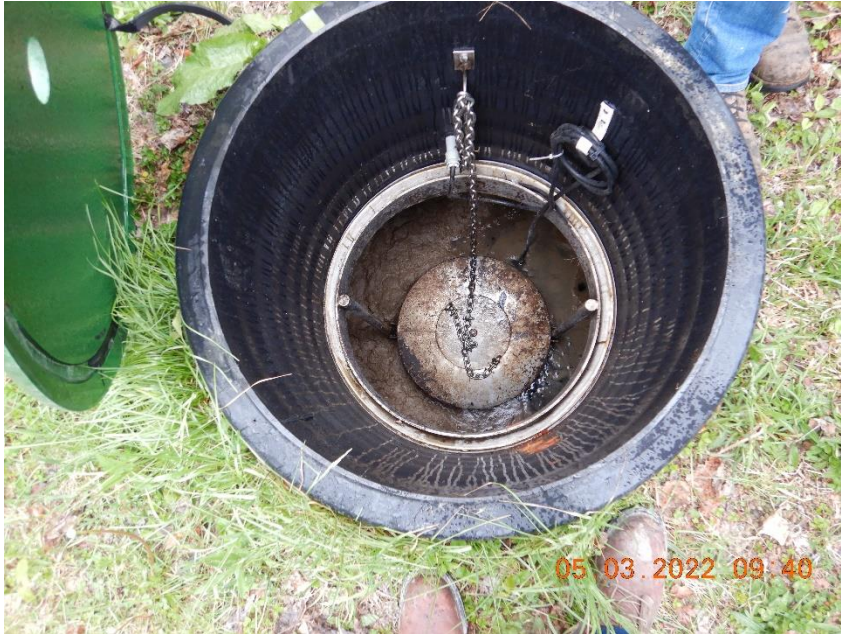
1: DSCN3841

Description: East floating decanter (first decanter) in the sequencing batch reactor.

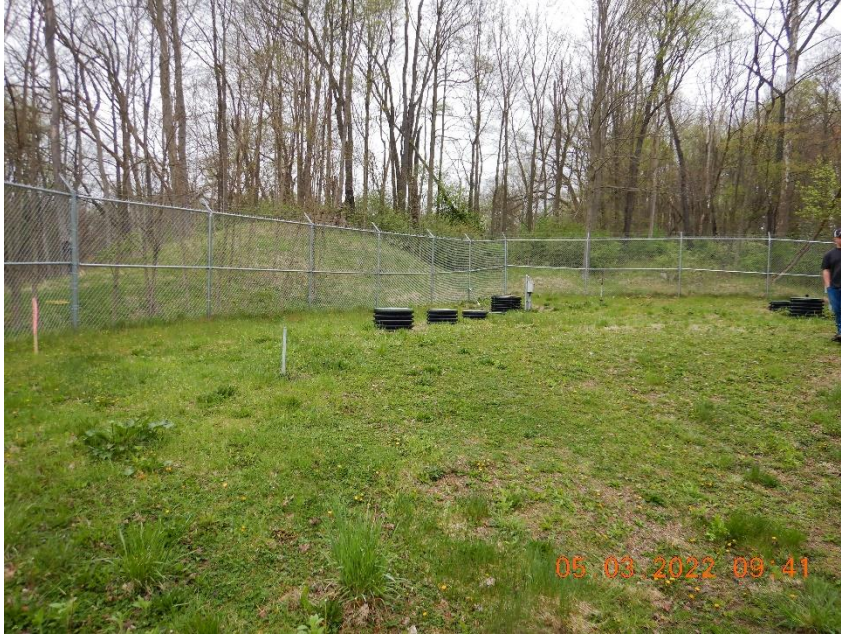
3: DSCN3843

Description: View looking over the underground location of the 30,000-gallon primary treatment tank for the facility.

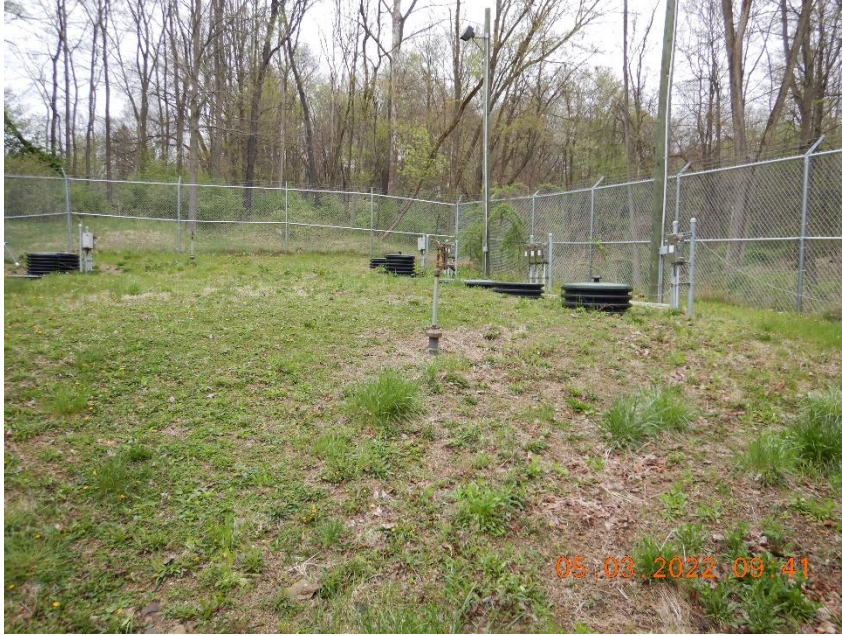
4: DSCN3844

Description: View looking over the underground location of the sequencing batch reactor for the facility.

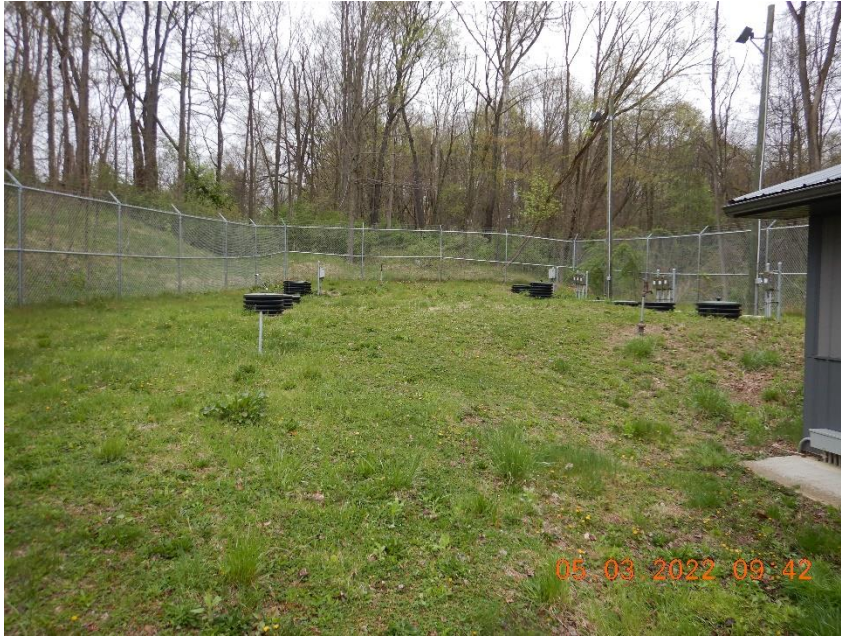
5: DSCN3845

Description: Overview of the exterior plant area where the primary treatment tank (to the left) and the sequencing batch reactor (to the right) are located. The corner of the facility control building is visible off the right side of the photograph.

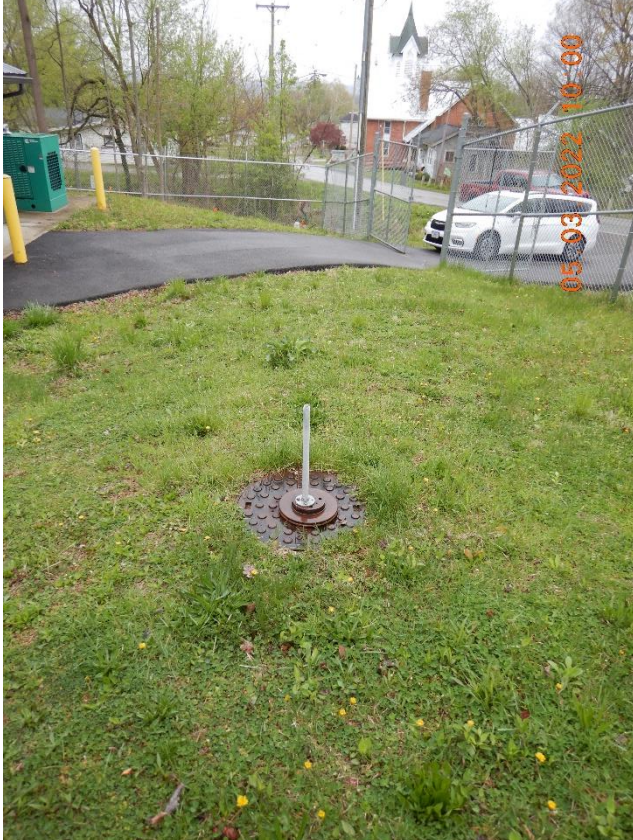
8: DSCN3848

Description: View looking towards the west end of the facility property from the location of the primary treatment tank.

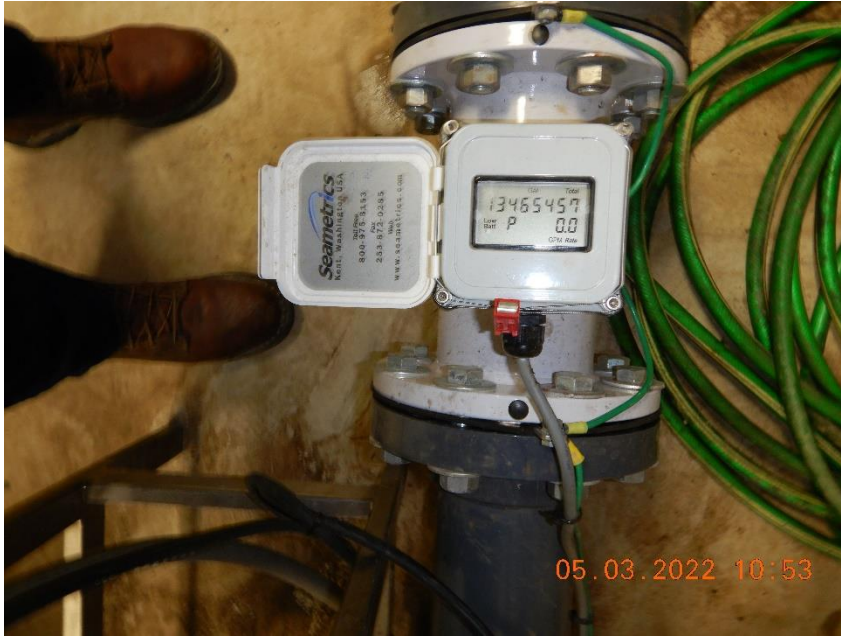
13: DSCN3853

Description: Flow totalizer and magmeter for effluent flow.

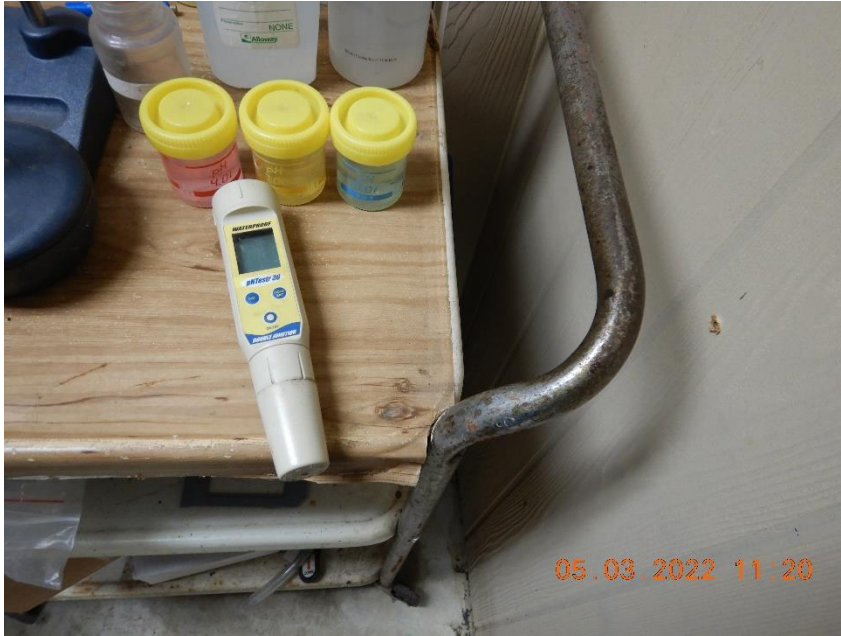
14: DSCN3854

Description: Oakton pHTestr 30 pH meter is used by the operators to collect on-site pH readings of samples. pH meter is calibrated using a three point calibration before each use.

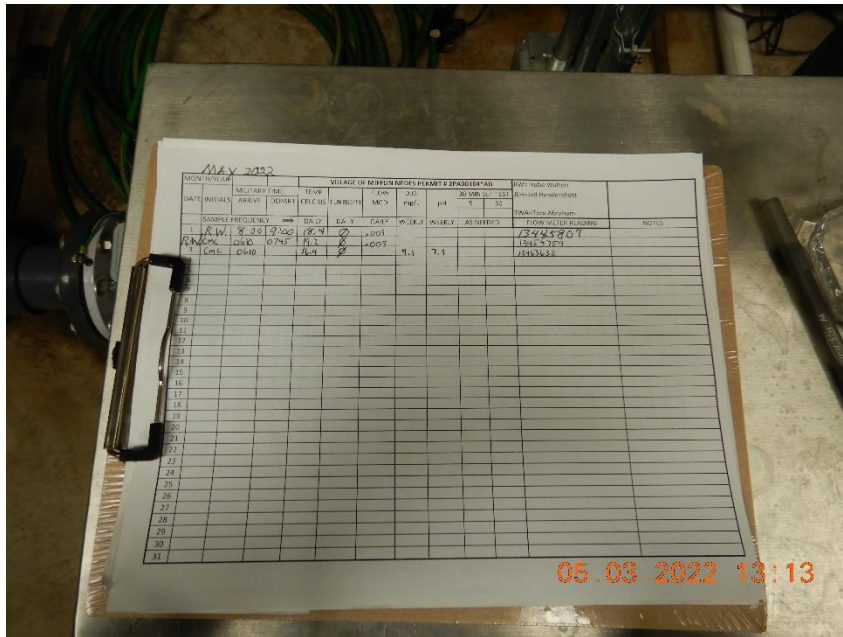
16: DSCN3856

- Although the temperature, turbidity, pH and DO monitoring results are recorded on the log sheet in the WWTP control building, the specific sample collection times for the grab samples used for these measurements and the times when the measurements were taken do not appear to be noted on the log sheets or in the entries in the bound operator notebook. It could not be verified if the measurements occurred within 15 minutes of the samples being collected.

Description: May log sheet used to document operator site hours; pH, DO, turbidity, and temperature readings; general daily flow and flow totalizer readings.

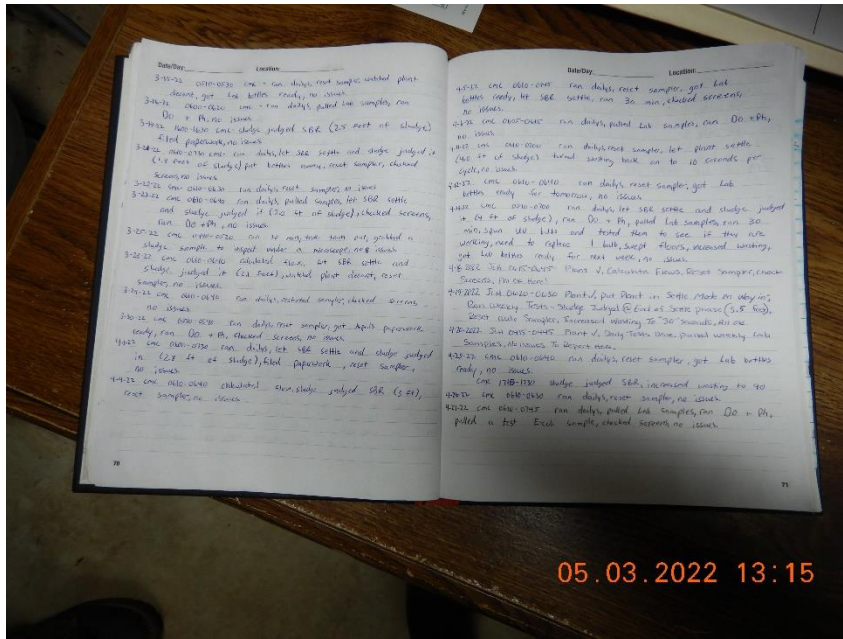
17: DSCN3857

Description: On-site bound operator notebook that the operators use to document specific site activities conducted and hours on site with each site visit.

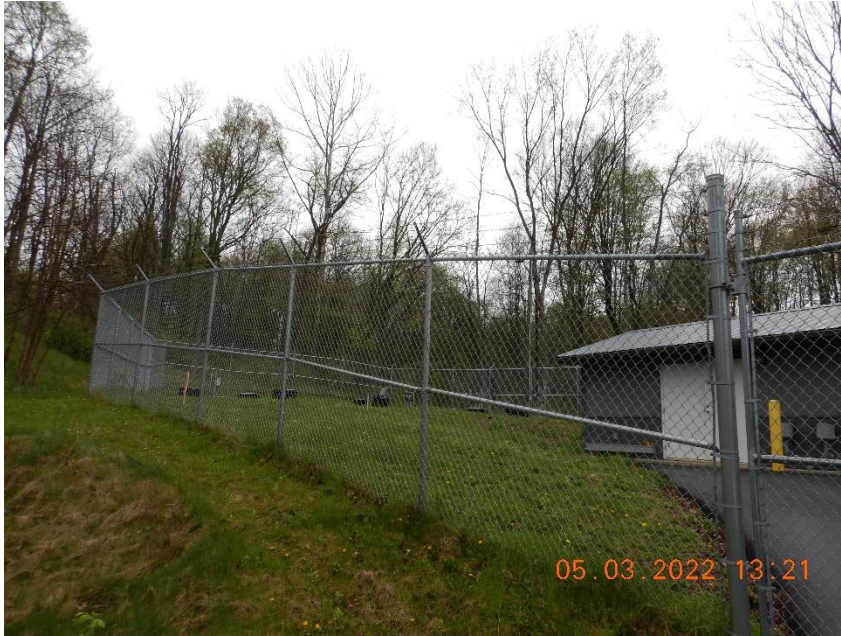
20: DSCN3860

Description: Exterior view of the east side of the Village of Mifflin WWTP. Facility control building also visible. A chain link fence surrounds the facility.

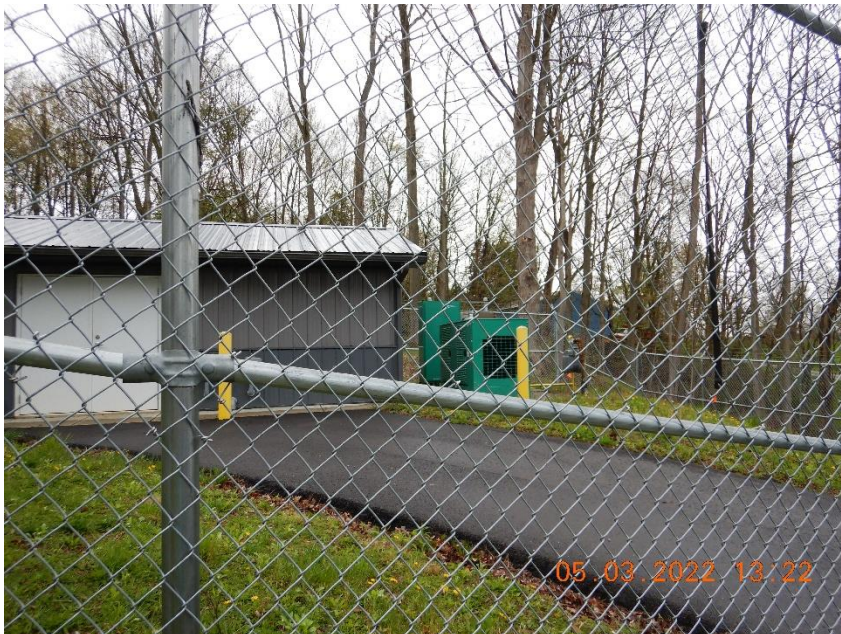
21: DSCN3861

Description: View of the facility control building and the emergency generator.

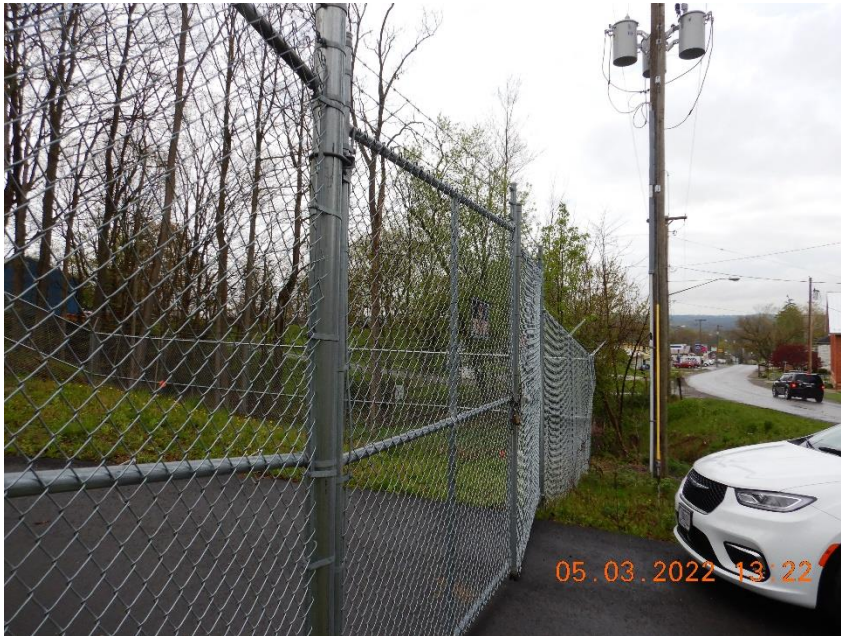
22: DSCN3862

Description: View of the north fenceline in front of the Village of Mifflin WWTP.
