## **PURPOSE OF INSPECTION**

The purpose of the inspection by the U.S. Environmental Protection Agency (USEPA) at the Tilden Mining Company L.C. mine (Tilden) of the Cleveland-Cliffs Inc. facility (Cliffs or Facility) in Ishpeming, Michigan was to describe, evaluate, and document compliance with the Clean Water Act (CWA) and their National Pollutant Discharge Elimination System (NPDES) permit.

**Cleveland Cliffs Inc. – Tilden and Empire Mine**  
**EPA Inspection 9/13/2022 – 9/15/2022**  
**Photomap Overview**

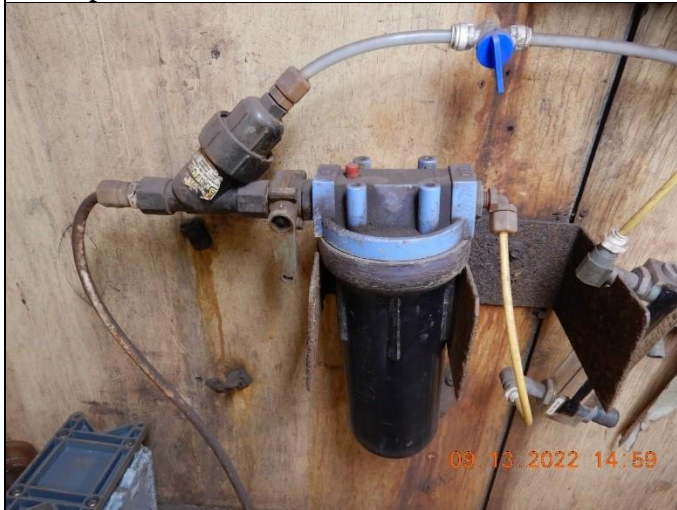
2: DSCN0961.JPG

Description: Filter on the water line with the continuous chlorine analyzer at the Tilden sewage treatment system.

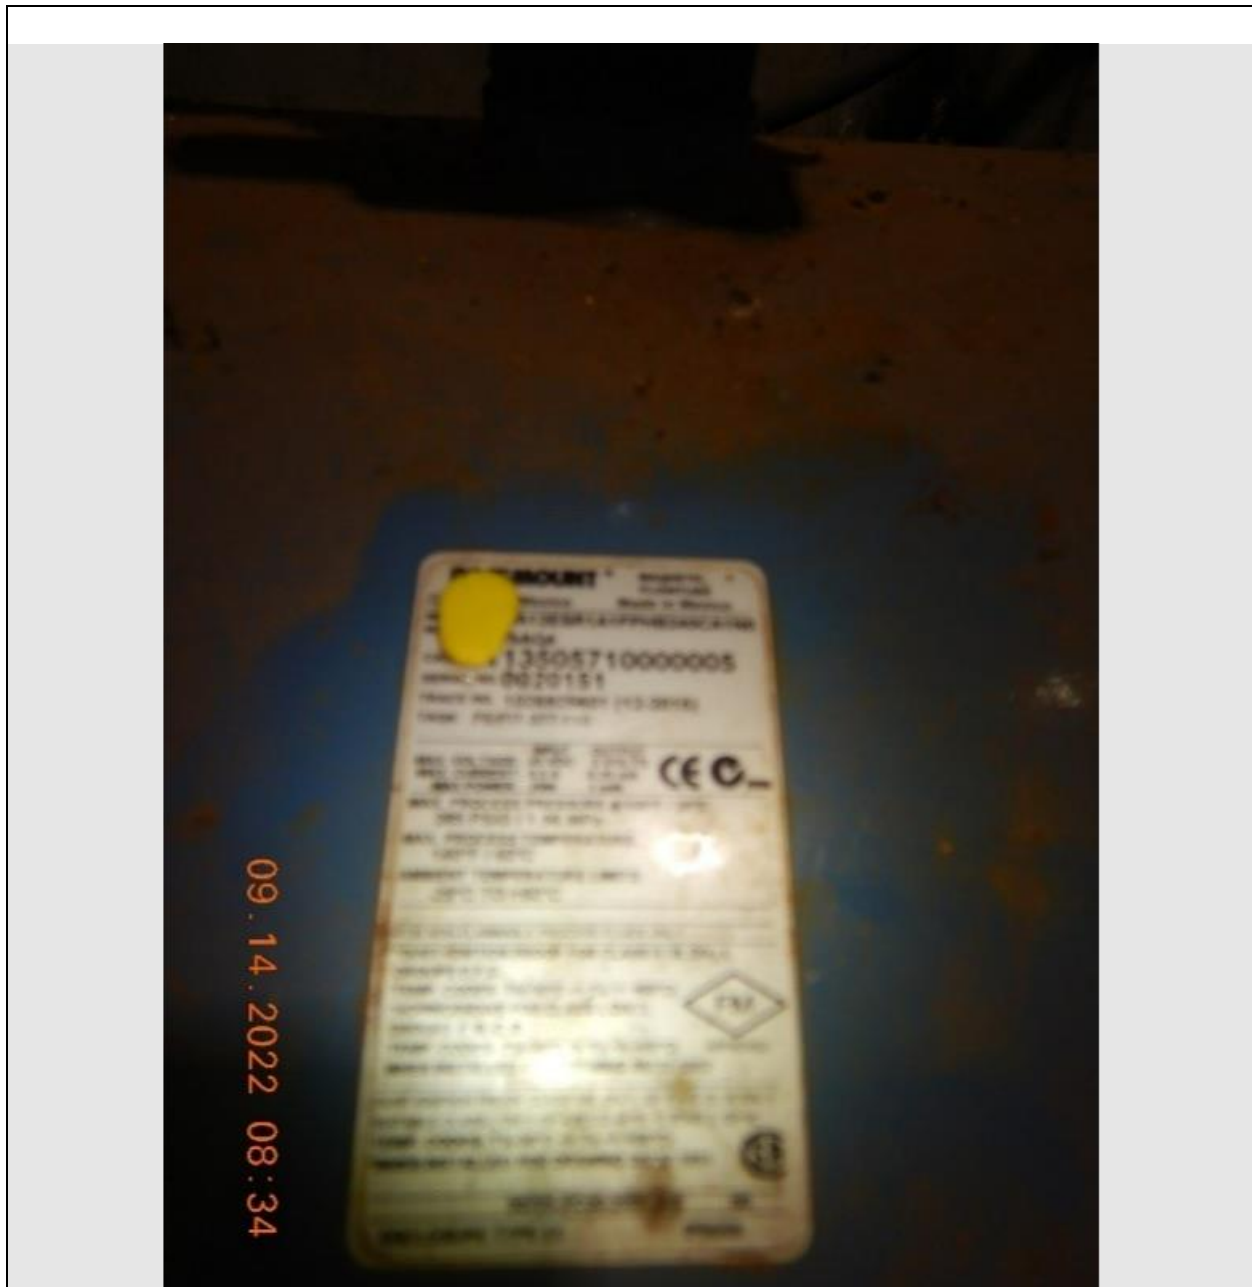
13: DSCN0972.JPG

Description: pH, Temperature and Turbidity measurements on train #1 at the treatment facility for the Tilden tailings basin discharge. Per Michael Korvela, these continuous measurements are for operational purposes only. At the time of the inspection, pH, temperature, and turbidity all had active alarms.

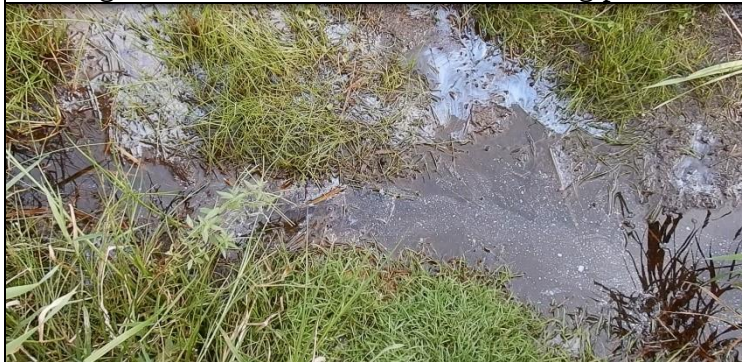
22: DSCN0986.MP4

Description: Location of possible daylighted seep at the east side of the tailings basin. Camera is facing downstream. Location of monitoring point 04.

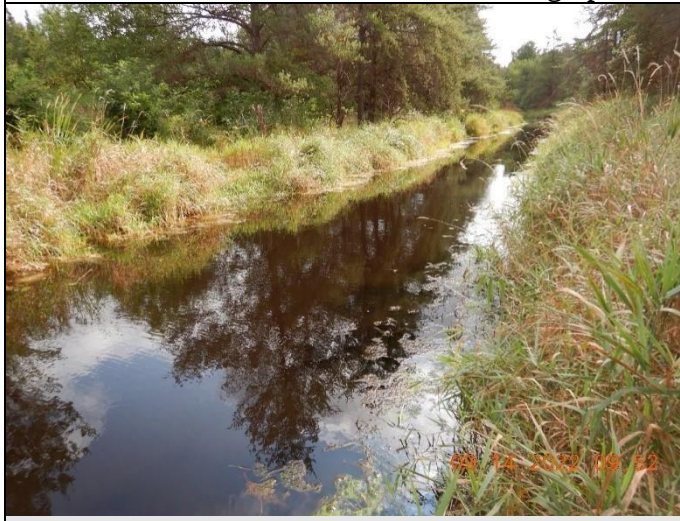
24: DSCN0988.JPG

- USEPA observed and conducted field monitoring on flowing water originating from a location near the toe of the outslope of the east side of the Tilden tailings basin, at a location north of the Gribben Clarification Facility. The waterway is shown in photos 19 through 24, including a video of the flowing water. This location is a possible daylighted seep, which is not monitored as an NPDES outfall, stormwater monitoring location, nor an SSMP location. USEPA field monitoring at this location showed a conductivity of greater than 1,000  $\mu\text{S}/\text{cm}$ , which is above the background values.

Description: Location of possible daylighted seep at the east side of the tailings basin. The water had an iridescent sheen. Camera is looking upstream at the outslope of the tailings basin.

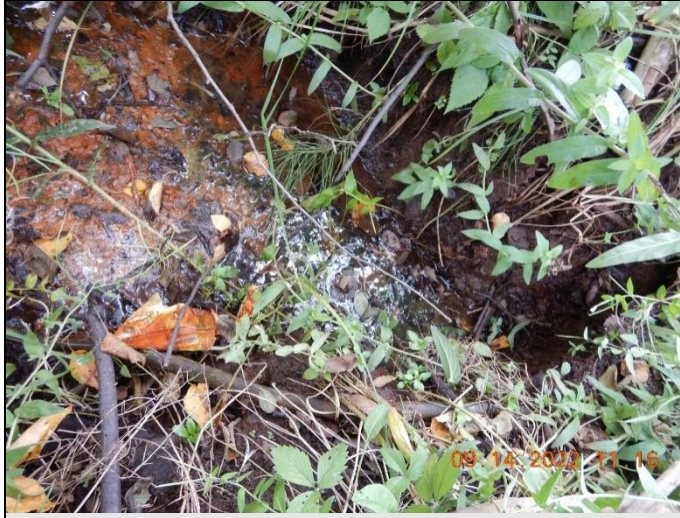
31: DSCN0995.JPG

- USEPA observed and conducted field monitoring of flowing water originating near Hoover Pond impoundment of process water. Water flowing from inside culvert connected to impoundment was originating from an unspecified source. Northeast of the culvert is a possible daylighted seep and EPA field monitoring at this location showed a conductivity of greater than 900  $\mu\text{S}/\text{cm}$ , which is above the background values. The waterway, culvert, and possible daylight seep are depicted in photos 29 through 32.

Description: Northeast of the location of the downstream end of the culvert shown in photo 29. Possible location of a daylighted seep. At the time of the inspection the water shown in this photo was flowing and had a red/orange discoloration.

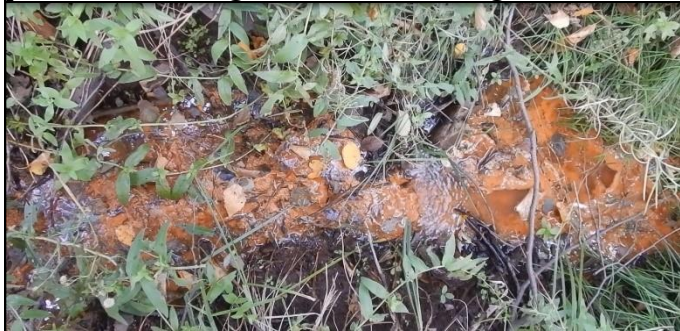
32: DSCN0996.MP4

Description: Northeast of the location of the downstream end of the culvert shown in photo 29. Possible location of a daylighted seep. At the time of the inspection the water shown in this photo was flowing and had a red/orange discoloration.

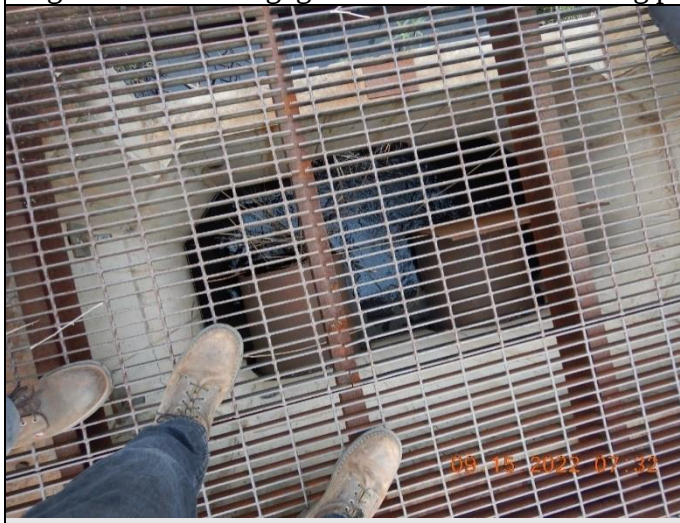
40: DSCN1004.JPG

- During the inspection, USEPA observed waste material from mining operations adjacent to a waterway known as Partridge Creek. Runoff from the slopes of the waste material would drain into a waterway flowing through a historic outfall 003. This is shown in Photos 37 through 42. The Facility representatives stated that NPDES compliance monitoring was no longer being conducted at this location because the discharge was not considered a wastewater. A copy of a cover letter from Michigan Department of Environmental Quality (now EGLE) on June 29, 2017, transmitting the compliance evaluation inspection notes from an April 27, 2017, visit at the Empire Mine (MI0000094) was given to EPA. The June 29, 2017, cover letter was provided as the record of the approval from EGLE. The June 29, 2017, letter references a low selenium concentration and no active mine pit dewatering as justification for changing the NPDES permit, which had expired in 2016.

Description: Staff gage at the historic Empire Outfall 003. Facility representatives said they no longer use this staff gage. Location of monitoring point 09.

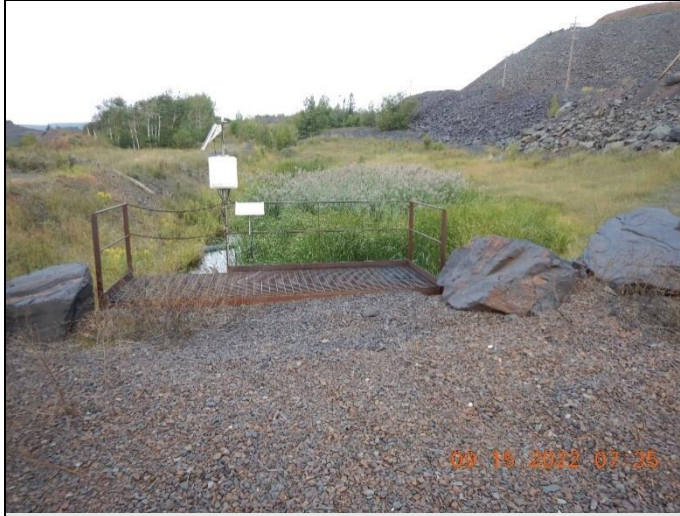
41: DSCN1005.JPG

Description: Control structure at the historic Empire Outfall 003.

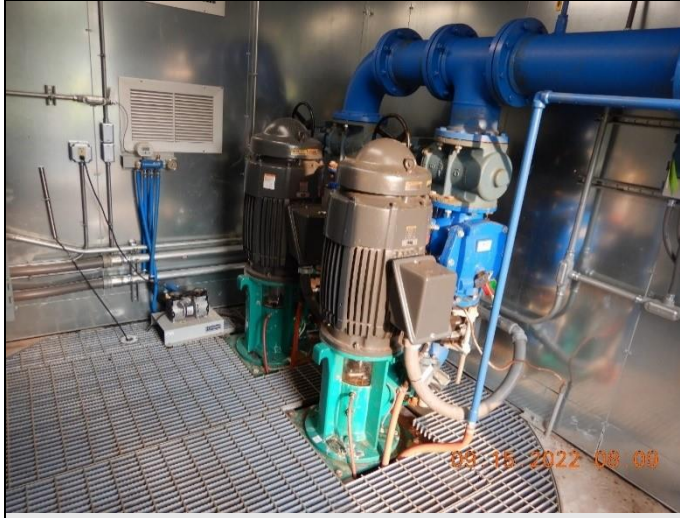
47: DSCN1011.JPG

Description: Inside collection system pump house at CC-95.

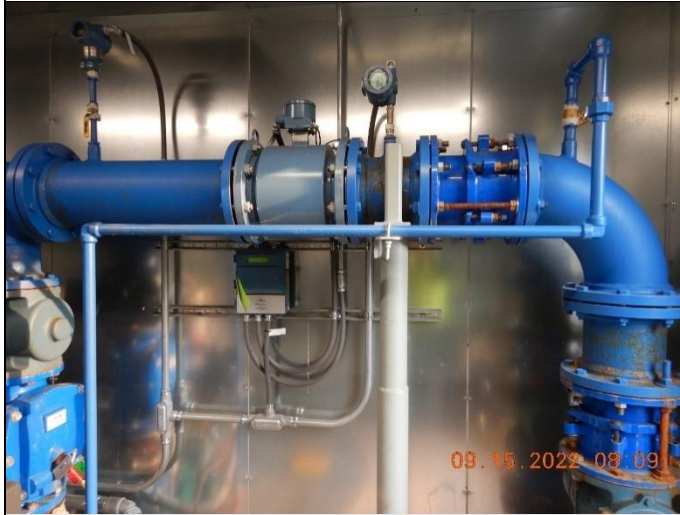
48: DSCN1012.JPG

Description: Inside collection system pump house at CC-95. Flow meter shown in this photo.

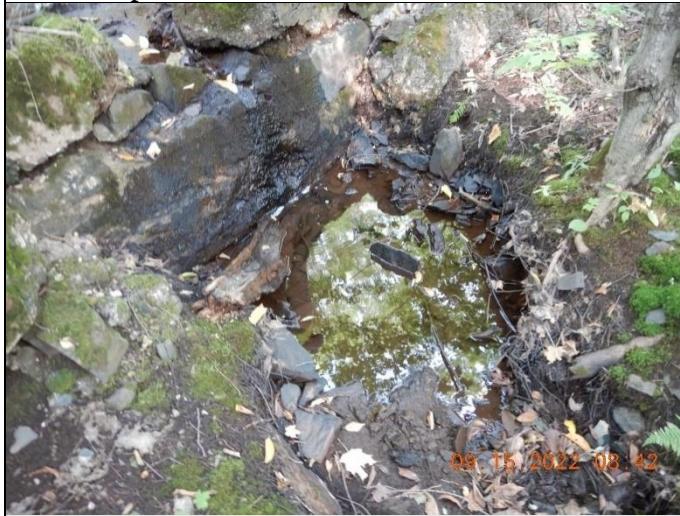
50: DSCN1014.JPG

Description: At stormwater monitoring location '12' or CC-175. Stormwater is monitored at the location shown in this photo, as the water flows over the end of a small stone bridge. EPA monitoring location 13.

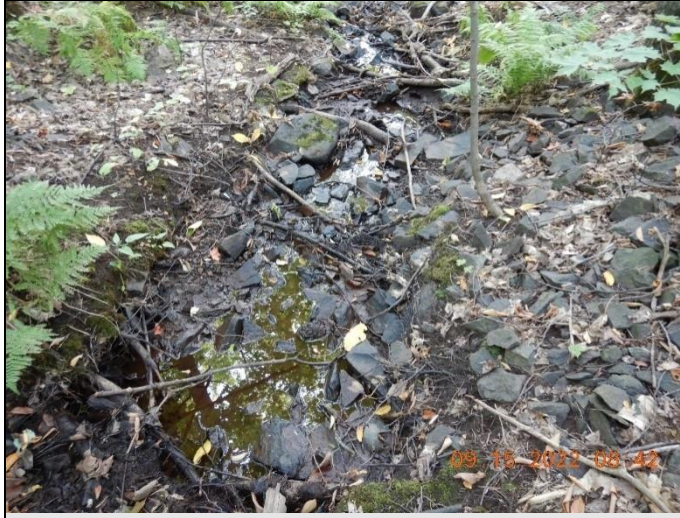
51: DSCN1015.JPG

Description: At stormwater monitoring location '12' or CC-175. Looking downstream from where stormwater monitoring occurs.

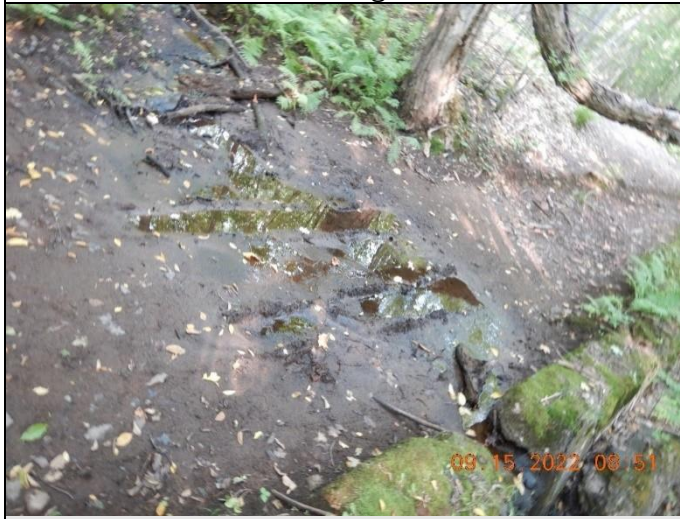
52: DSCN1016.JPG

Description: At stormwater monitoring location '12' or CC-175. Location where stormwater flows across the top of a bridge for a rough pathway upstream of where stormwater monitoring occurs.

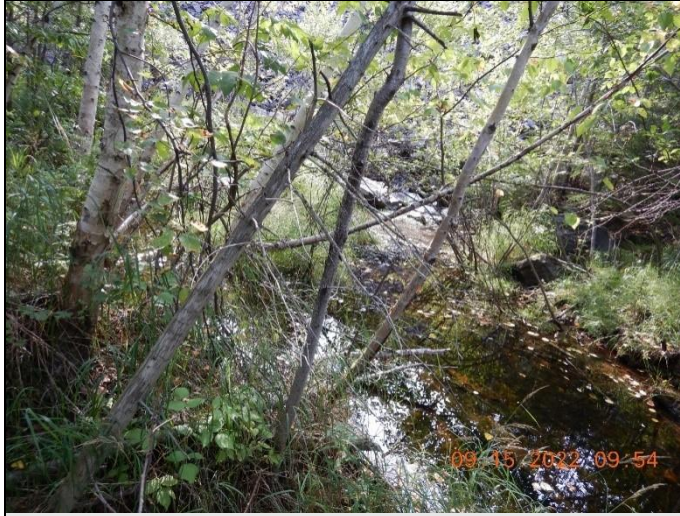
53: DSCN1017.JPG

Description: At stormwater monitoring location '12' or CC-175. Looking upstream of where stormwater monitoring occurs.

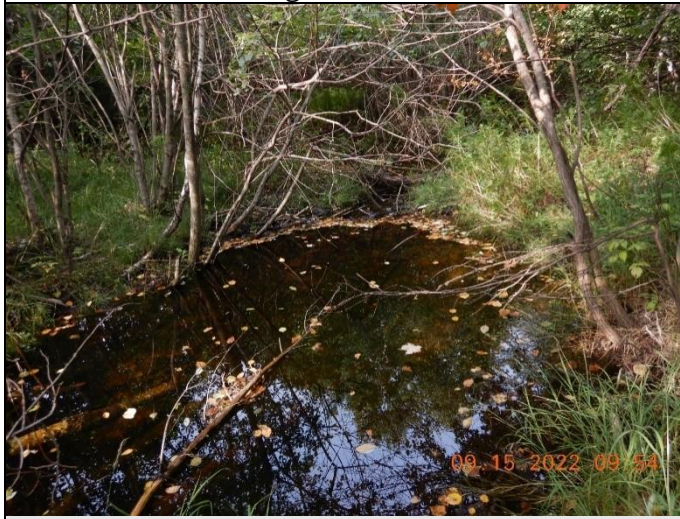
54: DSCN1018.JPG

Description: At stormwater monitoring location '12' or CC-175. Looking upstream of where stormwater monitoring occurs.

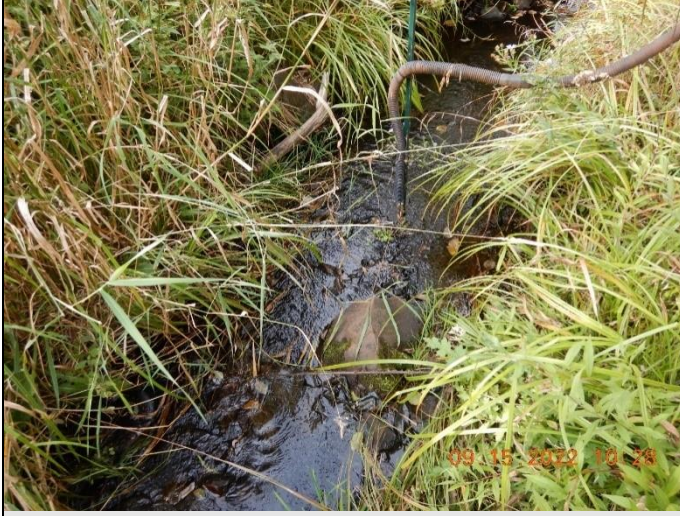
56: DSCN1020.JPG

- Locations CC-291 and CC-292 were not in the current version of the SWPPP available during the inspection, and are not associated with an NPDES outfall. USEPA field monitoring during the inspection showed a specific conductivity of 623  $\mu\text{S}/\text{cm}$  and 439  $\mu\text{S}/\text{cm}$  respectively. At the time of the inspection, these monitoring locations were flowing despite dry weather conditions.
- During the inspection, USEPA observed unvegetated rock piles in the tributary for the water flowing to the control structure for the historic Empire outfall E003.
- Several on-site water bodies present with dark orange coloring, suggesting high levels of iron and conductivity within the water.
  - Stormwater monitoring location '13' or CC-179, was visited during the inspection. The water at this location had an unnatural red color and is shown in photo 63.

Description: At the location of stormwater monitoring location CC-292. At the time of the inspection, the depth of the water at this location was several inches. EPA monitoring location 15.

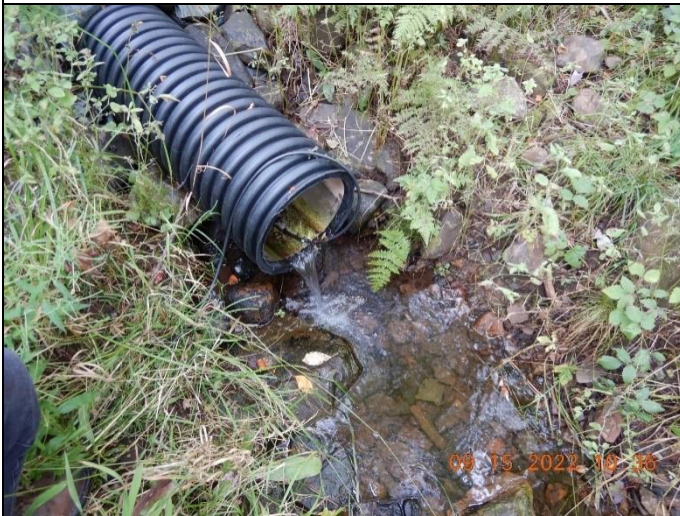
57: DSCN1021.JPG

Description: At the location of the selenium monitoring location CC-291. EPA monitoring location 16.

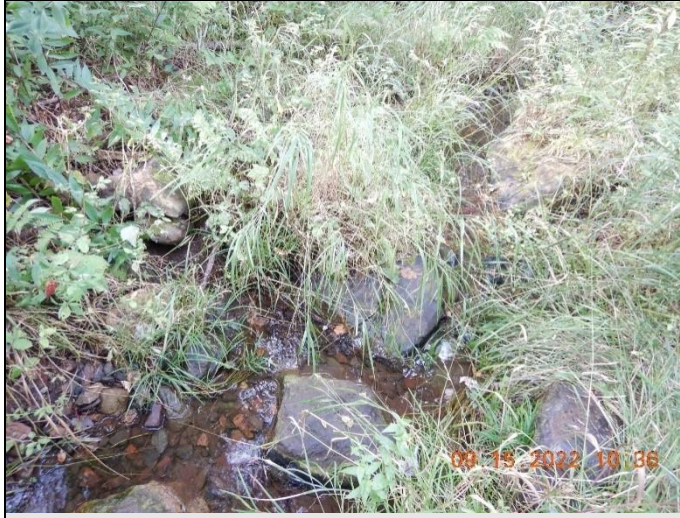
58: DSCN1022.JPG

Description: Downstream of the location of the selenium monitoring location CC-291.

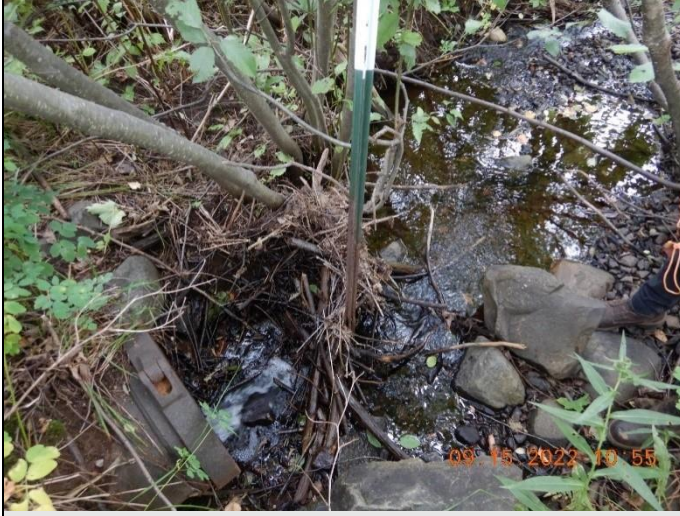
60: DSCN1024.JPG

- Stormwater monitoring location 'M' or CC-93: the SWPPP shows that the rock stockpiles are a source of exposure in the tributary to this location. Field monitoring conducted by USEPA showed a conductivity of 585  $\mu\text{S}/\text{cm}$ , which is above the background values. At the time of the inspection, this stormwater monitoring location was flowing despite dry weather conditions.

Description: At the location of the stormwater monitoring location 'M' or CC-93.

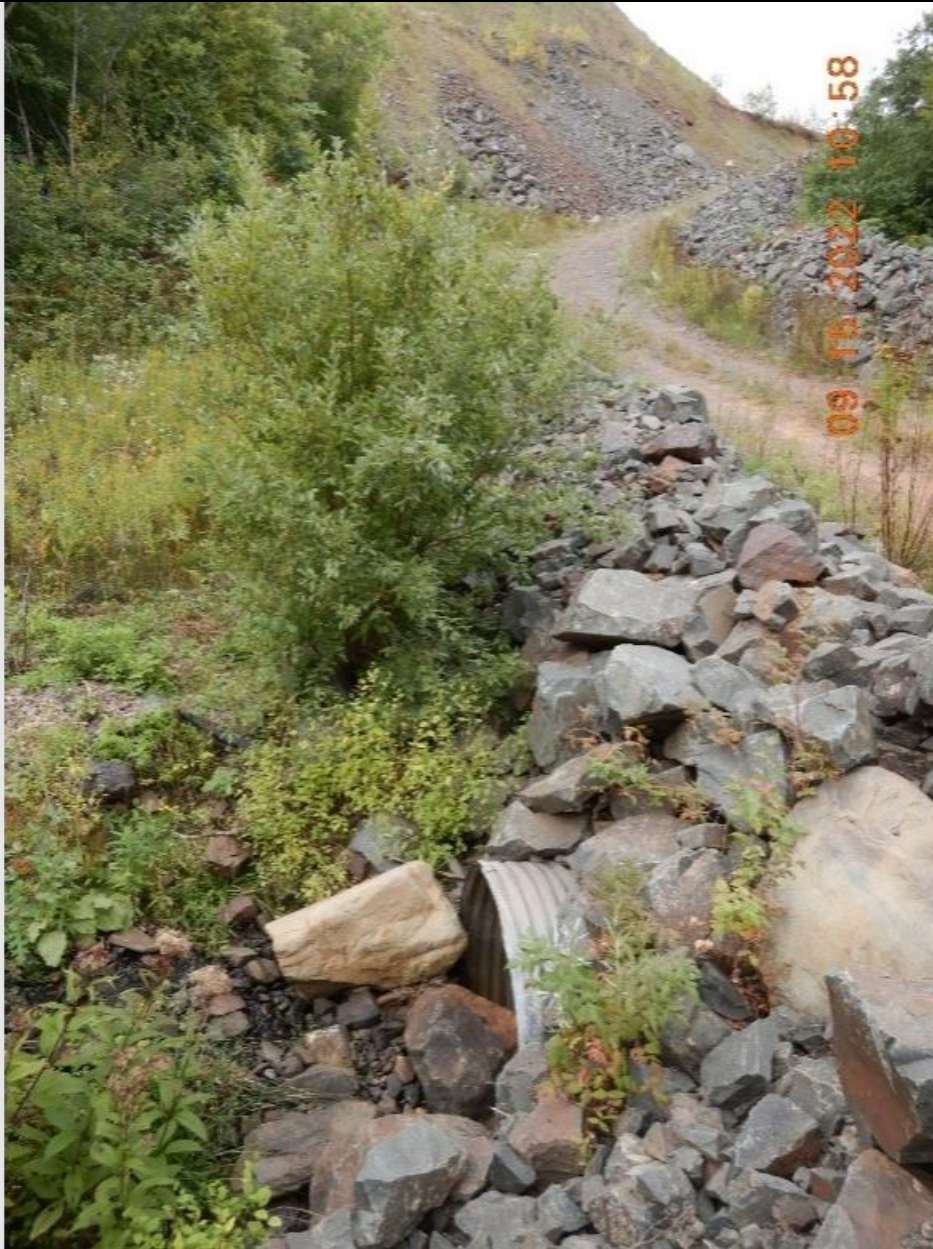
61: DSCN1025.JPG

Description: Upstream of the stormwater monitoring location 'M' or CC-93.

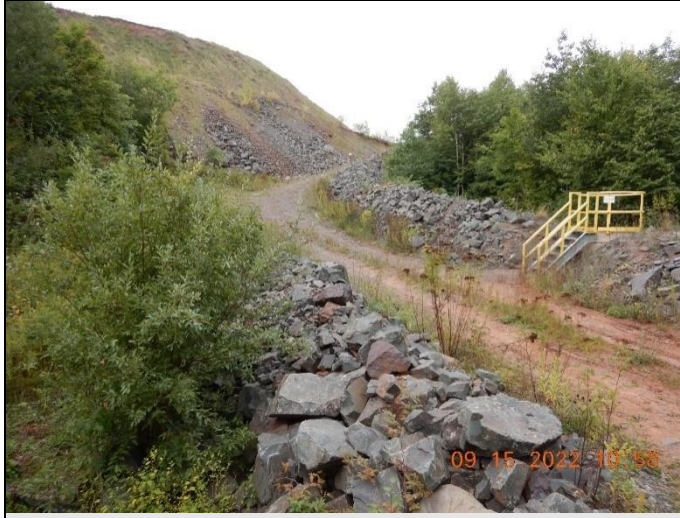
62: DSCN1026.JPG

Description: Upstream of the stormwater monitoring location 'M' or CC-93.
