**UNITED STATES ENVIRONMENTAL PROTECTION AGENCY**  
**REGION 5**  
**77 WEST JACKSON BOULEVARD**  
**CHICAGO, ILLINOIS 60604**

**SUBJECT:** CLEAN WATER ACT INSPECTION REPORT  
*Suburban Acres Mobile Home Park, Warsaw, Indiana*

**Facility Name:** Suburban Acres Mobile Home Park

**Date(s) of Inspection:** April 2, 2025

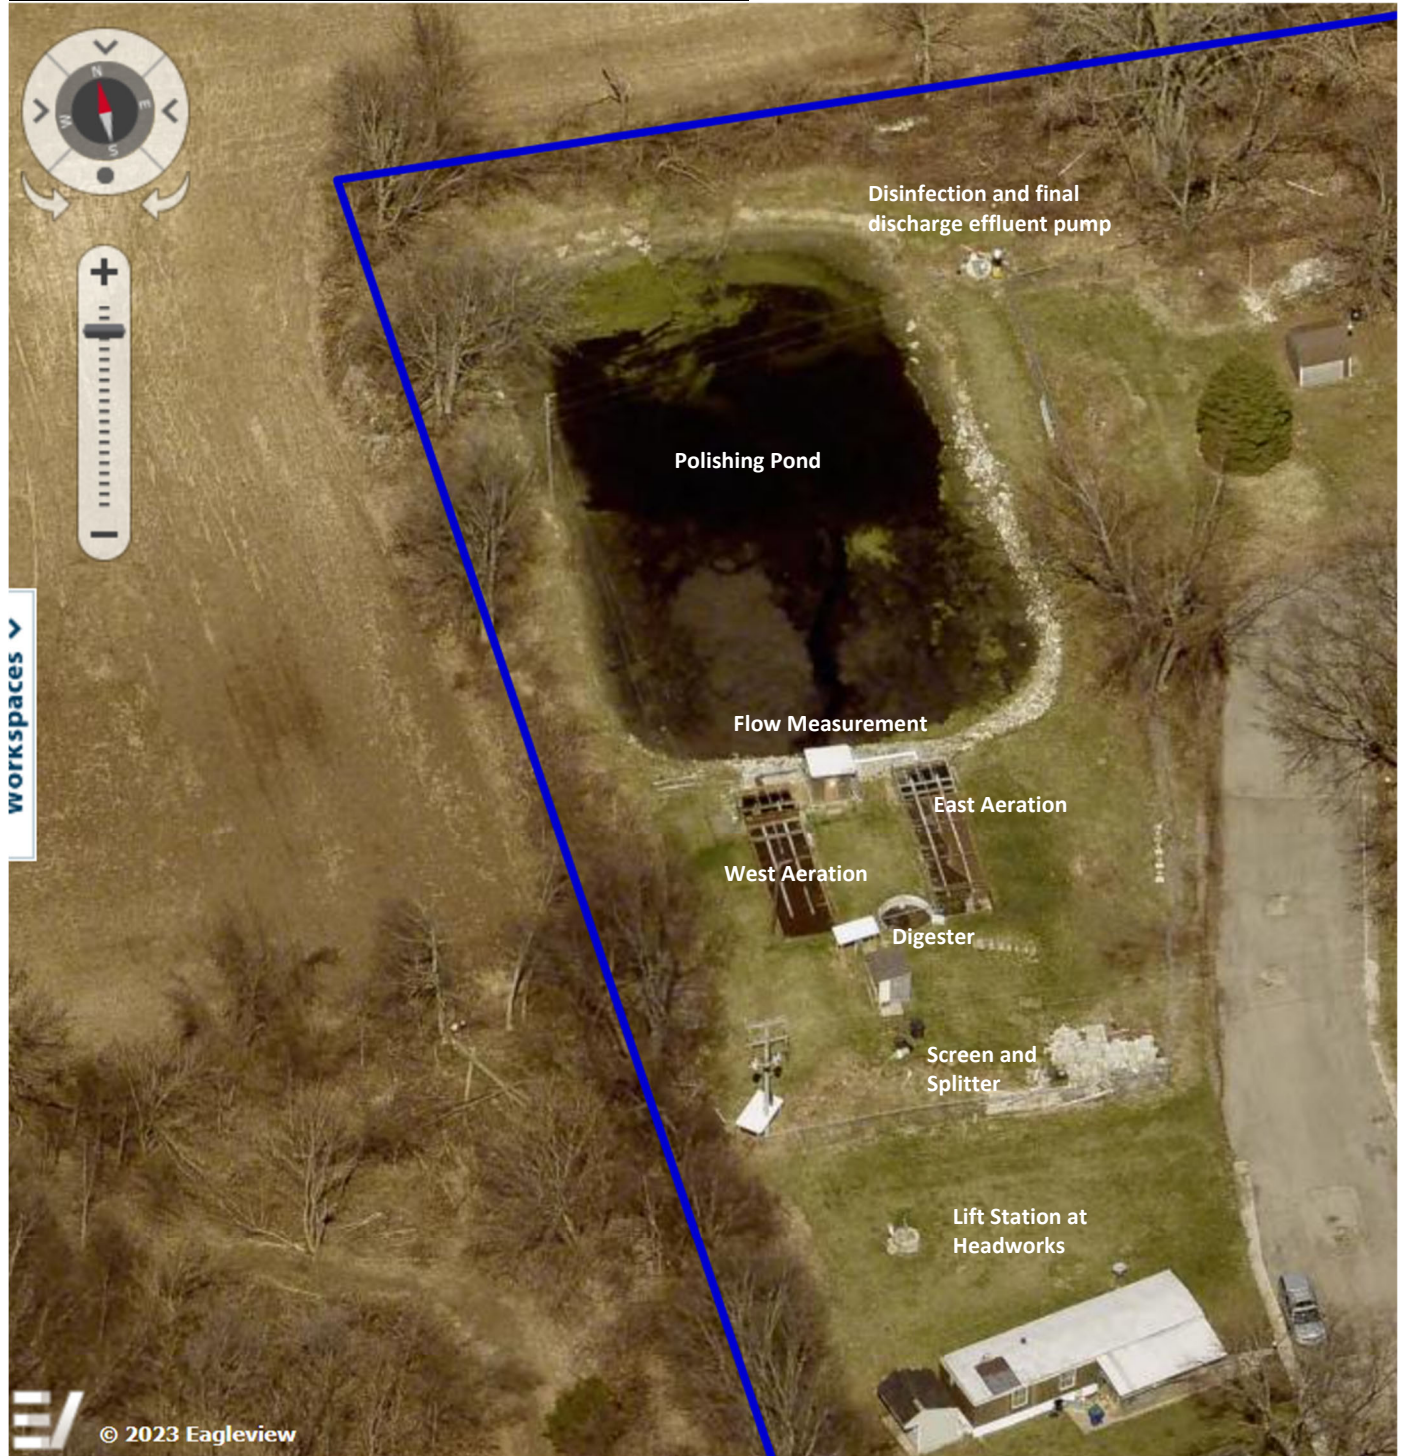
**APPENDIX A: AERIAL AND ESTIMATE OF POLISHING POND AREA**

The approximate area of the polishing pond is 11,400 sf, which is less than 0.3 acres. See the map included in Appendix A. The volume of wastewater generated between June and December 2023 would result more than 20 feet of elevation change in the polishing pond. At the time of the inspection the polishing pond did not have sufficient free board to stored more than 9 acre-feet of wastewater. Since the disinfection system is located directly upstream and inside the effluent pump station, any wastewater leaving the polishing pond through means other than the effluent pump would not have received full treatment.

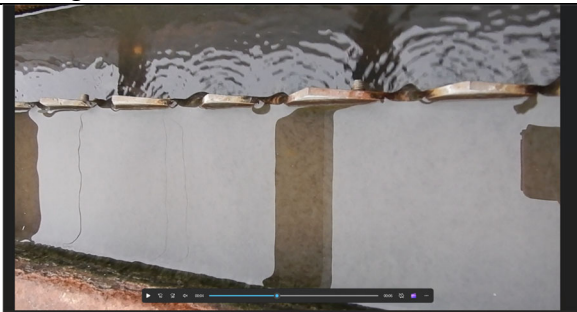
Description: At the west clarifier, at the time of the inspection, flocs were visible near the surface, and were observed flowing over the weir and out the clarifier. The circle shows a location where the flocs were visible flowing over the weir.

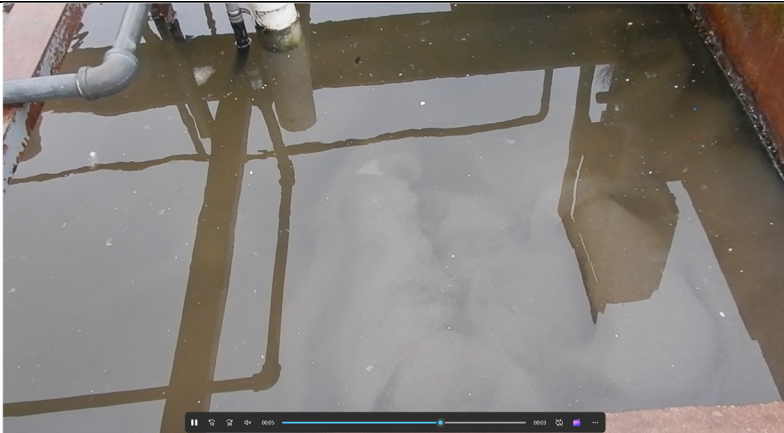
Description: At the west clarifier, flocs were observed rising and swirling near the surface.

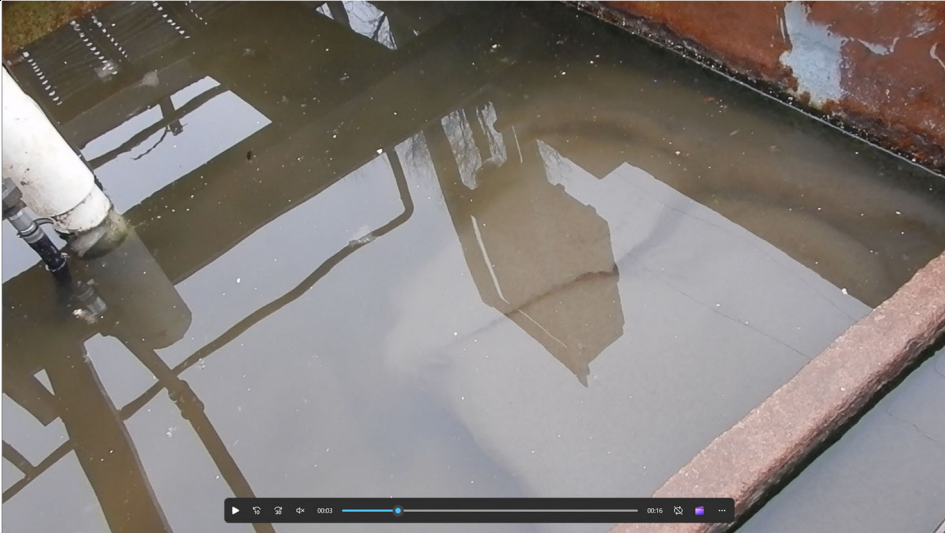
**15: DSCN2460.MP4**

Description: 9 second video of the west clarifier showing the flocs rising and swirling near the surface.

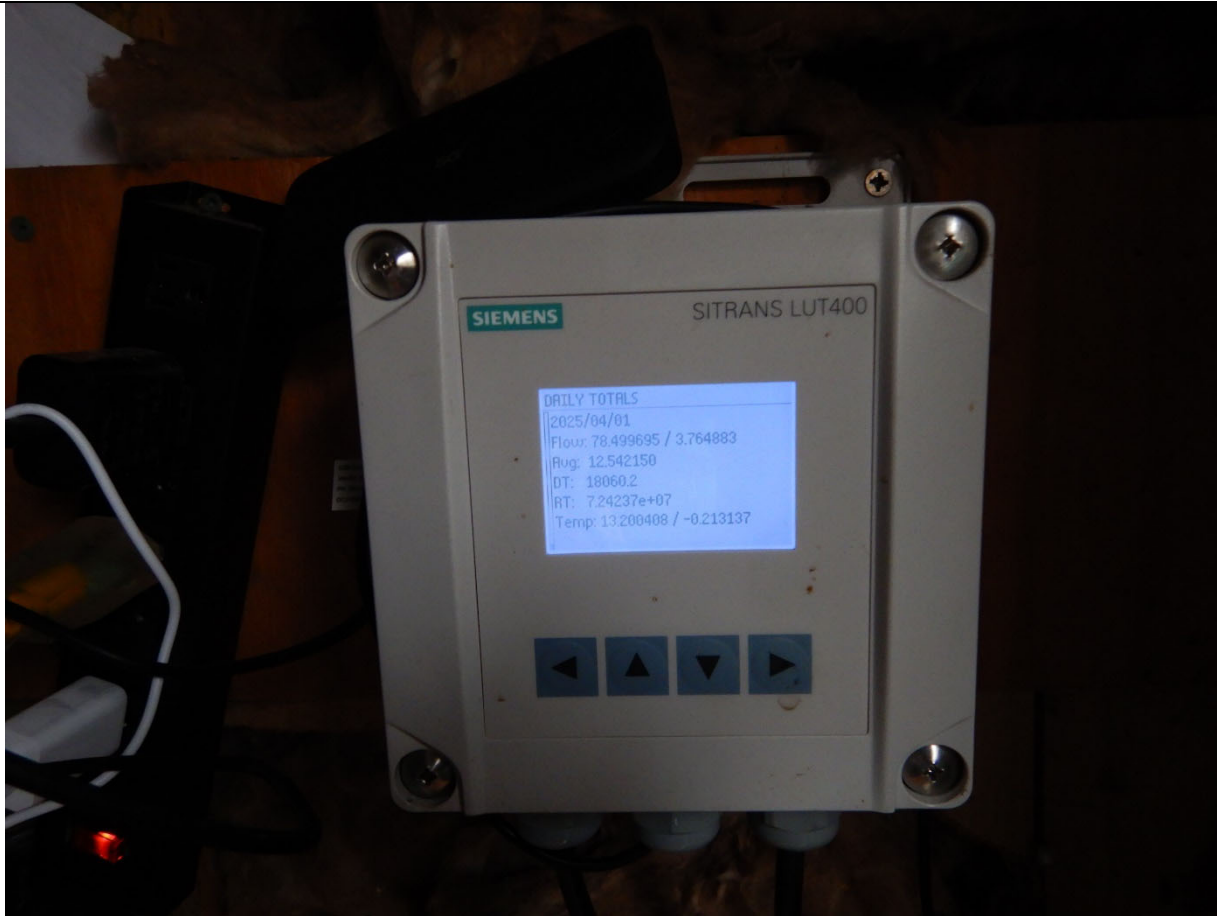
Description: Readout on the flow measurement device, at the time of the photo, the device was showing 11.2 gal/min, 3.6 in head and a daily totalizer flow of 75.

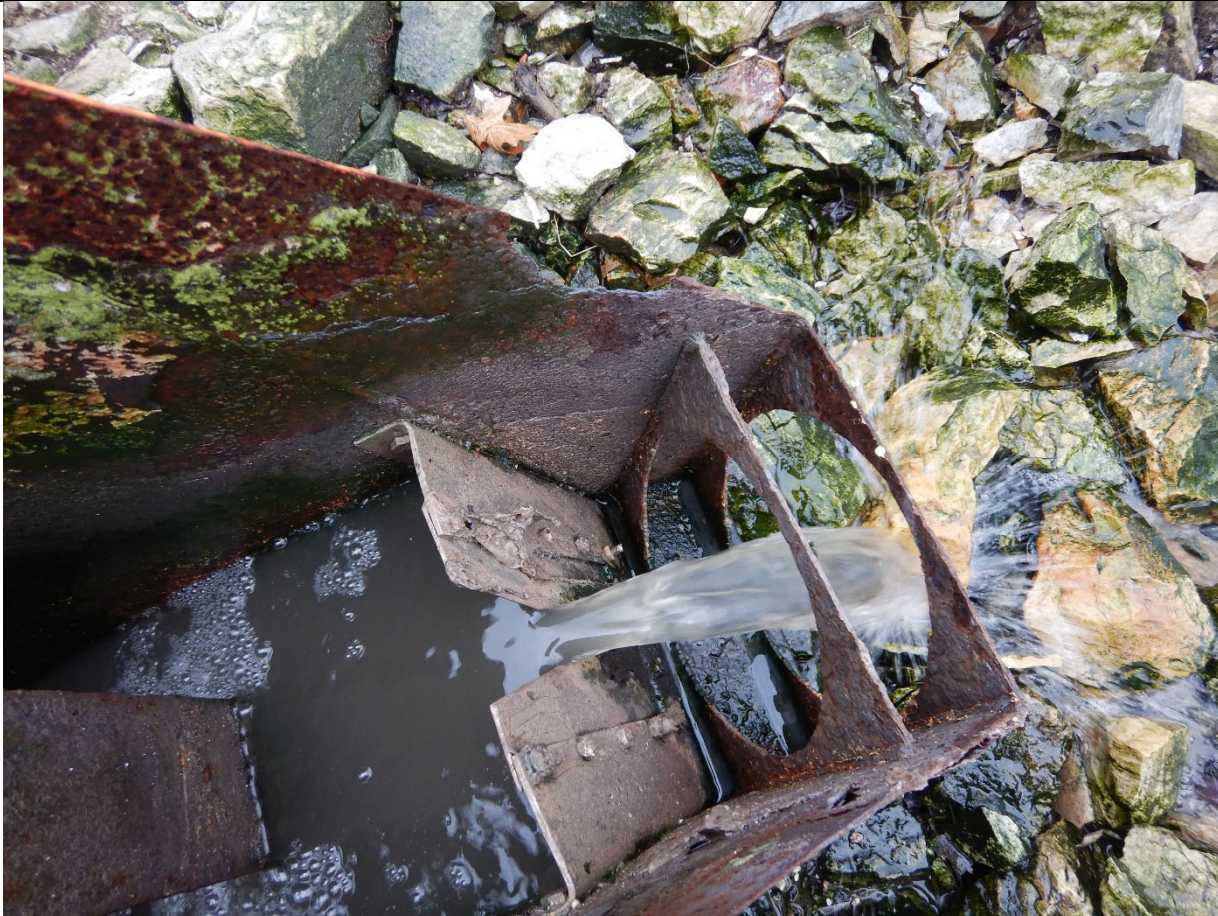
Description: Location of MP05 at the flow measurement device, immediately upstream of the pond.

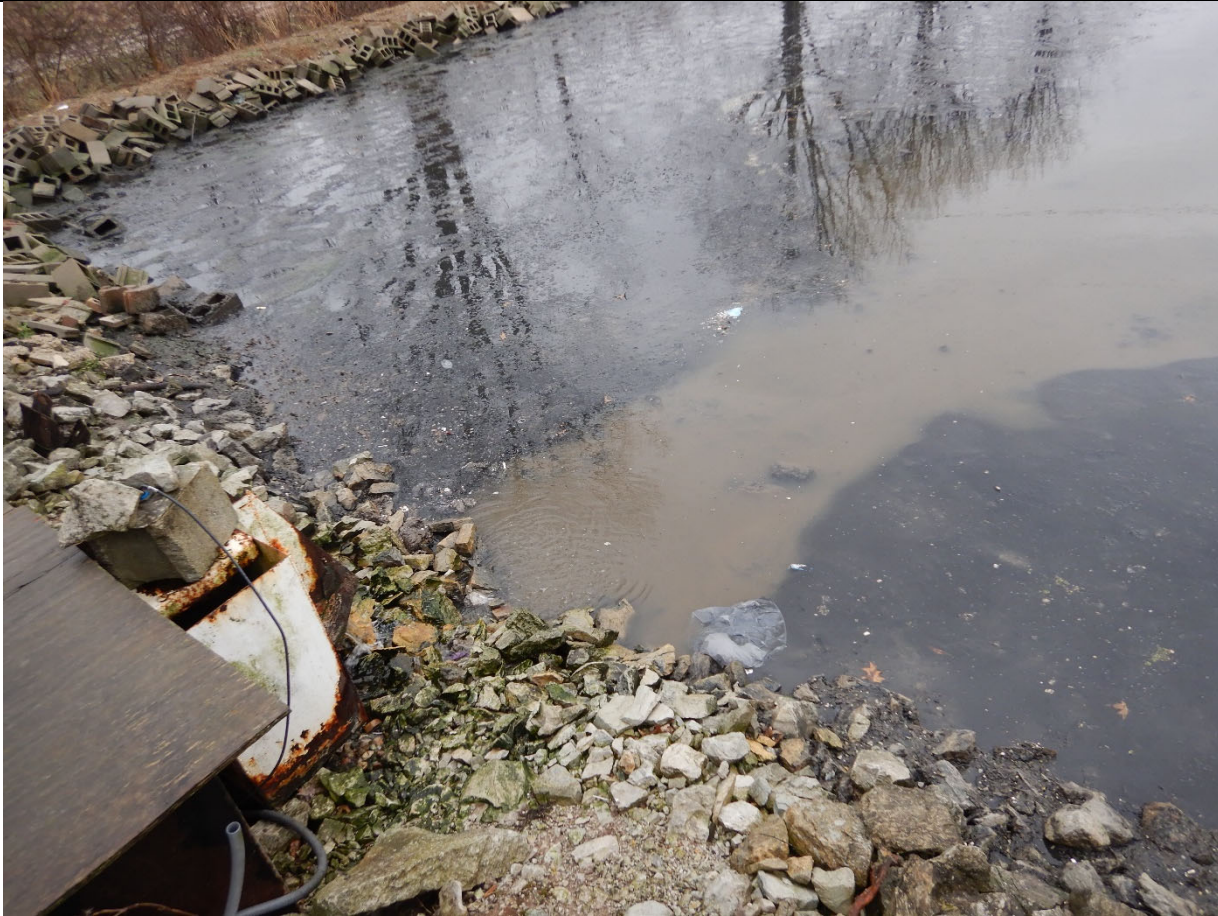
Description: Treated wastewater from the weir. The water was discolored. This was the location of MP05, the turbidity at this location was 446 NTU.

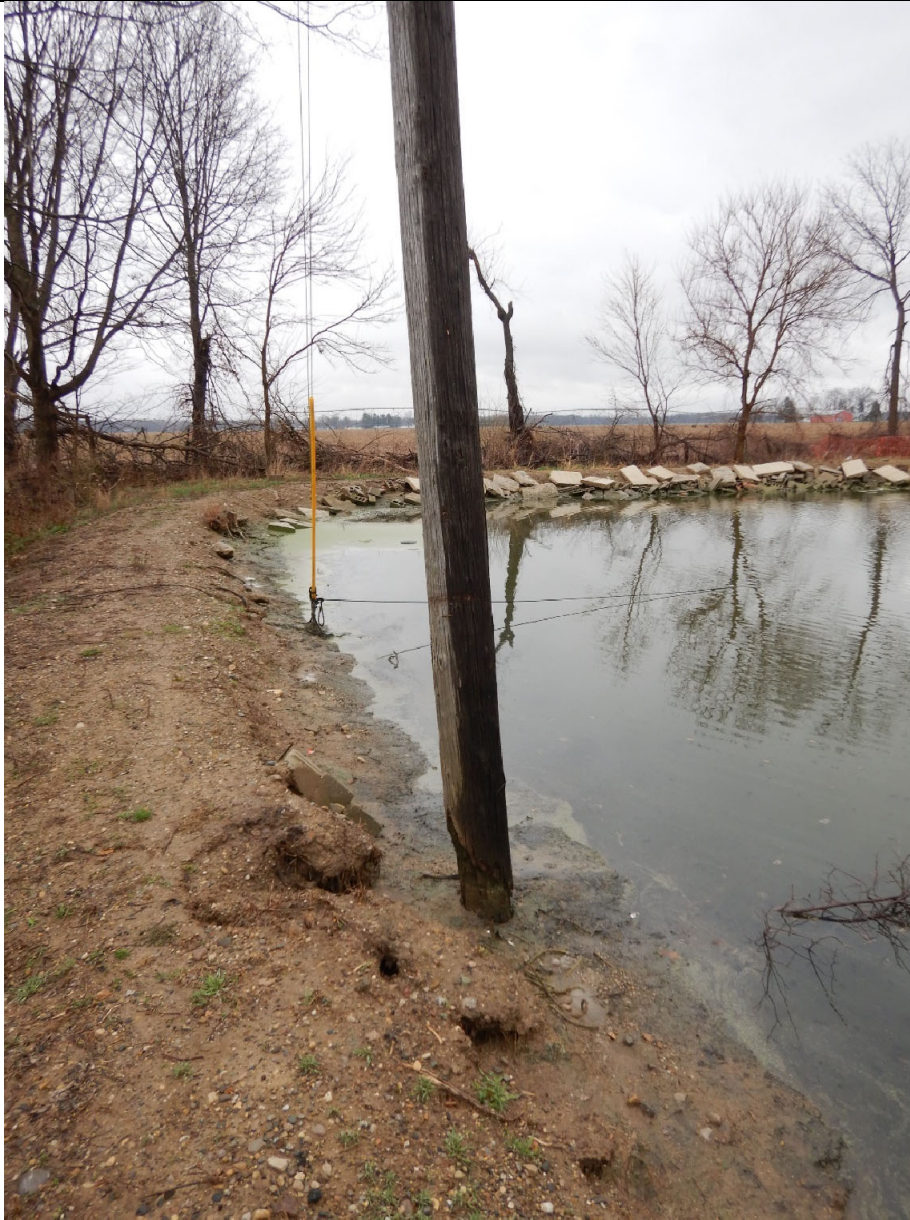
- The west aeration basin had brown foam on the surface (photos 5, 25 and 26),
- There was scum on the surface of the west aeration basin clarifier (photos 6, 7, and 8)
- The east aeration basin clarifier had flocs moving up toward the surface indicative of high flows or disruptions in the clarifier flow (Photo 14 and videos 15 and 16),
- The flocs in the east aeration basin were visible flowing over effluent weir (photos 10, 11, 14 and video 12),
- Excessive black solids material was present in the southern end of the polishing pond (photos 30 and 31),
- Excessive algae growth was present at the north end of the polishing pond (photo 36),
- An electrical pole and tree stumps were present on the inside edge of the berm surrounding the pond (photos 36 and 37).

Description: North end of the polishing pond. There were stumps remaining from trees on the interior side of the berm, and algae at this location.
