**CWA COMPLIANCE EVALUATION INSPECTION REPORT  
U.S. ENVIRONMENTAL PROTECTION AGENCY, REGION 5**

Compliance Evaluation Inspection (Clean Water Act portion of a Multi Media Inspection)

Scott Air Force Base  
501 Hangar Road, Building 531  
Scott Air Force Base, Illinois, 62225  
St. Clair County

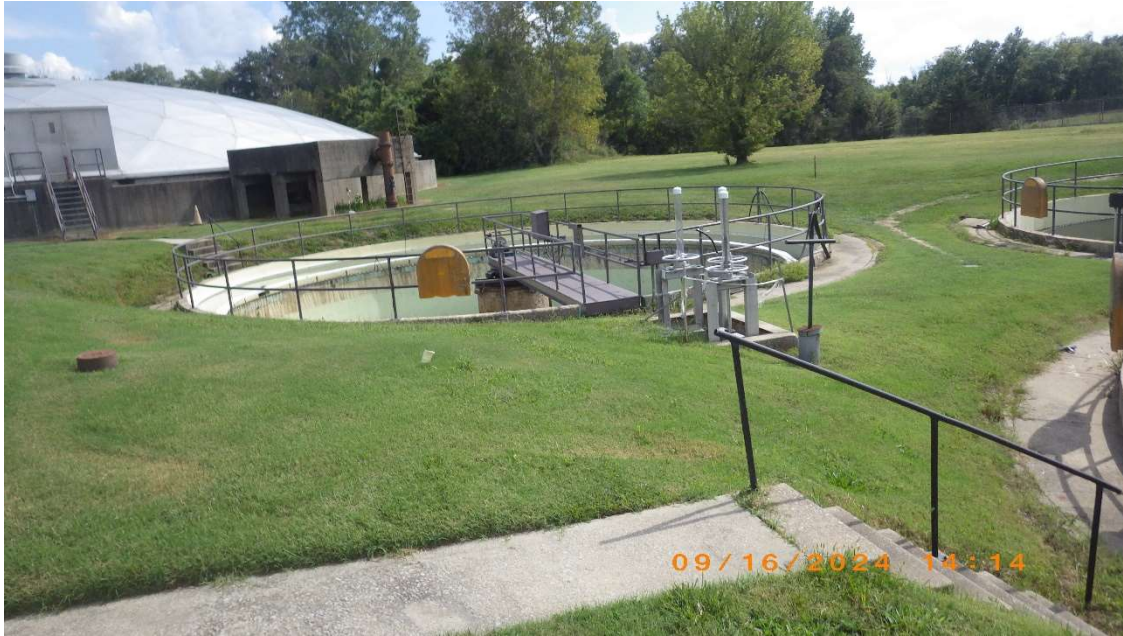
13: RIMG0013

Description: Final clarifiers. SAFB personel stated that algae was cleaned from the final clarifiers every Thursday.

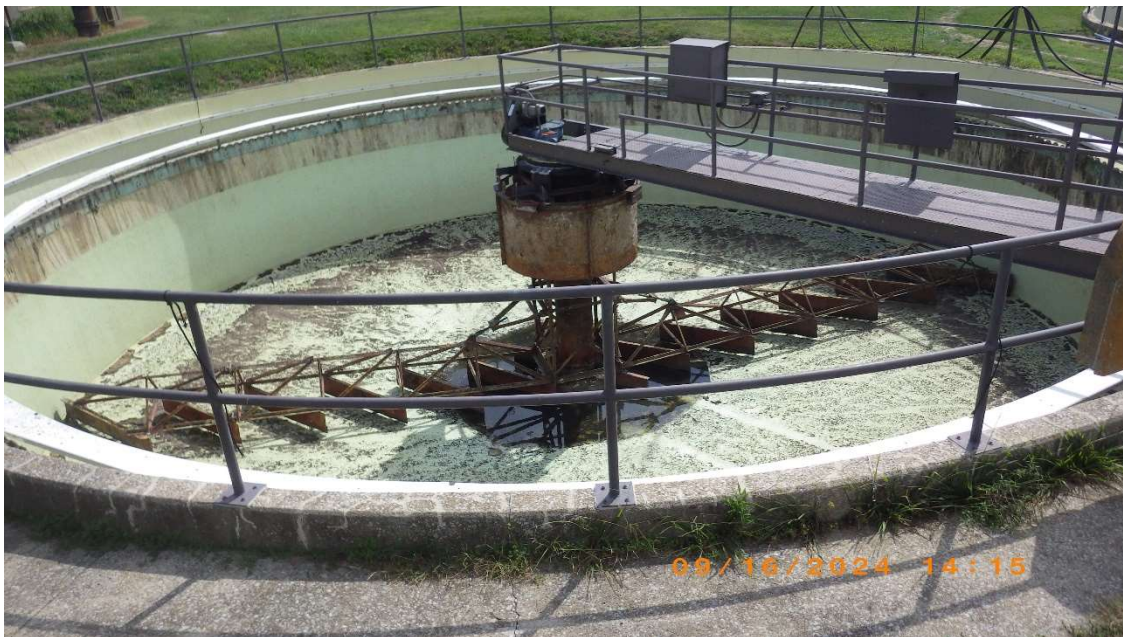
14: RIMG0014

Description: Final clarifier not in service. This clarifier was down for maintenance. Trickling filter in background to the left.

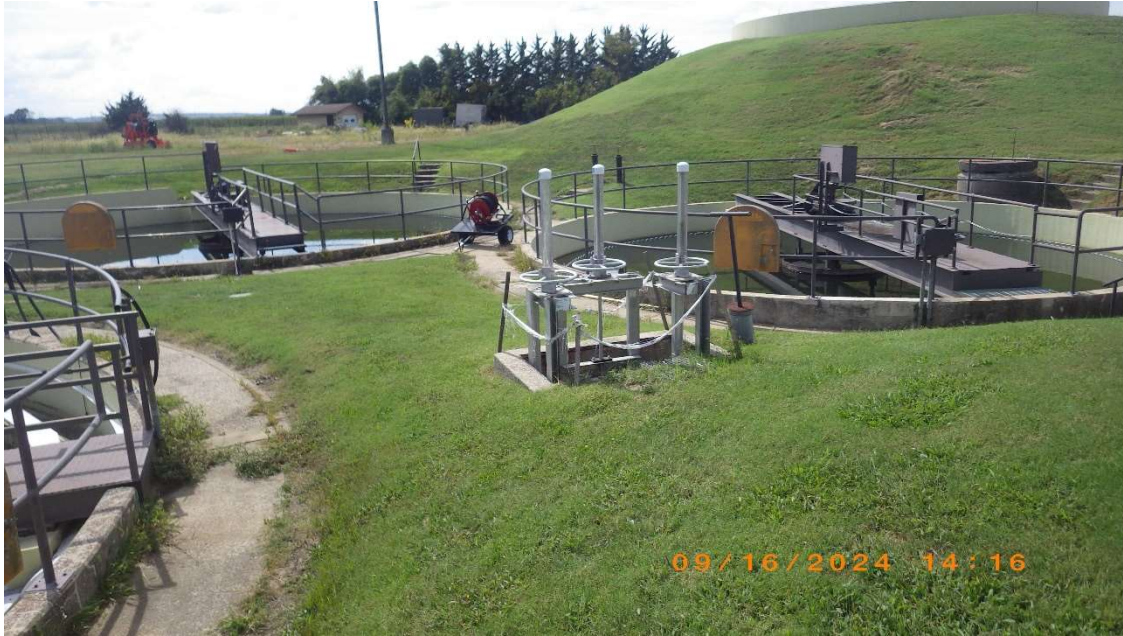
15: RIMG0015

Description: Final clarifier not in service. This clarifier was down for maintenance.

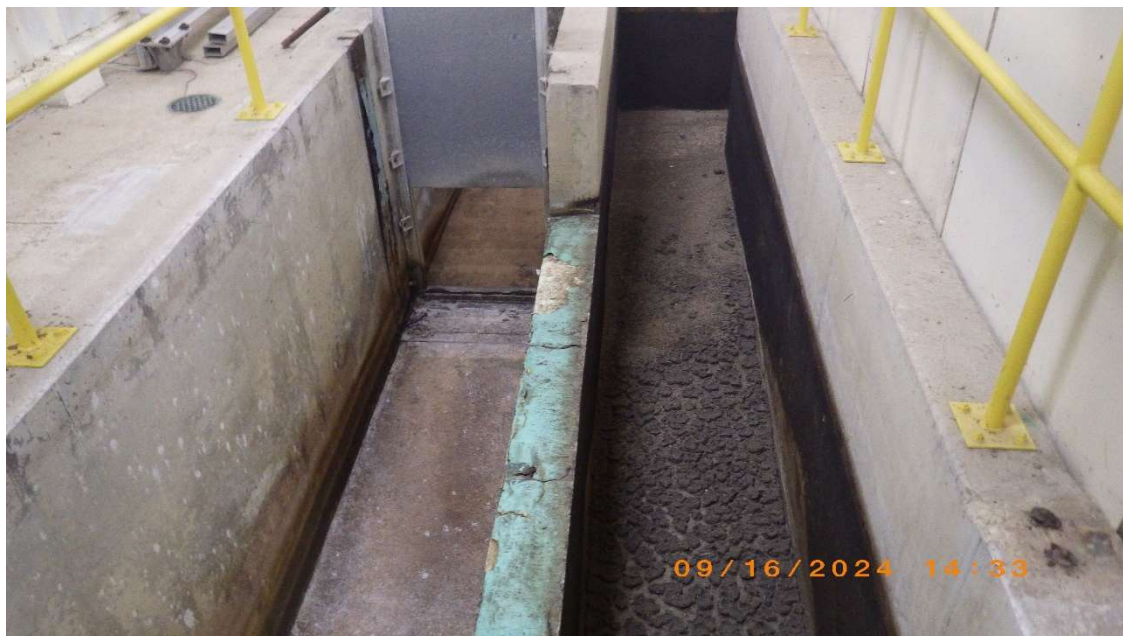
Description: Non-operational disk filter. SAFB personel stated that the disk filters were non-operational due to snail shells in the effluent that immediately clogged the filter spray nozzles. SAFB personel stated that multiple solutions had unsucessfully been attempted to return the disk filters to service and that the plant was considering alternative replacements.

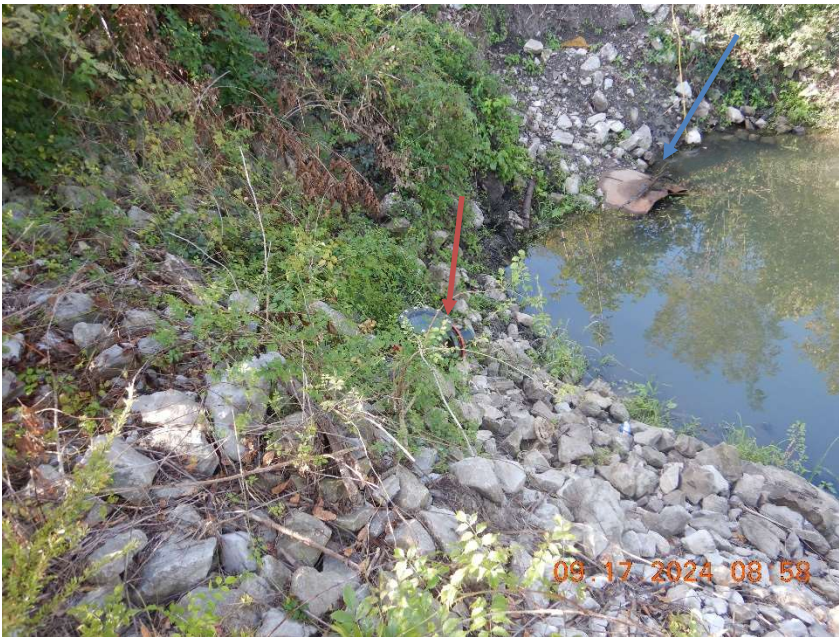
4: DSCN4233

Description: Looking south at the culvert (blue arrow) under the access road to the landfill at stormwater “OUTFALL 3” also called “O-MC1” Note black pipe with red flange (red arrow). The SAFB personnel were unsure what the pipe was.

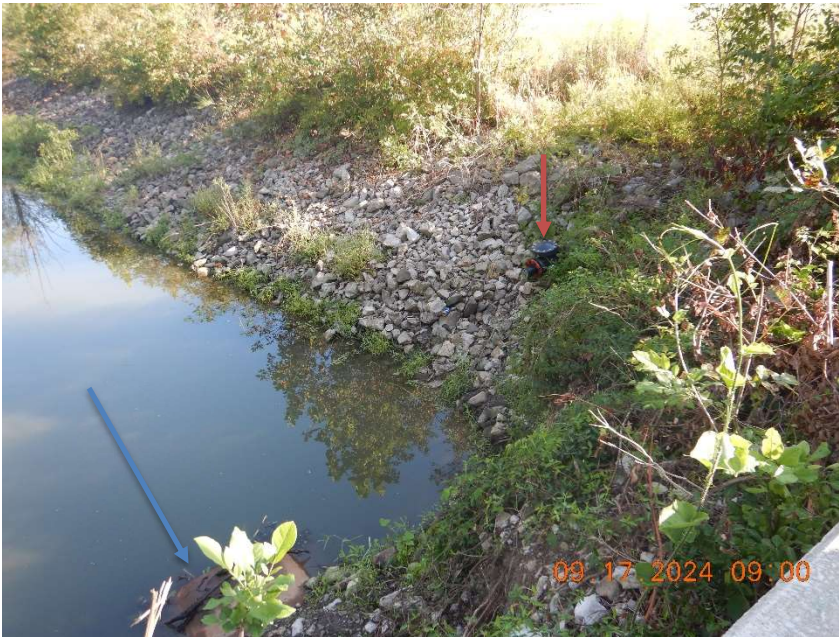
5: DSCN4234

Description: Looking south at the culvert (blue arrow) under the access road to the landfill at stormwater “OUTFALL 3” also called “O-MC1” The waterway is an unnamed tributary to Silver Creek. Note black pipe with red flange (red arrow). The SAFB personnel were unsure what the pipe was.

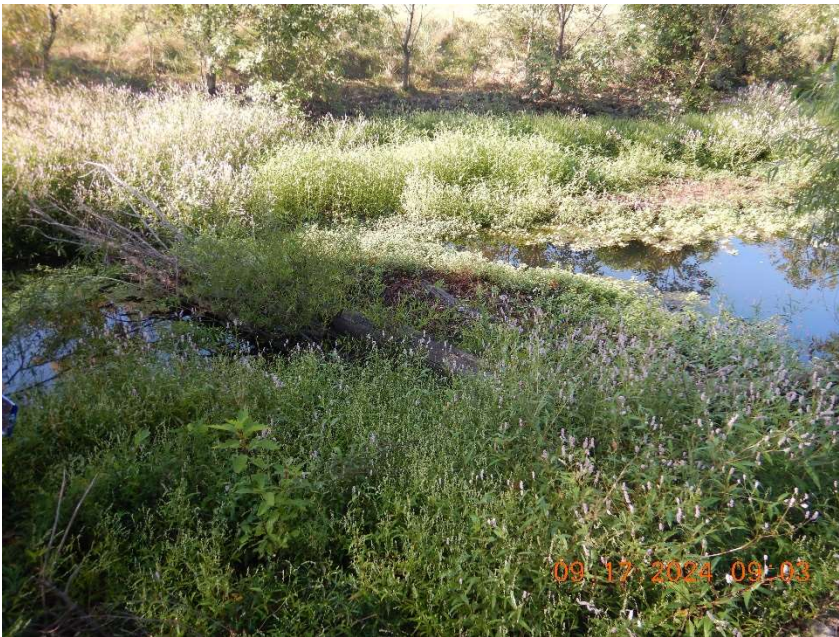
6: DSCN4235

Description: Looking north at the culvert (blue arrow) under the access road to the landfill at stormwater “OUTFALL 3” also called “O-MC1” Note black pipe with red flange (red arrow). The SAFB personnel were unsure what the pipe was.

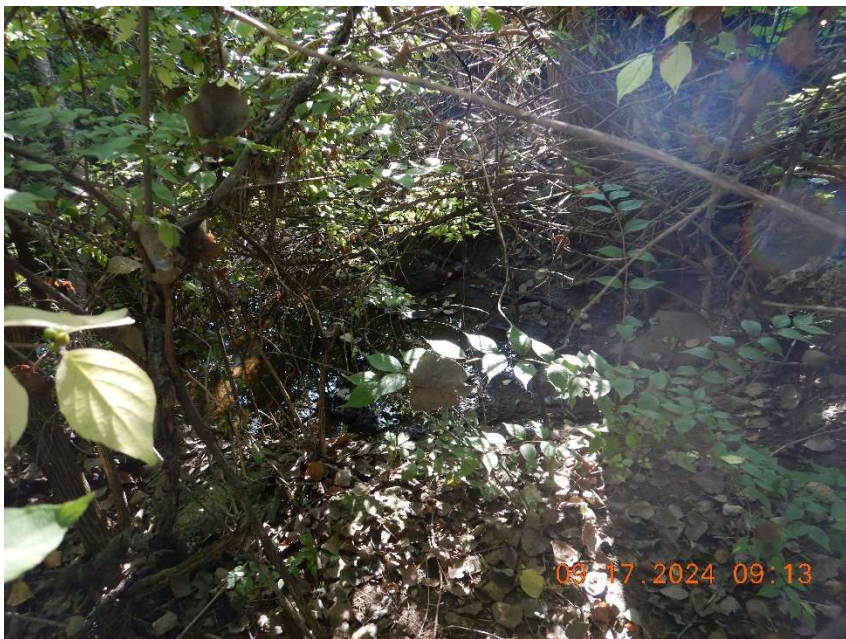
8: DSCN4237

Description: Looking south at “OUTFALL 4” also called “O-MC2”. This is the confluence of the waste water treatment plant discharge and the unnamed tributary to Silver Creek. Note black pipe similar to the one observed in photos 4-6 (red arrow).

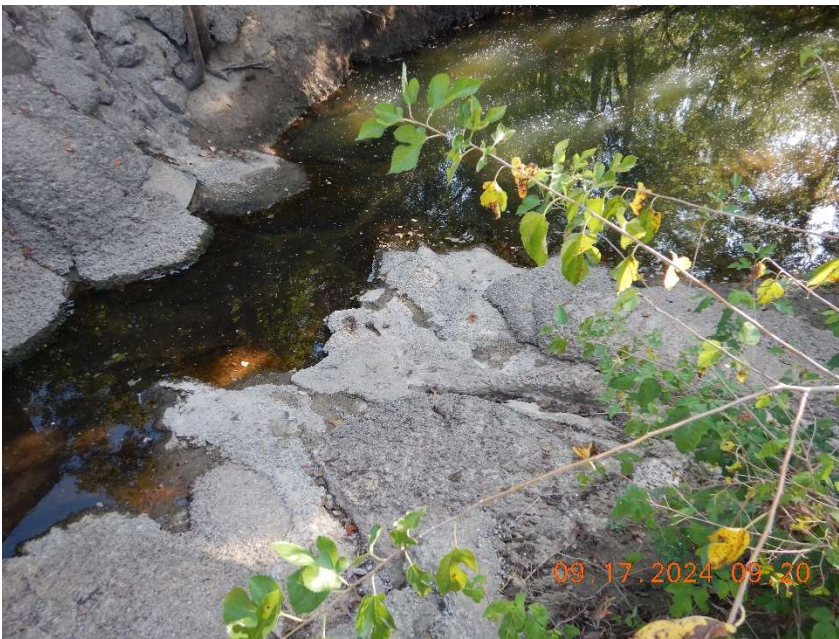
10: DSCN4239

Description: East side of culvert under Scott Lake Road. Storm water sampling location named “OUTFALL 6” also known as “O-CC1”. Note how concrete has been poured to stabilize the stream bank.

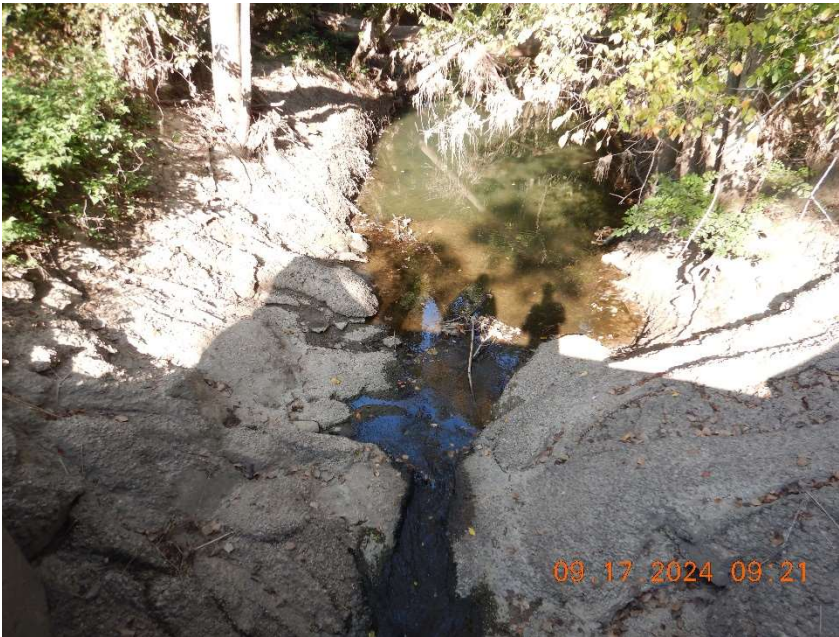
12: DSCN4241

Description: West side of culvert under Scott Lake Road. Storm water sampling location named “OUTFALL 6” also known as “O-CC1”. Note how concrete has been poured to stabilize the stream bank.

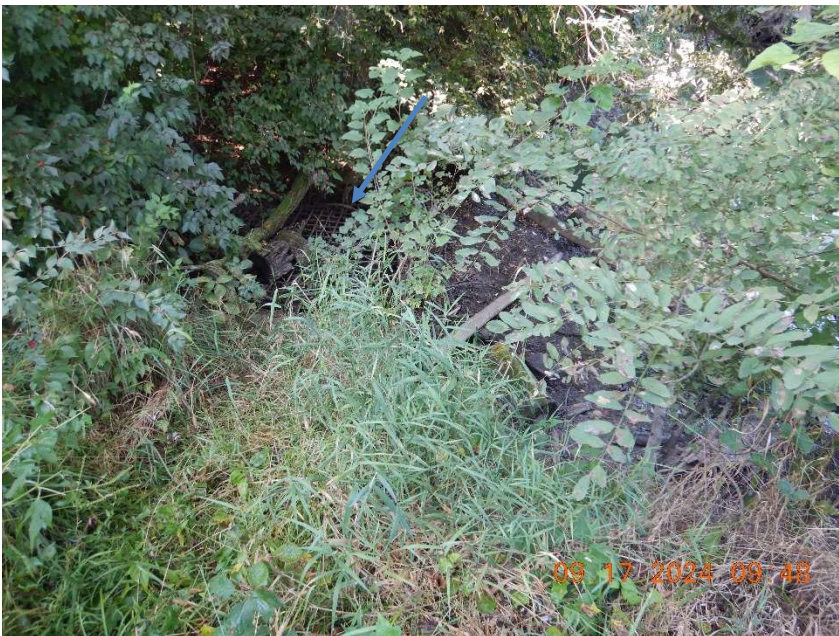
13: DSCN4242

Description: Lake level control structure (blue arrow) located at the southeast corner of Scott Lake. SAFB personnel stated that this was the inlet of a pipe that outlets at storm water sampling location “OUTFALL 7” also known as “O-SL1”

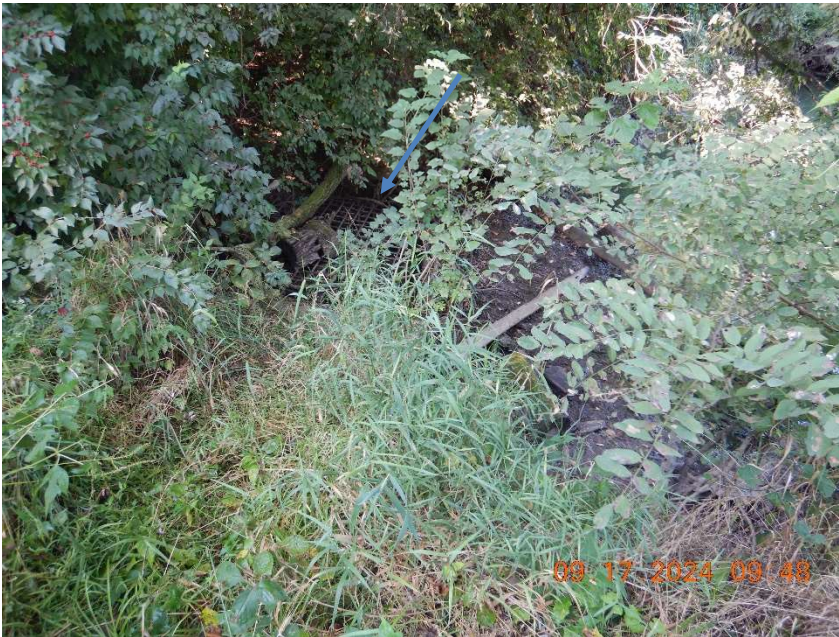
14: DSCN4243

Description: Lake level control structure (blue arrow) located at the southeast corner of Scott Lake. SAFB personnel stated that this was the inlet of a pipe that outlets at storm water sampling location “OUTFALL 7” also known as “O-SL1”

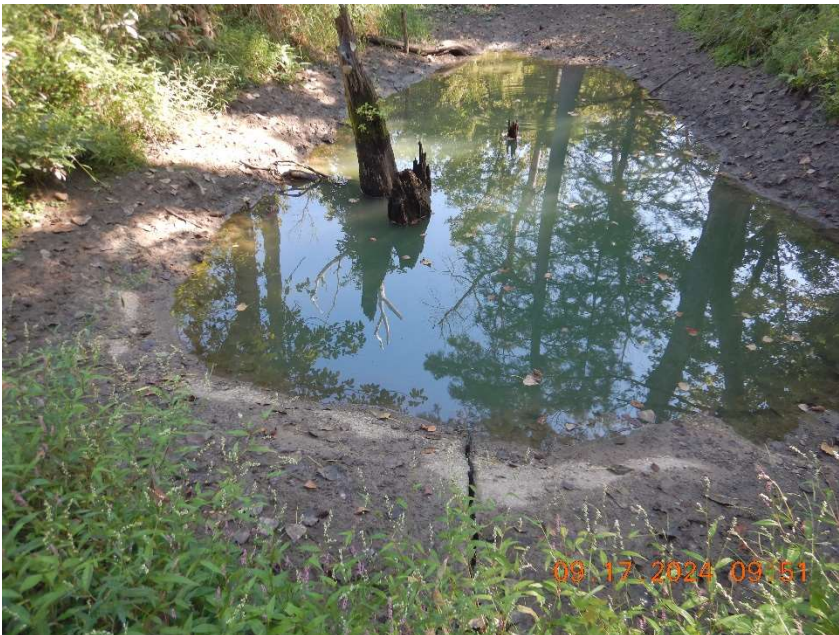
15: DSCN4244

Description: Storm water sampling location “OUTFALL 7” also known as “O-SL1”. SAFB personnel stated that there was a submerged pipe that was the outlet for the lake level control structure seen in photo 14. At the time of the inspection, no surface water connection was observed, however a chanel was observed from the pool of water to the southeast toward the unnamed tributary of Silver Creek.

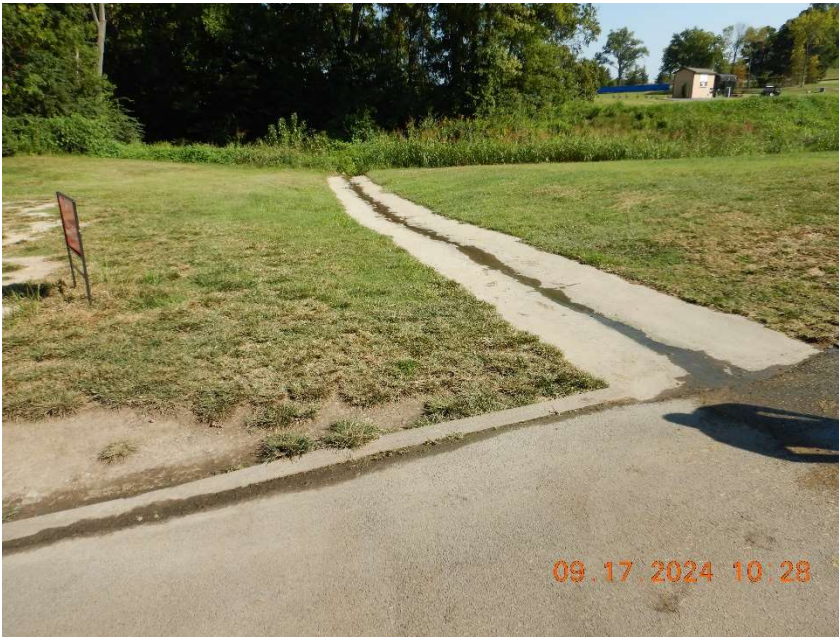
18: DSCN4247

The inspectors then proceeded to view “OUTFALL 7” (O-SL1), the Golf Course Pond, and then “INFLOW 1” (I-CC1). At “INFLOW 1”, EPA observed a leaking hose contributing runoff to “Cardinal Creek” (photos 13-21). Mr. Busch was unaware of what the hose was used for, if this was from the cart wash area, or if any cleaners were being utilized.

Description: Looking north along the concrete swale toward the unnamed tributary.

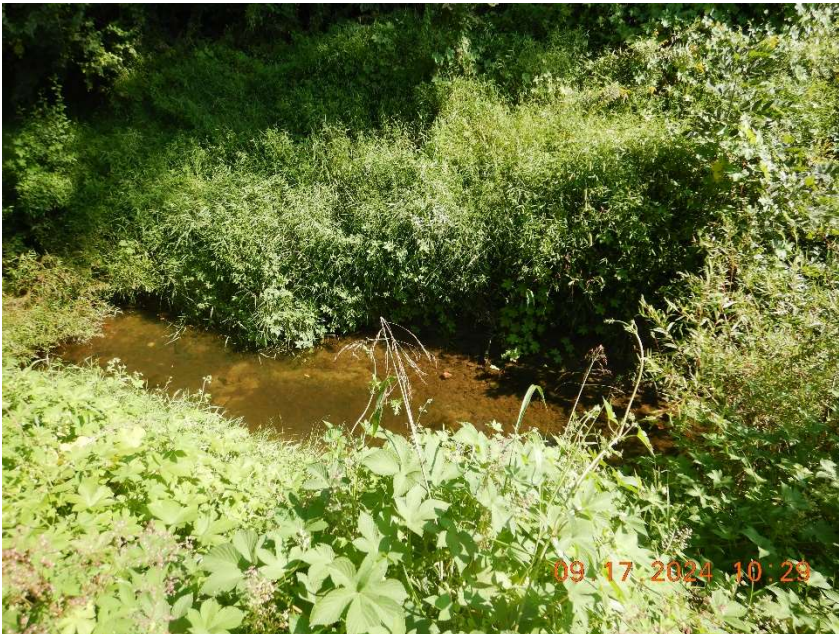
19: DSCN4248

Description: Looking north down the stream bank into the unnamed tributary.

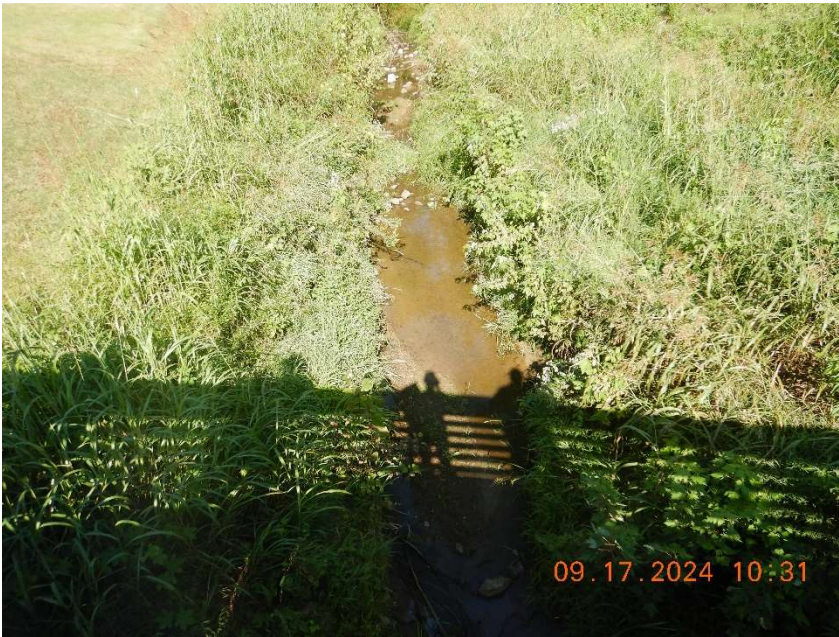
20: DSCN4249

Description: Looking downstream along the unnamed tributary at stormwater sampling location “INFLOW 1” which is also known as “I-CC1”.

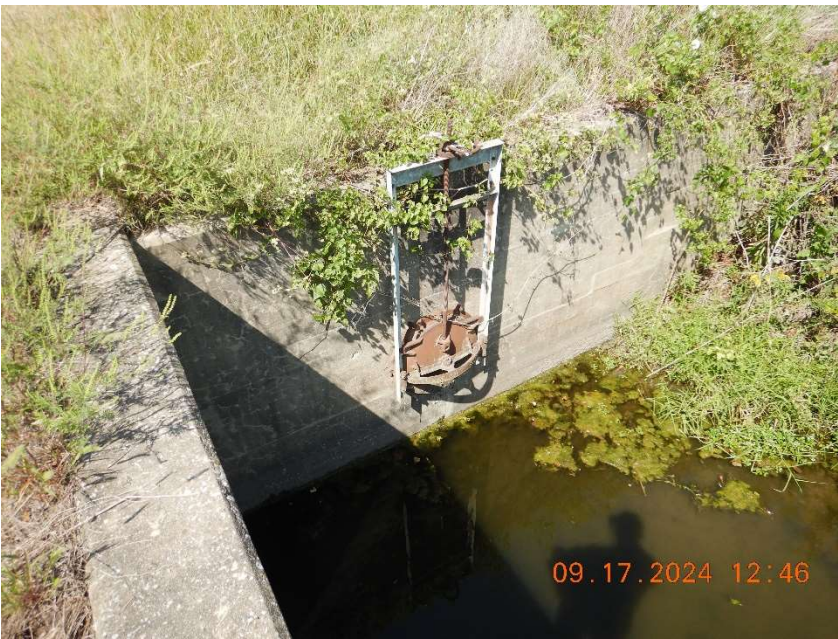
37: DSCN4266

Description: East side of control structure at the west end of the south ditch.

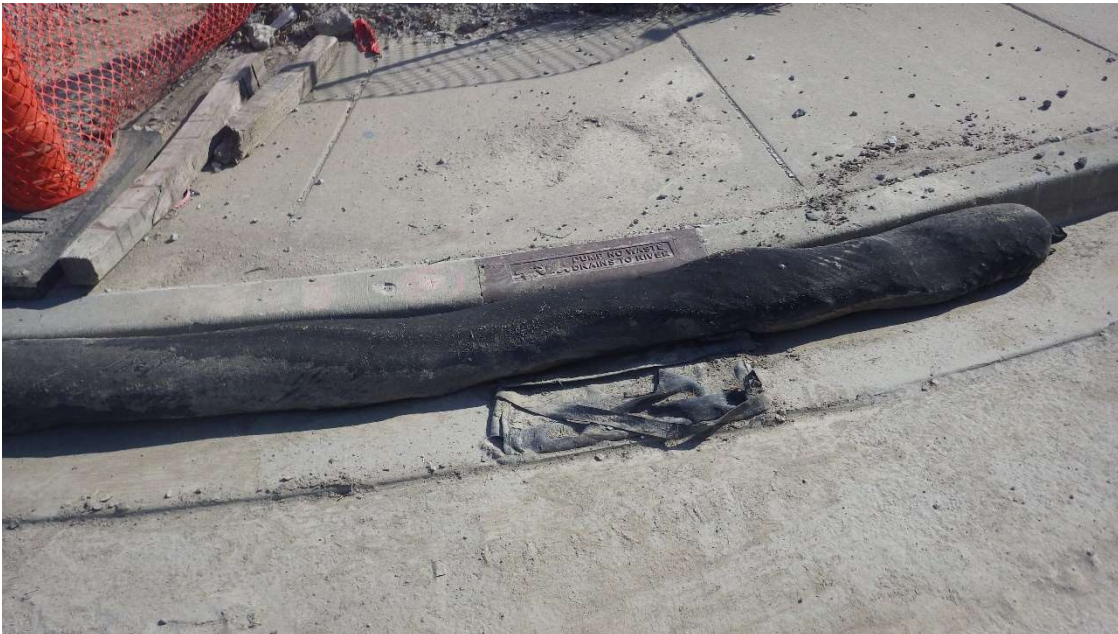
9: RIMG0009

EPA then began a walkaround of the construction site. Beginning on the west side of the site, EPA observed BMPs in place including storm drain inlet protection (photo 9) and silt fence

Description: Storm water drain inlet protection.

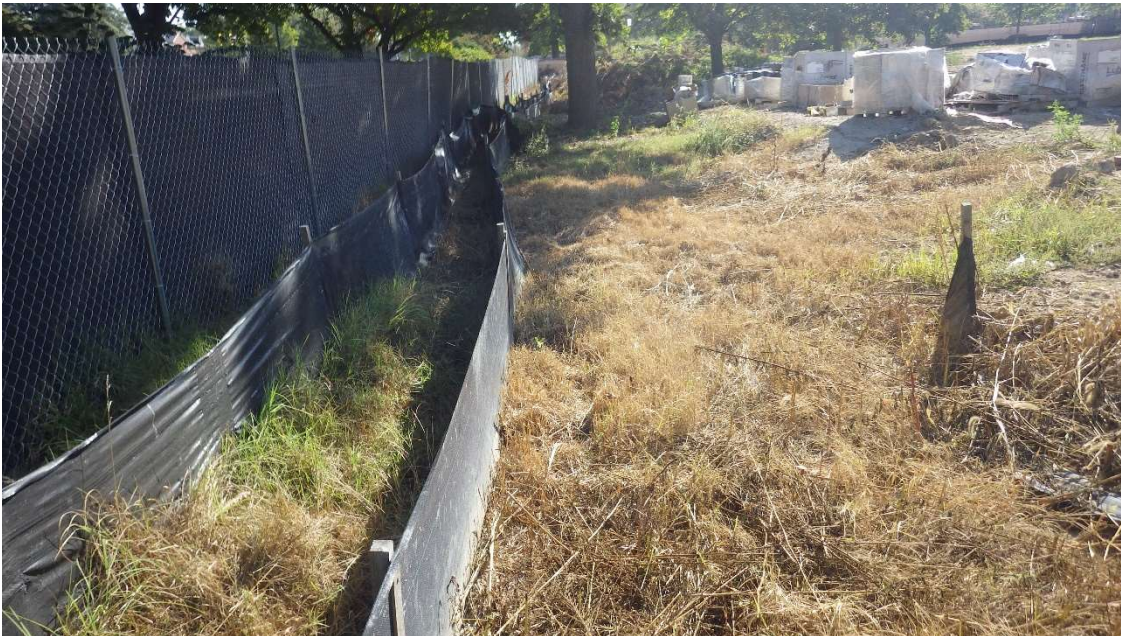
13: RIMG0013

Description: Double silt fence around perimeter of disturbed area.

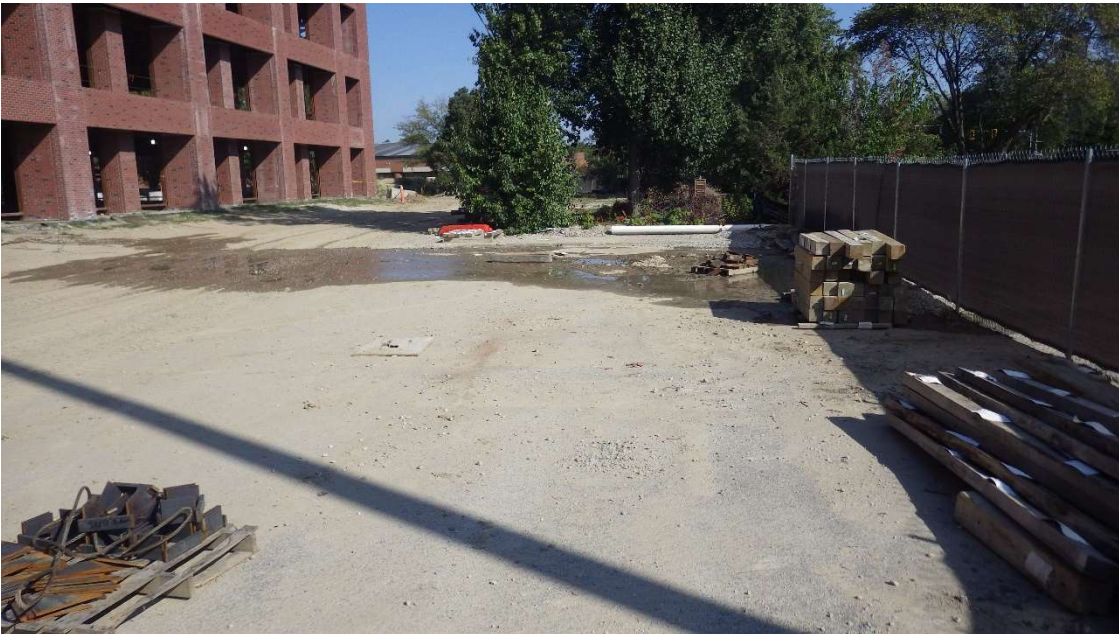
17: RIMG0017

Description: Water flowing east off the construction site to a storm drain. Note sediment in flow path of water.

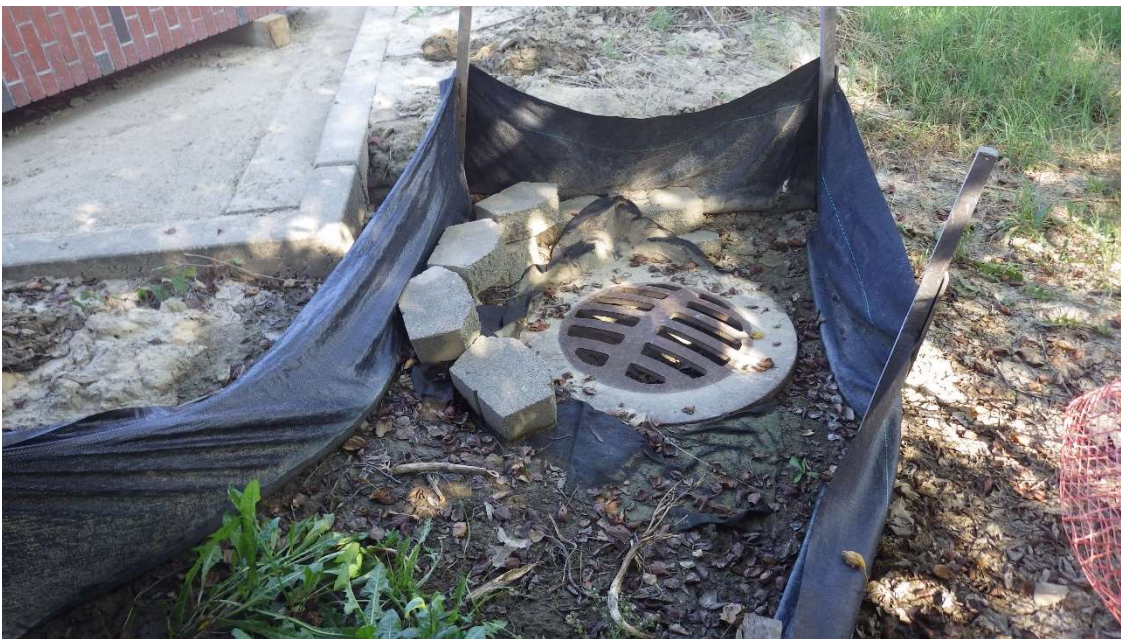
19: RIMG0019

Description: Filter fabric around storm water drain inlet.

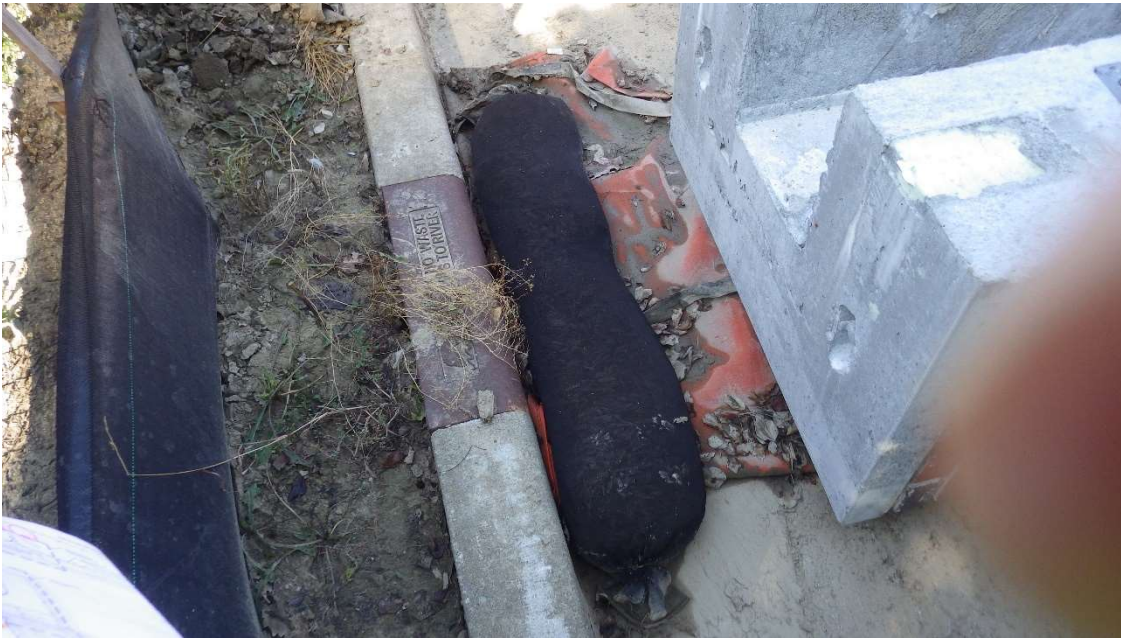
20: RIMG0020

Description: Curb drain protection.

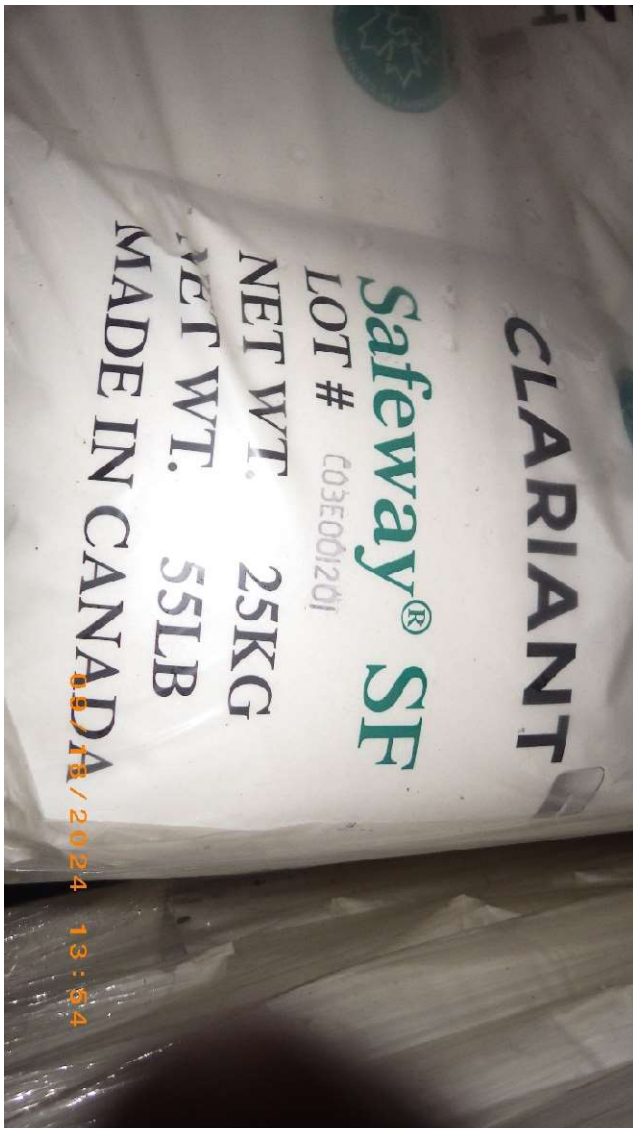
28: RIMG0028

Description: Bags of de-icing product stored in the Salt Barn.

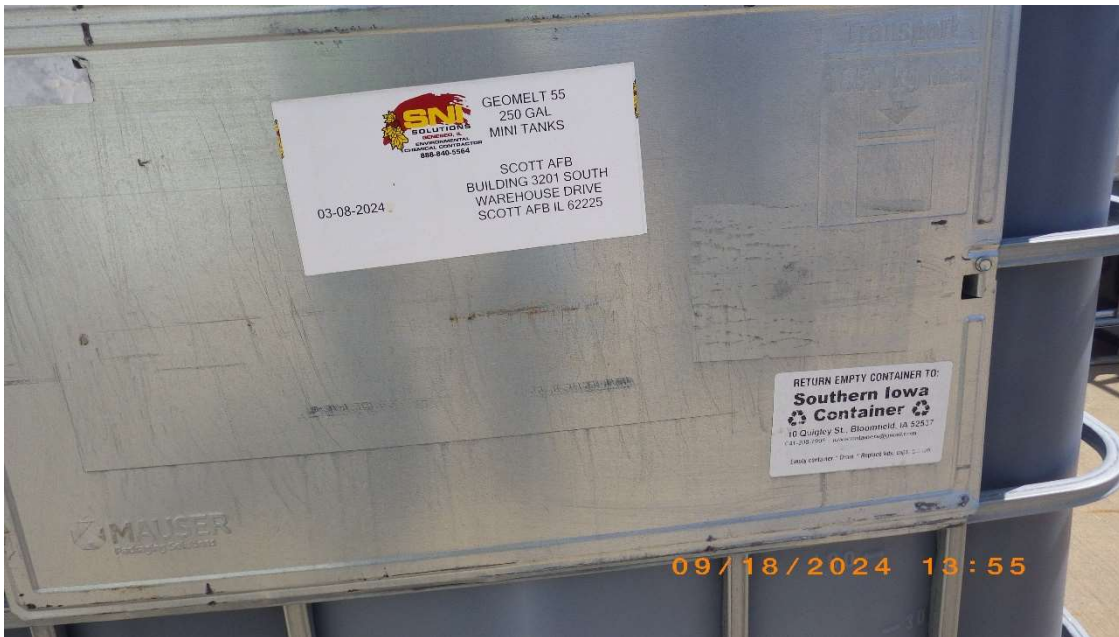
29: RIMG0029

Description: De-icing product stored in the Salt Barn.

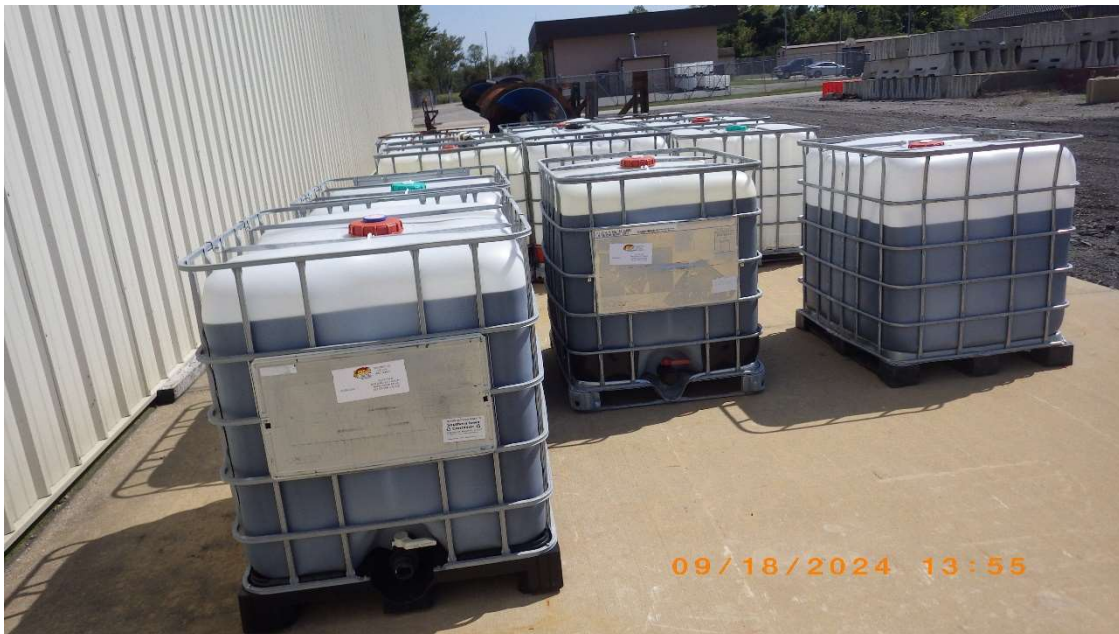
30: RIMG0030

Description: 250 gallon tanks of “Geomelt 55” beet juice additive stored on the south side of the Salt Barn.

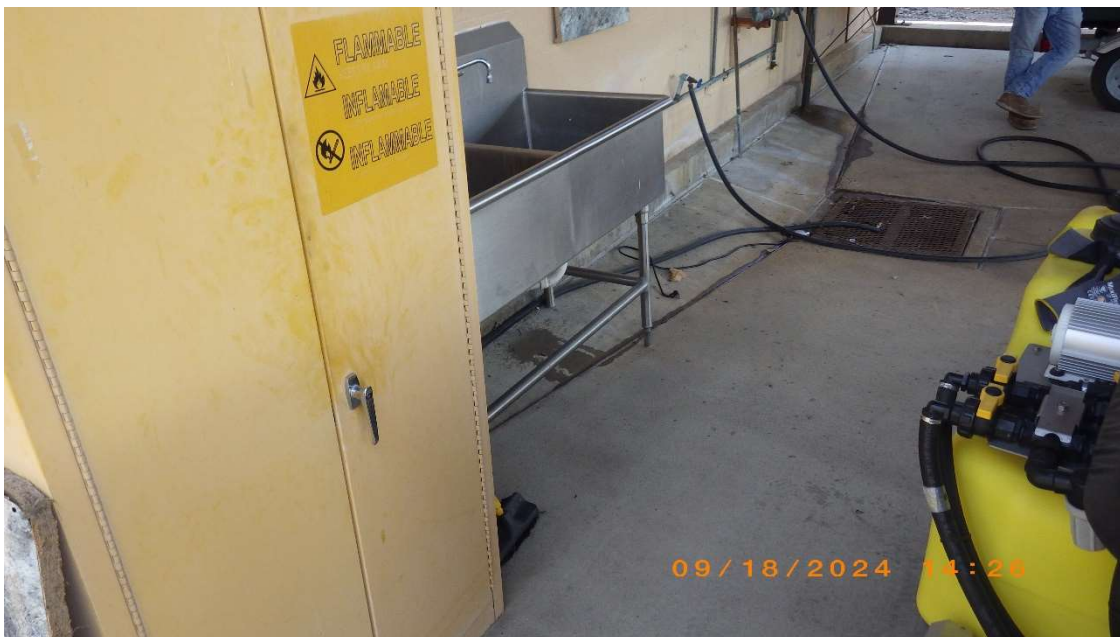
33: RIMG0033

Description: Spill container in one of the pesticide buildings.
