# NPDES Compliance Inspection Report

## Ron and Leo's Welding Services

**NPDES Permit Tracking Number  
# WAU000665**

**Inspection Date: 01/18/2023**

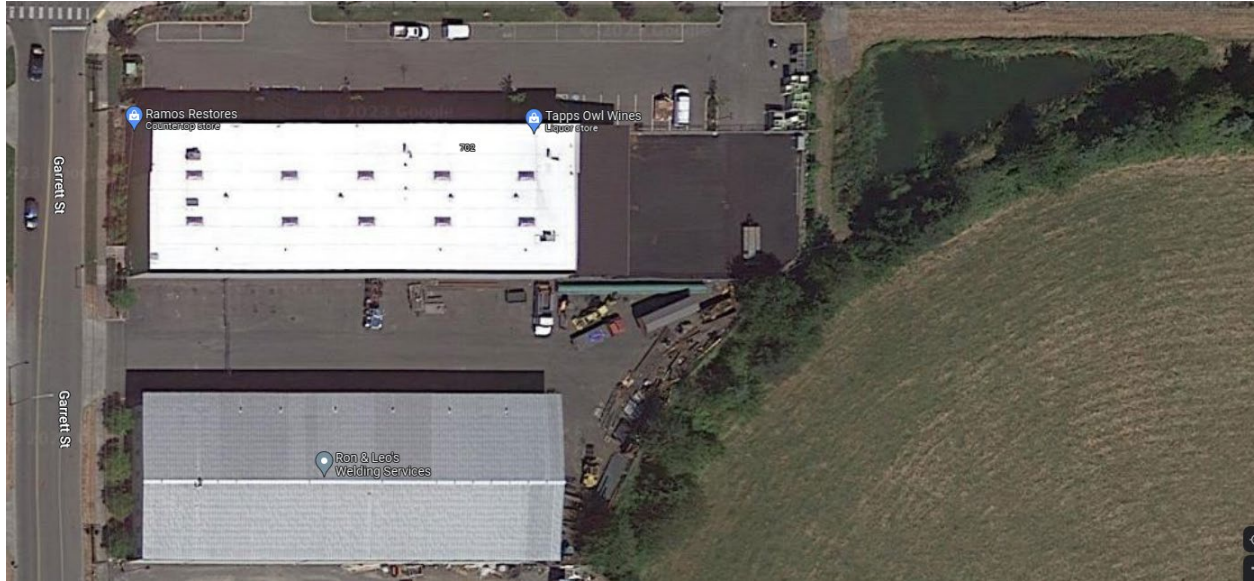
Figure 1: Ron and Leo's Welding Service shown in lower portion, with darker gray roof. Upper right shows municipal stormwater pond south of Battersby Avenue

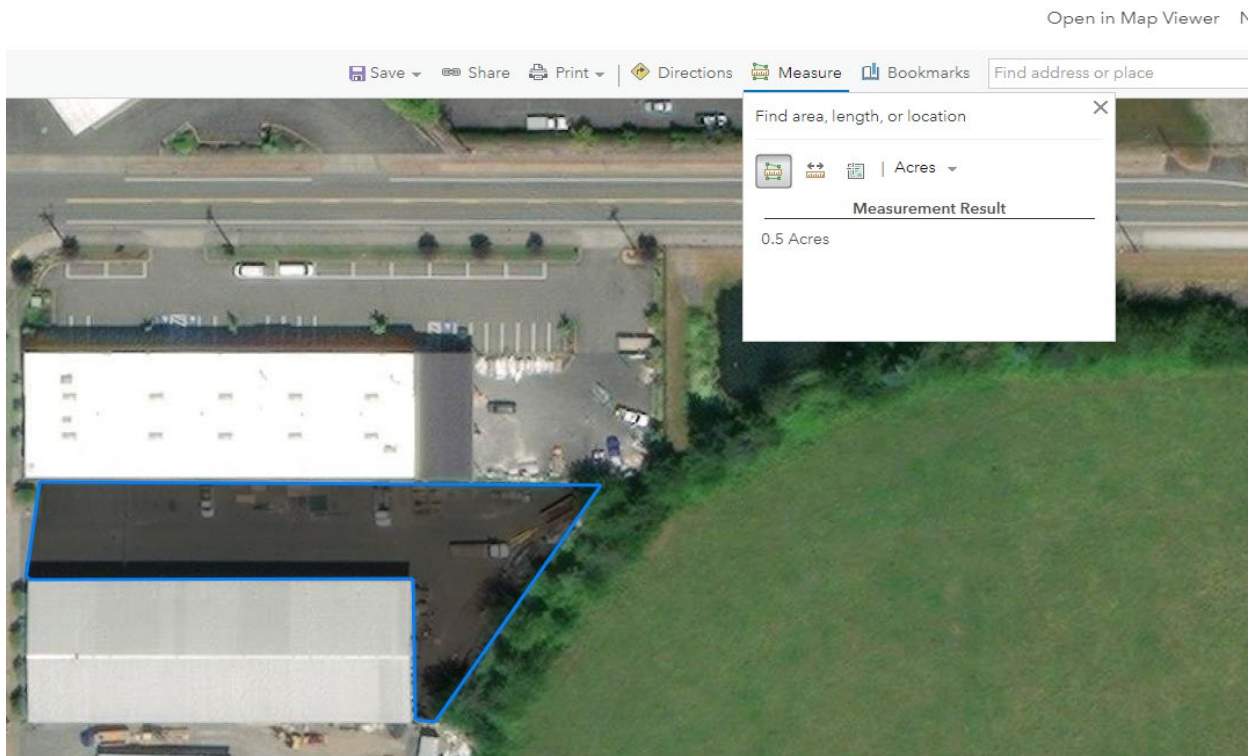
Figure 2: GIS imagery of the portion of the Ron and Leo's Welding Service Facility exposed to rainwater, approximately 0.5 acres.

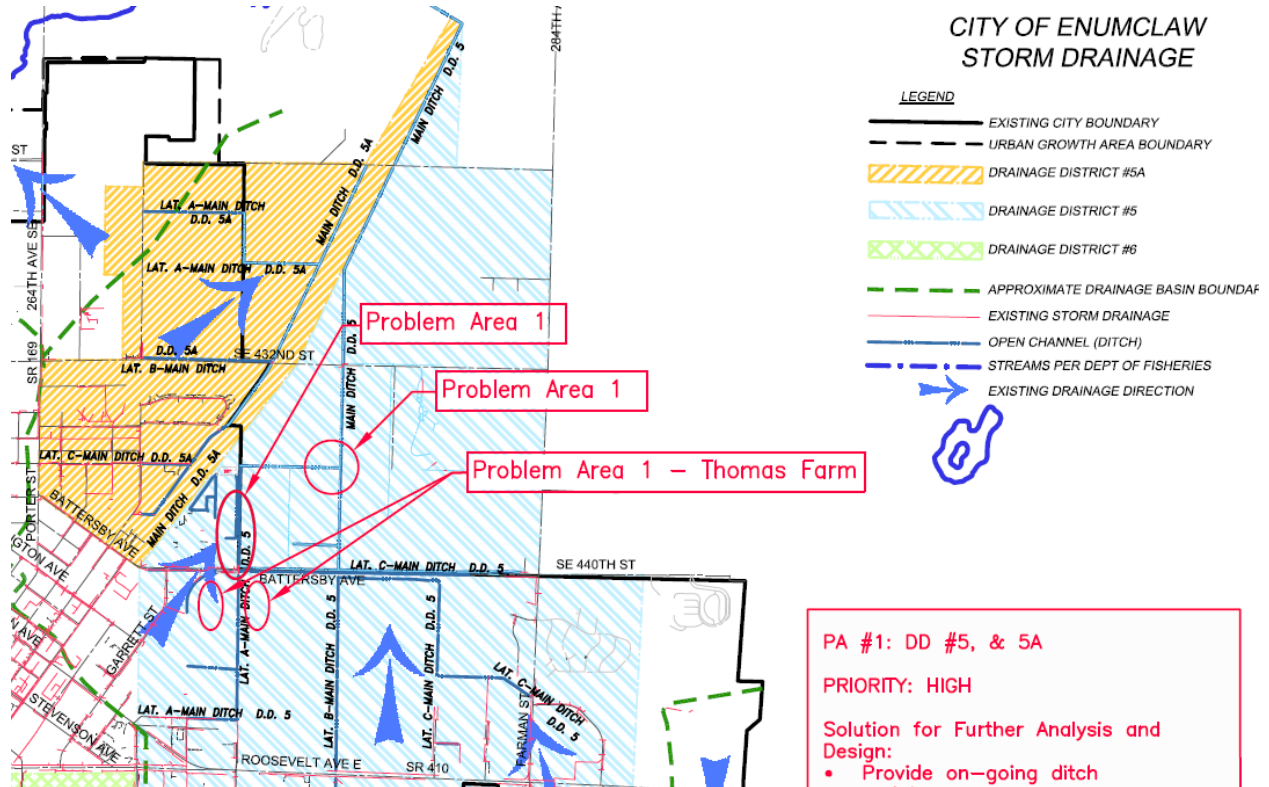
Figure 3: Image from pdf pg. 164 of city's Comprehensive Stormwater Plan. Stormwater from the Facility flows northeast, then north through Drainage District 5 and to the Newaukum Creek.
