## Region 6 Compliance Assurance and Enforcement Division

### INSPECTION REPORT

| Company Name: | <b>Southwestern Electric Power Company</b> | | |
| Facility Name: | <b>Lieberman Power Plant</b> | | |

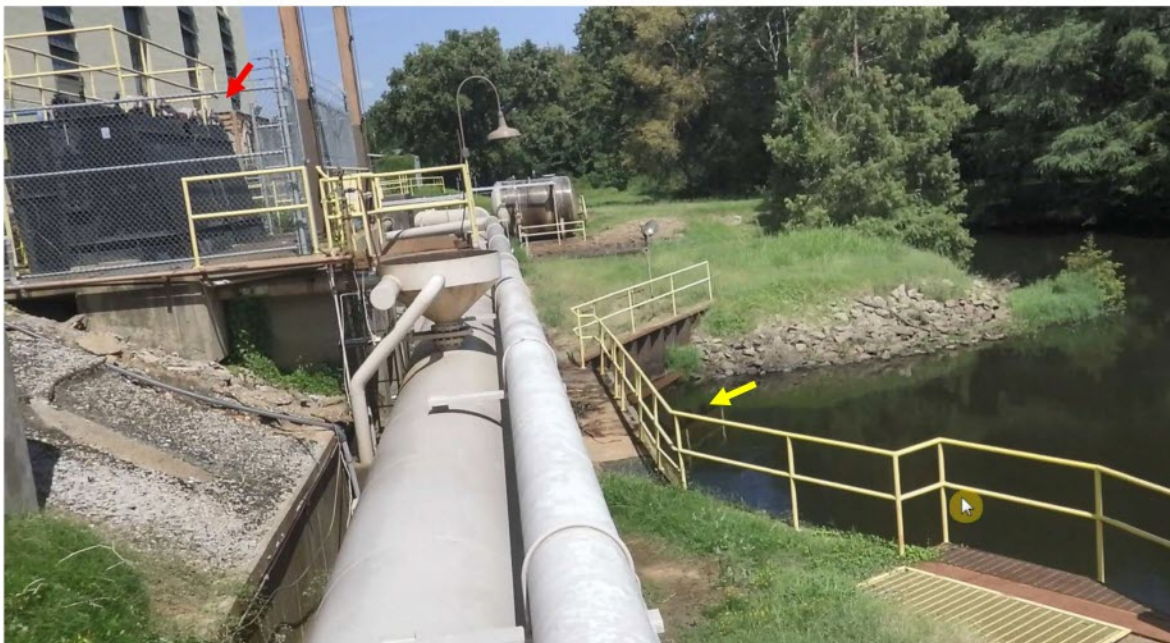
Photo No. 3

Description: This image shows units # 3 and 4 that uses Caddo Lake's water for its intake, cooling, and industrial processes. The water passes through intake units (yellow arrow) through traveling channels and screens (3/8-inch square steel mesh each) being pumped by circulating water pumps (red arrow).

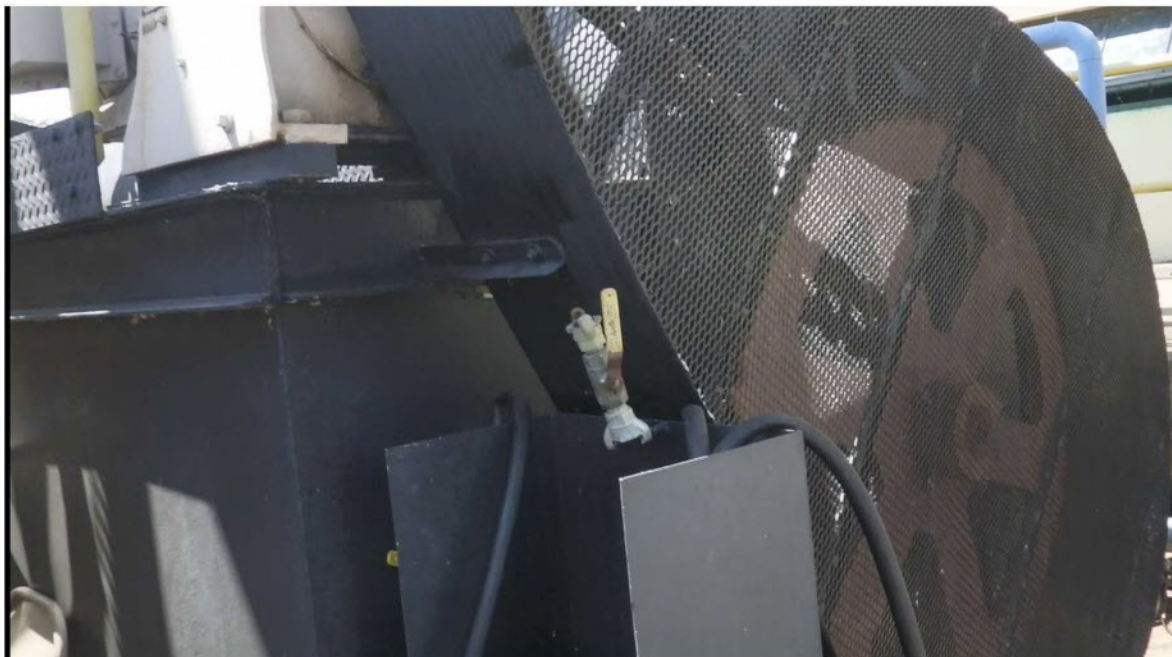
Photo No. 4

Photograph File Name: IntakePump.JPG  
Date of Photograph: 08/01/2023  
Latitude and Longitude: 32.704228, -93.961041  
Orientation: S  
Map Datum: WGS-84  
Time of Photo: 10:25 AM  
Photographer: Jack Arias  
Description: This image shows screens (3/8-inch square steel mesh each) being pumped by circulating water pump.

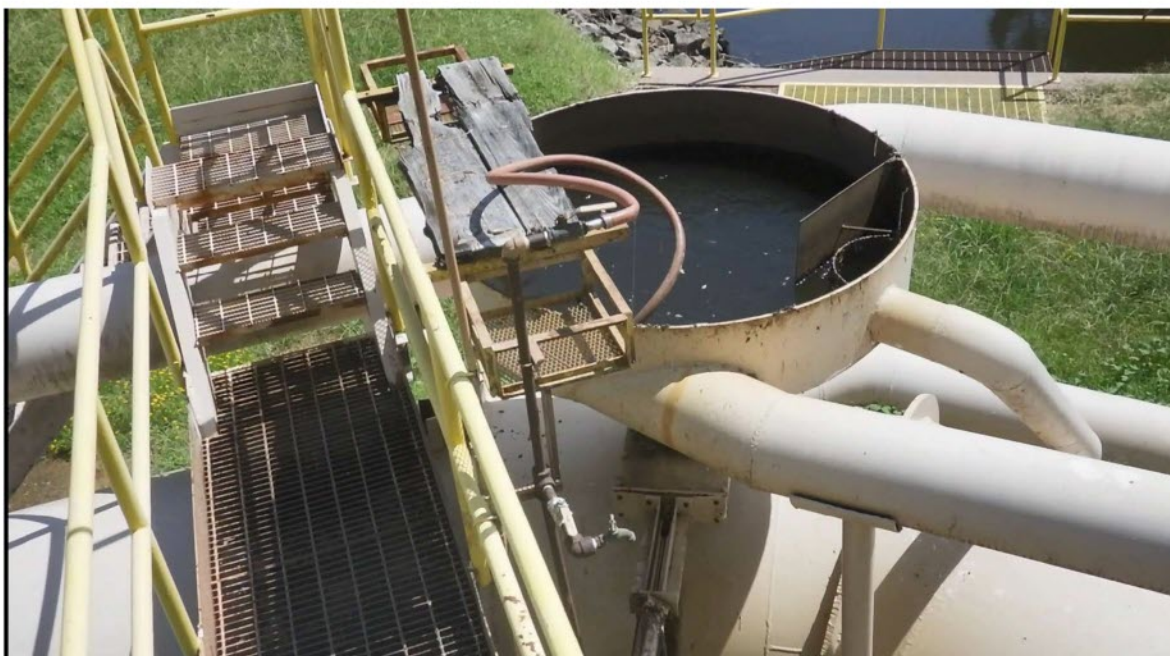
Photo No. 7

Photograph File Name: Sepintake.JPG  
Date of Photograph: 08/01/2023  
Latitude and Longitude: 32.704187, -93.960925  
Orientation: SE  
Map Datum: WGS-84  
Time of Photo: 10:34 AM  
Photographer: Jack Arias  
Description: This image shows the drain system that separates fish from intake and returns fish to the lake.

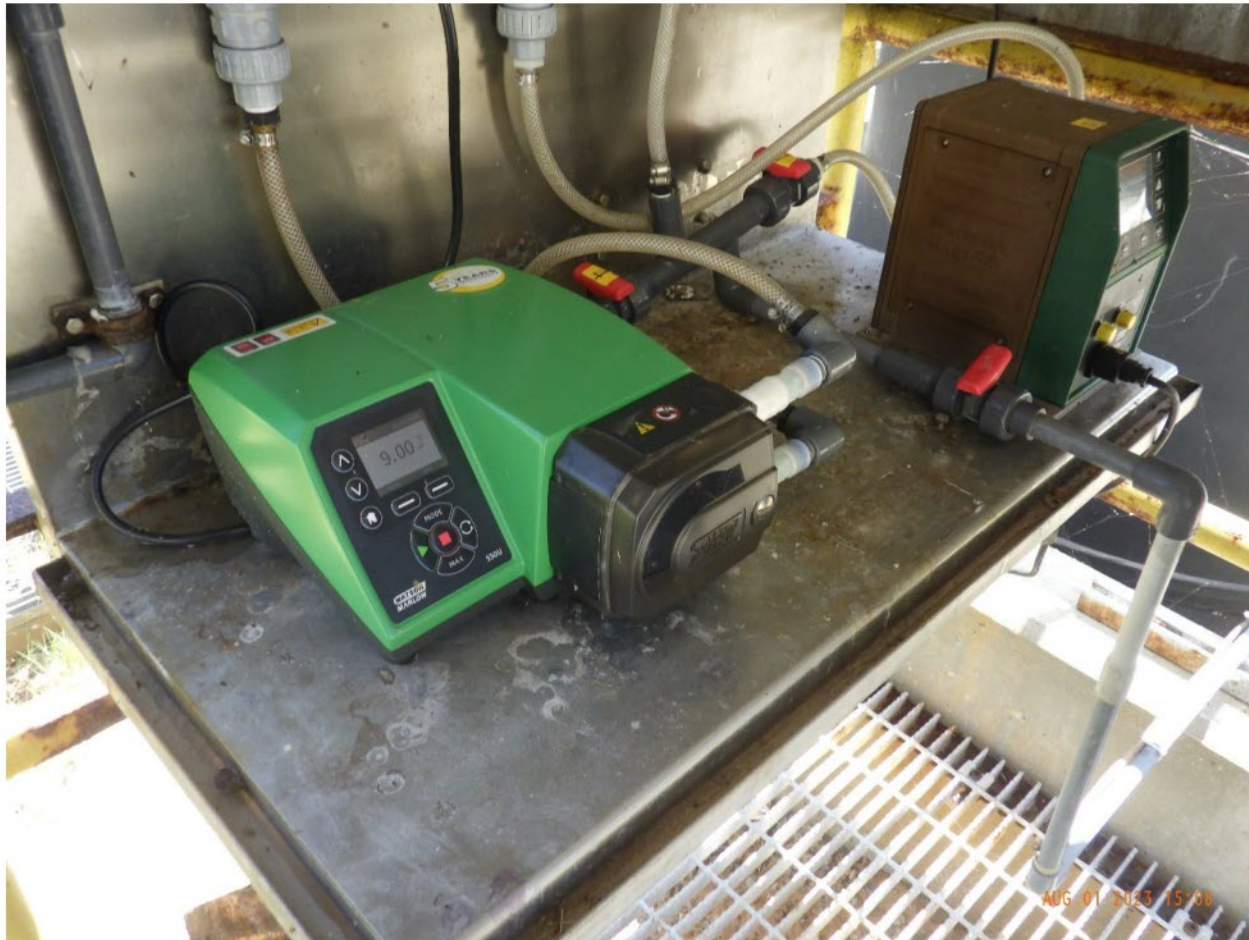
Photo No. 9

Facility apply Sodium hypochlorite (bleach) to control and inhibit marine growth that could foul the condenser, piping, heat exchangers, and other equipment where the circulating water flow. I inspected the enclosing chemical process and found a leak on the pipe that formed part sodium hypochlorite's control system. I observed corrosion formation on pipe and areas that got in contact with sodium hypochlorite. This acid could produce irritations and burns on people. Also, it could cause carcinogenic effects on water. (See Photo Nos. 8 – 10 in Appendix 1).

Photograph File Name: R0010337.JPG  
Date of Photograph: 08/01/2023  
Latitude and Longitude: 32.704233, -93.961383  
Orientation: SE  
Map Datum: WGS-84  
Time of Photo: 3:08 PM  
Photographer: Jack Arias  
Description: This image shows the application process of sodium hypochlorite control area.

Facility needs to fix the leak and later provide information and pictures that demonstrate the corrective action.

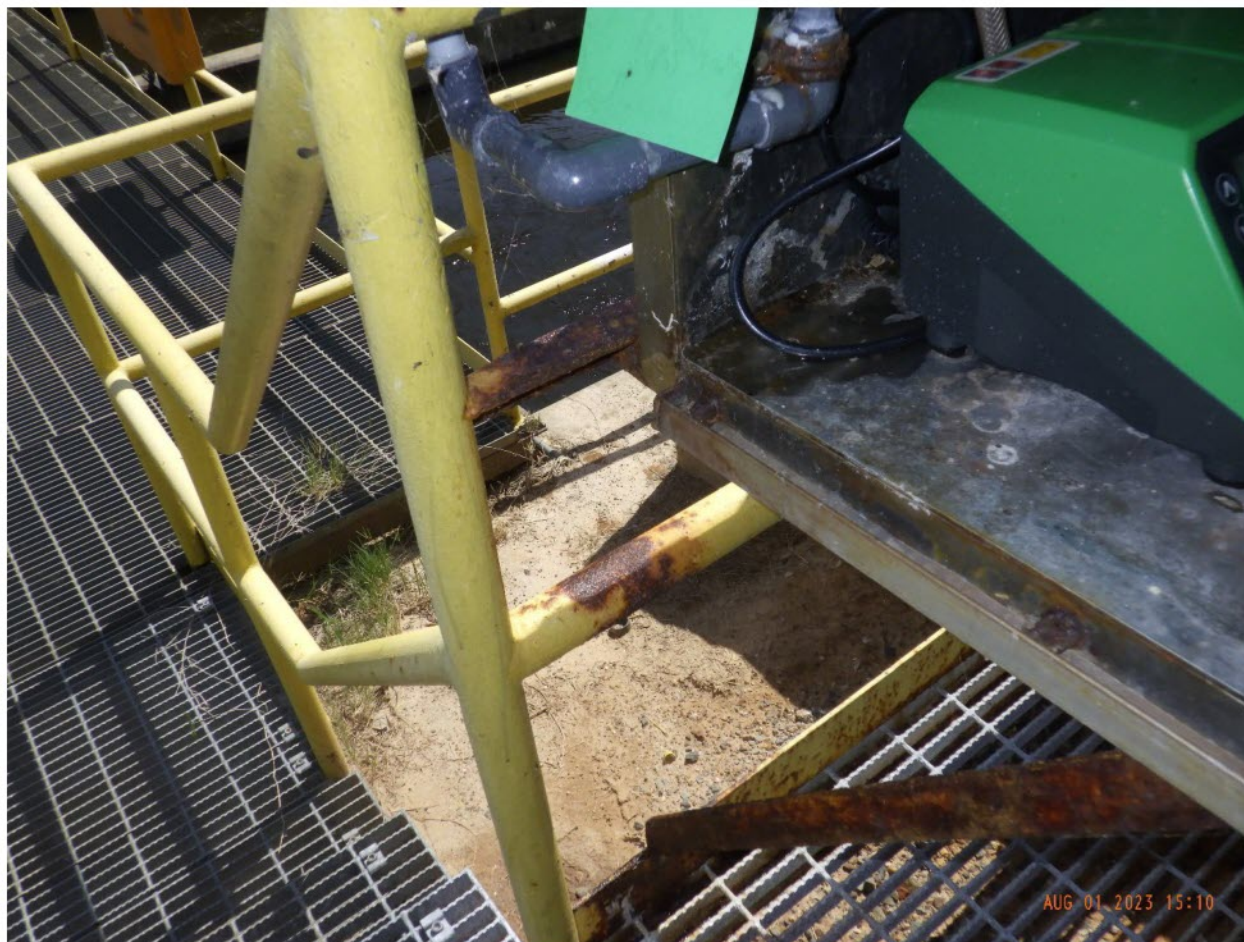
Photo No. 10

Photograph File Name: R0010338.JPG  
Date of Photograph: 08/01/2023  
Latitude and Longitud: 32.704233, -93.961383  
Orientation: SE  
Map Datum: WGS-84  
Time of Photo: 3:10 PM  
Photographer: Jack Arias  
Description: This image shows a leak on pipes and areas that formed part of the application control area of sodium hypochlorite.
