**REGION 3**

**Report Title:** Clean Water Act, Section 404 Inspection Report for Preston Hoopes Site  
**Inspection Date(s):** 08/8/2024  
**Start Time:** 11:09 **End Time:** 13:10  
**Regulatory Program(s):** Inspections authorized pursuant to Clean Water Act, Sections 308 and 404 (33 U.S.C. §§ 1318 and 1344)  
**Site Name:** Preston Hoopes  
**Site Location:** Intersection of Loucks Mill Road and T536  
Ulysses Township, Pennsylvania 16948  
**Latitude:** 41.892121 **Longitude:** -77.743672  
**County/Parish:** Potter County  
**Site Owner(s):** Preston Hoopes  
**Mailing Address:** 1002 Empson Road  
Ulysses, Pennsylvania 16948

**DSB-ID #:** ECAD-5531

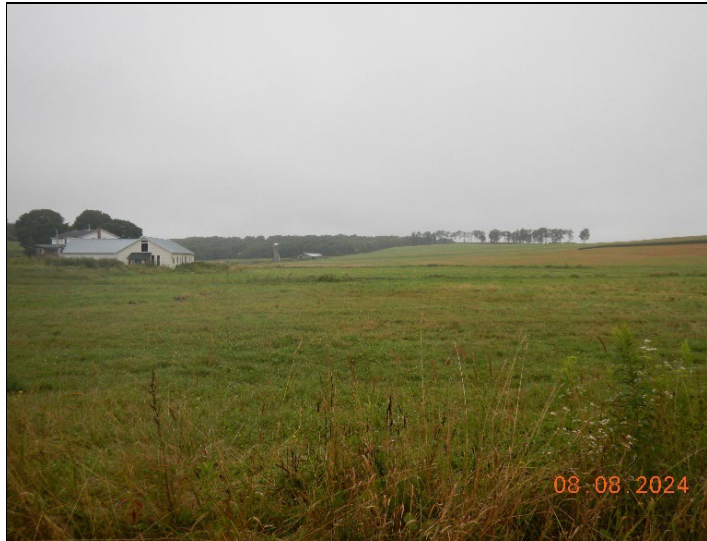
Hoopes Property  
Date: 8 August 2024  
Photo ID: DSCN5555.JPG  
Photo taken by: Laura Mathew

Notes: General view facing north of the Hoopes Property.

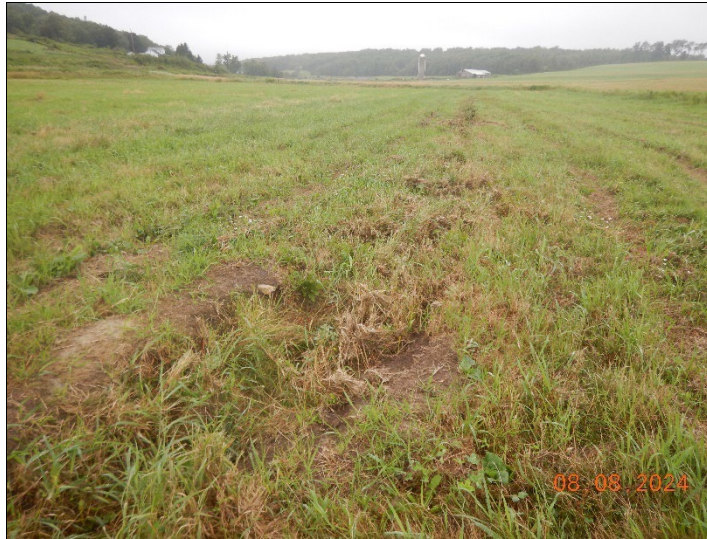
Hoopes Property  
Date: 8 August 2024  
Photo ID: DSCN5561.JPG  
Photo taken by: Laura Mathew

Notes: North facing view further downstream of the Genessee River.

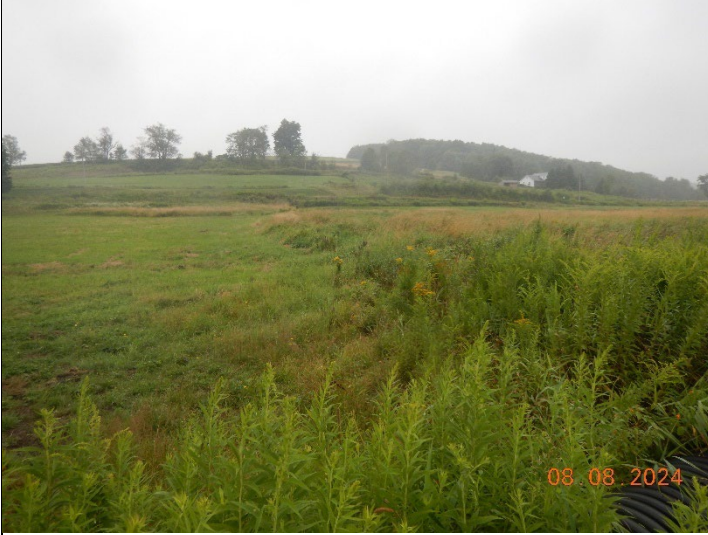
| | <p>Hoopes Property<br/>Date: 8 August 2024<br/>Photo ID: DSCN5564.JPG<br/>Photo taken by: Laura Mathew</p> <p>Notes: Looking west along the property boundary line.</p> |

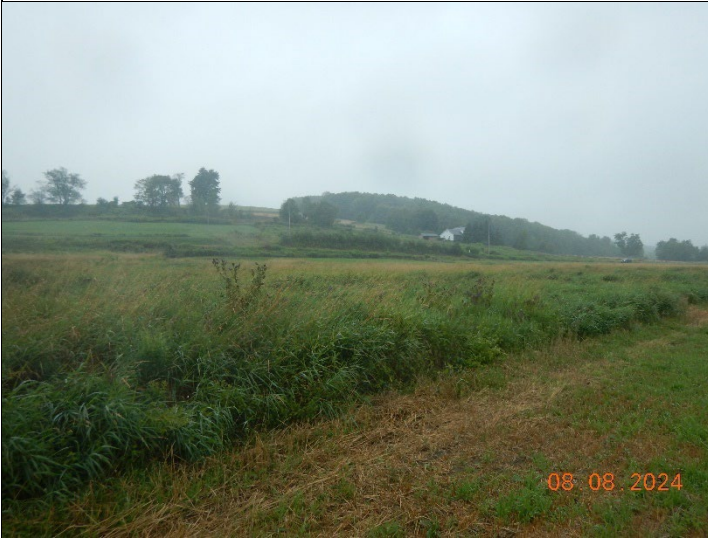
| | <p>Hoopes Property<br/>Date: 8 August 2024<br/>Photo ID: DSCN5565.JPG<br/>Photo taken by: Laura Mathew</p> <p>Notes: Northwesterly view looking towards Loucks Mill Rd of the Hoopes property.</p> |

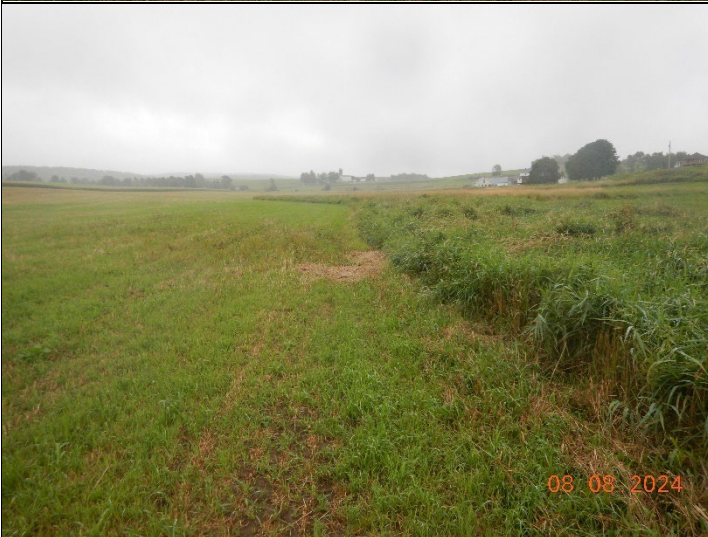
| | <p>Hoopes Property<br/>Date: 8 August 2024<br/>Photo ID: DSCN5566.JPG<br/>Photo taken by: Laura Mathew</p> <p>Notes: South-facing view along former fence line.</p> |

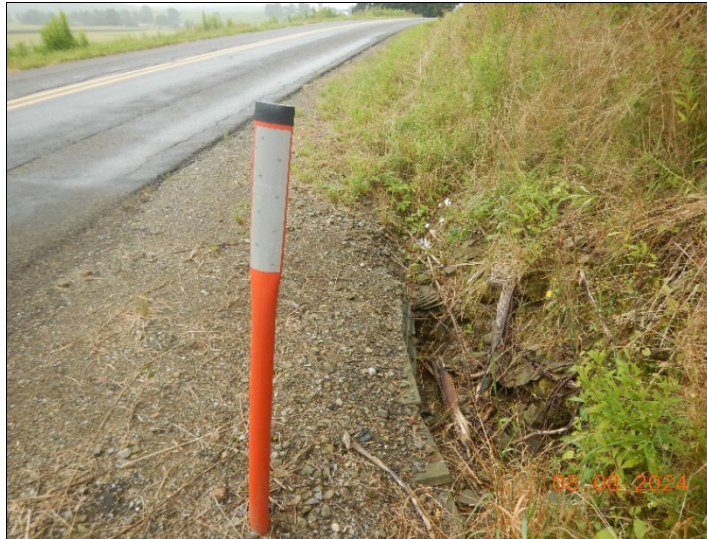
Hoopes Property  
Date: 8 August 2024  
Photo ID: DSCN5573.JPG  
Photo taken by: Laura Mathew

The inspection moved to the south and vehicle depressions were observed in the field. Surface water was present in the vehicle depressions at the time of the inspection (DSCN5570 and DSCN5571). A culvert under Loucks Mill Road was observed with water flowing to the Site (DSCN5572). Ecotune stated this culvert had recently been installed, replacing an older culvert.

Notes: Inlet of stormwater drainage under Loucks Mill Road.

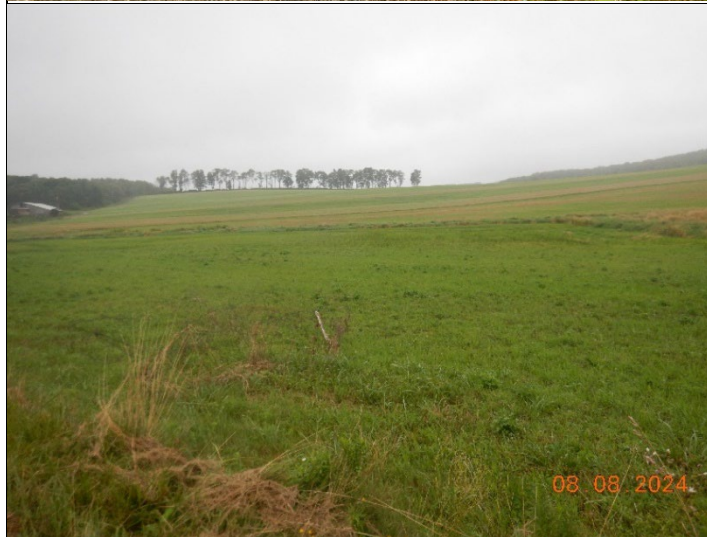
Hoopes Property  
Date: 8 August 2024  
Photo ID: DSCN5574.JPG  
Photo taken by: Laura Mathew

Notes: Northeast view overlooking the Hoopes property from the culvert along Loucks Mill Road.

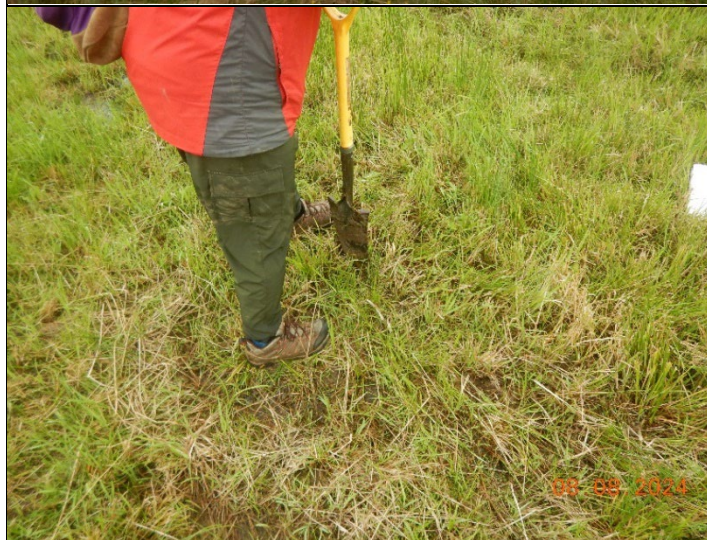
Hoopes Property  
Date: 8 August 2024  
Photo ID: DSCN5575.JPG  
Photo taken by: Laura Mathew

Notes: Location of Soil Boring #2.

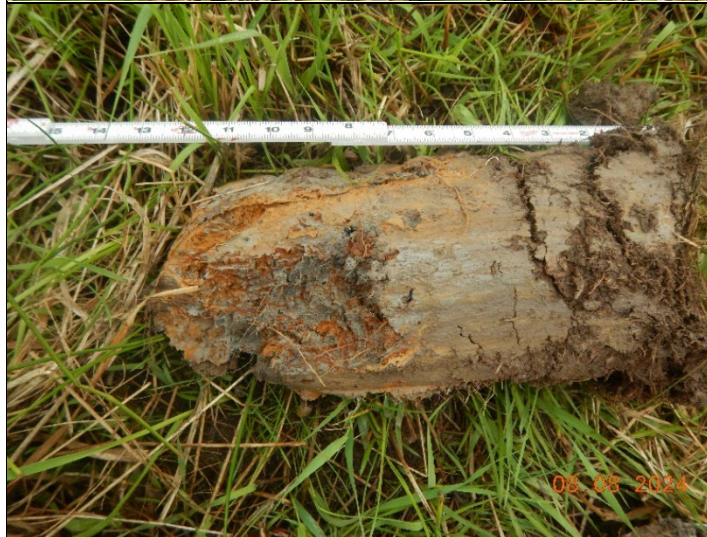
Hoopes Property  
Date: 8 August 2024  
Photo ID: DSCN5578.JPG  
Photo taken by: Laura Mathew

(Attachment 2) and was characterized as: [0-4 inches] 100% 7.5YR 3/2 silty loam; [4-12 inches] 60% 2.5YR 4/1 silty loam with 40% 7.5YR 4/6 redoximorphic features (DSCN5577). The soil profile met the technical definition of a hydric soil (Indicator F3). The soil was saturated and surface water was observed nearby (DSCN5576). The area had approximately 85% vegetation cover that was comprised of grass.

Notes: Another view of Soil Boring #2.

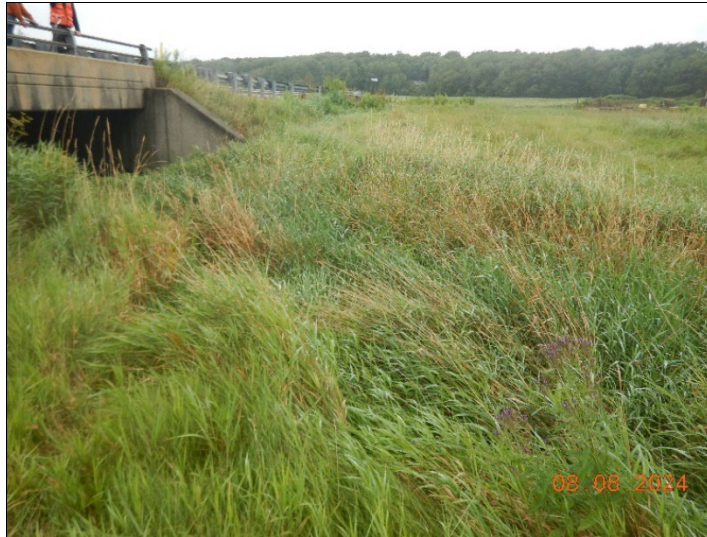
Hoopes Property  
Date: 8 August 2024  
Photo ID: DSCN5582.JPG  
Photo taken by: Laura Mathew

Notes: Southeast view of the Genessee River downstream of culvert.

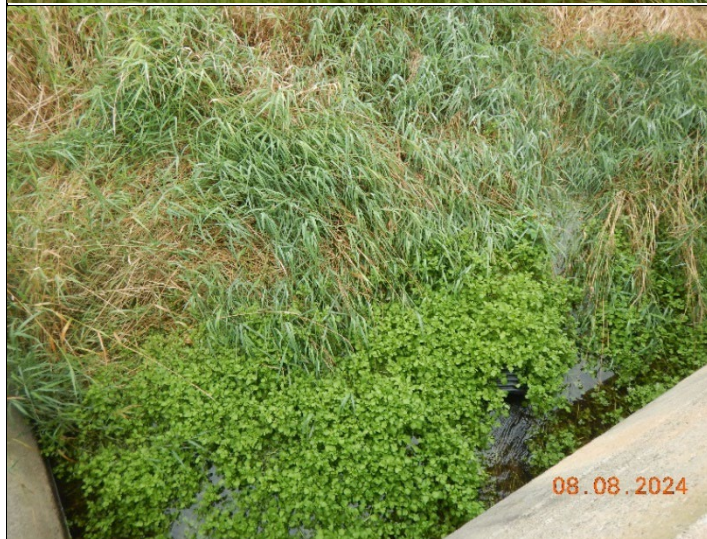
Hoopes Property  
Date: 8 August 2024  
Photo ID: DSCN5583.JPG  
Photo taken by: Laura Mathew

Notes: View of the Genessee River flowing out of the culvert under Loucks Mill Road.

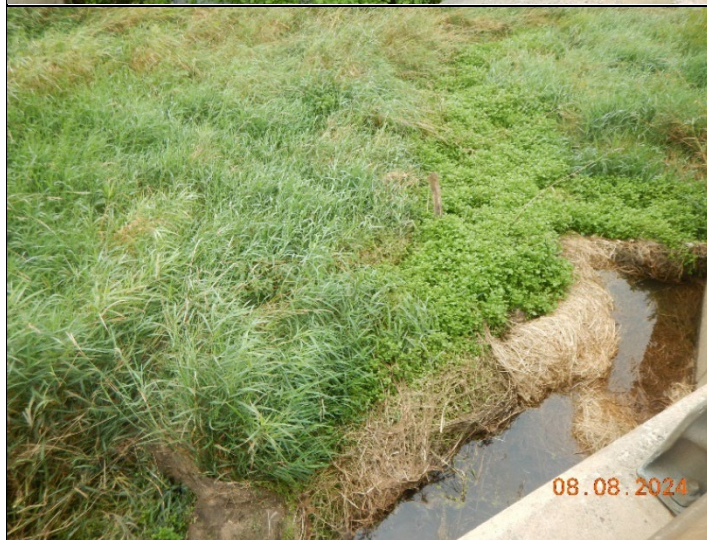
Hoopes Property  
Date: 8 August 2024  
Photo ID: DSCN5584.JPG  
Photo taken by: Laura Mathew

Notes: Another view of the Genessee River flowing out of the culvert.

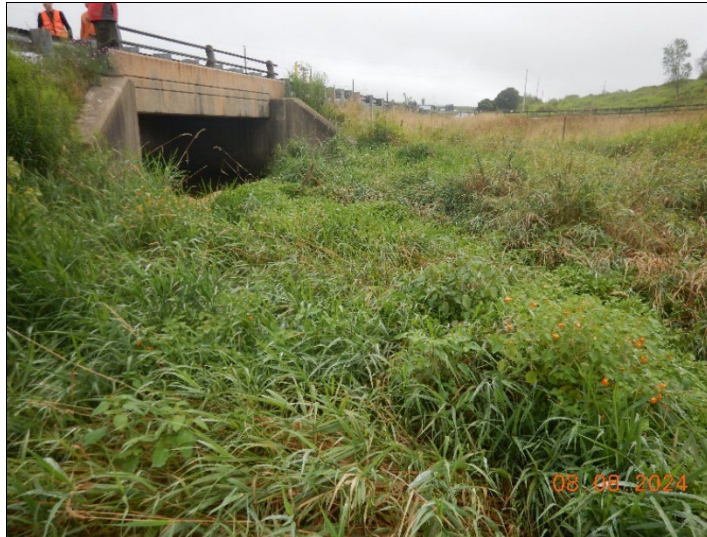
Hoopes Property  
Date: 8 August 2024  
Photo ID: DSCN5585.JPG  
Photo taken by: Laura Mathew

Notes: East facing view of Genessee River.

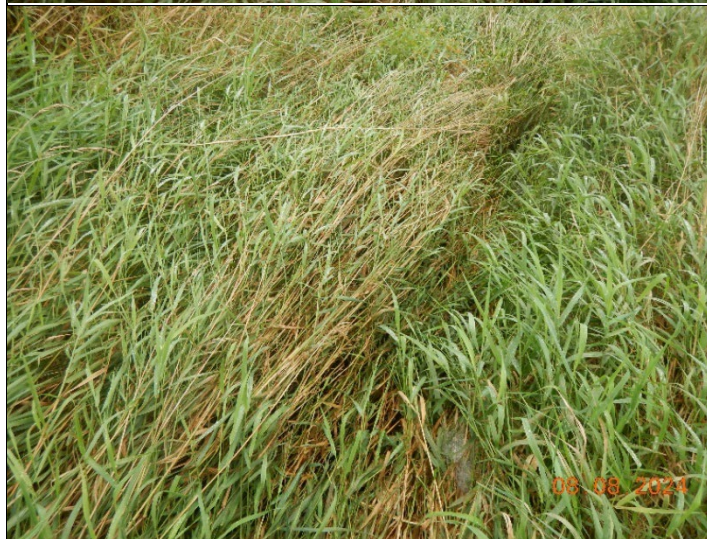
Hoopes Property  
Date: 8 August 2024  
Photo ID: DSCN5586.JPG  
Photo taken by: Laura Mathew

Notes: View of vegetation in and around the Genessee River.

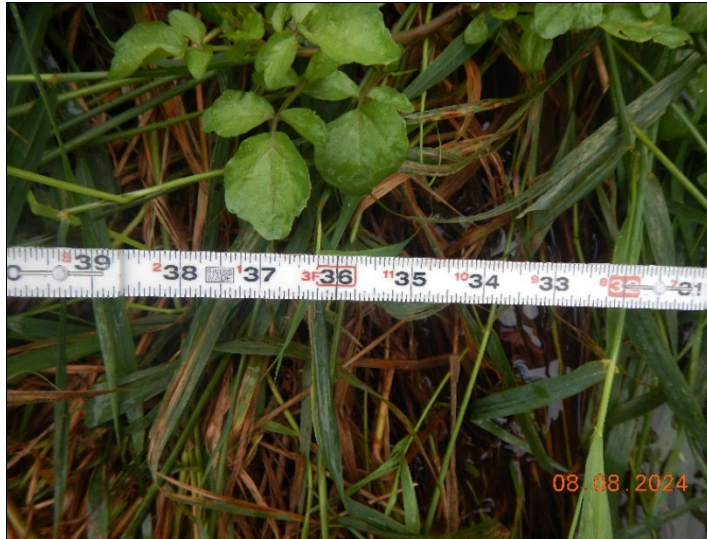
Hoopes Property  
Date: 8 August 2024  
Photo ID: DSCN5588.JPG  
Photo taken by: Laura Mathew

Notes: Width of the Genessee River.
