## Compliance Inspection Report for Stormwater Discharges from Construction Activities (CGP)

| <b>Site/Project Name:</b><br>Ashmont Planned Development | | <b>NPDES Tracking Number:</b><br>TNR155437 | | <b>Date Coverage was Issued:</b><br>April 10, 2023 | |
| <b>Name of Permittee (Developer/Operator):</b> Ashmont Developer LLC | | | | | |

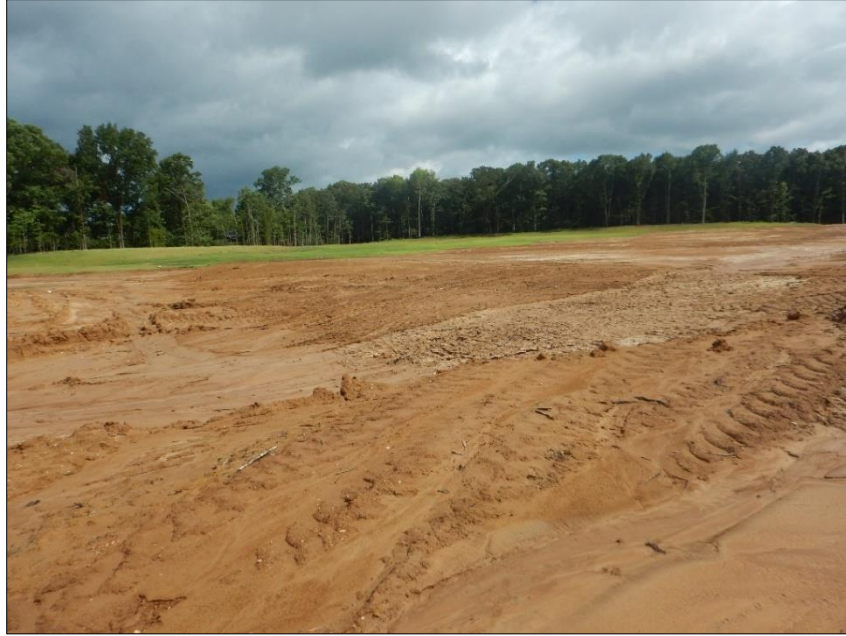
Photograph 5. View, facing west, of the northwestern portion of the Site. This area was actively under construction at the time of the inspection.

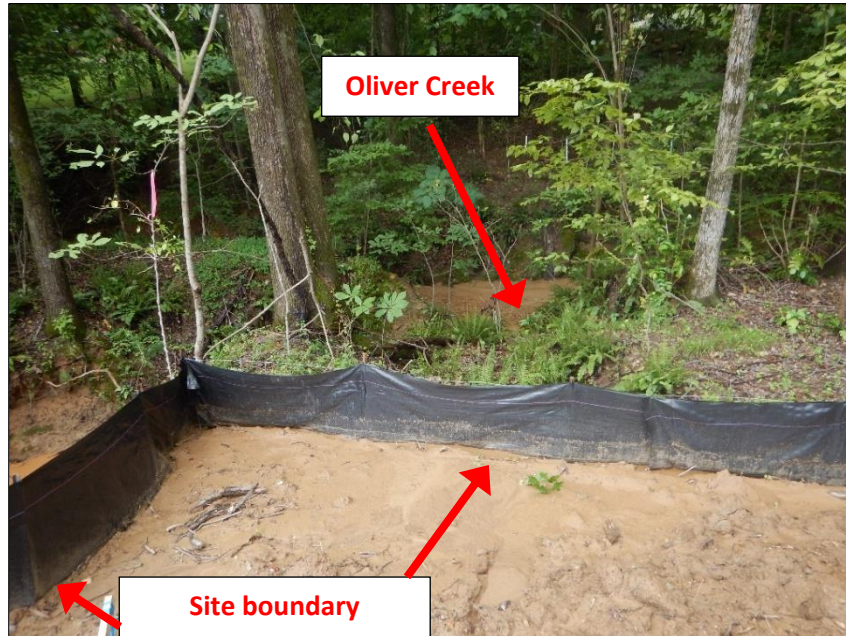
The EPA Inspection Team observed silt fence with sediment accumulation that reduced the capacity of the control by at least 40% [Refer to **Appendix B, Photograph Log (Photographs 8, 12, 13, 14, 16, 17, 19, 20, 24, 25, 28, 35, 40, 48, 52, 61, 62, 64, 66, 67, and 68)**].

- The EPA Inspection Team observed that silt fence without backing, by itself and not as part of a stormwater treatment train, was not an adequate sediment control for northern and western Site perimeters [Refer to **Appendix B, Photograph Log (Photographs 8, 12, 13, 14, 17, 19, 20, 24, 25, 28, 35, 47, and 48)**].

Photograph 17. View, facing northwest, Oliver Creek running south to north adjacent to the Site.

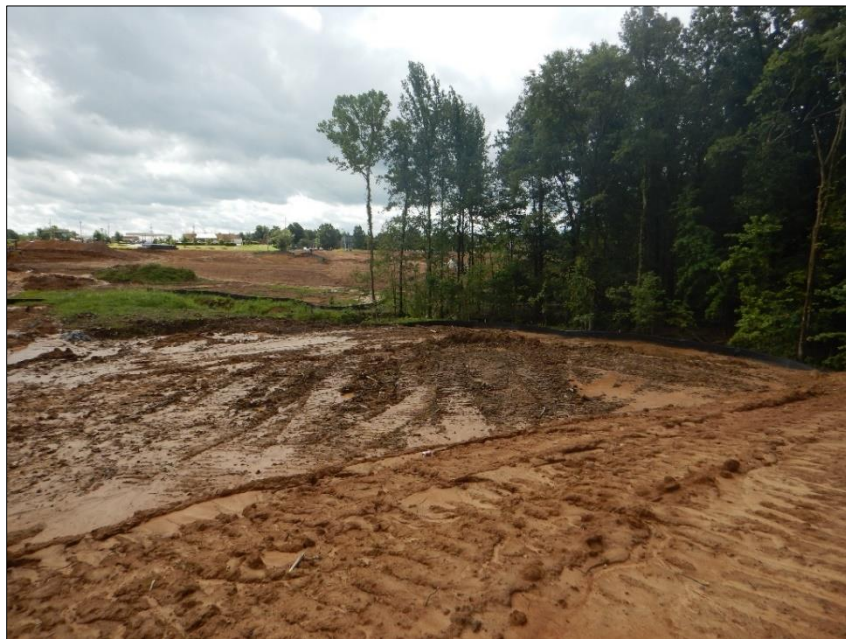
Photograph 22. View, facing south, of an active construction area in the western portion of the Site.

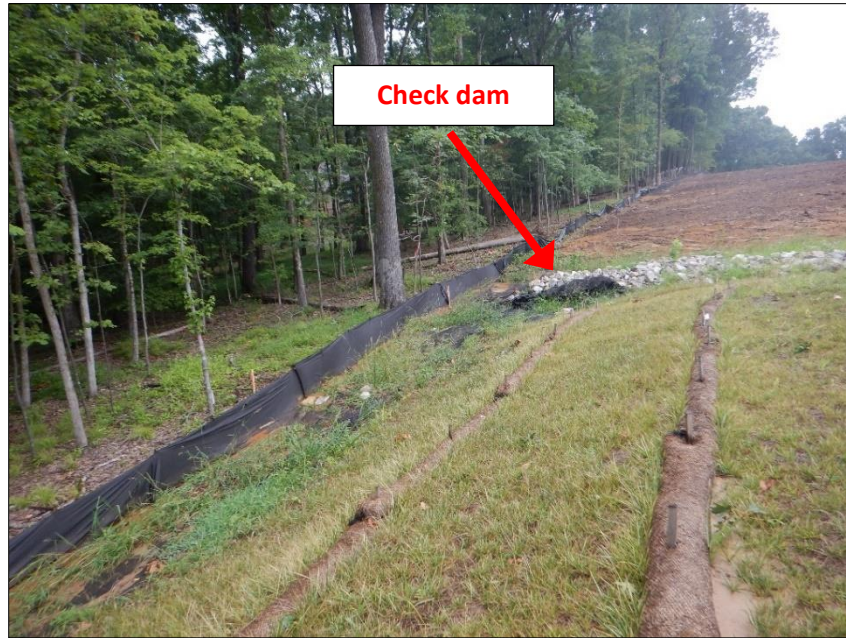
| 5. FIELD EVALUATION & PLAN IMPLEMENTATION | | |
|---|---|---|
| b. Are EPSCs functioning correctly at all disturbed areas/material storage areas? | N/A | <p>The EPA Inspection Team observed undercutting of the wattles and silt fencing at Outfall #18 [Refer to <u>Appendix B, Photograph Log (Photographs 29 and 30)</u>].</p> <p>The EPA Inspection Team observed sediment undercutting the silt fencing and the discharge of sediment offsite in areas south of Outfall #5 and west of Outfall #7. The EPA Inspection Team observed evidence of sediment discharge offsite at Outfalls #16, #14, and several unidentified outfalls that have not been assigned identification numbers in the EPSC plan [Refer to <u>Appendix B, Photograph Log (Photographs 11-14, 19, 24, 25, 40, 48, 50, 52, 62, 66-68)</u>, and <u>Appendix C, Exhibit Log (Exhibit 5)</u>]. Refer to Section 5.a., above.</p> |

| 5. FIELD EVALUATION & PLAN IMPLEMENTATION | | |
|---|---|---|
| temporarily/permanently ceased, was the area stabilized within 14 days? (permit section 3.5.3.2) If yes, describe below each location and measures taken to stabilize the area(s). | | [Refer to <b>Appendix B, Photograph Log (Photographs 29, 30, and 31)</b> ]. According to the Site representative, the area had been inactive for more than two weeks. |

Photograph 29. Upgradient view, facing northeast, of a check dam and straw wattle erosion and sediment controls upgradient of Outfall #18.

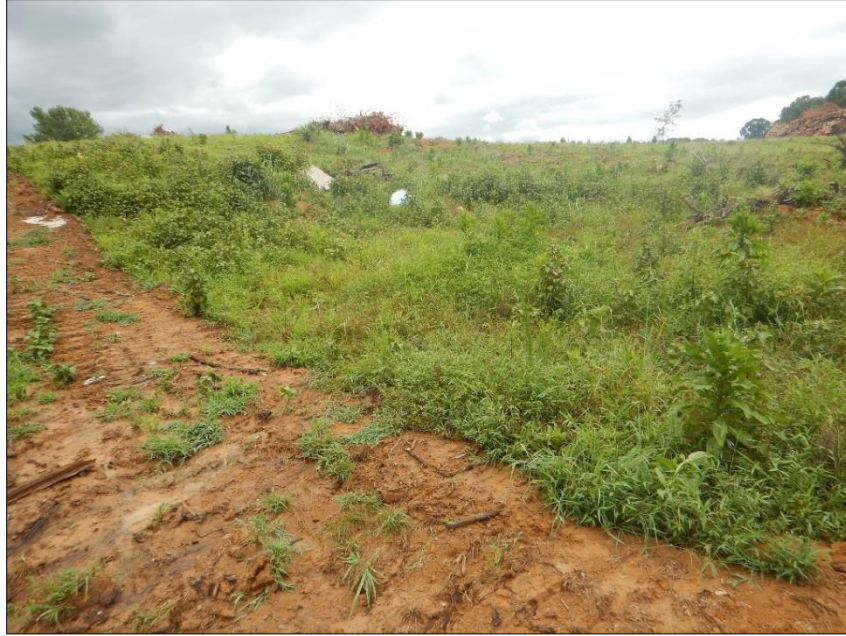
Photograph 37. View of a disturbed area upgradient of Outfall #17.

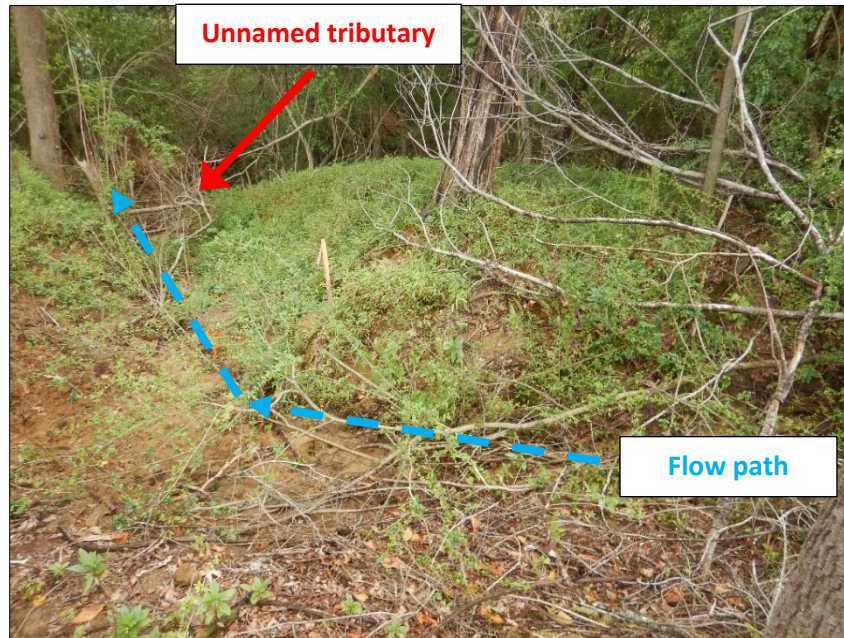
Photograph 51. Downgradient view of a stormwater flow path leading from the Site towards the unnamed tributary to Oliver Creek.

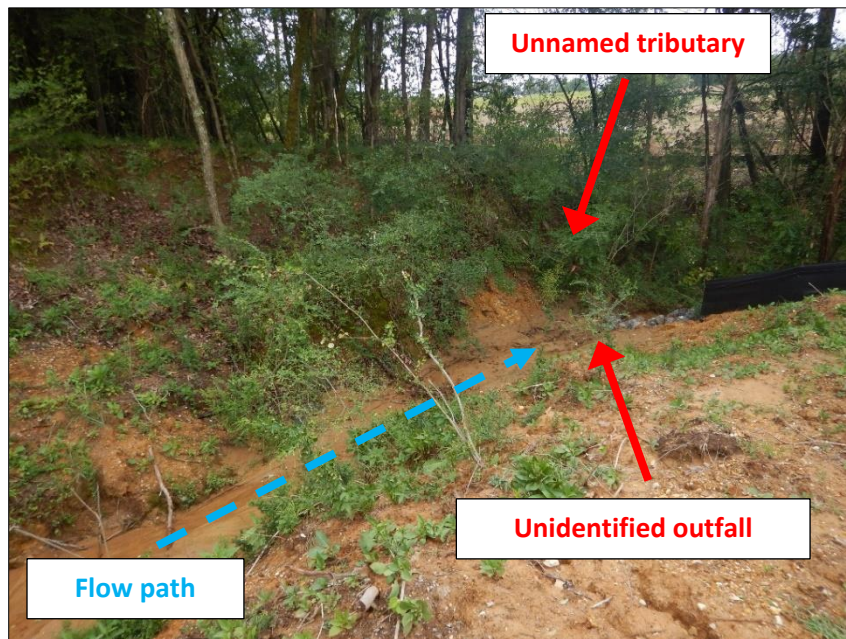
Photograph 58. Downgradient view of the stormwater flow path leading towards an unidentified discharge point in the center of the Site.

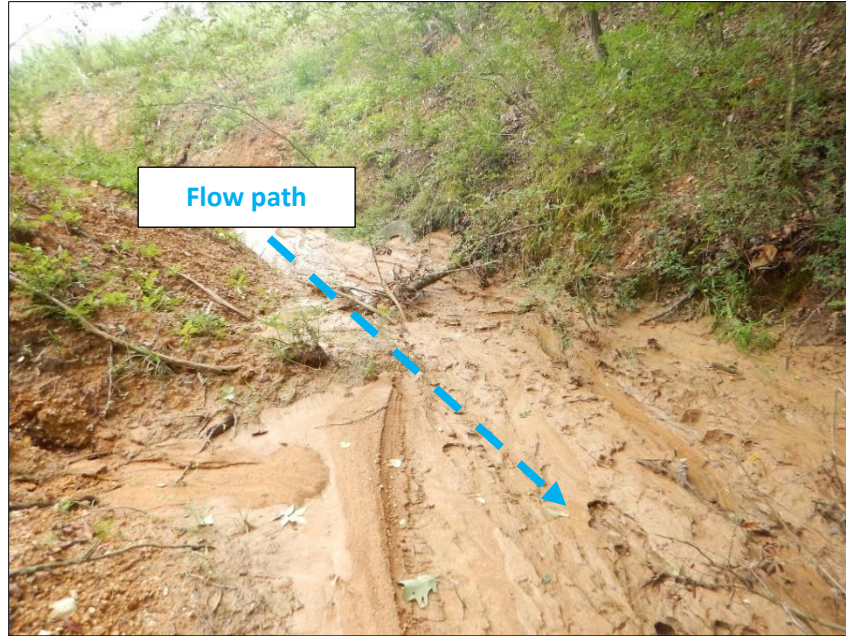
Photograph 59. Upgradient view of the stormwater flow path leading towards an unidentified discharge point in the center of the Site shown in [Photograph 58](#).

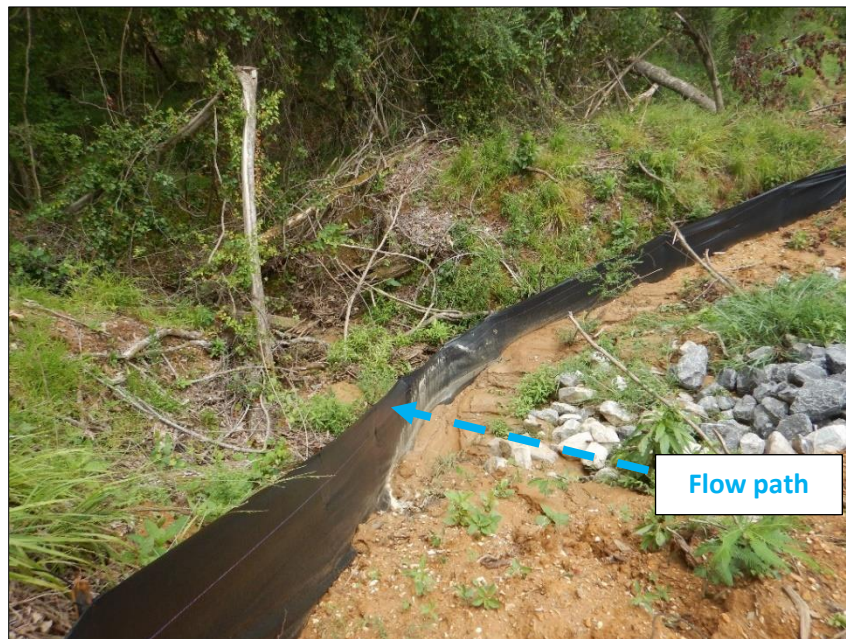
The EPA Inspection Team observed multiple instances where silt fence was installed across areas of concentrated stormwater flow [Refer to **Appendix B, Photograph Log (Photographs 11, 14, 16, 24, 25, 35, 38, 47, 48, 50, 52, 61, 62, 64, 66, 67, and 68)**].

Photograph 64. Closer view of the unidentified discharge point shown in [Photograph 63](#). The silt fence was installed across the discharge point, an area of concentrated flow.

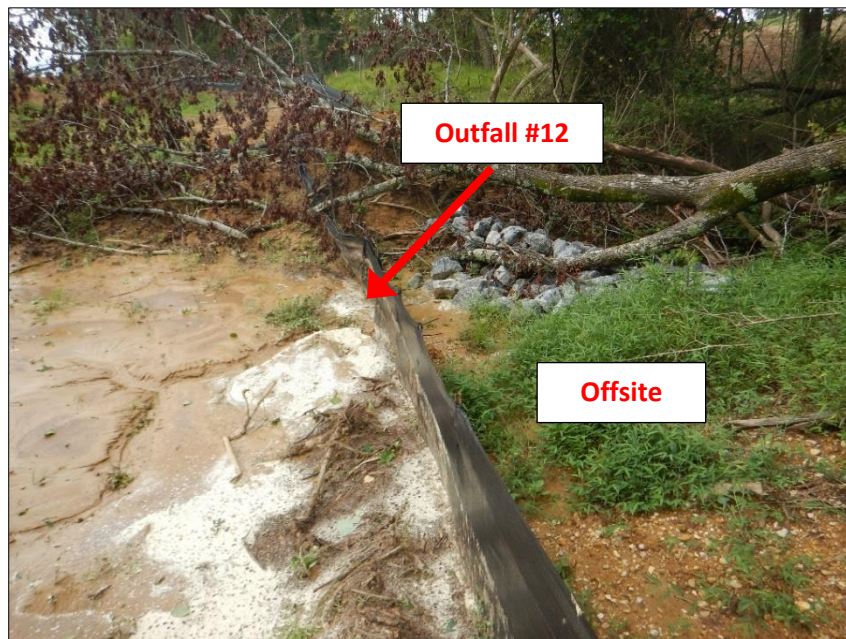
The EPA Inspection Team observed evidence of sediment discharge offsite at Outfalls #16, #14, and several unidentified outfalls that have not been assigned identification numbers in the EPSC plan [Refer to **Appendix B, Photograph Log (Photographs 11-14, 19, 24, 25, 40, 48, 50, 52, 62, 66-68)**, and **Appendix C, Exhibit Log (Exhibit 5)**].

Photograph 66. View, facing southeast, of Outfall #12 in the center of the Site. It was unclear what the white substance on the ground was. The silt fence was installed across the outfall, an area of concentrated flow.

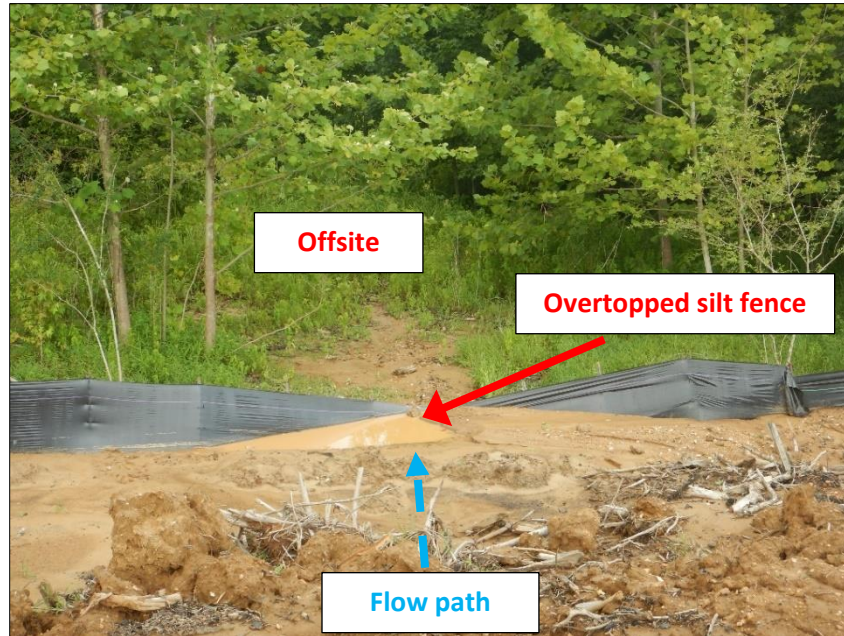
Photograph 67. View, facing west, of sediment overtopping the silt fence and discharging offsite in the center of the Site. The silt fence was installed across the discharge point, an area of concentrated flow.

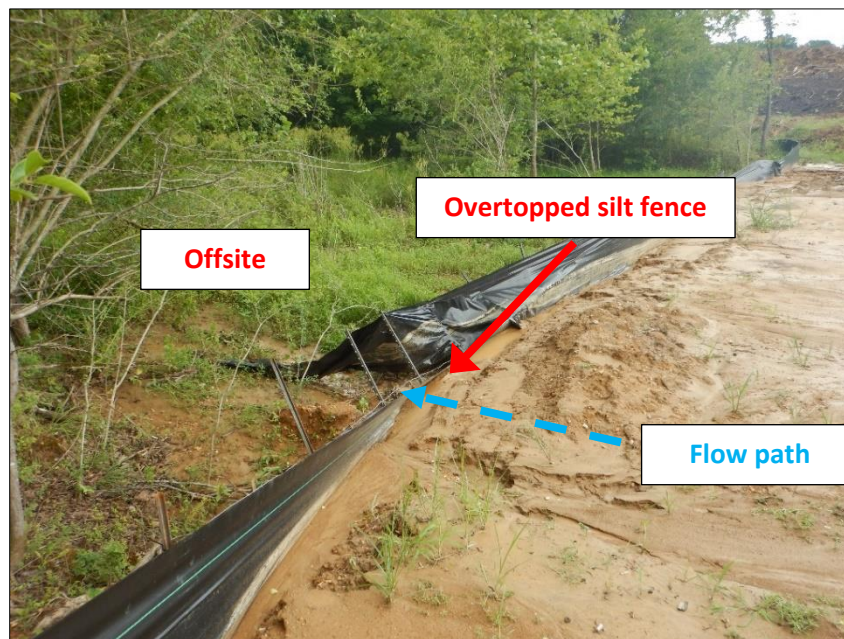
Photograph 68. Additional view of the sediment overtopping the silt fence and discharging offsite in the center of the Site shown in Photograph 67. The silt fence was installed across the discharge point, an area of concentrated flow.
