**Subj:** Inspection Report Clean Water Act

A. *Facility Name:* Boston Concrete Corporation (the "Facility")  
<https://bostonconcrete.com>

## **V. Site Inspection – October 3<sup>rd</sup>, 2024**

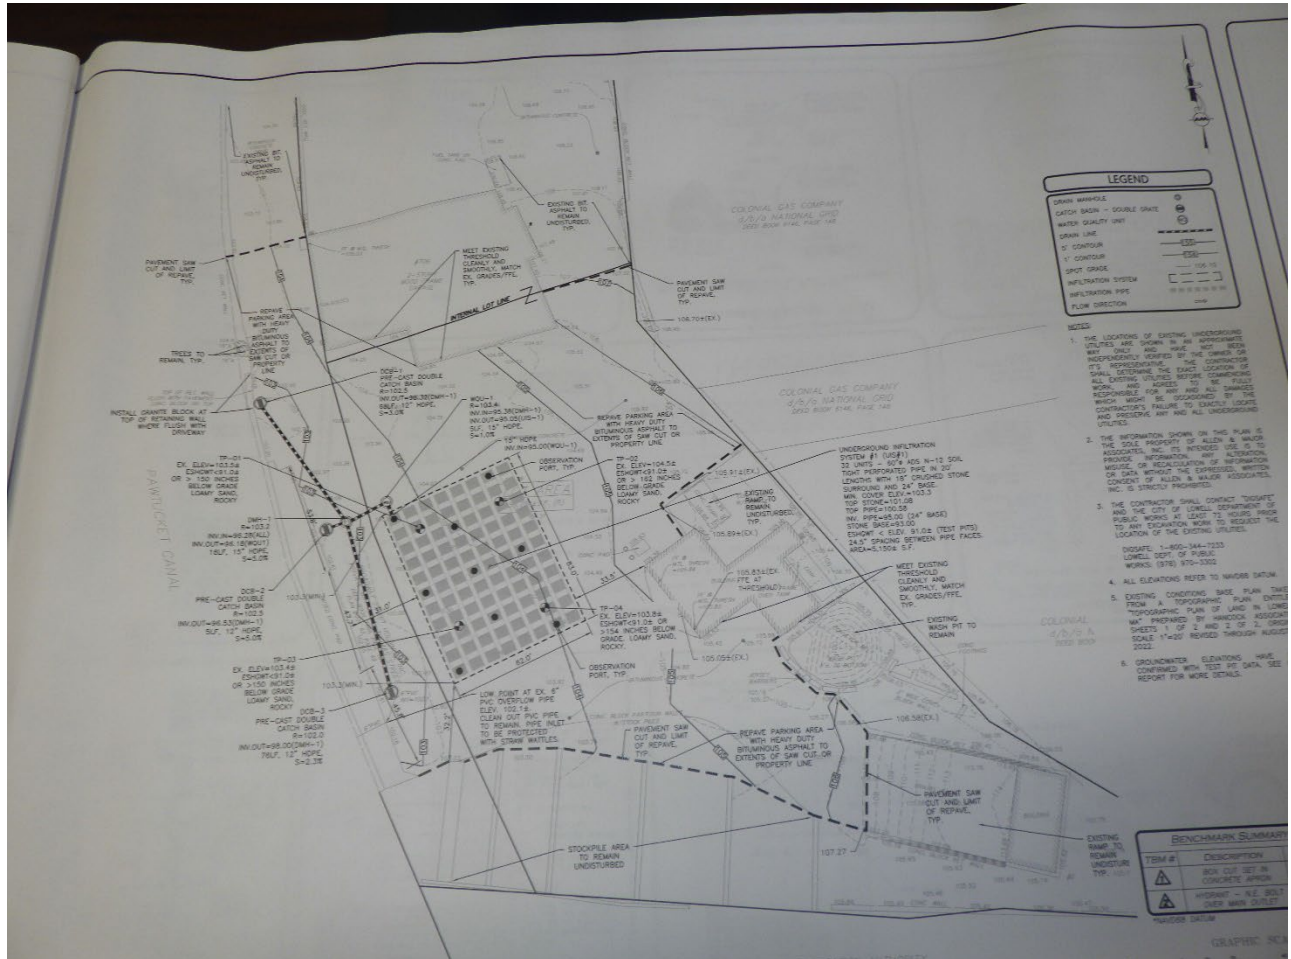
**Image 2:** Dated 3/29/2024

Inspector Canzano asked facility representatives when the liner in the washout pit was last replaced. Ms. Marshall stated that the liner had been replaced two times this year. Inspector Canzano then showed facility representatives 3 google earth images (Attachment C) showing liquid flow path and water staining from certain areas leading to outfall 2. Mr. Ploof explained that some of the staining on the asphalt is from sand delivery and when the sand becomes wet and saturated, the drag out from the sand can cause staining. The dark staining seen on the google earth images was the staining from such events. Inspector Ali asked about the production of colored concrete. Ms. Marshall stated that the company adds coloring, and it is listed as being a biodegradable pigment and operators add color in the concrete mixer truck on arrival to customers. Ms. Marshall informed the inspection team color of concrete doesn't occur on site.
