**CASE HISTORIES  
OF  
ACCIDENTS  
IN THE  
CHEMICAL INDUSTRY**

**MANUFACTURING CHEMISTS ASSOCIATION**

**VOLUME TWO**

**JANUARY 1966**

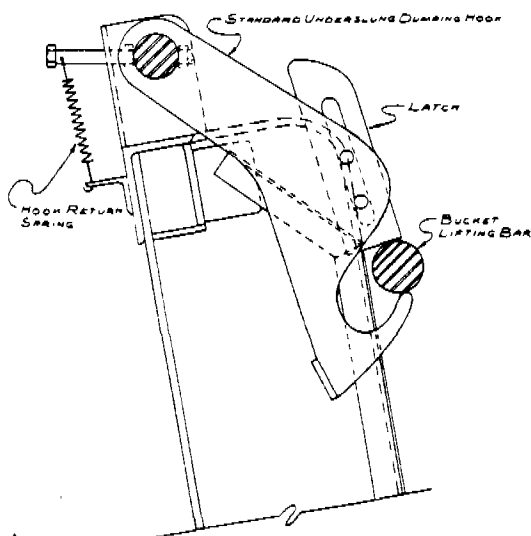
Type of hook and spring involved in accident.

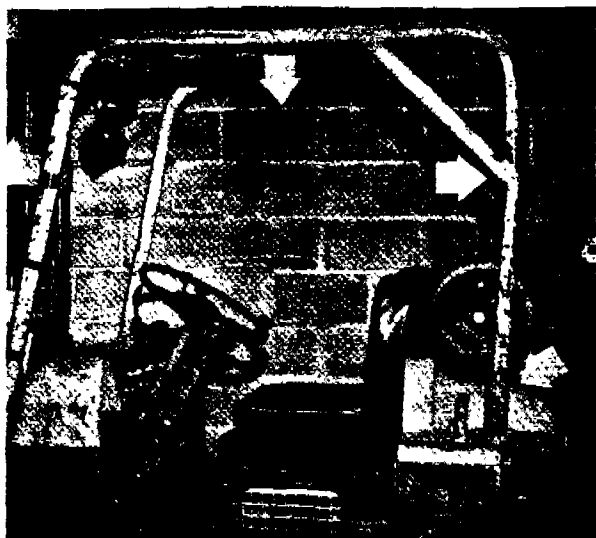
A load of paper pulp, weighing about one ton, fell on top of a fork lift truck guard. The shock bent the frame slightly as illustrated in the photograph (next page). The operator was fully protected and therefore was not injured. The top of the pile extended about 12 feet above the truck so the average drop of the paper was about 8 feet before striking the guard. Structural engineers say that this is somewhat equivalent to dropping 8 tons from a height of one foot on top of the guard.

Years ago, when fork lift trucks were introduced, the need for overhead protection was recognized. Standards for guards were developed through design and tests. The adequacy of these guards has been demonstrated on several occasions. Each time the guard prevented injury. The operator's first reaction is to escape, to avoid by jumping or running away. This urge was fortunately curbed by the operator and he stayed in the safe cage made by the guard and the truck.

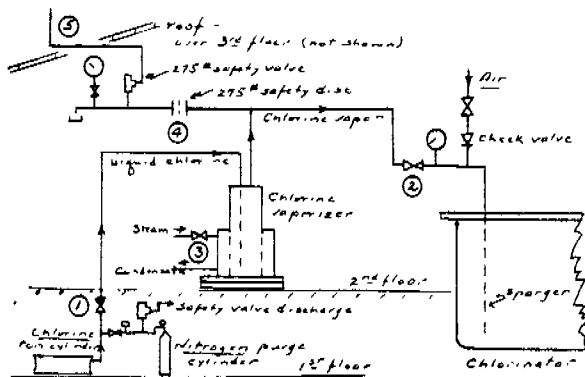
The system is protected by a safety disc and safety valve in series with each set at 275 psi. Investigation showed that the safety disc had blown from the pressure developed in the system. The pressure could not release, however, through the safety valve because the safety valve discharge line was plugged at an elbow (5). There is doubt that the safety valve was in good order since a subsequent test showed it did not release until under a 600 psi pressure. Consequently, the safety disc gasket ruptured and the excess vented into the shop.

**Cause:** 1. The chlorine system should have been completely shut off during the steam shut-down period. The operating instructions did not cover the steps to be followed in the event of interrupted service.

2. The safety disc apparently leaked causing corrosion of the safety valve seat which prohibited discharge of the safety valve at 275 psi.

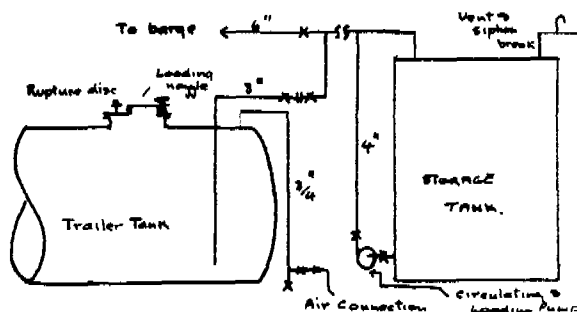
The most likely explanation is the simplest, that the loading nozzle swing bolt failed first on one weld, causing air release and chattering, followed by failure of the other weld. The blowing open of the cover was followed by the sweep of

air out of the opening. At the same time, the acid in the 6-inch pipe line flowed back into the tank under its 12 or 15 psi static head causing enough surface disturbance to let a sizeable amount of acid be carried up into the air.

It should be noted that the 2-inch lead rupture disc on the manhole did not rupture. The exact rupture pressure of this disc is not known as it is cut from lead sheet on demand. This disc does fail occasionally at normal or slightly above normal blowing pressure. The lack of failure in this case tends to verify the weakness of the cover clamp.

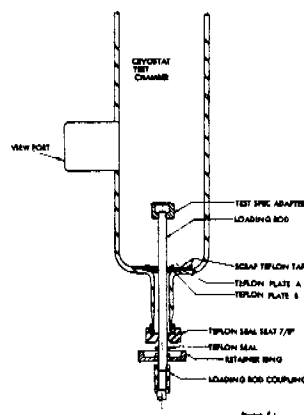
mately 2:25 P.M. the bottom retaining ring and teflon seal were loosened. (See sketch.) The next step was to remove the lower loading rod in the test chamber. The lower loading rod coupling was frozen solidly in place. Temperature at the center of the cryostat at this time was -300°F. Test personnel used a heat gun (hot air dryer) to free the coupling. As the loading rod was being pulled up through the bottom of the cryostat, a flash fire occurred. Three test personnel received first and second degree burns on hands, arms, and face. Evidence of the fire was found as far as 4 feet from cryostat and on the outside of the cryostat, indicating fire was not confined to interior of cryostat. The test cell exhaust fan was running during this period.

**Cause:** This test program had been under-way for approximately 4 months. Test personnel, in the interest of saving time, had bypassed Standing Operating Plan requirements for purging and bringing cryostat up to room temperature prior to entering test cell. This allowed the condition as noted to exist. It is assumed that this fire resulted from gaseous hydrogen remaining in bottom portion of cryostat, due to the failure to purge, cold temperature of cryostat increasing the gas density and poor ventilation of bottom of cryostat. The cause of ignition is assumed to be spark from or ignition by open filament of heat gun used to free loading rod coupling.

**Preventive Measures:** 1. Closer surveillance of all routine cryogenic operations has resulted from this incident.

2. Importance of cleanliness, purging, and Standing Operating Plan compliance was reiterated to all test personnel.

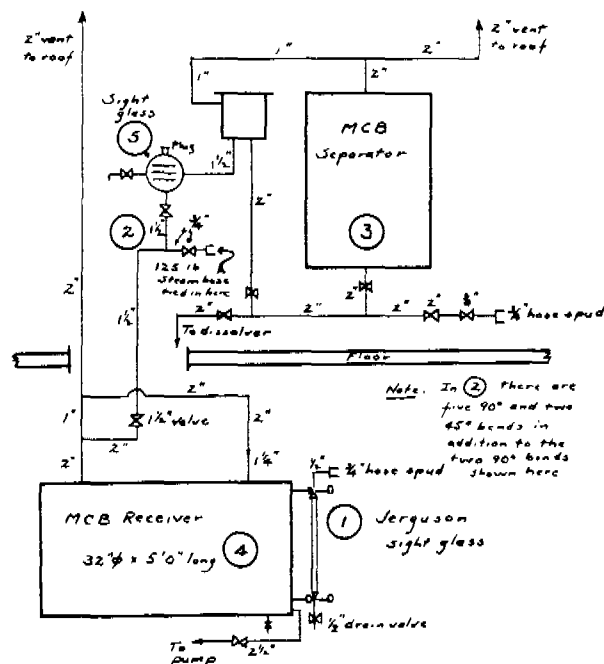
The horizontal receiver was an uncoded vessel. (Calculations made after the accident indicated that with all available venting unrestricted a 6 psi pressure could develop from a sustained flow of 125 psi steam through the product line. The receiver, when new, would have failed at about 13 psi. Corrosion had weakened the vessel to some degree and available venting was significantly reduced by product buildup. When steam broke through the blocked product line the venting

system did not release the steam rapidly enough to prevent a pressure buildup to the fail point of the receiver - under 13 psi.)

**Preventive Measures:** Engineering changes have been made in the process and equipment which completely eliminates the need for a horizontal receiver, and the product is piped directly from the separator into the process.

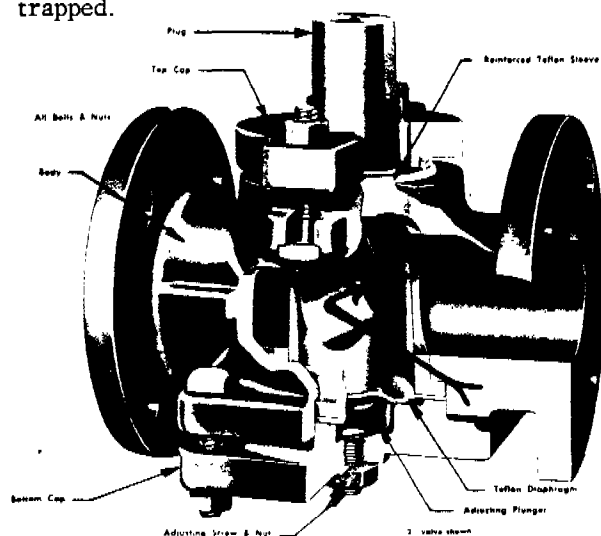
**Description:** A valve taken off the line is not necessarily free of entrained liquid under pressure within the valve, and such a condition is particularly true of plug cocks. An internal view of a plug cock is reproduced below, with the large arrow in the center indicating the area where acid, or other hazardous material can be trapped.

1. When removing a valve or plug cock, screwed or flanged type, from a line, full protective clothing, including a face shield, must be worn until the valve or cock has been opened, drained, washed and decontaminated.
2. Valves and plug cocks should be opened on the line before removing them. This may relieve built-up pressure, but there is no guarantee it will.
3. No plug cock that has been removed from a line is to be left unopened for any period of time.

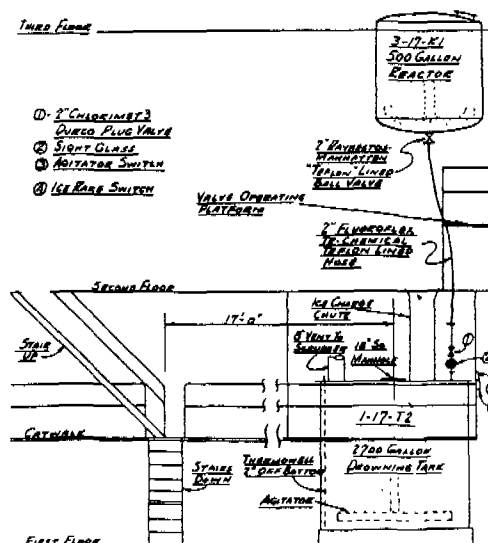
**Cause:** Apparently the operator, after he had made up the ice and water slurry mixture, failed to check the plug valve above the tank to make sure it was closed or else, wrongly opened the plug valve before opening the discharge valve of the reactor. When he opened the discharge valve of the reactor, the full flow of the product discharged into the drowning-tank, overheated and erupted out through the tank manhole.

(The product is discharged from the glass-lined reactor, through a two-inch Teflon-lined hose to the drowning-tank. There was a two-inch Teflon discharge ball valve at the bottom of the reactor and a two-inch Durco plug valve, located just above the top of the drowning-tank. The operating procedure for the drowning operation is to first open and close the plug valve at the drowning tank to drain the hose line, and then open the discharge valve at the reactor. Product feed flow is controlled by the operator through the plug valve above the top of the drowning-tank. Product flow into the drowning-tank is controlled so the temperature of the mixture is maintained at 5°C., which should take approximately forty-five minutes.)

Preventive Measures: 1. This operation and similar types are presently being reviewed to assure product feeds are adequately controlled to prevent a similar type accident.

2. Operators have been re-instructed in the valving procedure for operations of this type to make sure they are following operating instructions.
3. A Job Safety Analysis program has been initiated in the department to make sure employees are complying with prescribed operating procedures, and operations are adequately safeguarded.
4. In addition, to facilitate operations, the control valve extension handle on the tank has been relocated near the temperature recorder and the exit side of the manhole. Also, the agitator switch and ice rake switch have been relocated to the exit side of the manhole.

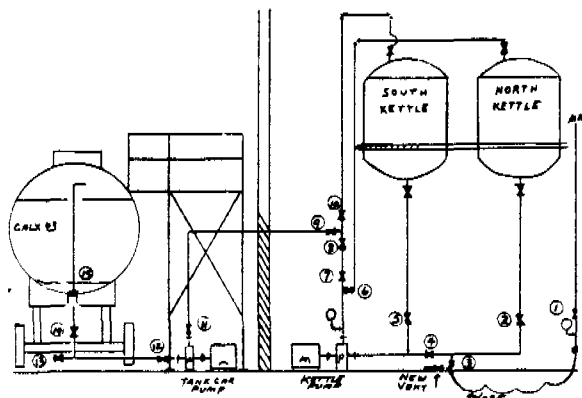
**Cause:** Employee failed to vent pressure remaining in the transfer line into the kettle (South Kettle--valve 10), before attempting to move the tank car foot valve.

(Note: The transfer line is blown clear with air through the tank car foot valve. When the operator, from a ground level location, notices mist coming out of the tank car dome, he shuts the air off, closes a valve (14) under the car, and closes the foot valve. After venting the remaining pressure in the transfer line into a process kettle (through valve 10), he disconnects the tank car.)

1. Air-blowing pressure for clearing the transfer line will be reduced from 50 pounds to 15 pounds.
2. A new vent valve has been installed on the hose side of the air valve so the transfer line can be rechecked for pressure before the hose is disconnected.
3. Employees have been re-instructed to vent line pressure into the processing kettle before disconnecting the line or moving the tank car foot valve.
4. Employees have also been rec cautioned to place themselves in a protected location when checking blowing operations.

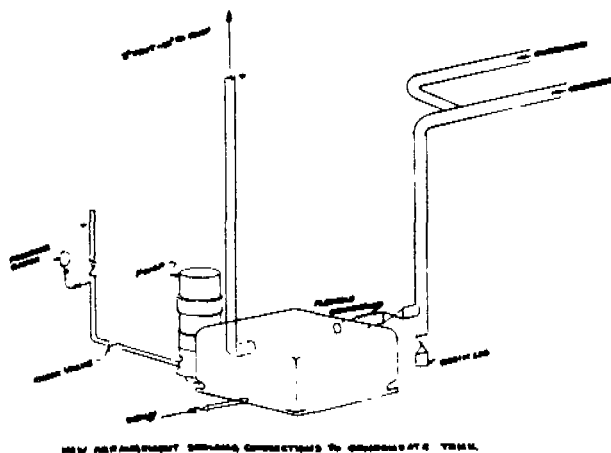
After closing the tank drain valve (#3), Mechanic "A" stood on the tank to reach valve (#1). Mechanic "B" was standing nearby (#7 on sketch) ready to hand Mechanic "A" a pair of channel locks, should he need them to adjust the packing gland on the valve. (This had been tightened when the valve was closed.)

As Mechanic "A" started to open valve (#1) the vessel ruptured with an explosive force. (Subsequent check disclosed the valve had been opened five turns. It took approximately twenty-two turns to open it fully. The valve is a standard 3 inch gate valve). Mechanic "B" was thrown back against some adjacent piping. Mechanic "A" was thrown into the air and over a sink stand, immediately south of the vessel, striking and breaking a wooden bench at the sink. He was found with his head, face up, against the sink with his feet resting on the bench. He sustained a

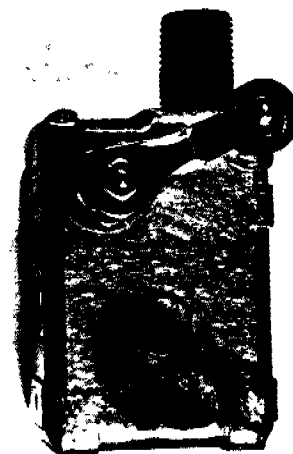
Investigation on the scene revealed that the switch burned through its aluminum explosion-proof case. The heat and pressure ruptured the case and propelled a piece of molten metal into the trash can. The illustration shows the rear of the case where the failure occurred.

Cause: A complete investigation revealed that this control switch was subject to a high intensity arc due to a short circuit in the system. Although the switch is designed for 440 volts, it is rated for a maximum of 15 amperes. When the short occurred, it was subject to the full 60 ampere load.

Preventive Measures: 1. An Engineering Standard has been revised to show how all control devices on 440 volt circuits will be fused separately in the motor starter box with a three ampere fuse.

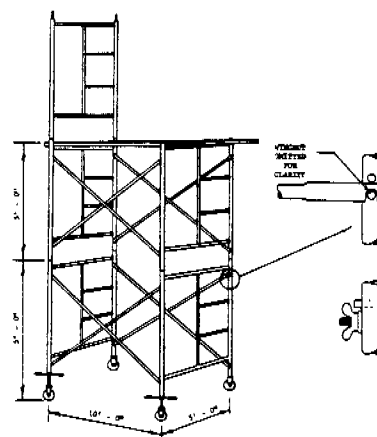
Some of the scaffold deficiencies contributing to the accident were as follows:

Only two planks (2 in. x 10 in. x 10 ft. and 2 in. x 10 in. x 14 ft.) without cleats were used for decking.

Eight of the sixteen wingnuts provided for securing the cross braces to the scaffold legs were loose. Some of the threaded studs were heavily crusted with fused metal from oxyacetylene cutting or rust and the wingnuts could not be turned. Also some cross brace locking studs were missing.

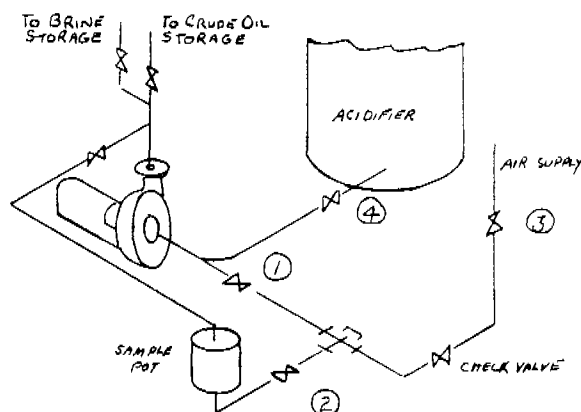
**Cause:** Employee failed to close sampling pot outlet valve (No. 2 - see sketch) before attempting to blow the product line clear.

**Preventive Measures:** The sampling pot has been eliminated, and the layer separations are observed through a sight glass.

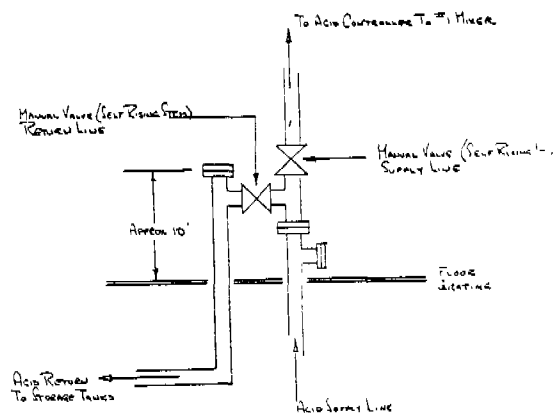
3. They then went upstairs to the job site and attempted to close the valve on the acid return line (see sketch). They found this valve to be extremely hard to operate. After cleaning the valve with steam, they attempted to close the valve by using a pair of channel-lock pliers. They succeeded in closing the valve part way and although the rising steam was escaping through the handle, they assumed the valve was closed and proceeded to loosen the bolts in the blind flange just after and above the return valve (see sketch). When the fourth bolt was loosened, acid under pump pressure sprayed onto both mechanics around their ankles. The return line valve was then completely closed by a production operator using a 14 inch pipe wrench.

Cause: 1. Improper method in performing this work was used by these mechanics. Although there were several possible ways of relieving and determining whether or not there was pressure on this line before disconnecting, nothing was done.

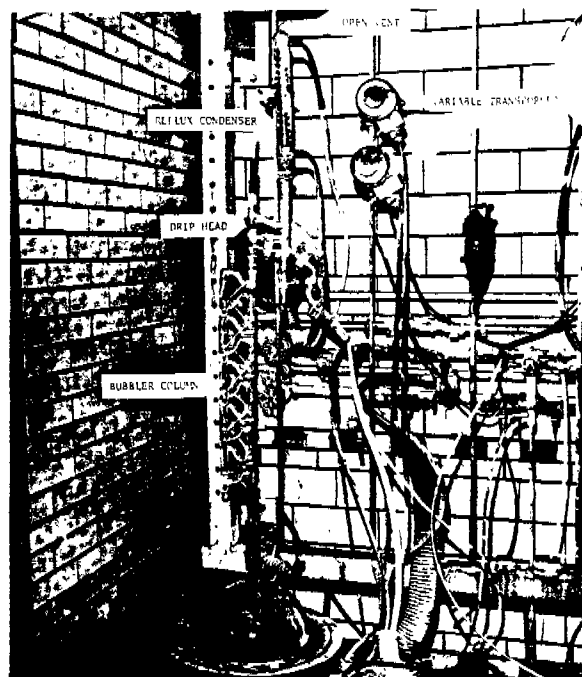
The chemicals were being heated in a 22-liter flask. The vapors were passing through a bubbler column and a "drip-head." At the top of the drip-head there was a top-vented reflux condenser from which a small proportion of the condensate was being diverted to a 12-liter receiving flask (see picture).

Cause: Material escaped from the top of the reflux condenser and contacted the variable transformer causing a flash fire to occur.

Preventive Measures: Relocate all variable transformers outside the hood. This is standard practice on all new hoods.

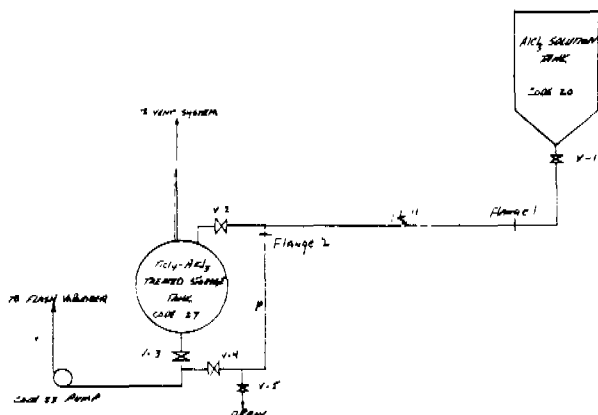
Description: Maintenance operating personnel were checking a corrosive liquid product pipeline to determine the reason for a block in the line. (Refer to sketch) V-1, v-2, v-3, v-4 were closed and v-5 was open. From a platform on top of code 27 above flange No. 2,

the employee proceeded to open flange No. 2. Three bolts had been removed from flange No. 2 and when the last and fourth bolt was loosened, there was a "puff" of irritating fumes that came from the opening and struck the employee in the face. The employee had to make his exit through a fumigated area due to the wind direction at the time.

Cause: 1. Employee did not wear the personal protective equipment required.
