## REGION 10 Enforcement Division

### INSPECTION REPORT

| <b>Inspection Date(s):</b> | 01/10/2022 and 01/24/2022 | Announced: No | |
| <b>Facility or Site Name:</b> | Carlile Transportation Systems, LLC | | |

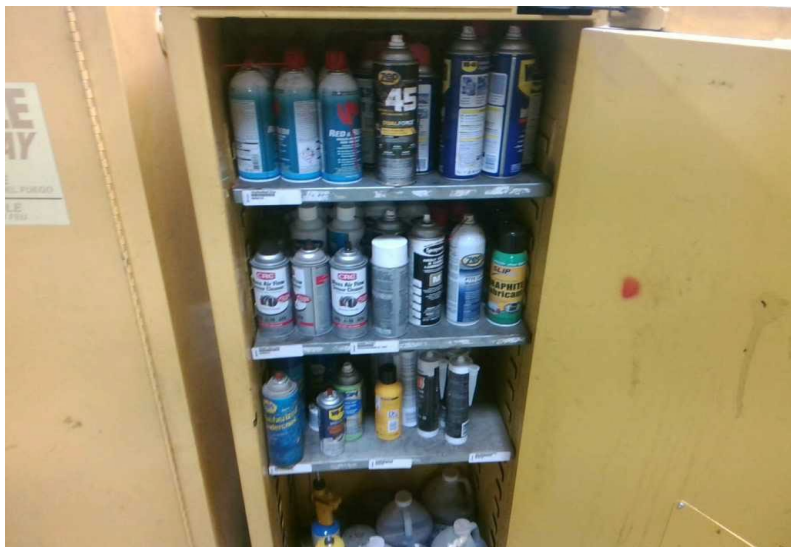
| <p>While in the trailer shop, I saw a fiberboard container that was labeled with the words "Used Aerosols Cans Only." While in the shop, I met Mr. Patrick Quiambao, Anchorage Shop Manager. I looked in the fiberboard container and saw approximately five aerosol cans. I inquired about the aerosols and Mr. Quiambao said that aerosol cans are punctured in the fiberboard container using a "Crowfoot."</p> <p>According to Mr. Quiambao, the shop generates approximately five waste aerosol cans each week.</p> | |

According to Mr. Quiambao aerosols are punctured when empty and sometimes if they stop working, they are still punctured into the fiberboard container. At the time of the inspection, the inside of the fiberboard container appeared to be stained with residue from waste aerosol cans.
