## WASHINGTON CAFO INSPECTION REPORT

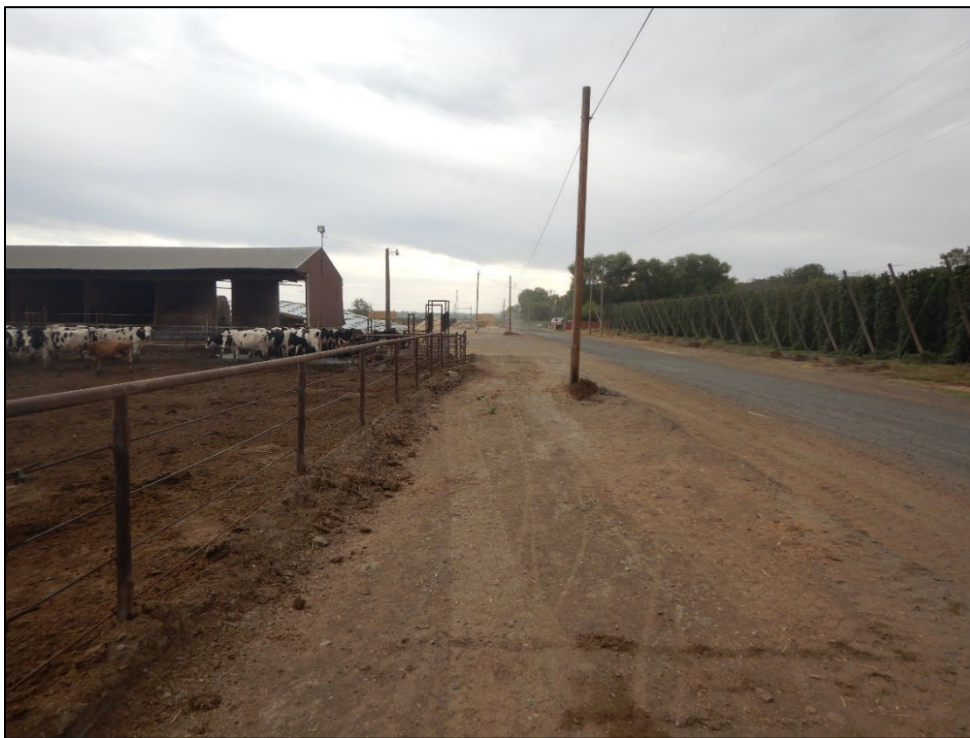
Photograph 1. View looking east along the southern production area boundary and Vance Road from a point near the facility driveway.

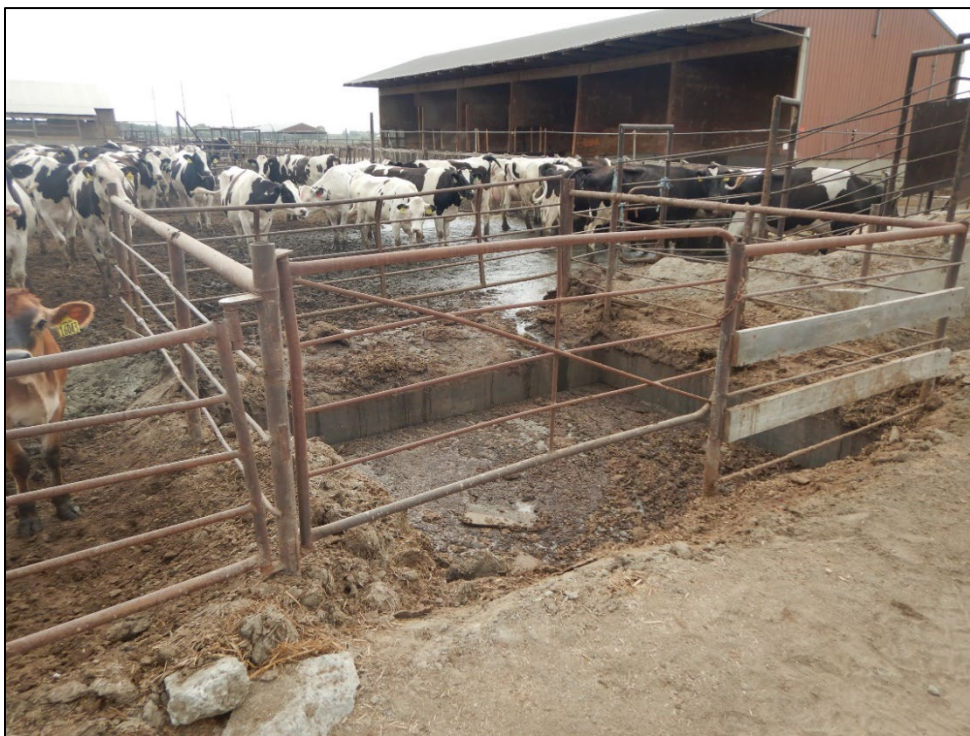
Runoff from the silage storage area drains to the east or west silage pits (Photographs 2, and 6-8).

Photograph 2. View looking northeast at the concrete-lined West Silage Pit.

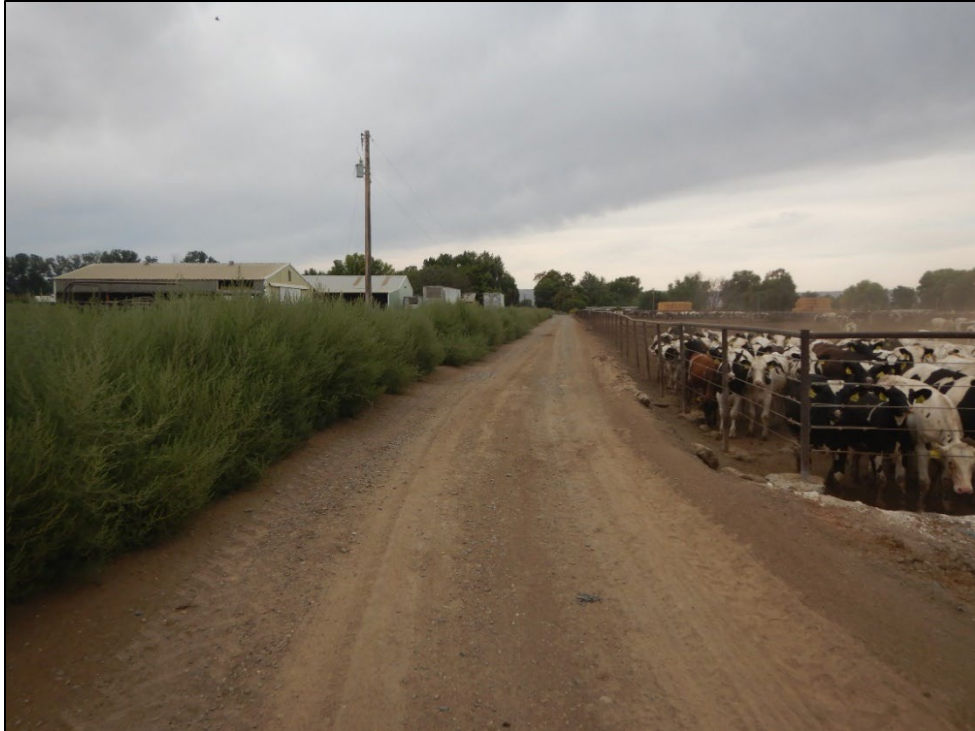
Photograph 9. View looking south along the eastern production area boundary from the northeast corner of the cattle pens. The buildings visible at the left side of the photograph are on adjacent property and are not part of the production area.

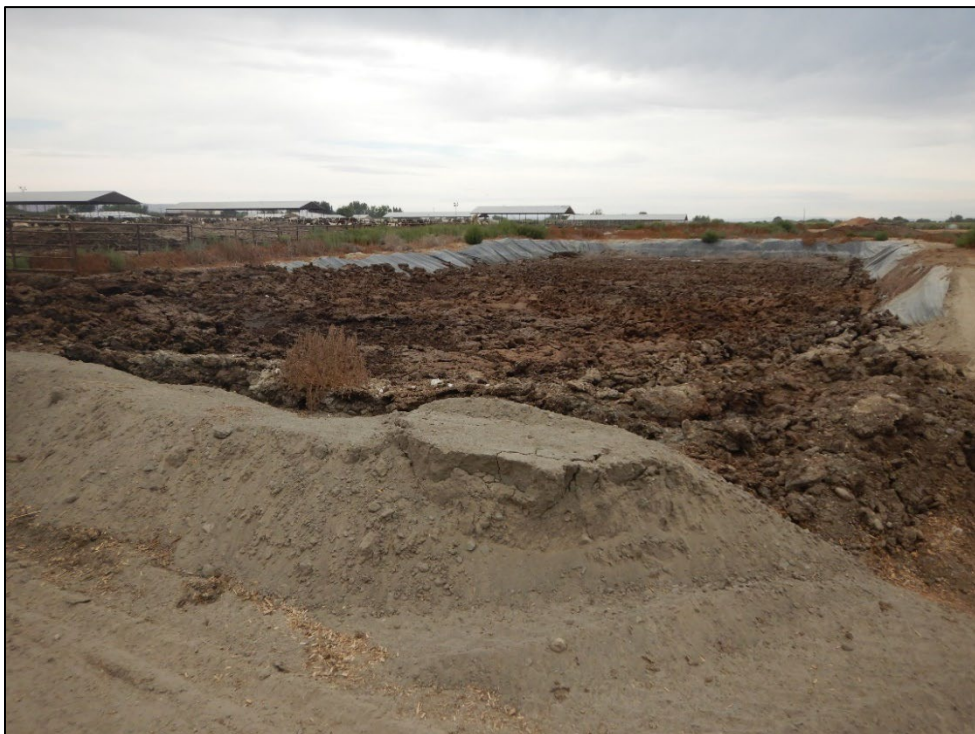
Photograph 10. View looking southwest across the Pen 8 Pit.

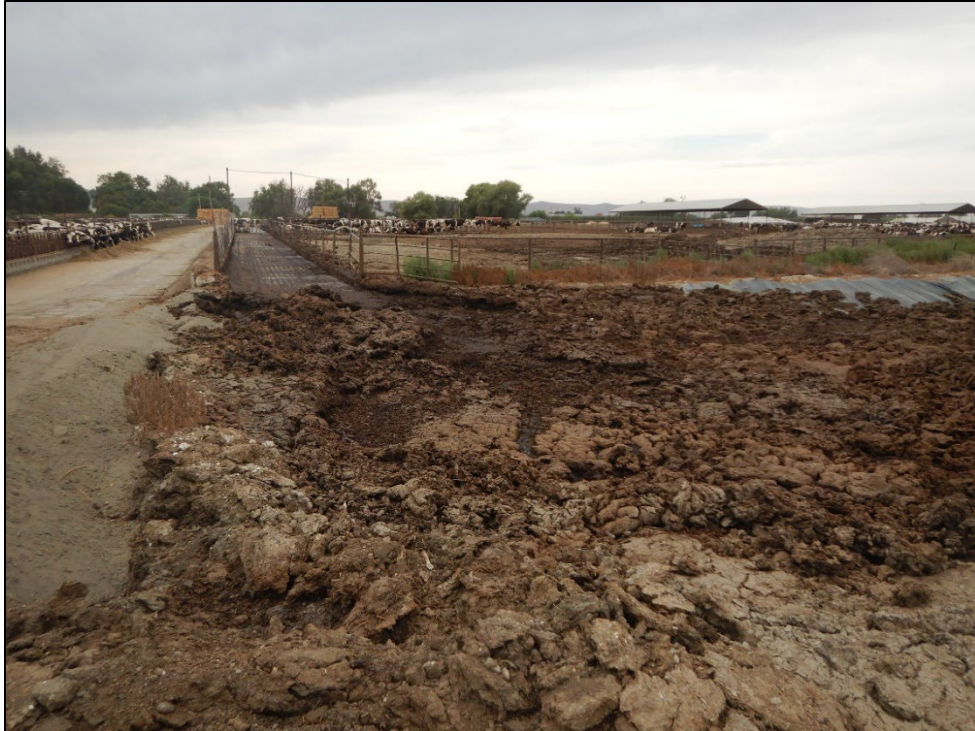
Photograph 11. View looking south across the Pen 8 Pit and the Pen 8 feed alley.

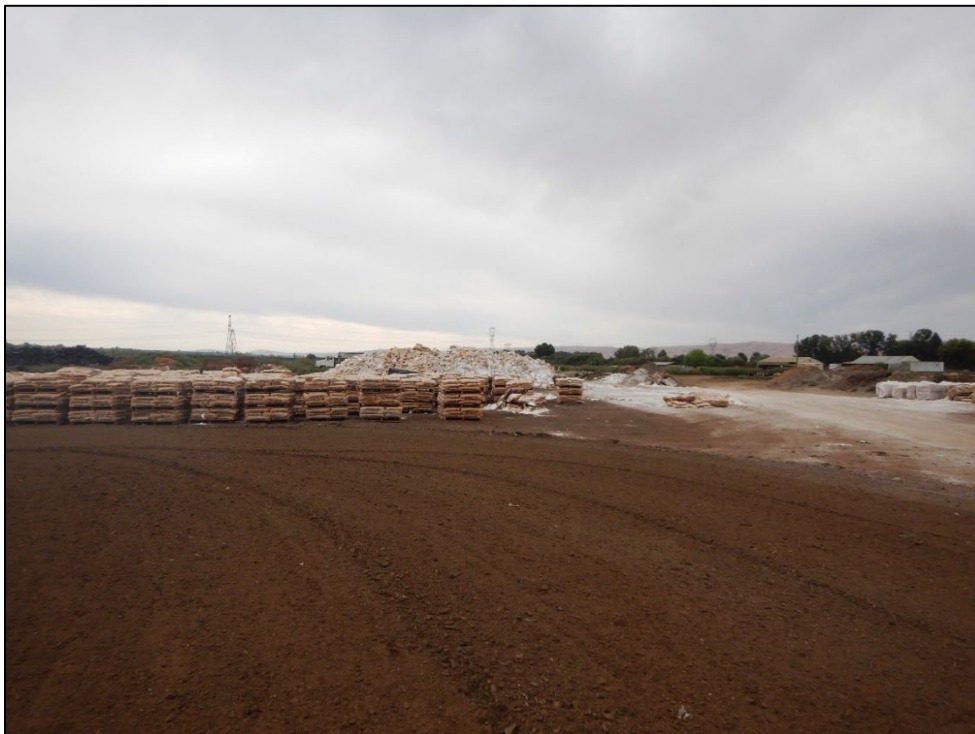
Photograph 12. View looking east towards the facility's lime storage area located near the northeast corner of the cattle pens.

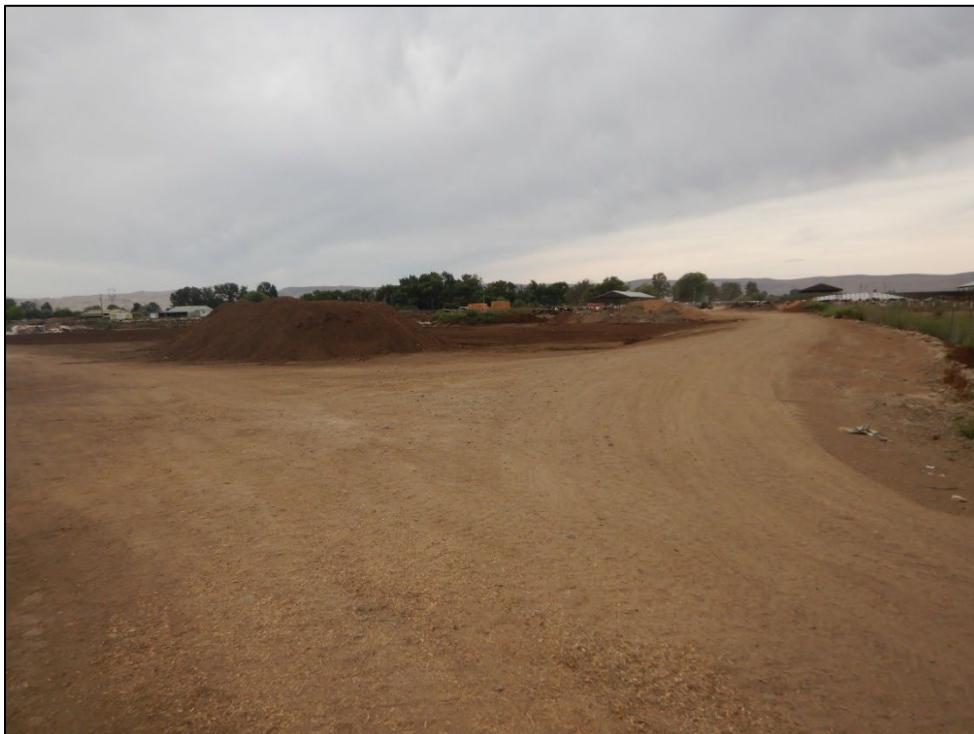
Photograph 14. View looking south towards the solid manure storage area and cattle pens. This photograph was taken from the same spot as [Photograph 13](#).

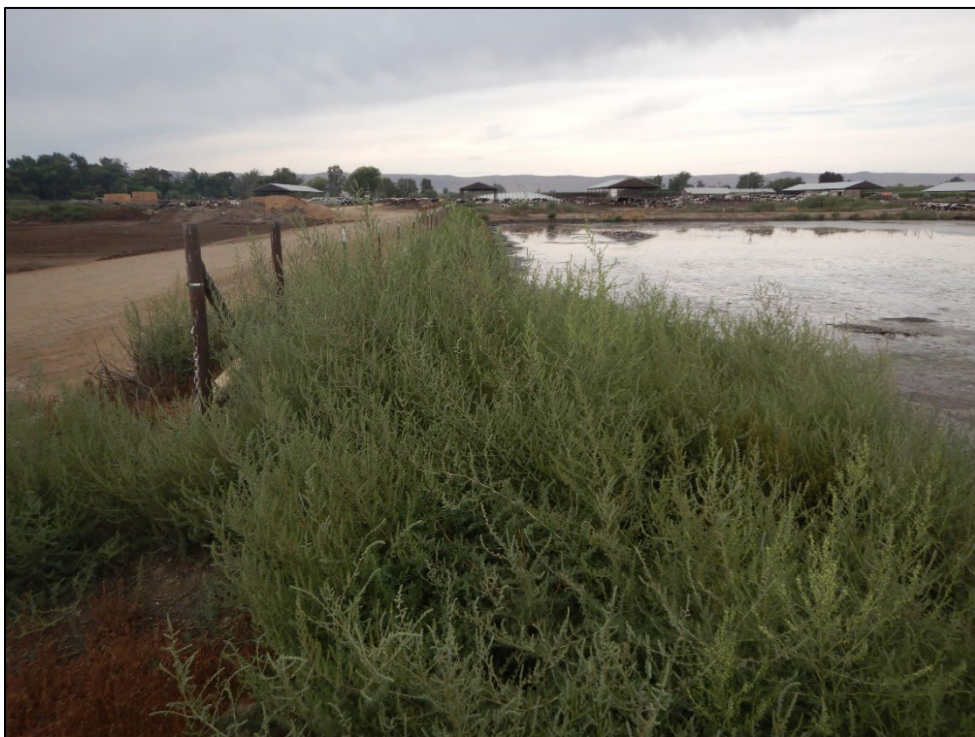
Milking parlor wash water is collected in the Milking Parlor Pit (Photographs 34), where it is then pumped to the concrete Settling Pit (Photographs 25 and 27). From the Settling Pit, wastewater is pumped into Lagoon 2 (Photographs 15-18).

Photograph 16. View looking south, along the eastern edge of Lagoon 2.

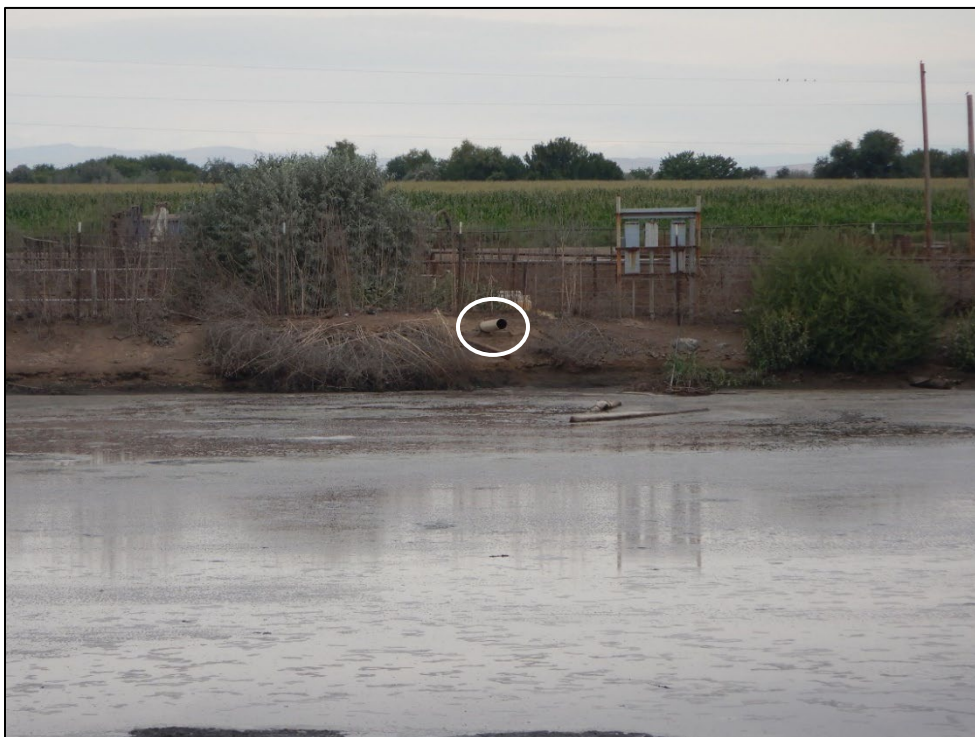
Photograph 18. View looking west towards the pipe (circled) that conveys wastewater from the Settling Pit to Lagoon 2.

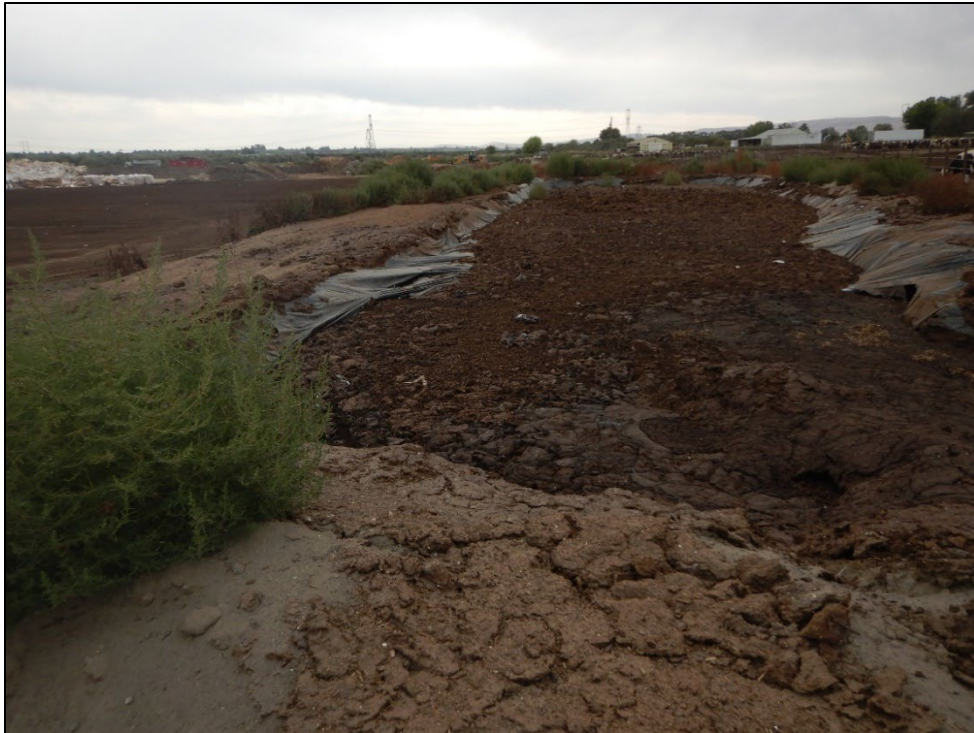
Photograph 21. View looking east across the Pen 4 Pit.

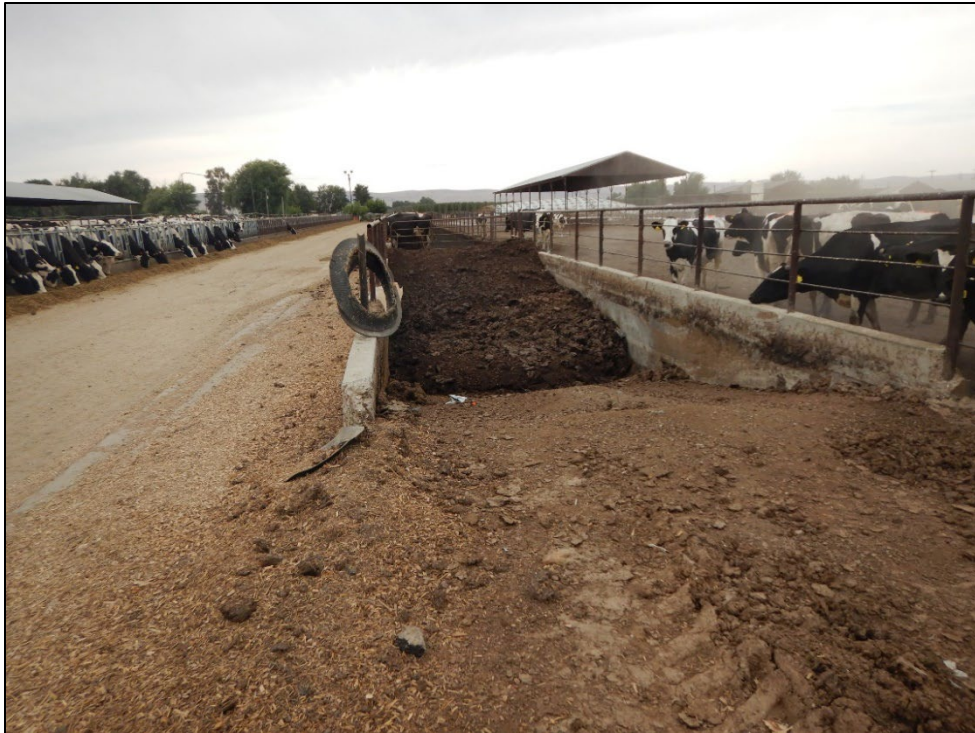
Photograph 23. View looking south at the Pen 3 Scrape Pit, located at the northeast corner of Pen 3.

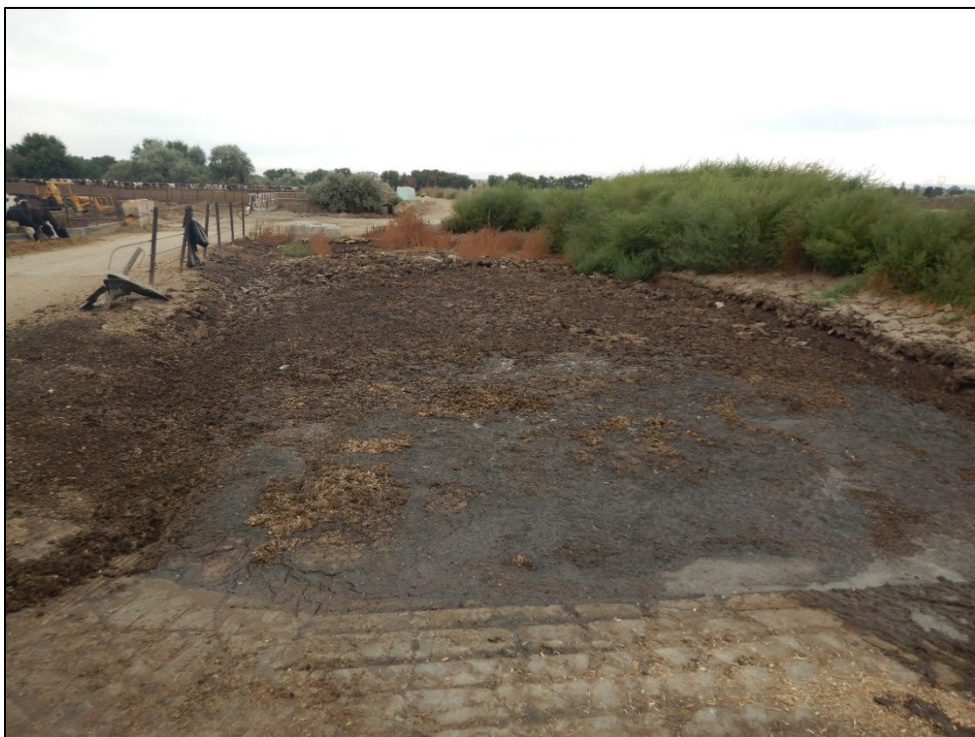
Photograph 24. View looking north across the Scrape Pit, located at the northwest corner of Pen 3.

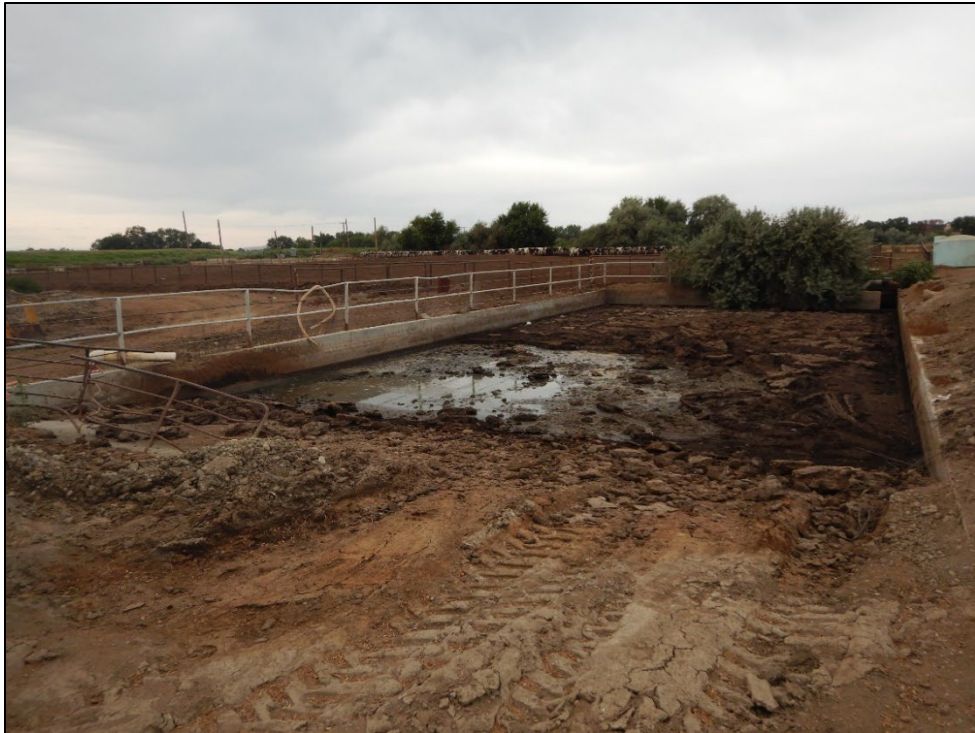
Photograph 25. View looking northwest across the Settling Pit.

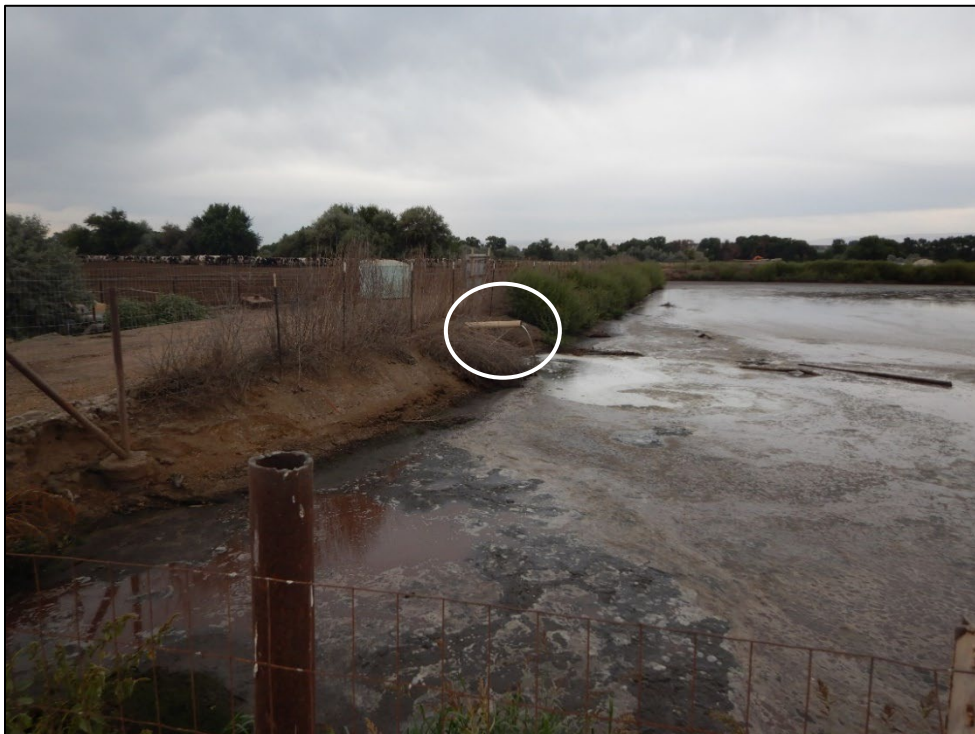
Photograph 26. View looking north at the PVC pipe (circled), also shown in [Photograph 18](#), that conveys wastewater from the Settling Pit to Lagoon 2.

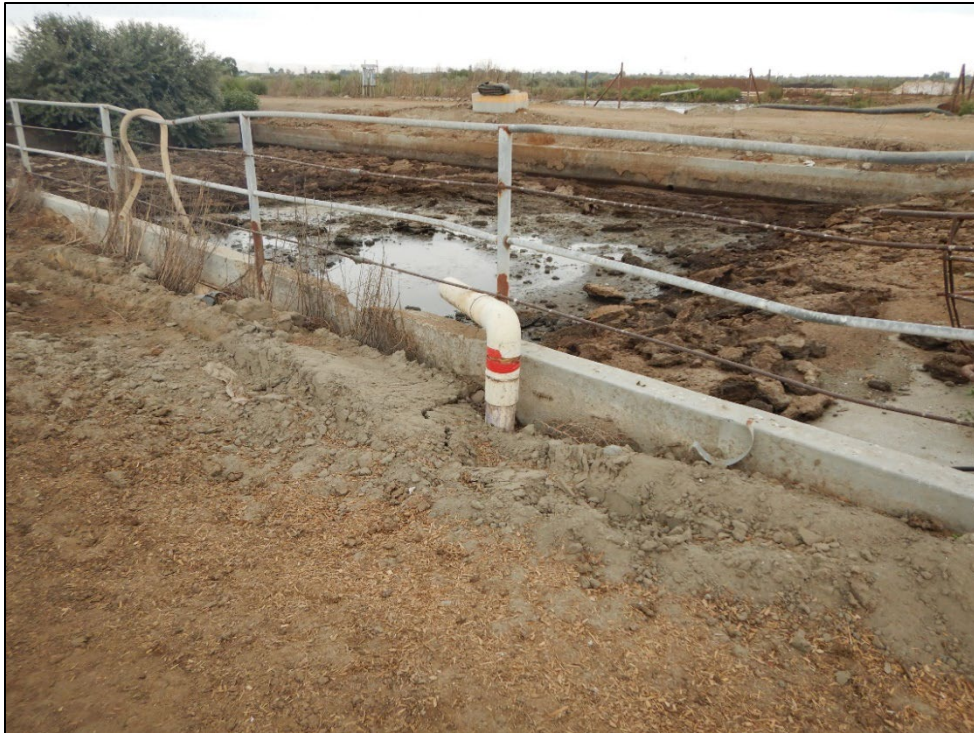
Photograph 27. View looking northeast across the Settling Pit. The PVC pipe shown in the photograph conveys wastewater from the Milk Parlor Pit to the Settling Pit.

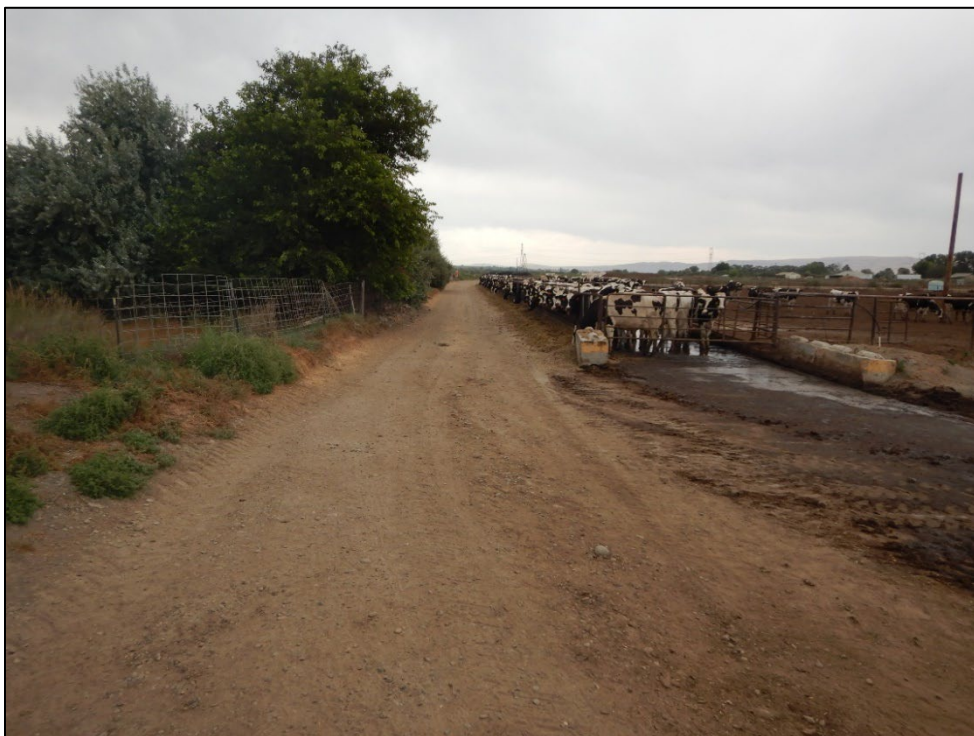
Photograph 30. View looking east along the northern production area boundary from the northwest corner of the site.

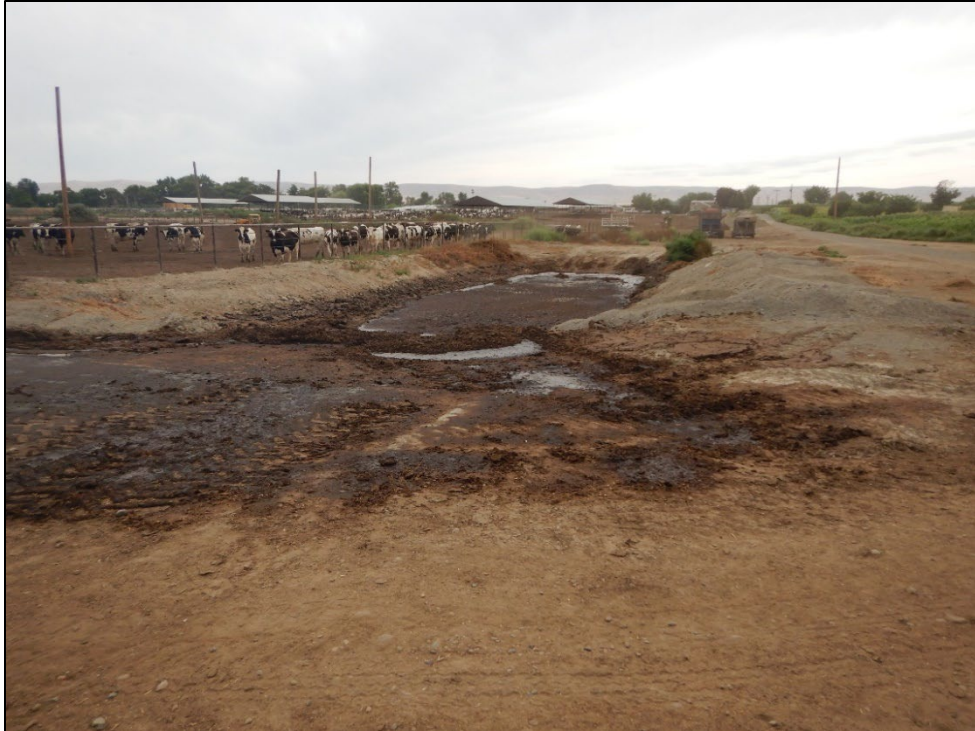
Photograph 31. View looking south at the Dry Cow Pit.

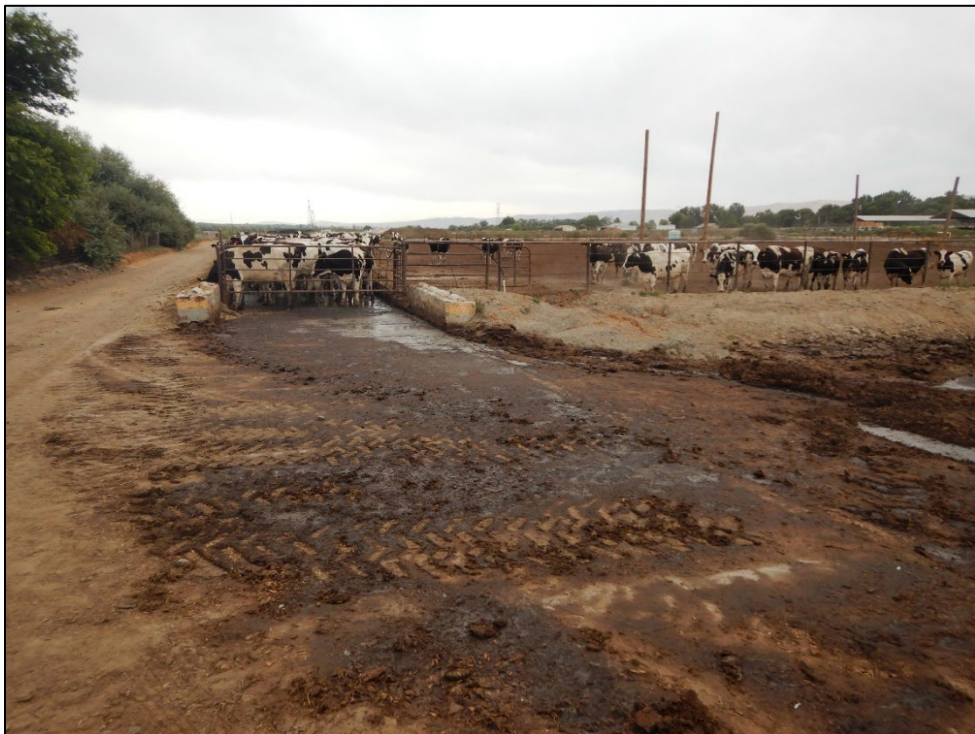
Photograph 32. View looking east at the runoff conveyance from the cow pens to the Dry Cow Pit shown in [Photograph 30](#).

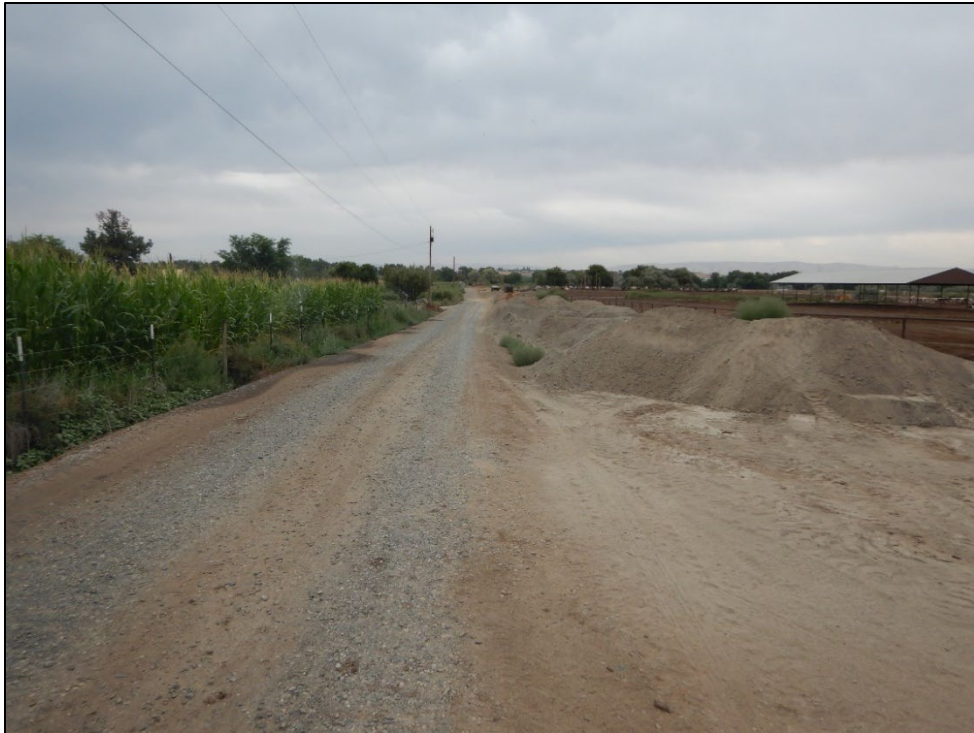
Photograph 33. View looking north along the western production area boundary from a point near the southwest corner of the cattle pens.

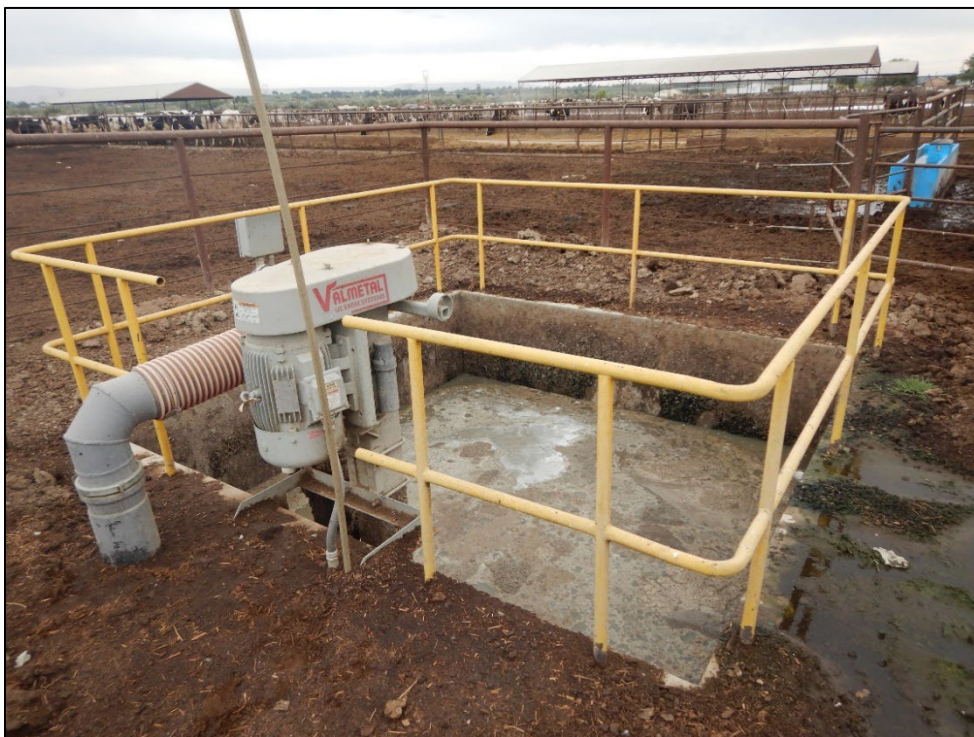
Photograph 34. View looking northeast at the Milk Parlor Pit.

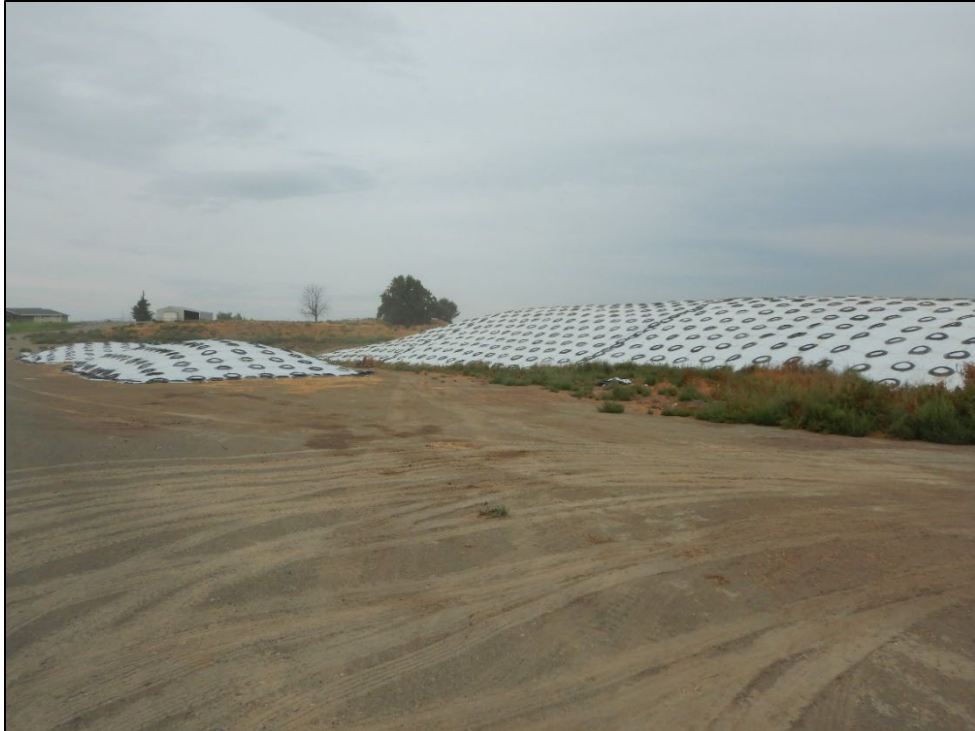
Photograph 35. View looking northwest at the silage storage area located between the Dairy Pivot and Wheeler's Pivot.

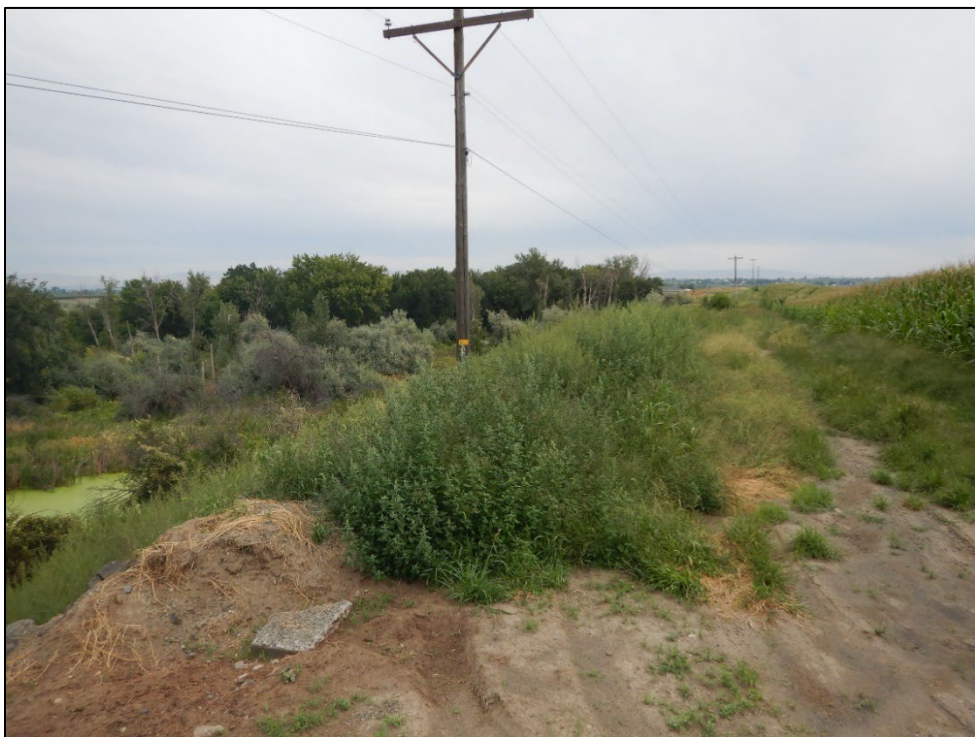
Photograph 36. View looking northeast along the Wheeler's Pivot northern field boundary. The Yakima River is located approximately 1800 feet north of the field boundary behind the trees in the background.

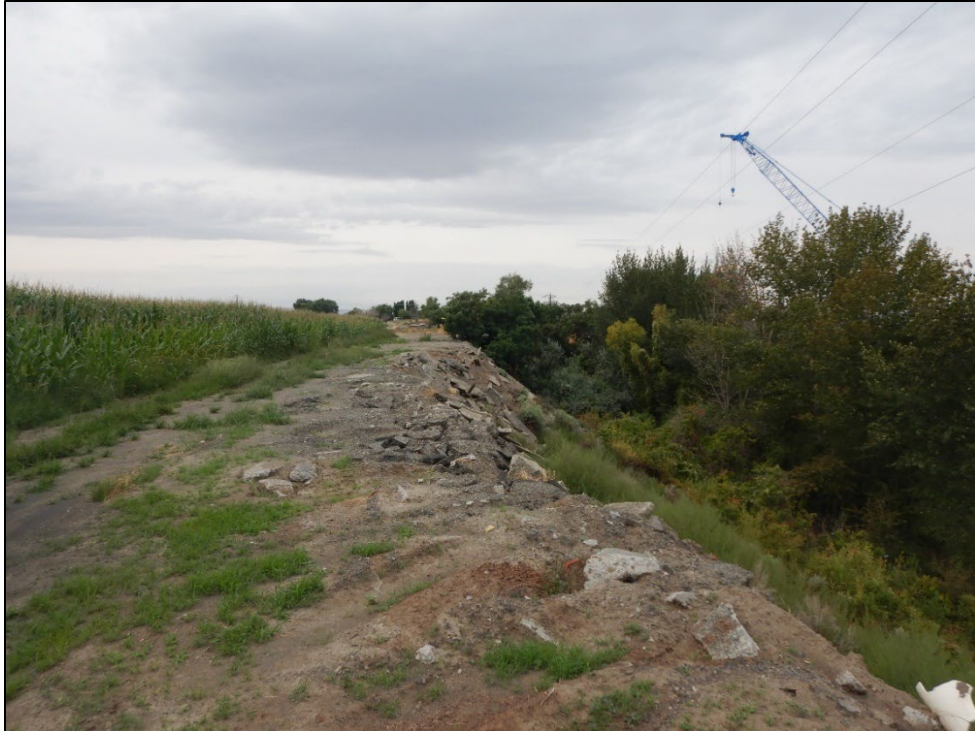
Photograph 37. View looking southwest along the Wheeler's Pivot field boundary. The Yakima River is located approximately 1800 feet north of the field boundary.
