Resource Conservation and Recovery Act (RCRA)
 Compliance Evaluation Inspection

Facility Name:	Patheon Puerto Rico Inc	
EPA ID Number:	PRR000000836	
Date of Inspection:	February 1, 2024	
Generator Status in Record:	Large Quantity Generator (LQG)	
Generator Status at the time of inspection:	Large Quantity Generator (LQG)	
RCRA Permitted:	No	
Basis for Inspection:	Core Program	
Corrective Action:	No	
Facility Physical Location: (Municipality, PR, zip code)	Carr. 670 Km 5.2, Manati, Puerto Rico, 00674.	
Geographical Coordinates:	18.198414, -65.972756	
Facility Contact:	Ms. Lorraine Afanador	787-409-5102
	EHS ¹ Supervisor	
	Email: lorraine.afanador@thermofisher.com	
	Mailing address: P.O. Box 3199 Manati, Puerto Rico, 00674	
Facility Contact:	Xiomara Torres	939-438-8566
	EHS Specialist II	
	Email: xiomara.torres@thermofisher.com	
	Mailing address: P.O. Box 3199 Manati, Puerto Rico, 00674	
Facility Contact:	Mr. Bernardo Jaime	939-610-0621
	EHS Manager	
	Email: bernardo.jaimejimenez@thermofisher.com

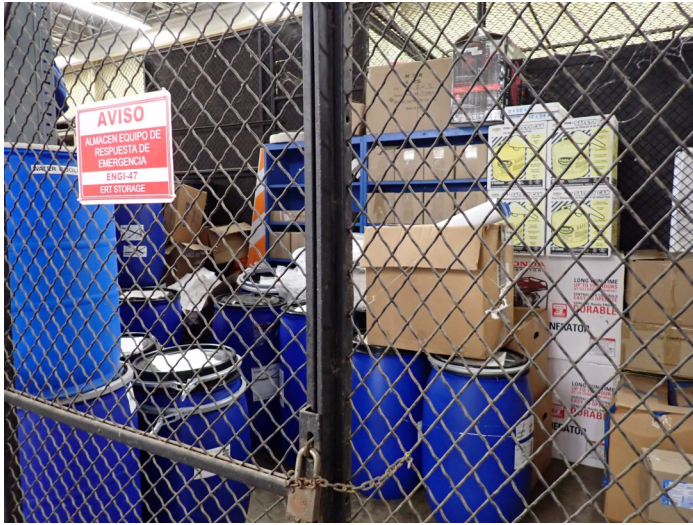
Picture 33 — Light Mechanical Shop Area— This is the ERT Storage ENGI-47 subarea. According to them, this area is used to store the facility’s emergency equipment.

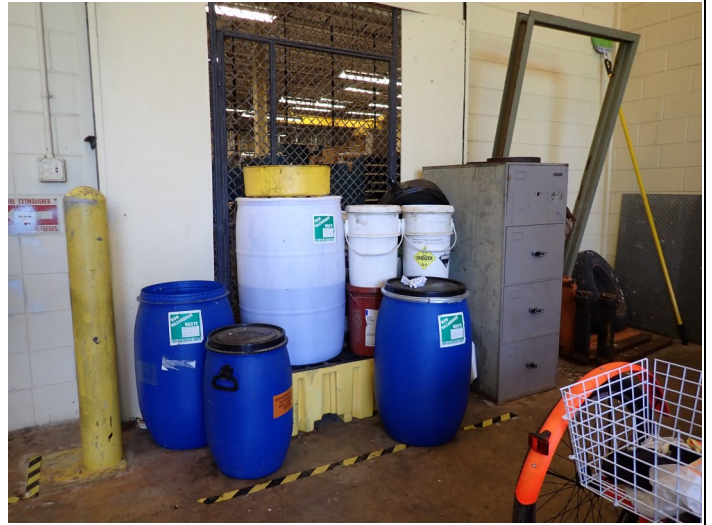
Picture 34 — Light Mechanical Shop Area— The Used Oil subarea is located towards the Building 501 entrance. According to the facility representative, this subarea collects the used oil generated at this location.

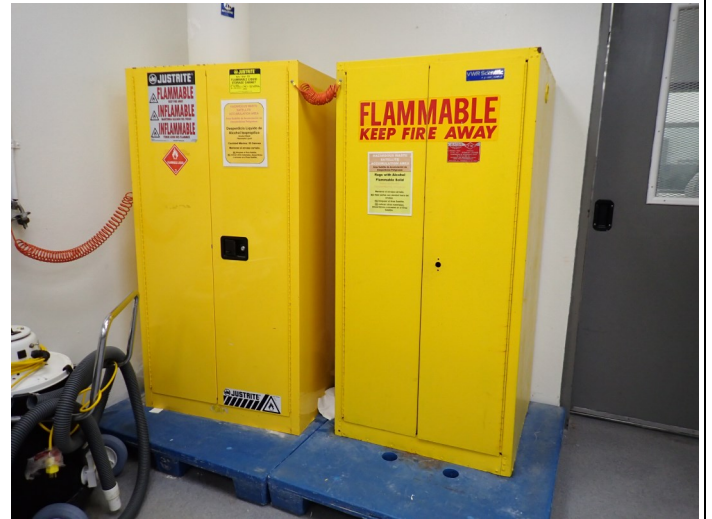
Here, two (2) yellow shelves, identified by the facility representatives as SAAs, were observed (Picture # 36). Additional information on each shelf is as follows:

Picture 36 — Room M15 Washroom Area - Here, two (2) yellow shelves, identified by the facility representatives as SAAs, were observed.

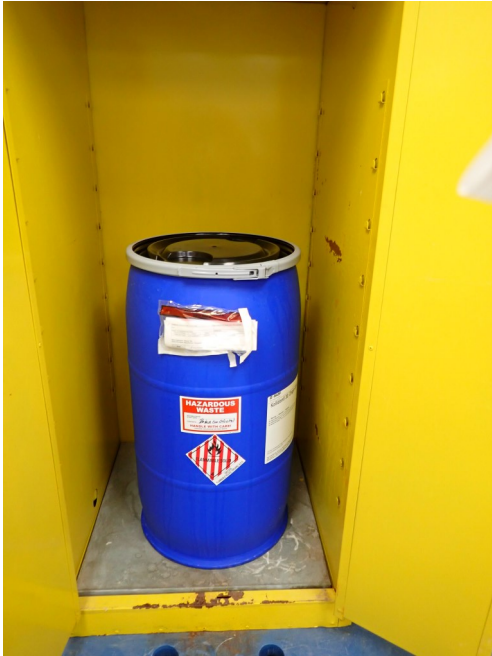
Picture 37 — Room M15 Washroom Area - Here, one (1) 35-gallon blue plastic container with paños con alcohol was observed. It was closed, labeled as hazardous waste, has a pictographic label, and grounded.

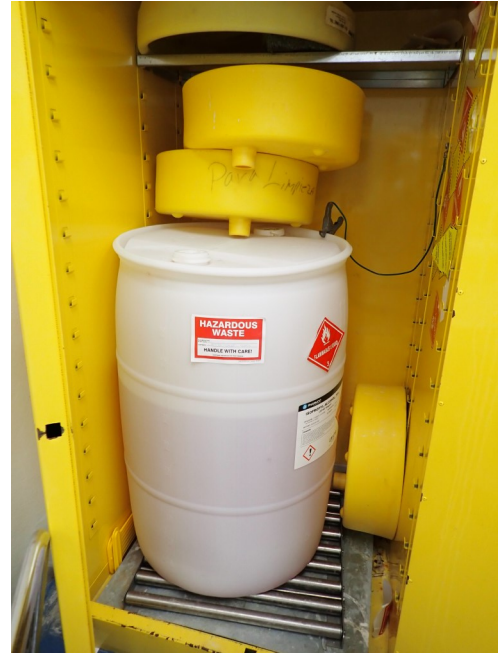
- a. One (1) 35-gallon⁵⁷ blue plastic container with paños con alcohol. At the time of the inspection, the latter was observed closed, labeled as hazardous waste, has a pictographic label and/or indication of the hazard available, and grounded. Also, the container appears to be in good condition and the shelf itself was labeled as flammable and rags with alcohol (Picture #37).
- b. One (1) 55-gallon white plastic container with alcohol waste 70%. At the time of the inspection, the latter was observed closed, labeled as hazardous waste, has a pictographic label and/or indication of the hazard available, and grounded. The container appears to be in good condition and the shelf itself was labeled as desperdicio líquido de alcohol isopropilico (Picture #38).

Picture 38 — Room M15 Washroom Area - Here, one (1) 55-gallon white plastic container with alcohol waste 70% was observed. It was closed, labeled as hazardous waste, has a pictographic label, and grounded.

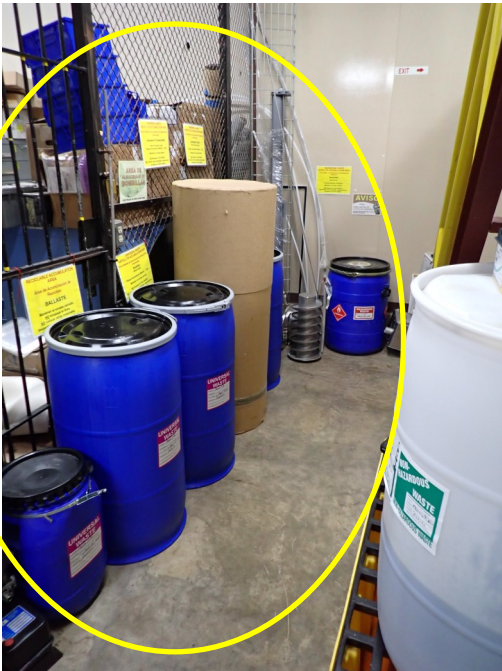
At the time of the inspection, six (6) containers were observed (Picture #39). Information on each one is as follows:

Picture 39 — Maintenance Shop Area— According to the facility representatives, this area is where the universal waste and hazardous waste are stored, and it is also used as a stock room. Six (6) containers were observed in this area.

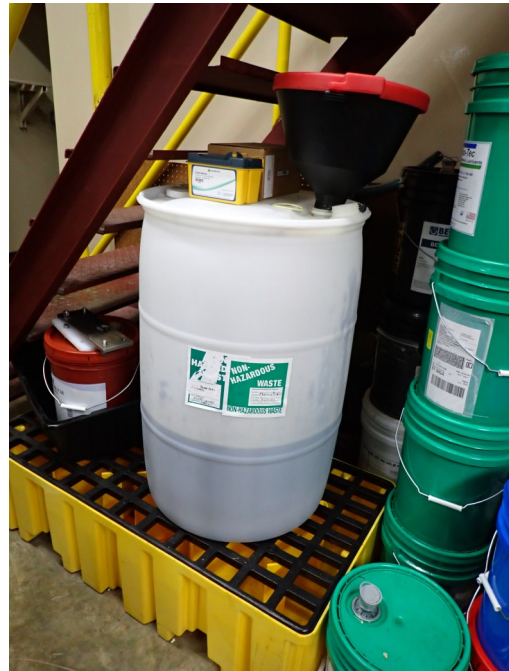
- g. One (1) 55-gallon white plastic container with Aceite usado. At the time of the inspection, the container was observed closed, labeled as non-hazardous waste, and was placed above a secondary containment (Picture #40).
- h. One (1) 35-gallon blue plastic container was observed labeled as aceite usado, nevertheless, when opened, rags impacted with used oil and a hose inside a plastic bag were observed inside. I told the facility representatives about this issue. At the time of the inspection, the container was observed closed, labeled as non-hazardous waste, and above a wheel-like round base (Picture #41).

Picture 40 — Maintenance Shop Area— Here, one (1) 55-gallon white plastic container with Aceite usado was observed. It was closed, labeled as non-hazardous waste, and was placed above a secondary containment.

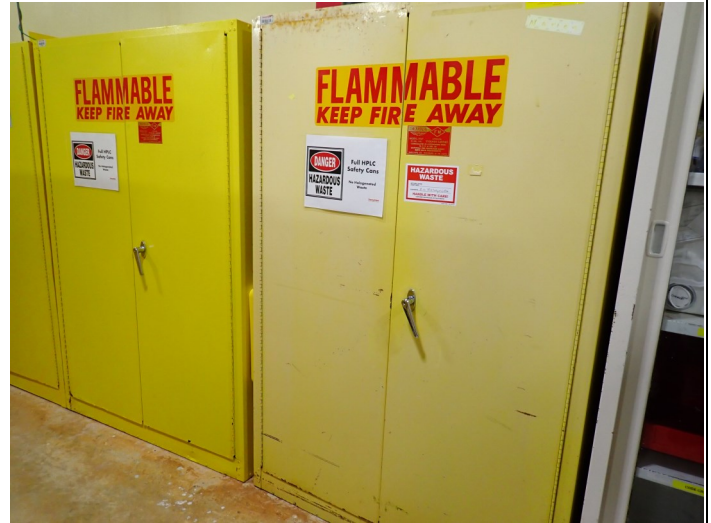
Description of the Area	This was the fifth area inspected and it is located at Building 401. Inside, two (2) yellow shelves were observed (Picture #42). Both were identified as flammable and Full HPLC Safety Cans with no halogenated waste. Additional information on each one is as follows.
-------------------------	---

Picture 42 — Laboratory Area-Chemical Storage Q3 Area— This area was located at Building 401. Inside, two (2) yellow shelves were observed.

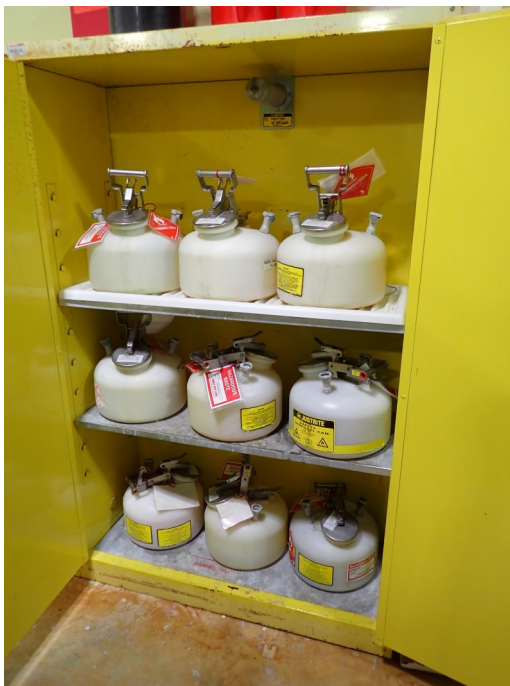
- a. One (1) yellow shelf labeled as flammable and Full HPLC Safety Cans no halogenated waste was observed. Inside, the latter had nine (9) 2.5-gallon⁶⁴ white plastic containers. At the time of the CEI, all of them were full⁶⁵, closed, labeled as hazardous waste, had a pictographic label and/or indication of the hazard, and appeared to be in good condition (Picture # 43). I asked the facility representatives where did this waste was generated. They told me that it was generated at the HPLC Laboratory Area. As a result, I asked them if this shelf was considered a SAA. They replied that is not a SAA, that is an intermediary area between the HPLC generation area and the 90-day HWAA.

Picture 43 — Laboratory Area-Chemical Storage Q3 Area— Here, one (1) yellow shelf labeled as flammable and Full HPLC Safety Cans no halogenated waste was observed. Inside, the latter had nine (9) 2.5-gallon white plastic containers.

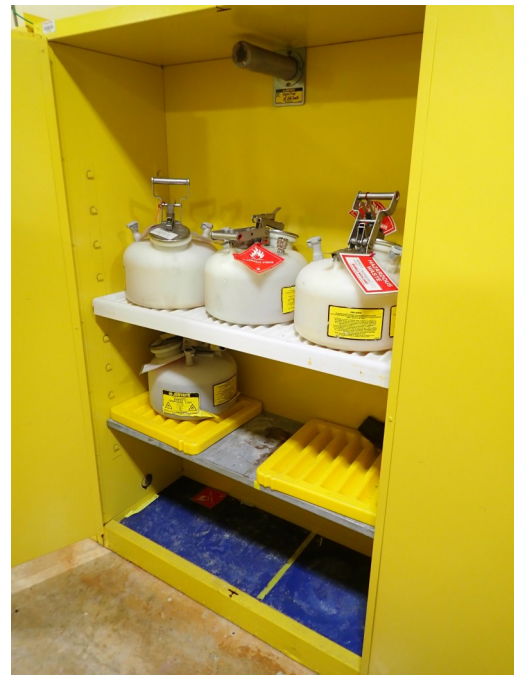
- b. One (1) yellow shelf labeled as flammable and Full HPLC Safety Cans no halogenated waste was observed. Inside, four (4) 2.5-gallon⁶⁶ white plastic containers were observed. At the time of the CEI, all of them were full⁶⁷, closed, labeled as hazardous waste, had a pictographic label and/or indication of the hazard, and appeared to be in good condition (Picture #44). I asked the facility representatives where did this waste was generated. They told me that, as previous information shared, it was generated at the HPLC Laboratory Area. As a result, I told them about the same issue, if this shelf is considered a SAA. They replied that all the containers observed are transferred daily from here to the 90-day HWAA. Mr. Rossy told me that usually, this action occurs every morning⁶⁸. I told them that additional information on this matter would be requested. Nevertheless, during the CEI in this location, information related to the facility SOP Waste Management QC Lab document was provided. The latter considered both shelves as SAA. The document identified them as SAA Room Q3- HPLC reservoir waste.

Picture 44 — Laboratory Area-Chemical Storage Q3 Area— Here, one (1) yellow shelf labeled as flammable and Full HPLC Safety Cans no halogenated waste was observed. Inside, the latter had four (4) 2.5-gallon white plastic containers.

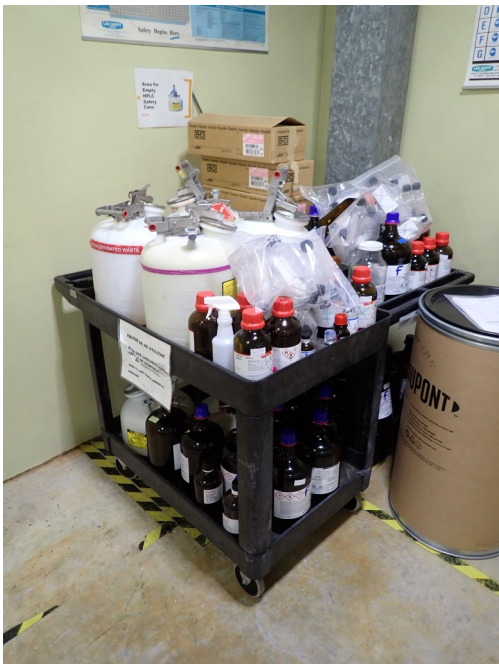
Additionally, I observed two (2) plastic carts with empty containers^{69 70} I asked them about the latter, and they told me that these would be recycled with Reciclaje del Norte, and they were rinsed at the hood that is located at the HPLC Laboratory Area. This subarea was identified as Empty HPLC Safety Cans (Picture #45). At the time of the inspection, five (5) 5-gallon white plastic containers were observed, where one (1) of them was empty. Also, all of them were observed labeled as hazardous waste and each one had a pictographic label and/or indication of the hazard. I asked the facility representatives about them, and they replied that, as previous containers observed on the shelves, they would also be transferred from this location to the 90-day HWAA.

Picture 45 — Laboratory Area-Chemical Storage Q3 Area— This subarea was identified as Empty HPLC Safety Cans. It consists of two (2) plastic carts with empty containers and five (5) 5-gallon white plastic containers, where one (1) of them was empty.

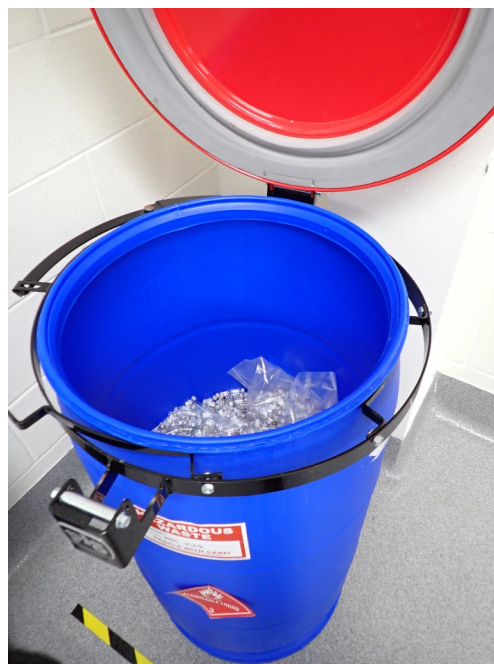
Here, one (1) 35-gallon⁷¹ blue plastic container with HPLC vials was observed closed, labeled as hazardous waste, and has a pictographic label⁷² and/or indication of the hazard available. Additionally, it was observed half full, the container appears to be in good condition, and the area was identified (Picture # 46). I asked the facility representatives about the hazardous waste generated at this location. They replied that the latter is generated in this room and from here is then moved to the facility's 90-day HWAA.

Picture 46 — Laboratory Area – Chemical Storage 26 Area— Here, one (1) 35-gallon blue plastic container with HPLC vials was observed closed, labeled as hazardous waste, and has a pictographic label available.

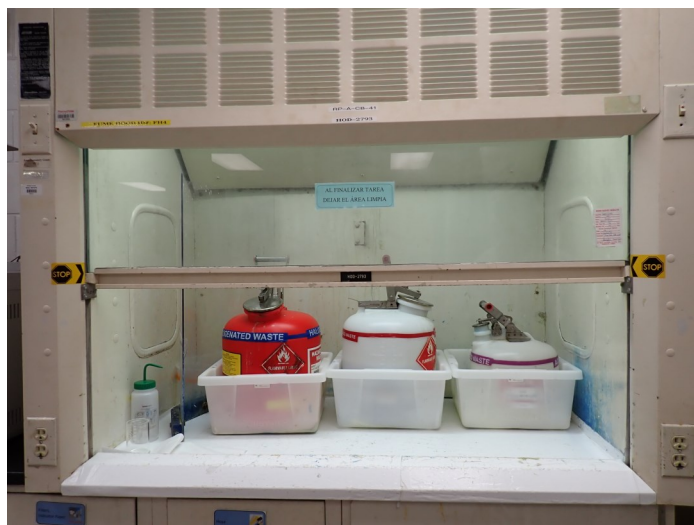
Description of the Area	This was the seventh area inspected. It is located in Building 401, inside the Chemical Storage Q5 room. According to the facility representatives, tests on raw materials are conducted at this location. Here, one (1) hood and HPLCs equipment were observed (Picture #47). At the time of the CEI, the area was undergoing construction activities ⁷³ . Mr. William Rosario, Lab Manager, Ms. Rosa Rosario, Supervisor, Ms. Erica Roman, Supervisor, and Mr. Oscar Colón, Supervisor, joined us at the inspection. Additional information on the latter is as follows.
-------------------------	---

Picture 47 — Laboratory Area – Chemical Storage Q5 Area— Located in Building 401, here, one (1) hood and HPLCs equipment were observed.

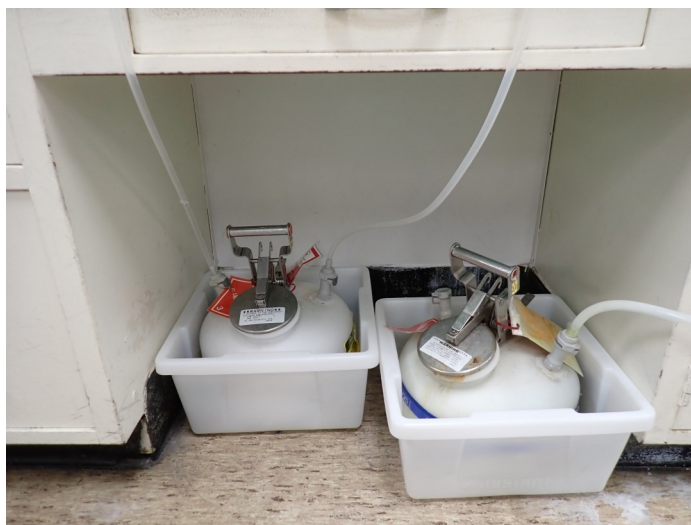
Picture 48 — Laboratory Area – Chemical Storage Q5 Area— Here, equipment identified as UPLC#LC_055 and UPLC#LC_054 were observed. At the time of the inspection, 2.5 white plastic containers were connected to the equipment, were labeled as hazardous waste, and had a pictographic label available.

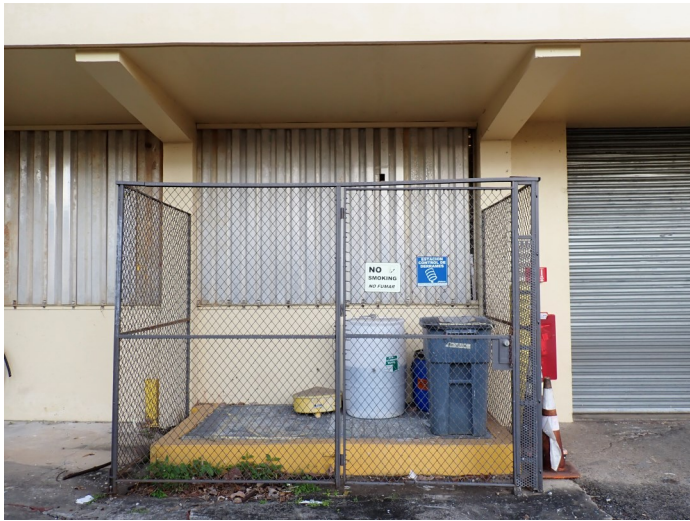
Picture 51 — Paint Storage Area— A metal-like cage area was observed closed and locked, had a cyclone fence as a physical barrier, and was located below a concrete high ceiling. Inside, two (2) containers were observed.

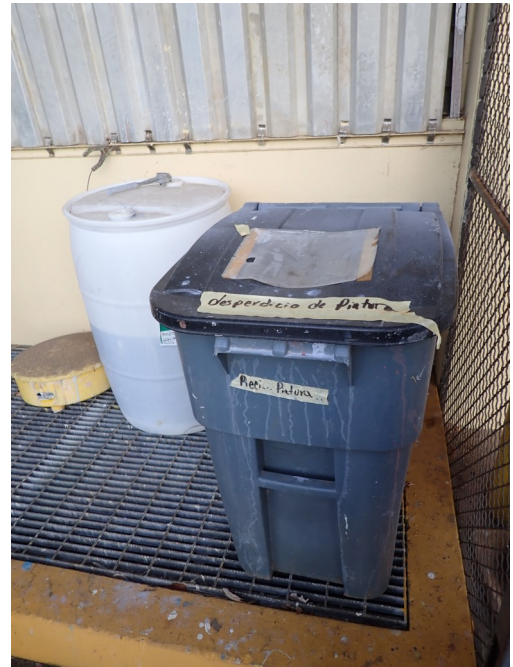
Picture 52 — Paint Storage Area—Here, one (1) trash can-like container was observed labeled as “Desperdicio de pintura”. According to the facility representatives, this container is not from them, is from the contractors.
