# NPDES Compliance Inspection Report

**Ultimate RB, Inc.  
McMinnville, Oregon**

**Permit #: ORR237043**

**Inspection Date: December 14, 2021**

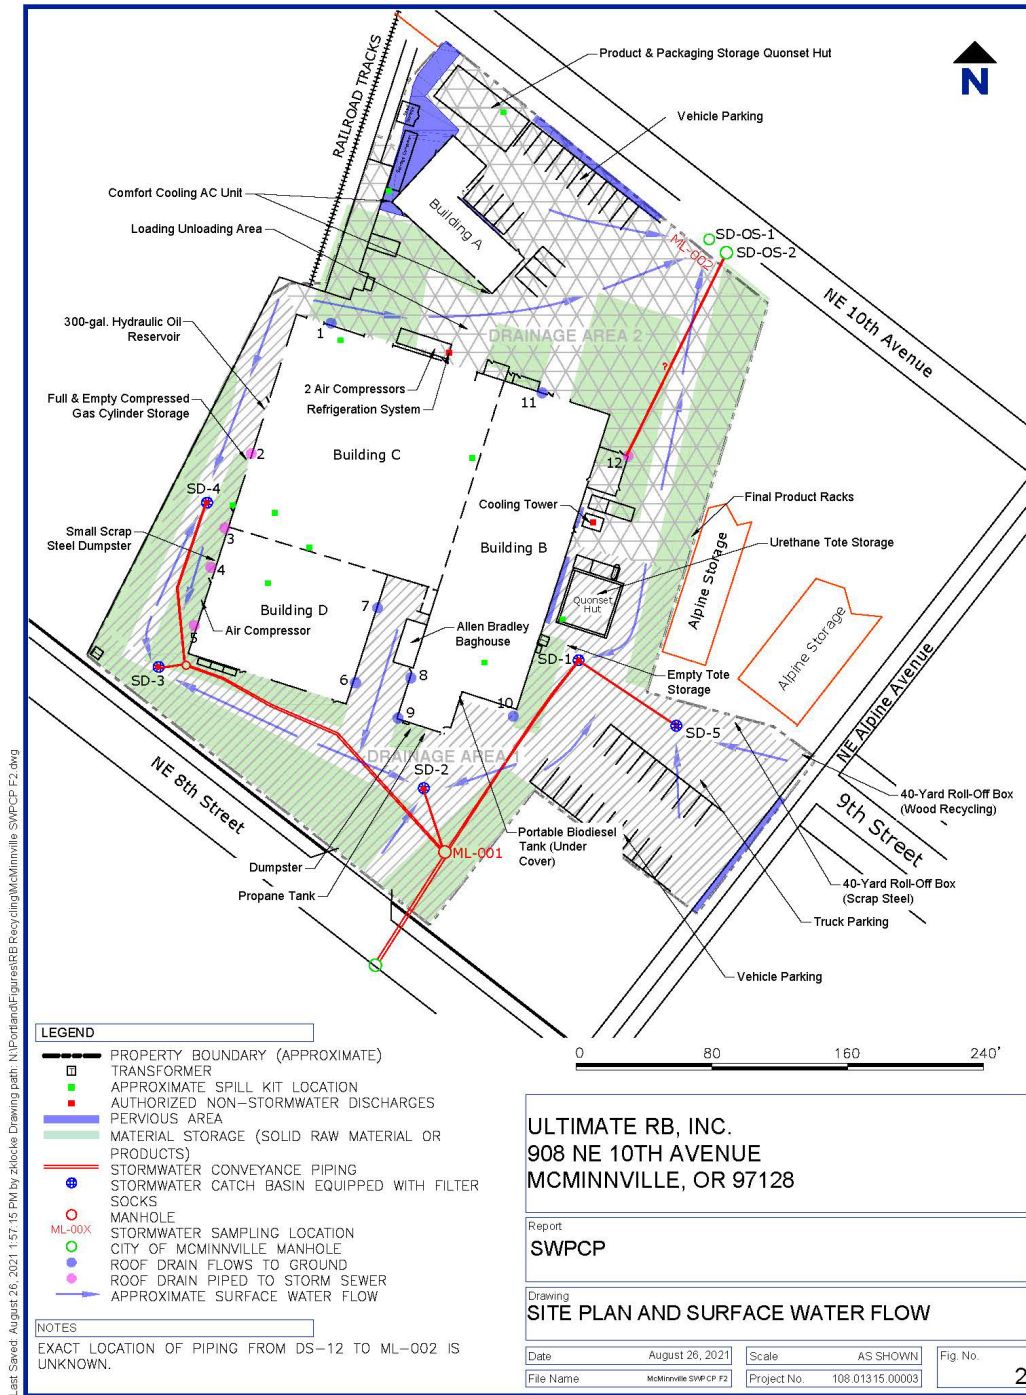
# Site Diagram Provided by Facility

At the time of inspection, I observed a large pile of crumb rubber stored outside of a production building. This piled material was not identified on the site map.

Upon review of the SWPCP, the SWPCP map, and the DMRs, I found two Monitoring Locations, ML001 and ML002, listed in the SWPCP and shown on the SWPCP map but only ML001 was on the DMRs as being monitored. I did not see any evidence to support any of the three justifications for exclusion mentioned in the Permit.
