# **NPDES Reconnaissance Inspection Report**

**Superior Systems, Inc.**

**EPA Unpermitted No. WAU000671**

**Reconnaissance Inspection Date: September 12, 2023**

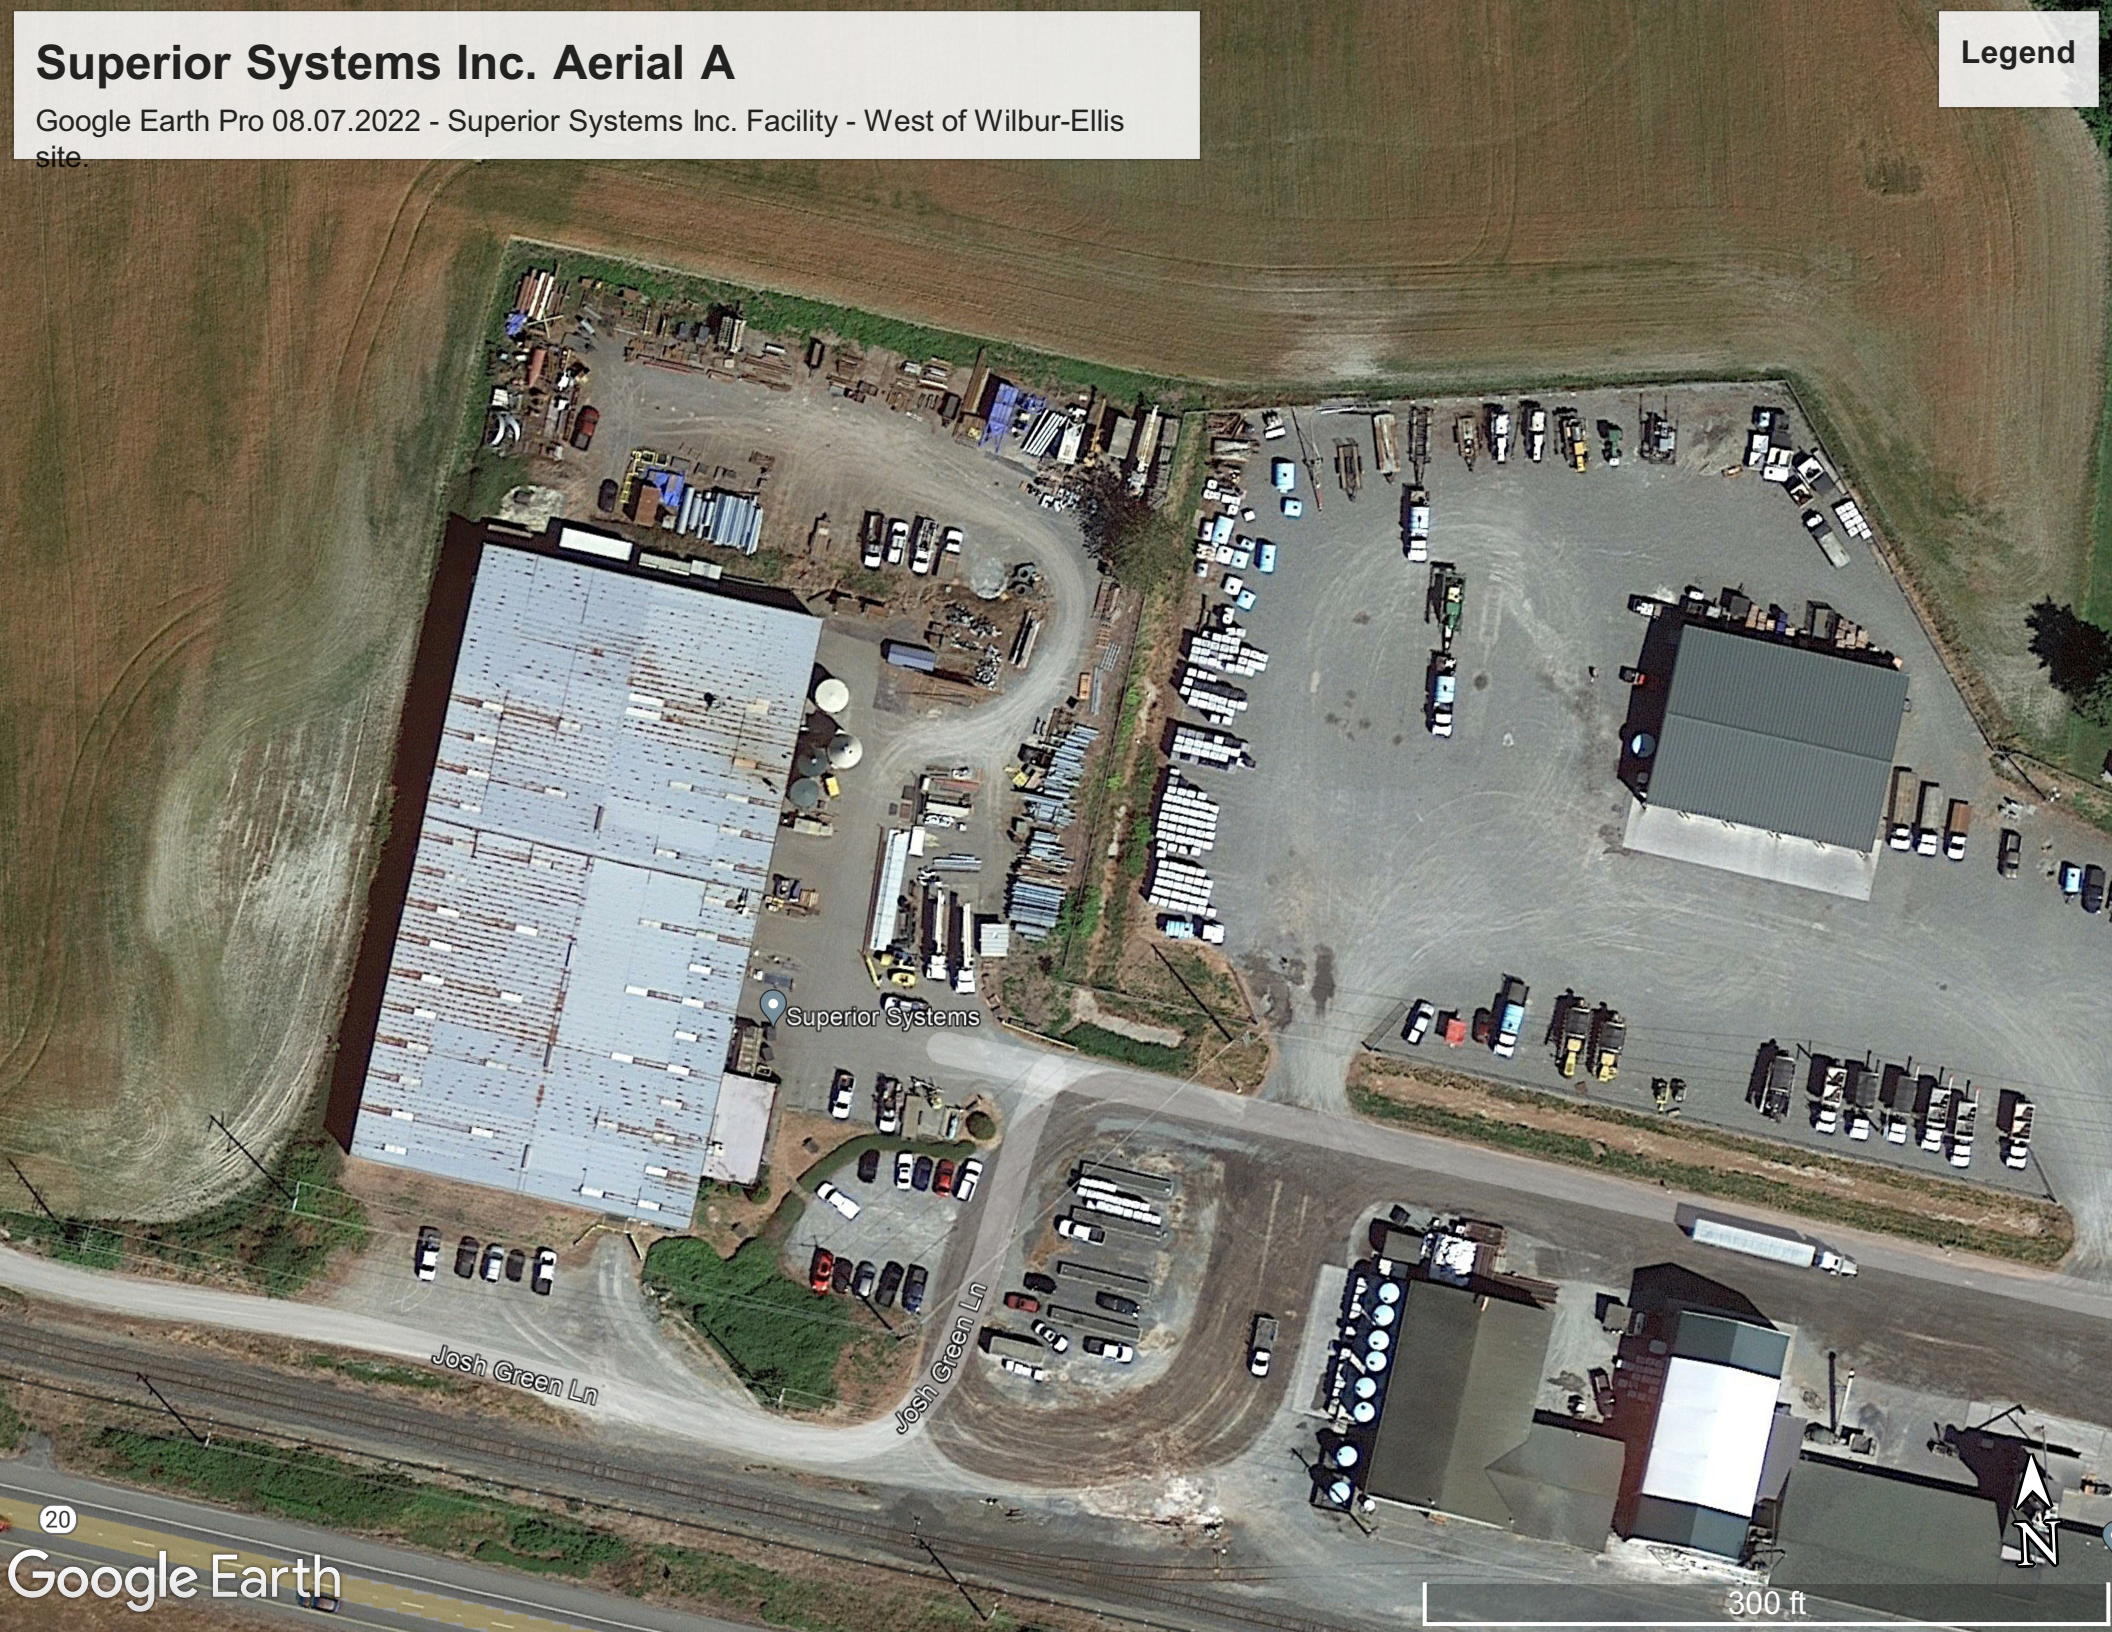
Google Earth Pro 08.07.2022 - Superior Systems Inc. Facility - West of Wilbur-Ellis site.

We also walked the northern area of the Facility site, along the northern-located equipment and material storage areas. We observed 3 stormwater catch basins (CB), spaced approximately 75 feet apart, running in an east-west direction along the gravel travel area of the SSI Facility's northern material storage areas. *See*, Attachment C, Superior Systems Inc. Aerial B (three red arrows pointing to CB locations (Google Earth Pro 08.07.2022)).

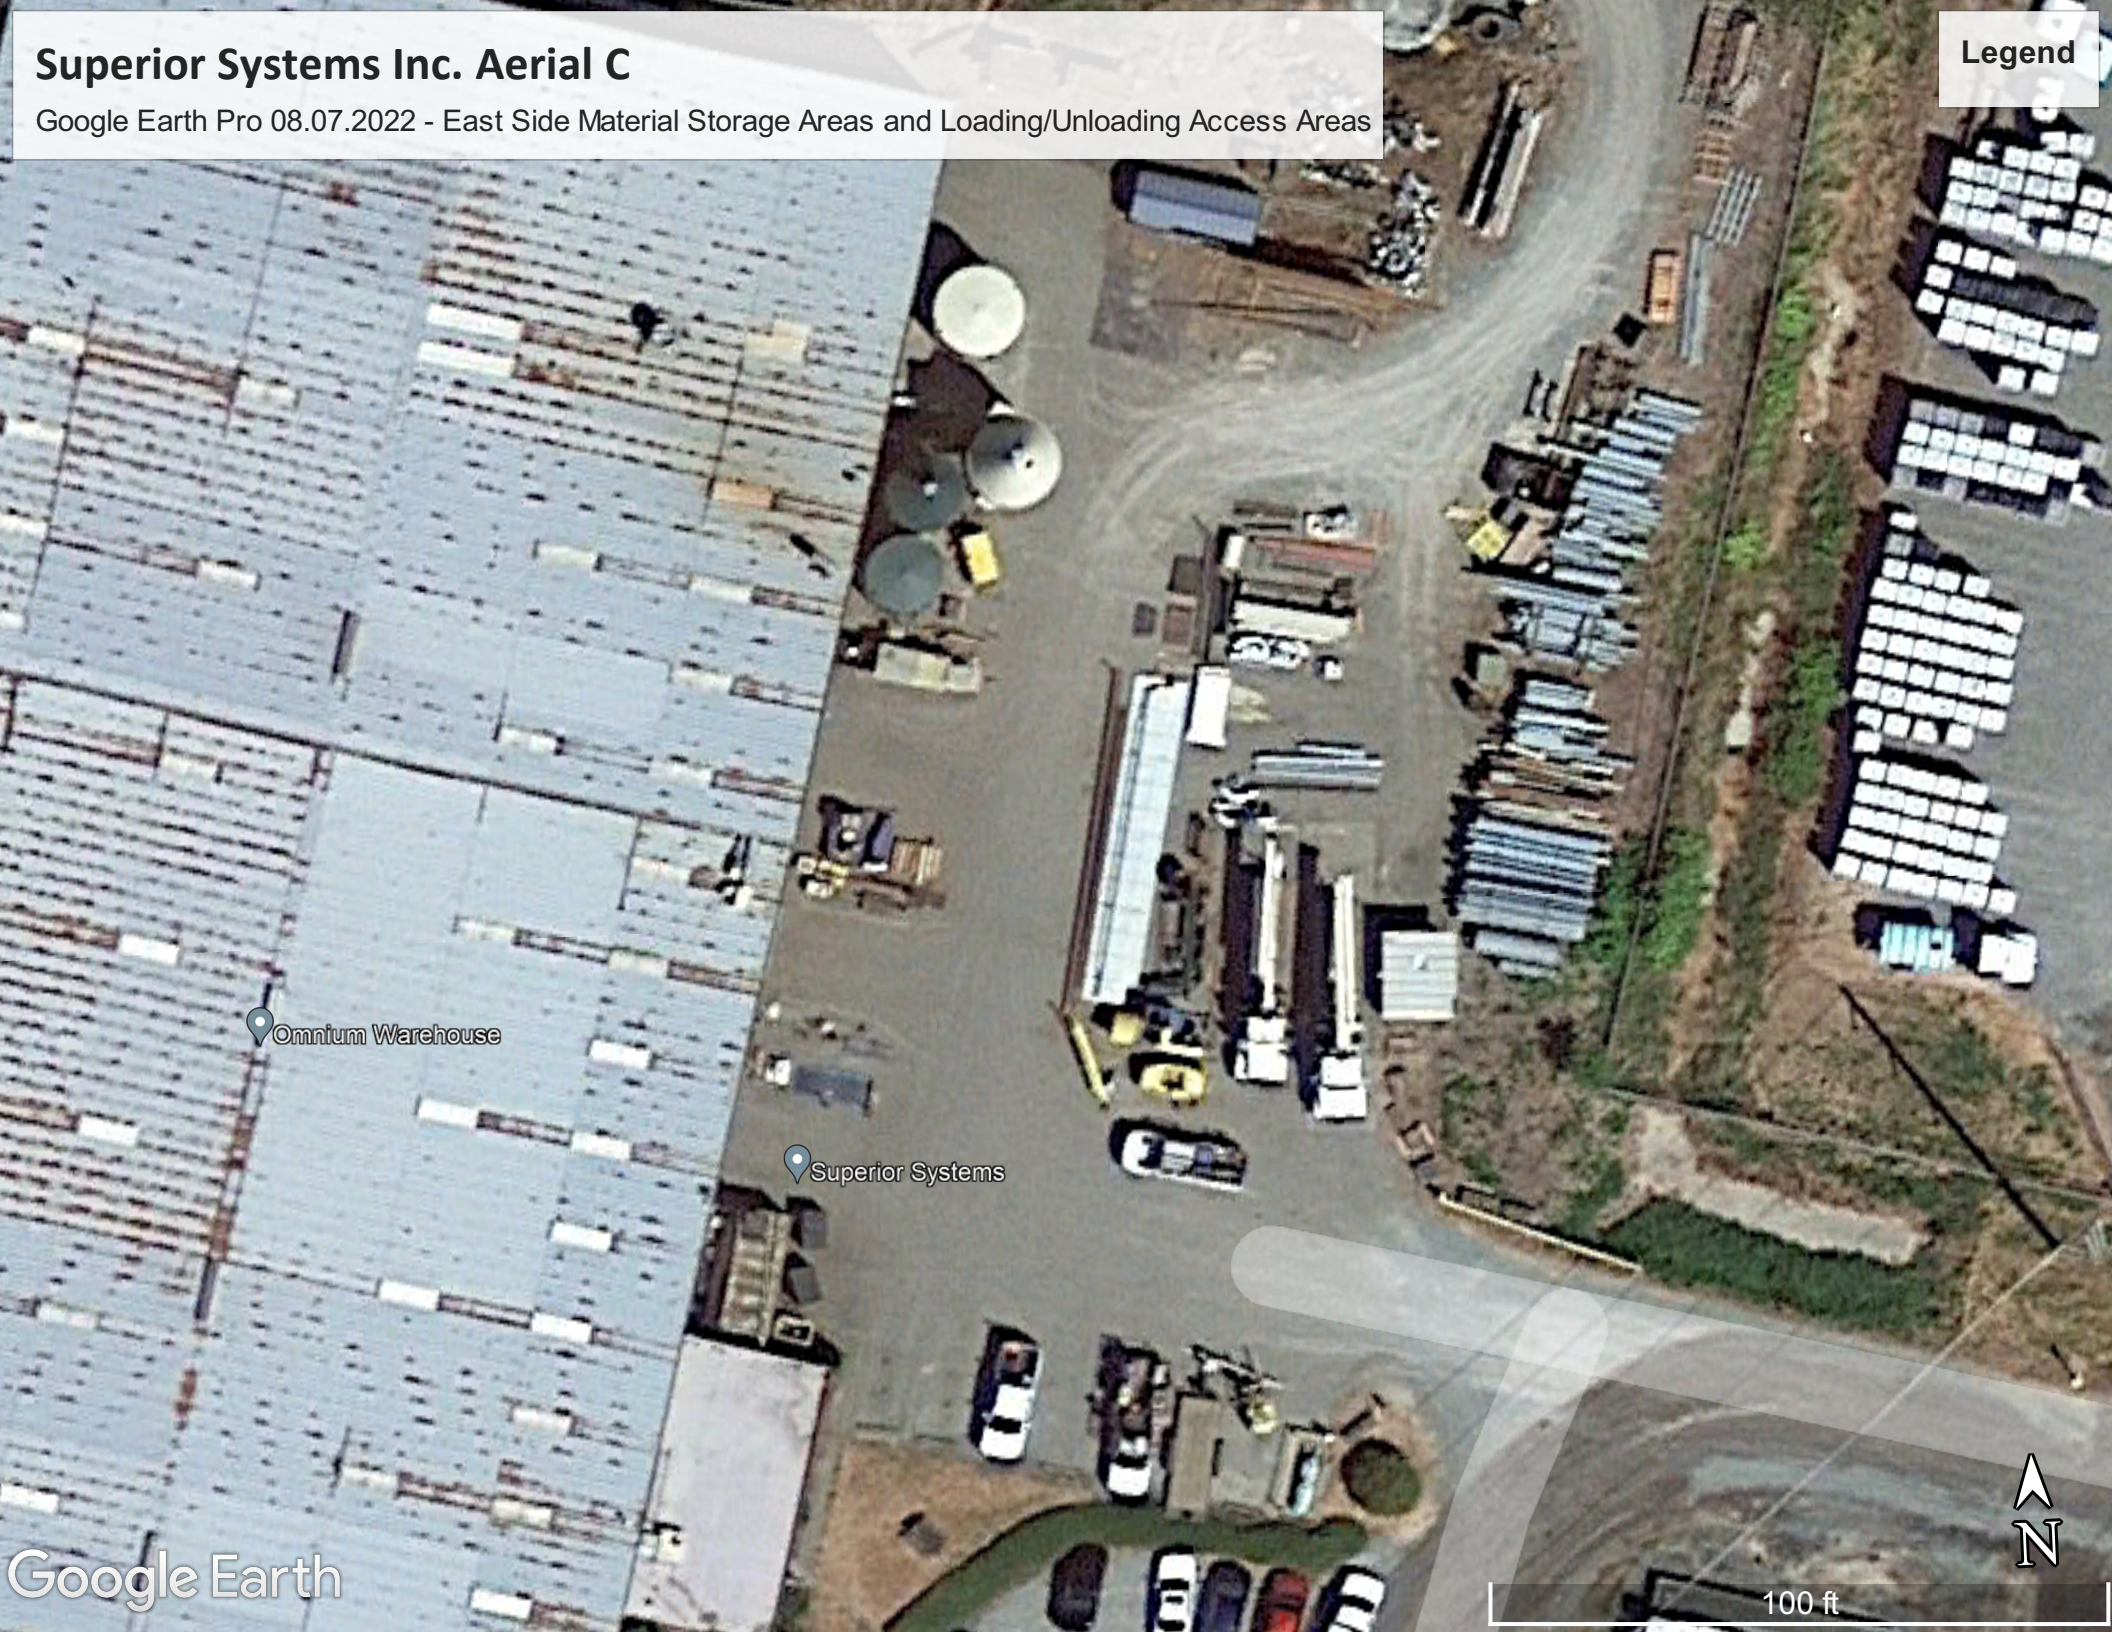
Google Earth Pro 08.07.2022 - East Side Material Storage Areas and Loading/Unloading Access Areas

From the biofiltration swale location, we proceeded to walk north between the building and the east-side material and equipment storage areas which grade is sloped toward the SSI/WEC border and the WEC biofiltration swale. Much of the stored materials appeared to be galvanized steel. Observations were also made of the roof downspouts which discharged to the sloped grade in an easterly direction. The Attachment C aerial images, Aerial B and Aerial C, were apparently take in August 2022 but they accurately depict the general equipment and material storage conditions observed on September 12. *See*, Attachment C, Superior Systems Inc. Aerials B and C (Google Earth Pro 08.07.2022).
