**Report Title:** Clean Water Act, Section 404 Inspection Report, Groff  
**Inspection Date(s):** September 19, 2023  
**Start Time:** 9:10 AM **End Time:** 1:45 PM  
**Regulatory Program(s):** Clean Water Act, Sections 308 & 404 (33 U.S.C. §§ 1318 & 1344)

**Site Name:** Groff Site  
**Site Location:** 100 Mill Road, Turbotville, PA 17772 (Montour County)  
**Latitude:** 41.095859 **Longitude:** -76.727306  
**County/Parish:** Montour

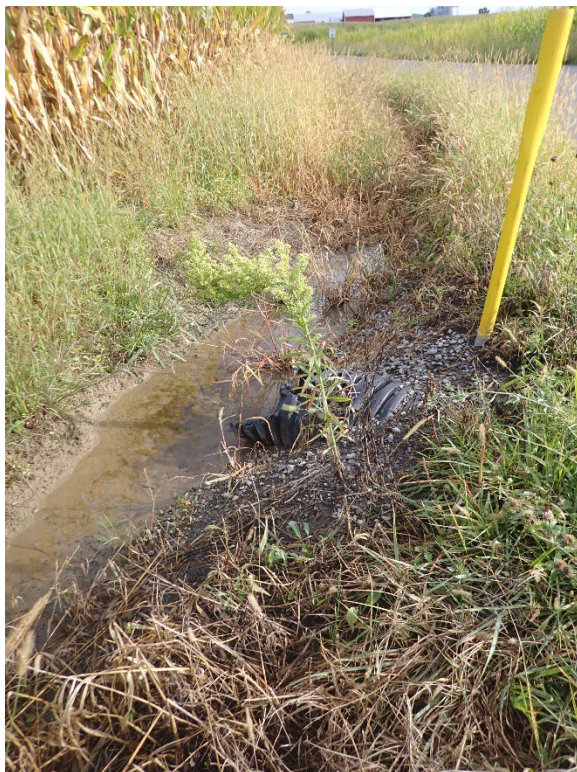
**Photograph I.E.** Culvert connecting flowing water between corn field and Mill Road to swale on northwest corner of Wetland 19. Facing North.

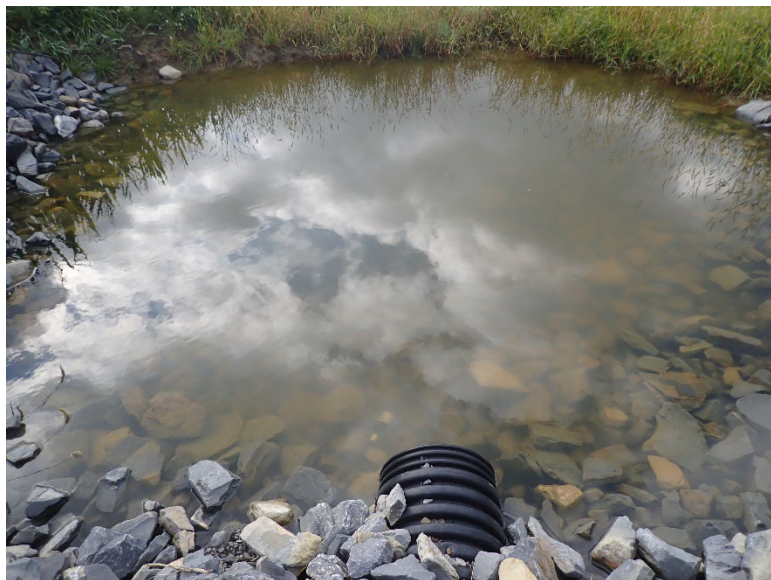
**Photograph II.D.** Culvert leading to swale at northwest corner of Wetland 19.

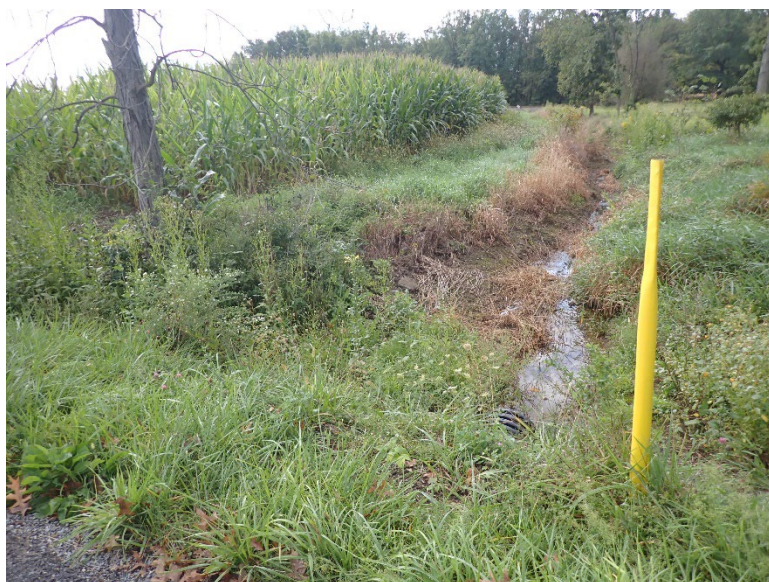
**Photograph IV.B.** Excavated Wetland 16 tributary. Facing south from Mill Road.

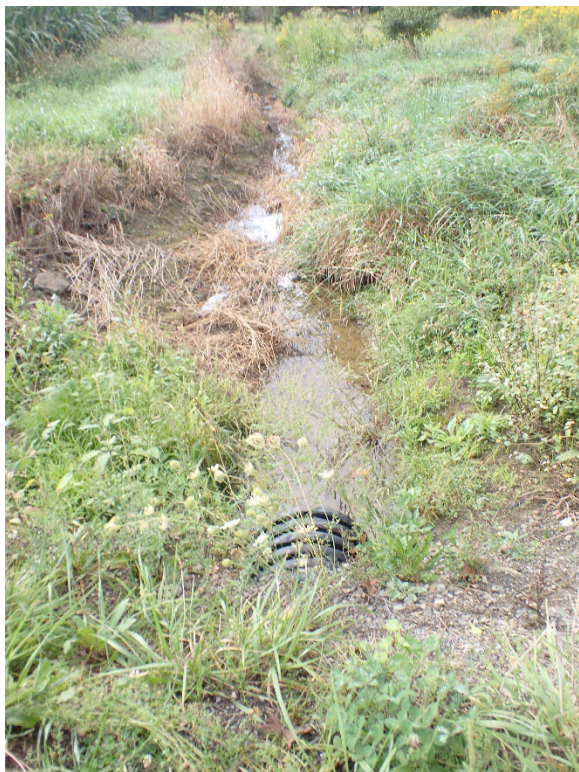
**Photograph IV.C.** Excavated Wetland 16 tributary. Facing south from Mill Road.

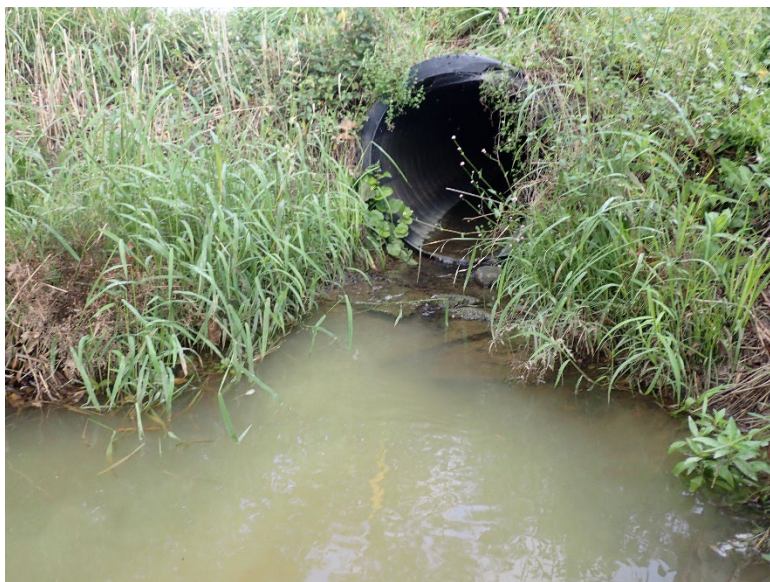
**Photograph IV.D.** Excavated Wetland 16 tributary culvert. Facing north.

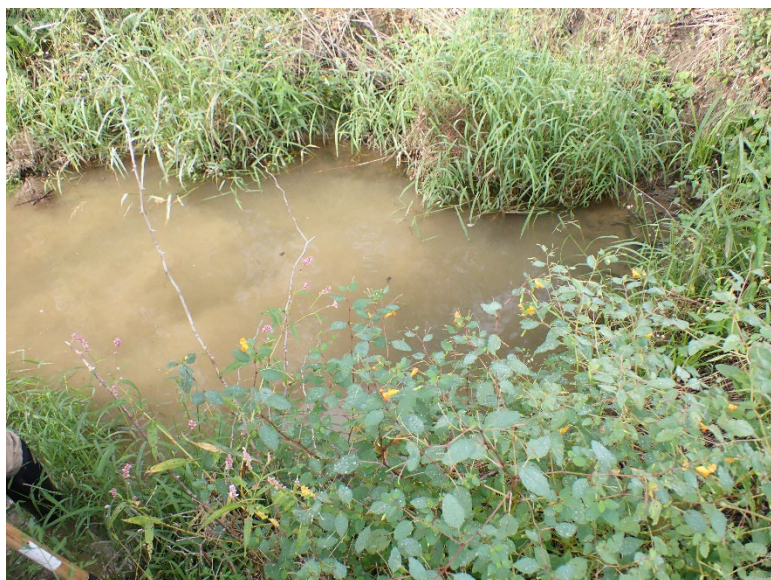
**Photograph IV.E.** Reed canary grass and jewelweed along banks of excavated Wetland 16 tributary.

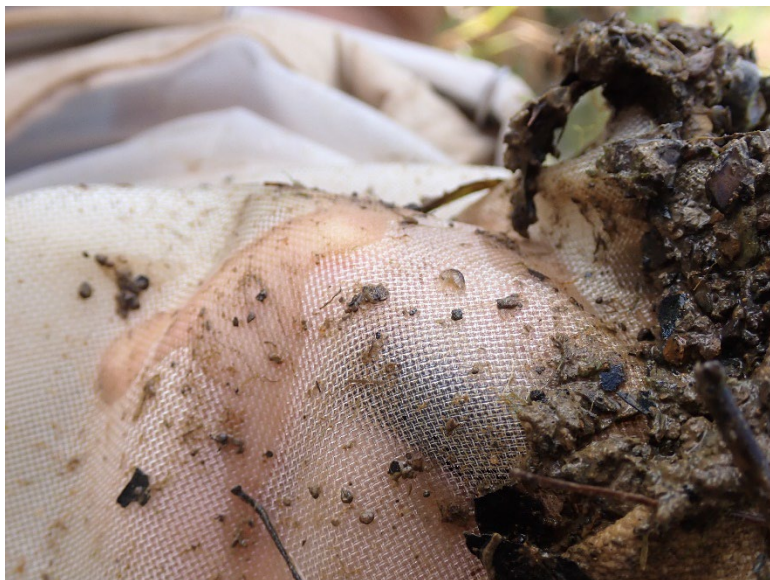
Benthic invertebrates, fish, algae, wrack lines, water-stained vegetation, and floating pondweed (*Potamogeton natans*) were observed along the excavated tributary (Photograph V.A – V.F). Evidence of earth-moving activities, including tree-clearing, grubbing, and grading were observed as burned bits of tree stumps were found within the corn field populating Wetland 16 (Photograph V.G).

**Photograph V.B.** Benthic invertebrates observed within excavated Wetland 16 tributary.

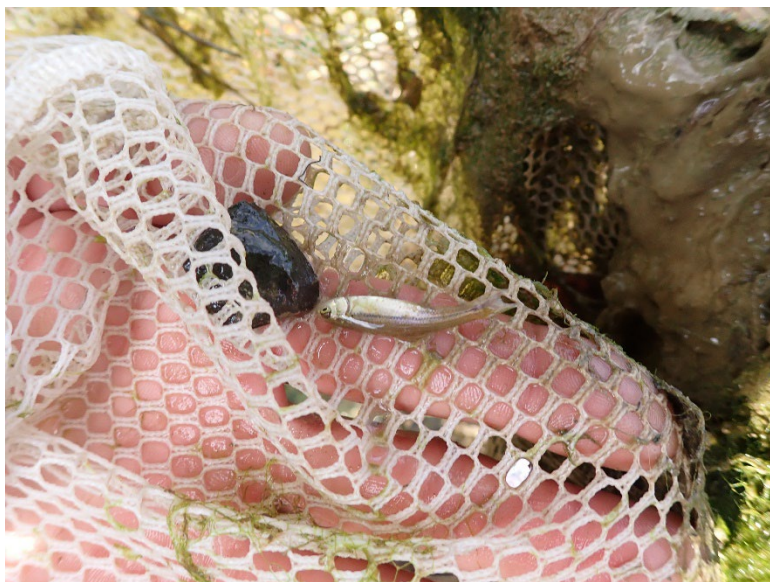
**Photograph V.C.** Fish observed in excavated Wetland 16 tributary.

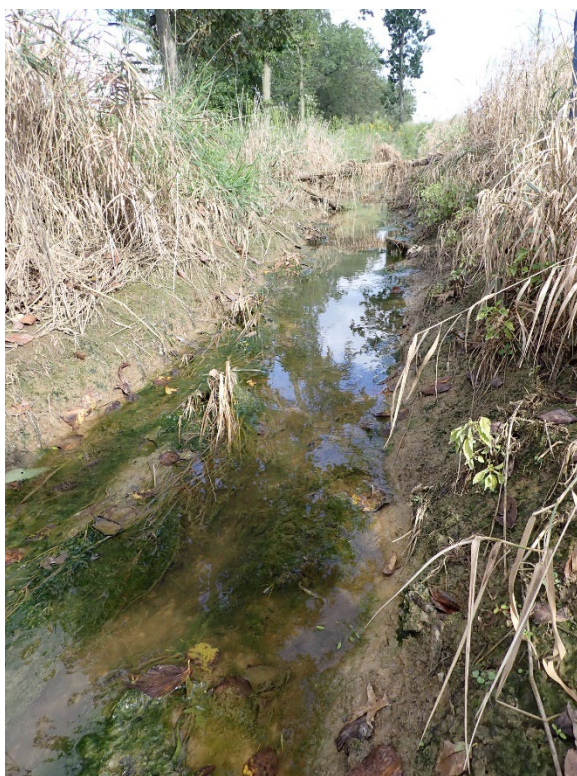
**Photograph V.E.** Excavated Wetland 16 tributary. Facing North.

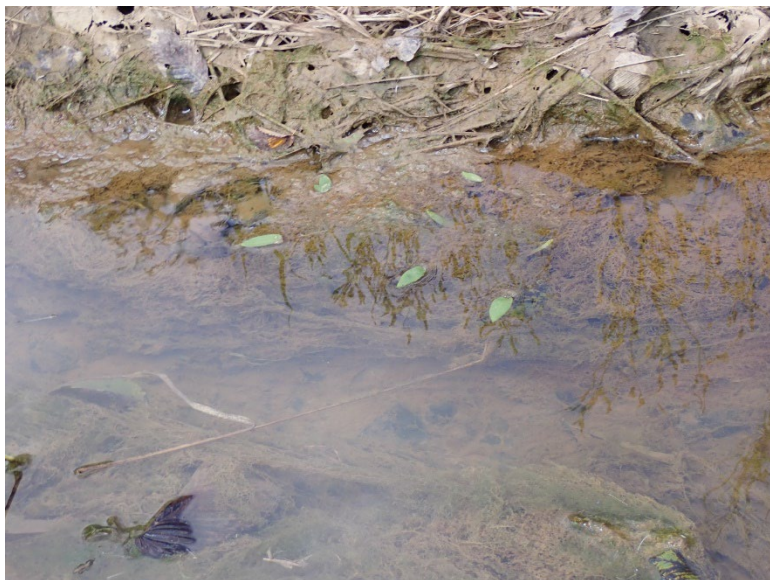
**Photograph V.F.** Floating pondweed observed in excavated Wetland 16 tributary.

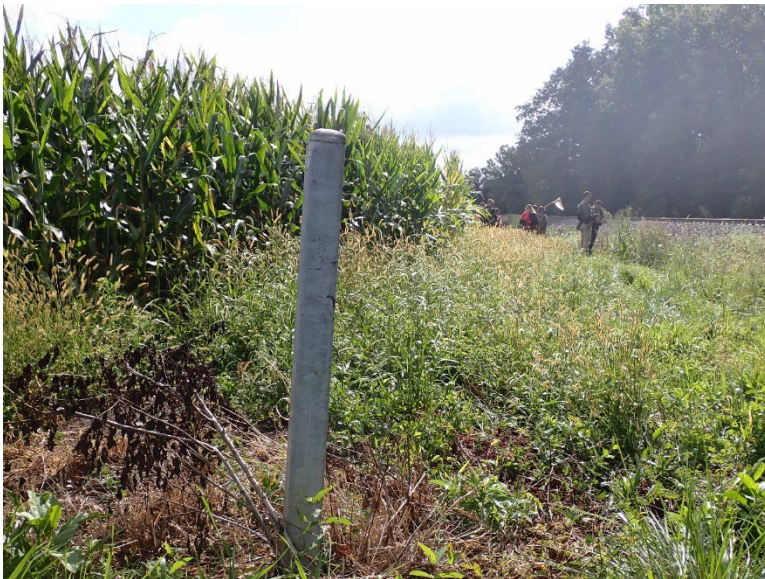
Corn crops were observed to be growing in the pipeline easement, situated directly between the southern border of Wetland 16 and the Railroad tributary. The boundary of the pipeline easement was marked by a water pipeline post (Photograph V.H – V.I).

**Photograph V.I.** Water pipeline post, marking the boundary of the easement, at south end of excavated Wetland 16 tributary.

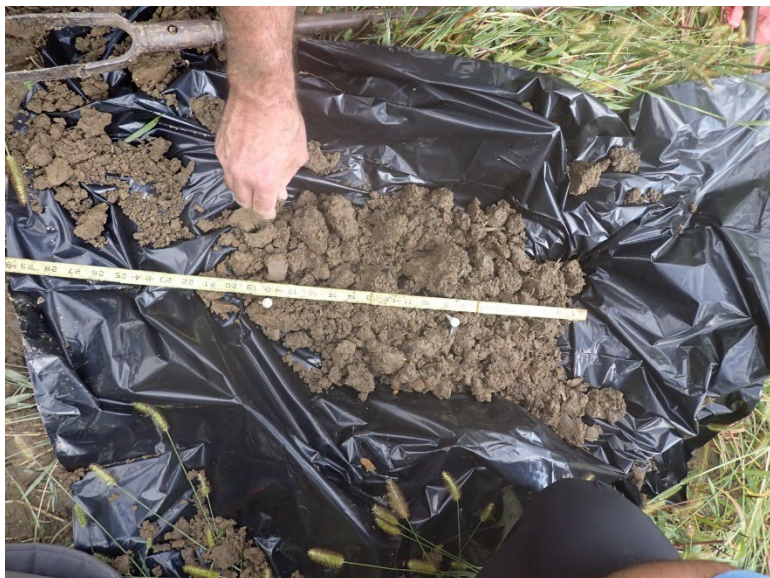
**Photograph VI.C.** DP1: Soil profile.

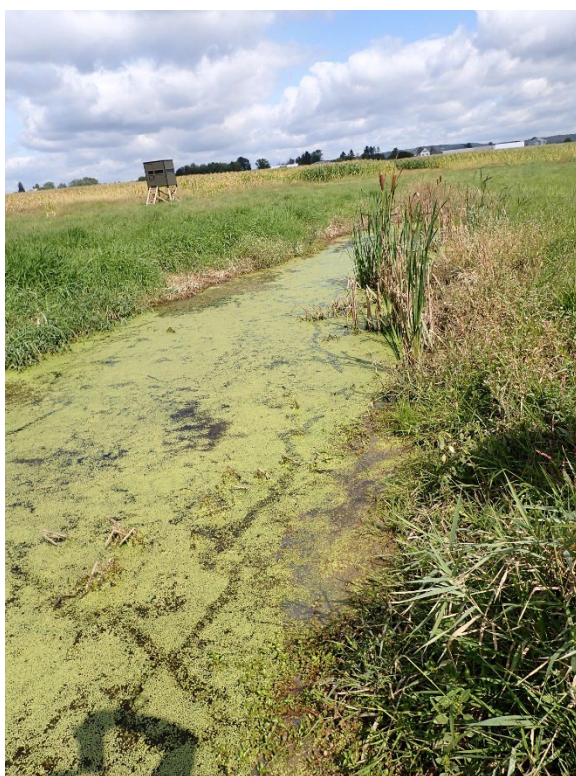
A direct connection between the two water bodies was documented in Photograph VIII.A. Flowing water, wrack lines, algae, and plow lines were observed in the area, as well as dying and stunted corn crops within Wetland 19 (Photograph VIII.B – VIII.I).

**Photograph VIII.B.** Excavated Wetland 19 tributary. Facing north.

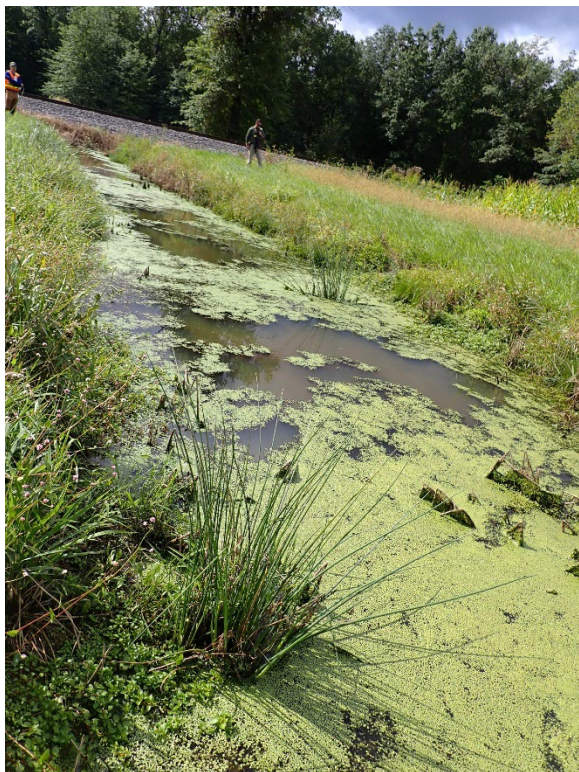
**Photograph VIII.C.** Excavated Wetland 19 tributary. Facing south.

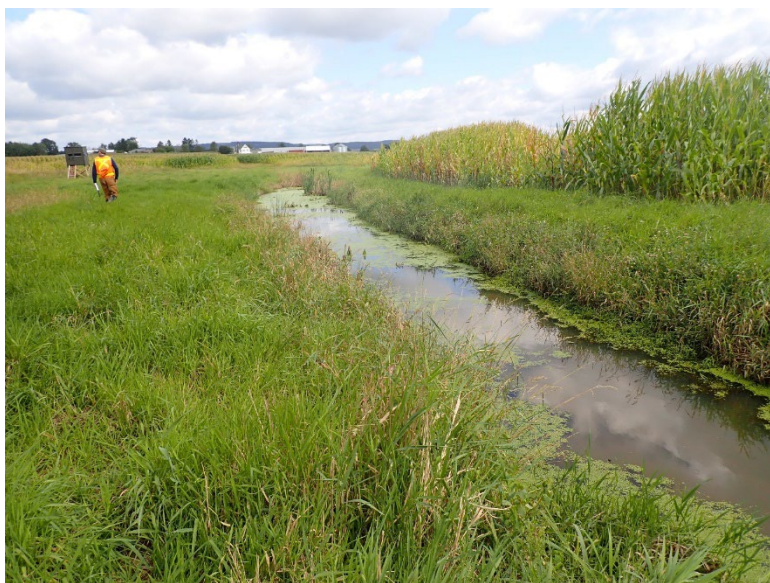
**Photograph VIII.D.** Excavated Wetland 19 tributary. Facing north.

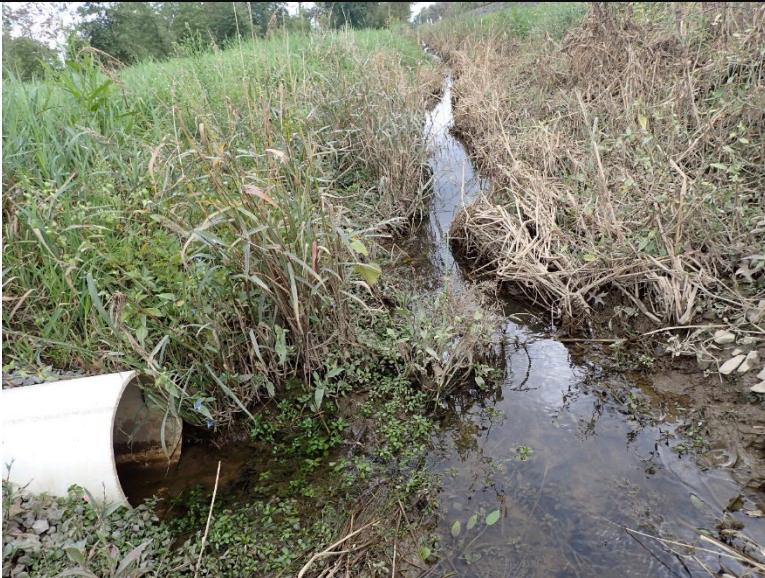
The inspection walkthrough continued from Point 5, southeast along the pipeline easement. A culvert draining water out of Wetland 8 into the Railroad tributary was observed (Photograph XI.A – B). Reed canary grass (*Phalaris arundinacea*) dominated the area (Photograph XI.C – XI.D). Evidence of tree-clearing in Wetland 8 was observed (Photograph XI.E – XI.G).

**Photograph XI.A.** Culvert draining Wetland 8 into Railroad tributary. Facing southeast along Railroad tributary.

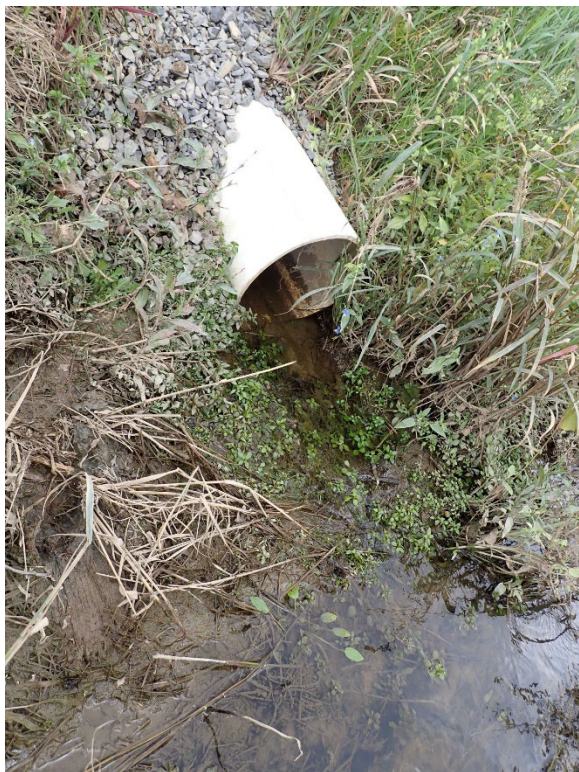
**Photograph XI.B.** Culvert draining Wetland 8 into Railroad tributary.

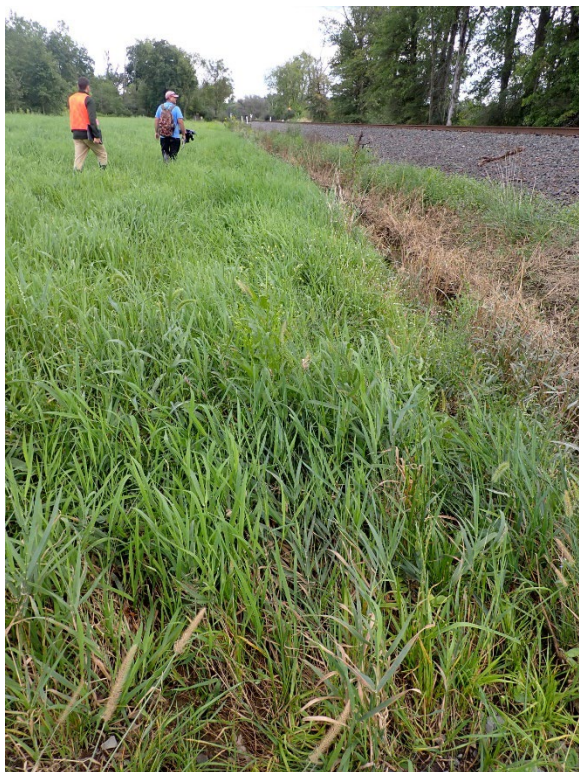
**Photograph XI.C.** Easement. South of Wetland 8, facing southeast.

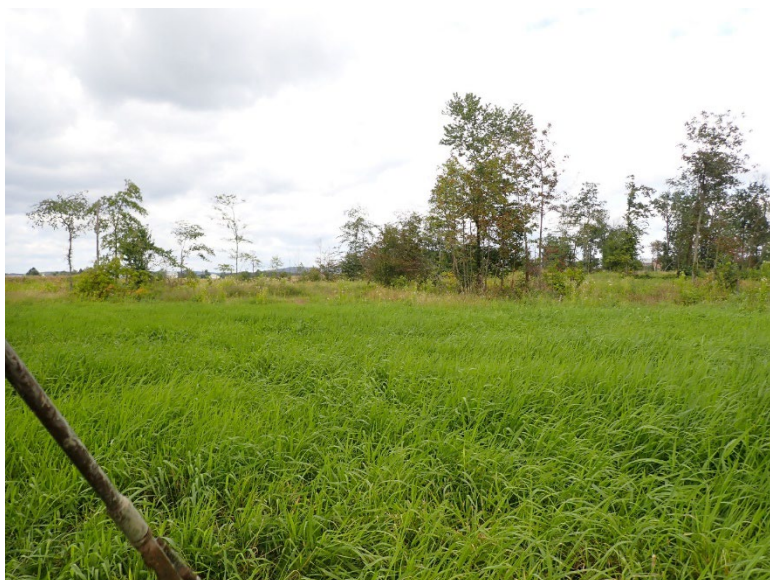
**Photograph XI.F.** Wetland 8. Facing north from easement.

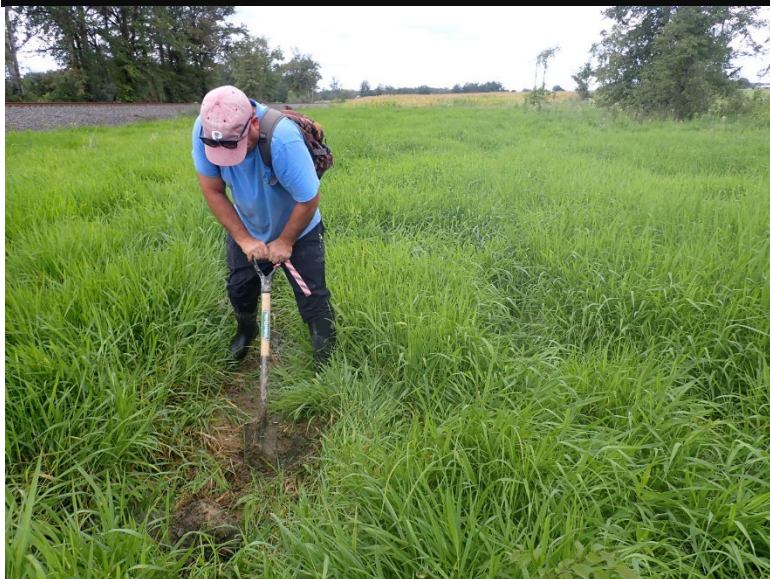
**Photograph XIII.A.** Location of DP4. Facing west within the easement.

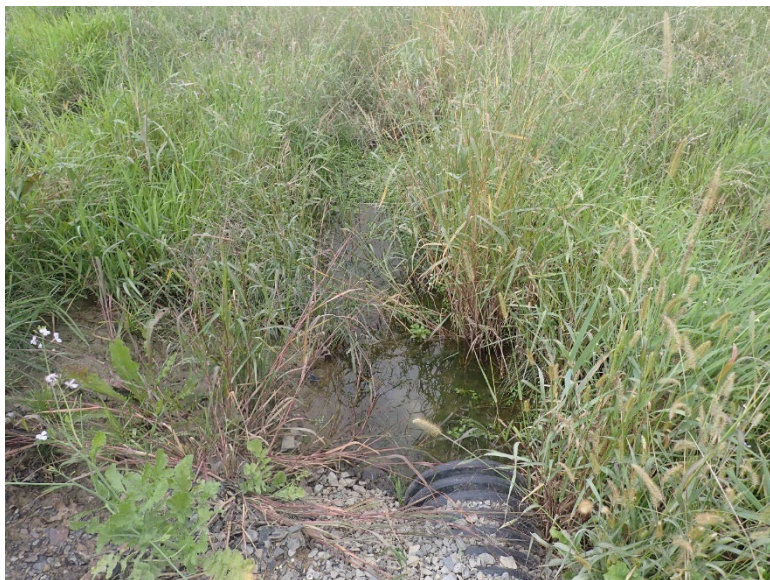
The inspection walkthrough continued from DP4, northwest along Wetland 8. A culvert draining Wetland 8, a drain line, mechanized tire tracks, wrack lines, and burned tree stumps were observed (Photograph XIII.G – XIII.K).

**Photograph XIII.G.** Second culvert draining Wetland 8. Facing South.

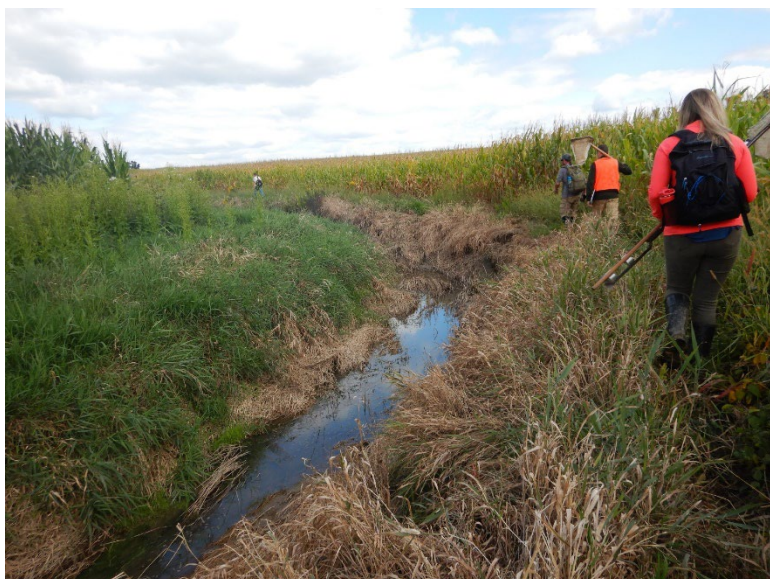
**Photograph XVI.A.** UNT-1. Facing north.

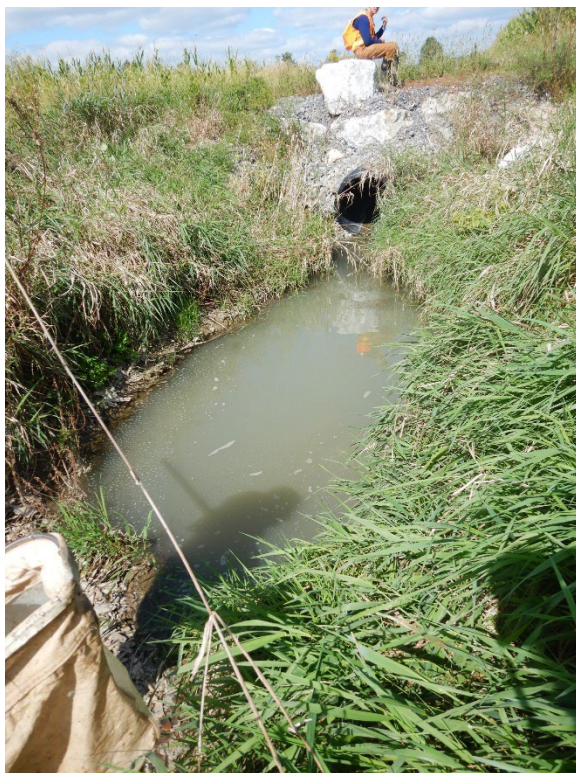
**Photograph XVII.B.** Swale and culvert along UNT-1. Facing north.

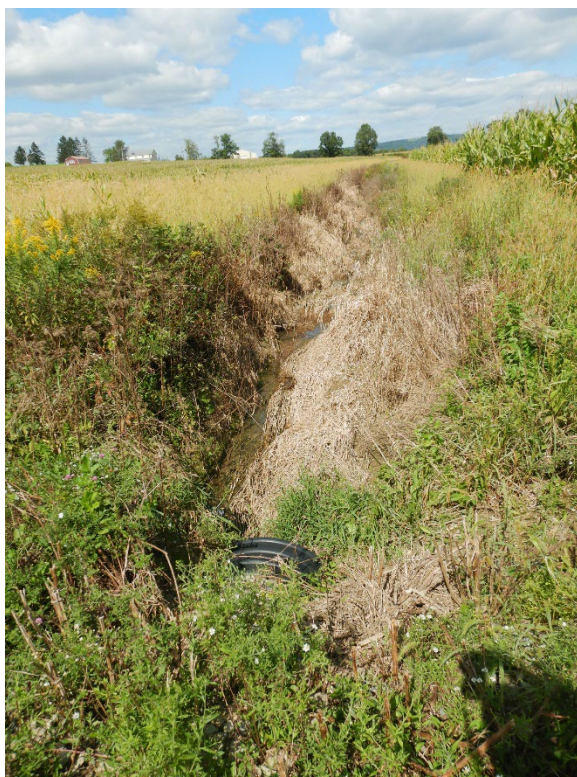
**Photograph XVII.D.** North extension of UNT-1. Observed while standing on an unnamed path atop a culvert along UNT-1.

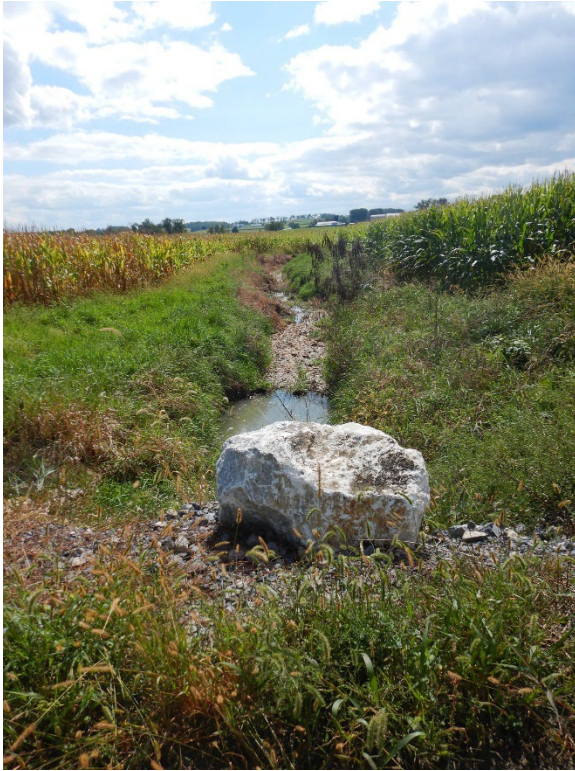
**Photograph XVII.E.** South extension of UNT-1. Observed while standing on an unnamed path atop a culvert along UNT-1.
